CONTENTS

SPECIAL BULLETINS

INTERIM REPORTS

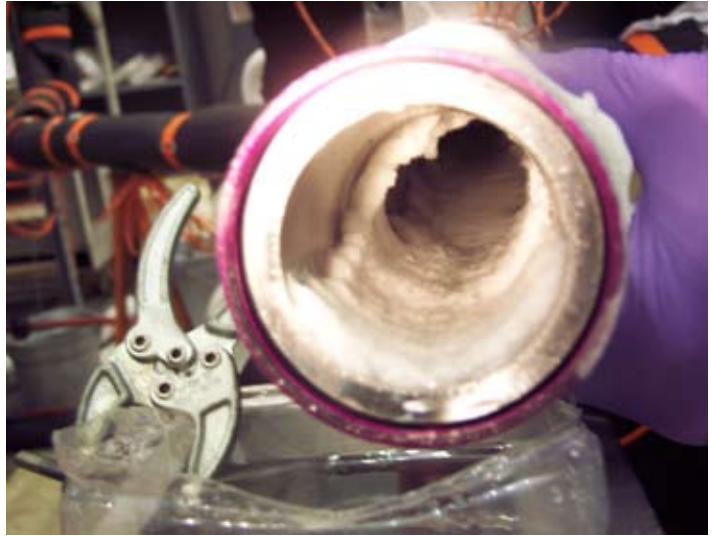
Figure 1

- Ice formed around the inside of all the fuel feed pipes from the boost pump discharge port to the front of the strut when fuel flowed for 3 hours at temperatures of -12°C (10°F) and -20°C (-4°F). The thickness of the ice was similar (1 to 2 mm) at both temperatures; however at -12°C (-10°F) the build-up of ice was more consistent and visually there appeared to be more ice throughout the system.

Ice in the flexible hose located at the rear of the strut

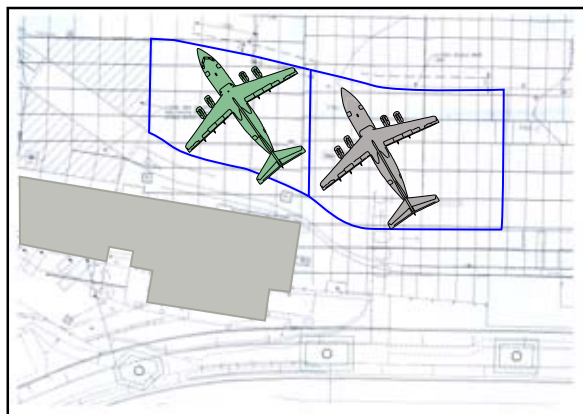
Location of the two parked aircraft.

D-AVRJ is the aircraft on the right and is about to taxi off the stand

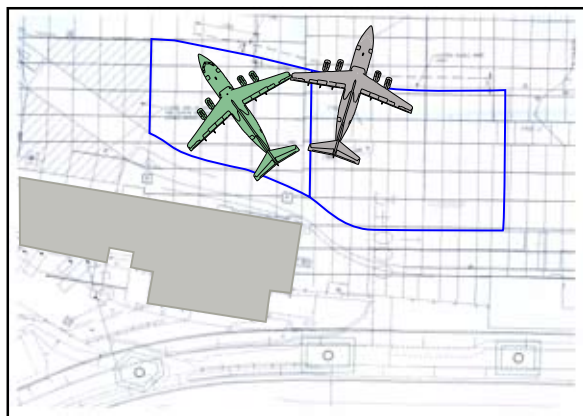
Position of the aircraft after the initial movement of D-AVRJ, which has stopped due to inadequate clearance between the left wing tip of D-AVRJ and the right wing tip of G-BZAT

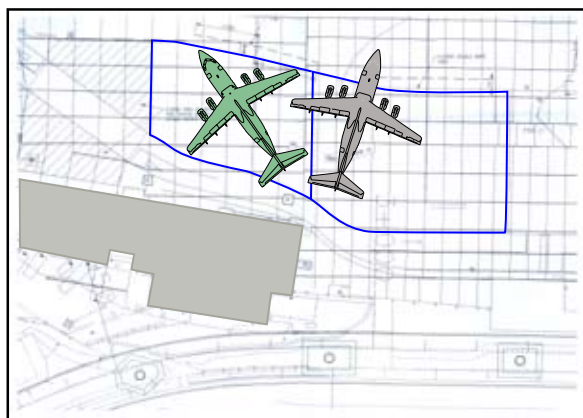
Position of the aircraft after D-AVRJ has been pushed backwards by a tug to provide additional wing tip clearance

When taxiing off Stand 10, the commander of D-AVRJ commenced a right turn, to ensure sufficient clearance with the RJ100. The aircraft was stopped on a heading of 013°(M). The heading then increased further during the pushback to 018°(M). The net effect of this was to increase the wingtip clearance, whilst reducing the tail clearance between the two aircraft, which went unnoticed.

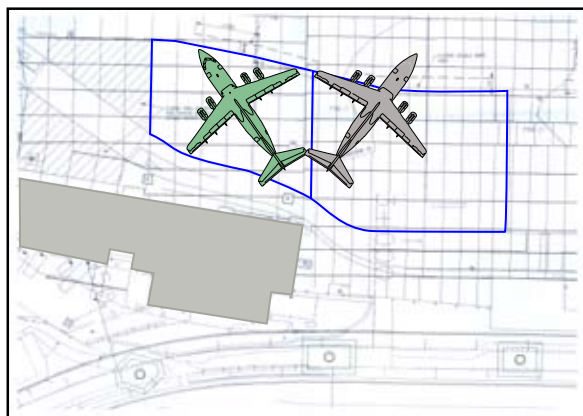
Figure 1

Position of the aircraft after D-AVRJ has taxied forward and contact has been made between the two horizontal tail planes

As D-AVRJ taxied forward again and turned to the right, its tail would have moved to the left, further reducing the tail clearance to the point where contact occurred.

The collision occurred due to a combination of the RJ100 on Stand 11 being parked 1 m to the right of its stand centreline, D-AVRJ on Stand 10 being pushed back onto a heading which further reduced the tail clearance, and the limited clearance between aircraft of this size when using these stands. The absence of a person monitoring the tail area meant that the inadequate tail clearance was not identified prior to the collision.

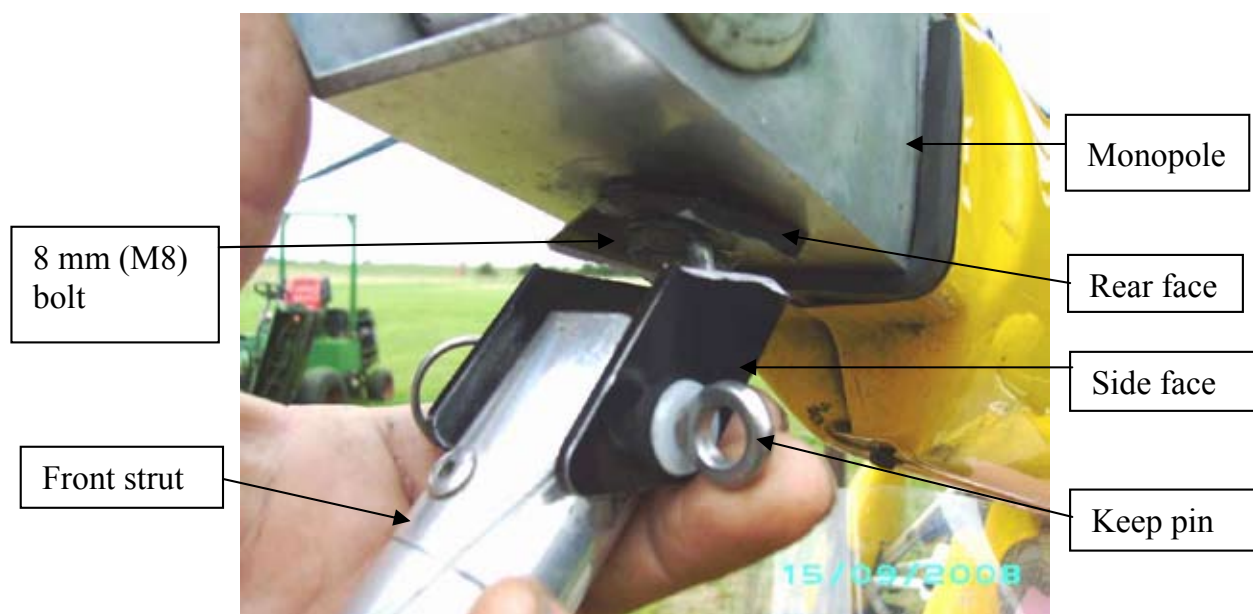
Figure 1

When rigging the aircraft it is possible for the upper bracket to rotate about the M8 securing bolt, such that the bracket is then orientated upside down. During the investigation a bracket on another Quantum aircraft was orientated upside down and an attempt was made to fit the front strut without the wing attached to the monopole. With the bracket in this orientation the distance between the keep pin holes in the bracket and the lower strut assembly was greater than when the bracket was correctly orientated and it was not possible to fit the keep pins. However, the manufacturer has stated that with the wing fitted to the monopole, the

Failed front strut bracket on G-BZMI

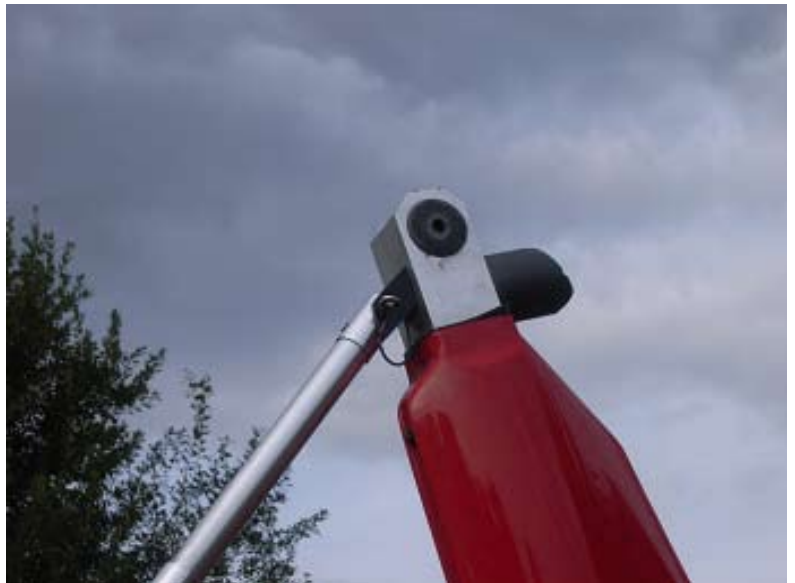
Figure 2

When the microlight is correctly rigged the front strut is aligned with the upper bracket (Figure 2).

Correct orientation of bracket
