CONTENTS

INCIDENT

Aircraft Type and Registration:	Boeing 757-3CQ, G-JMAB	
No & Type of Engines:	2 Rolls-Royce RB211-535E4-B-37 turbofan engines	
Year of Manufacture:	2001	
Date & Time (UTC):	12 December 2007 at 1935 hrs	
Location:	Stand 32, Manchester Airport	
Type of Flight:	Commercial Air Transport (Passenger)	
Persons on Board:	Crew - 10	Passengers - 283
Injuries:	Crew - None	Passengers - None
Nature of Damage:	Front of No 1 engine nacelle dented at one o'clock position	
Commander's Licence:	Airline Transport Pilot's Licence	
Commander's Age:	48 years	
Commander's Flying Experience:	10,048 hours (of which 6,119 were on type) Last 90 days - 94 hours Last 28 days - 55 hours	
Information Source:	Aircraft Accident Report Form submitted by the pilot

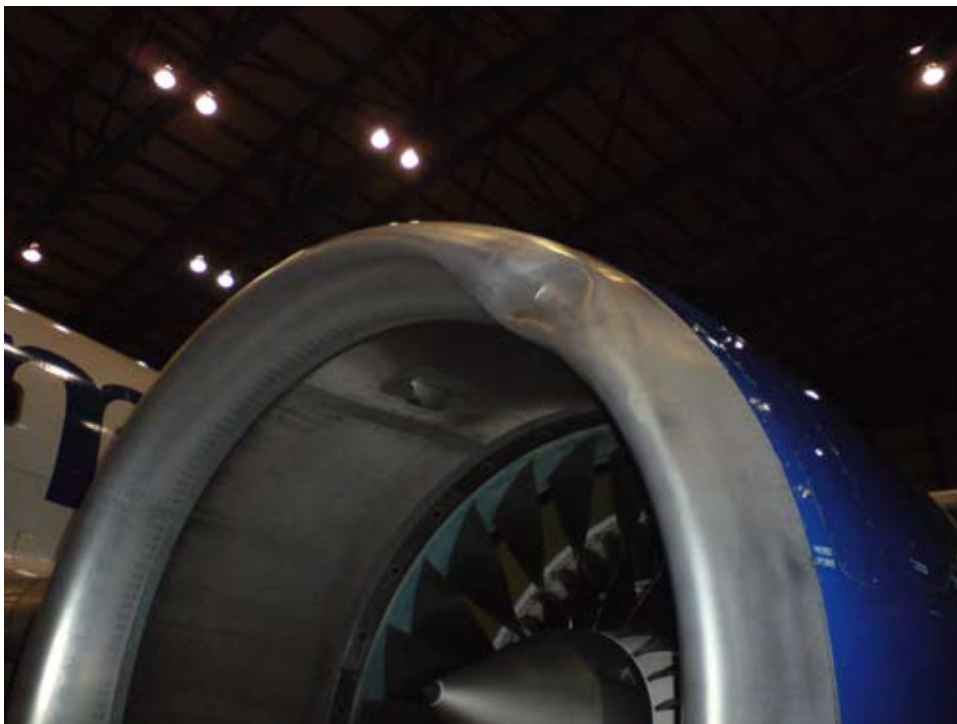
Figure 1

Maintenance personnel assessed the damage to the front upper intake lip of the intake cowl of the left engine as beyond allowable limits and replaced the cowling in accordance with the Aircraft Maintenance Manual. The engine strut, fairings, structure, mounts and fittings were also inspected but found to be undamaged.

Damage to engine cowling

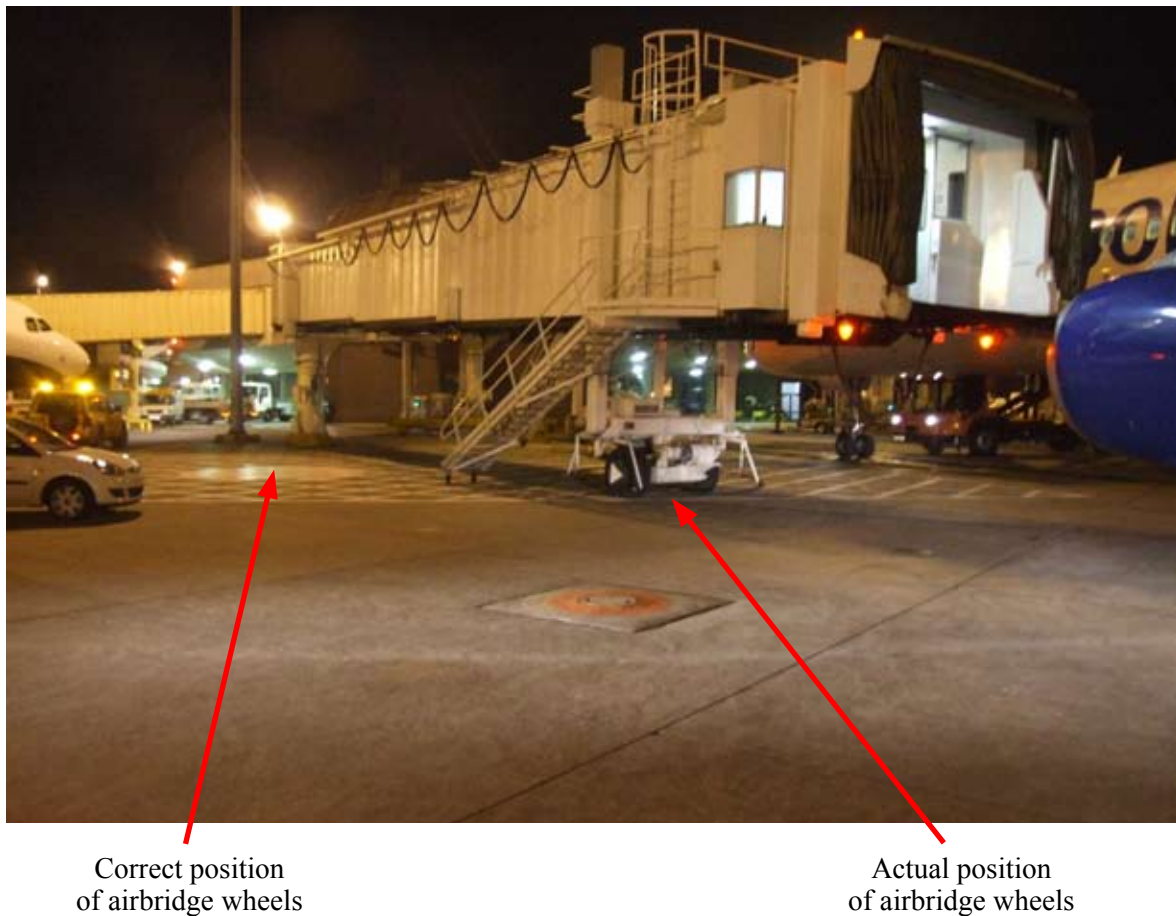
Figure 3
Parked position of airbridge

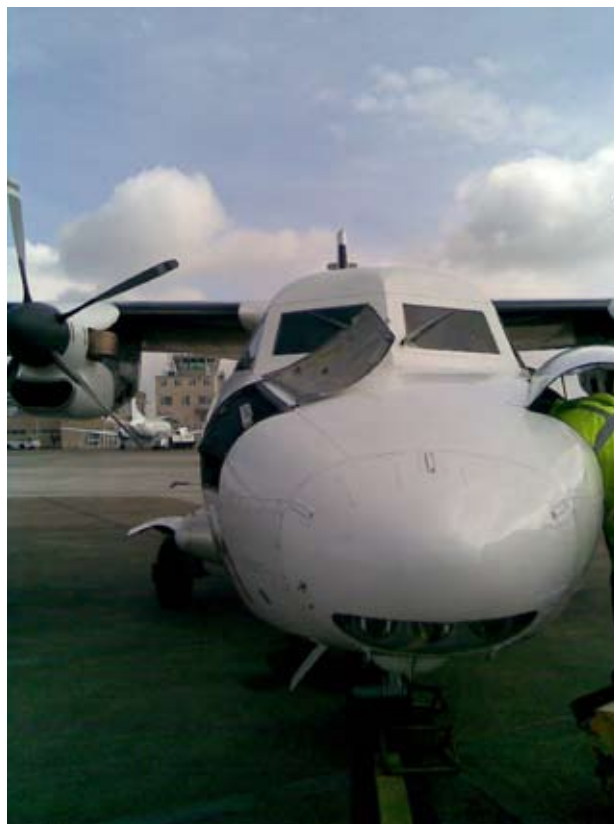
The airport Duty Manager at Ronaldsway was notified at 0950 hrs that the aircraft was landing with an open baggage door. From his position in the control tower, he could see that the door was open and a holdall was hanging out of the aircraft. One piece of baggage was subsequently found to be missing, which the commander believed might have been mislaid by the ground handling agency at Belfast City Airport. Figure 1 shows the position of the right nose baggage door after arrival at Ronaldsway.

Nose baggage door after arrival at Ronaldsway

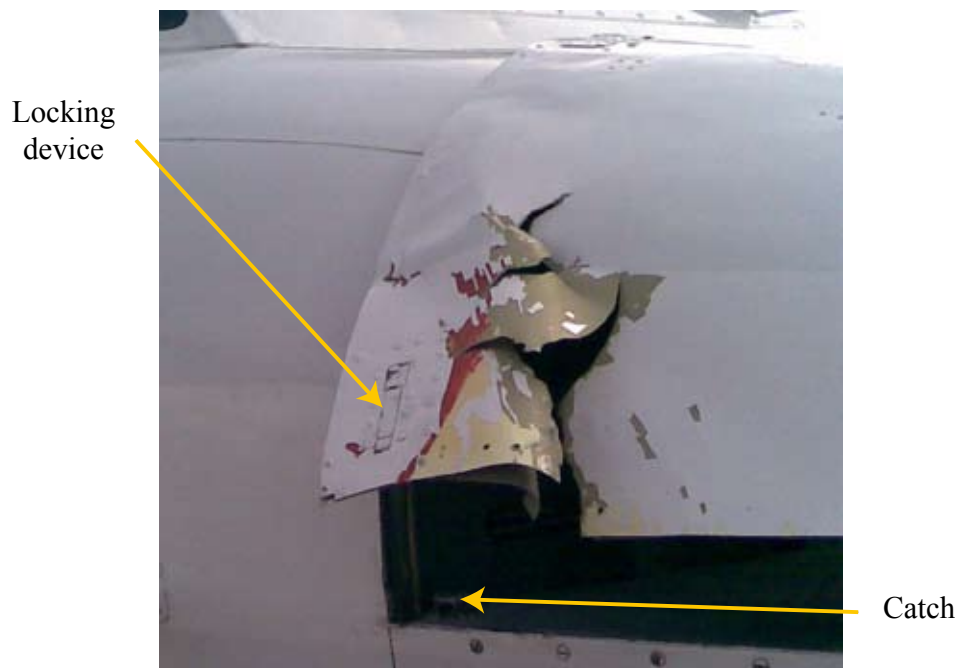
The operator's maintenance engineer inspected the baggage door and reported that there were no defects with either the door or its locking device that would have prevented the door from locking. From photographs taken by the Airport Manager at Ronaldsway, it can be seen that whilst the locking device appeared to be locked from the outside, the hook on the mechanism had not engaged with the catch (Figure 2).

did not open during the outbound journey suggests that it was probably opened at Belfast City Airport. Whilst the door locking mechanism appeared from the outside to have been locked, it is apparent, from the lack of damage, that the hook did not engage in the catch when

the locking mechanism was closed. A modification is available to fit a physical indicator to the front door locking mechanism, but the modification had not been incorporated on this aircraft.

Figure 2
Door locking mechanism

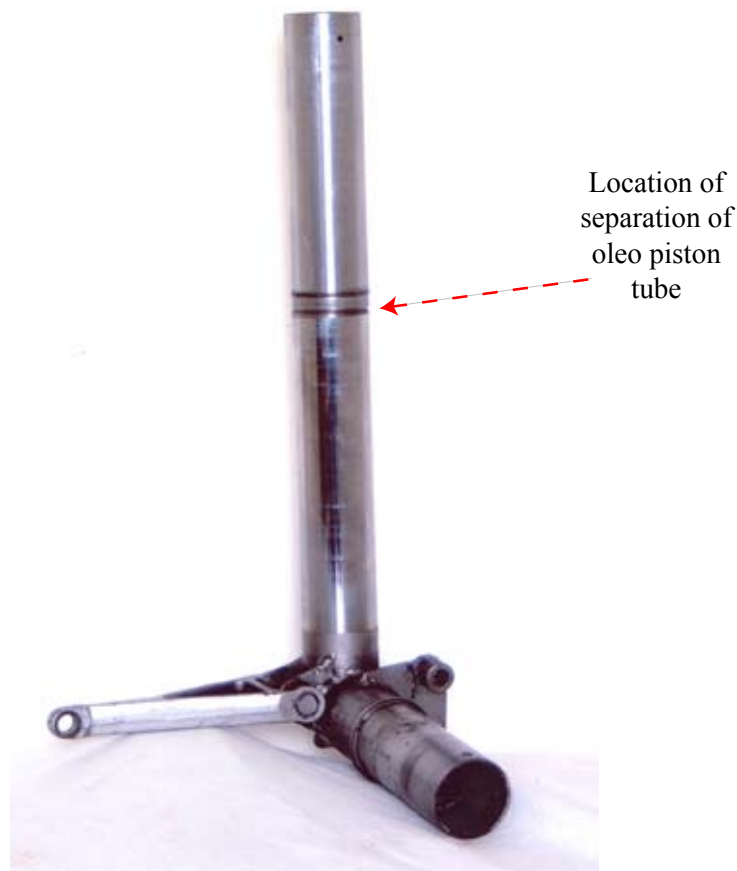
Metallurgical examination of the fractured oleo piston tube showed that it had failed along the lower of two grooves, where a circlip and seal are normally located, Figure 2. The piston tube had been separated for some time, as evidenced by debris recovered from within the unit and damage to the fracture surfaces. This damage meant it was difficult to determine the cause of the failure, other than that it had been associated with a fatigue cracking mechanism. No previous occurrences of this type of failure have reportedly occurred.

It is likely that the piston tube, having been failed at this location for some time, had continued to operate normally within the shock strut, with the torque links just being

able to retain the lower section within the outer cylinder when in flight. As such, when on the ground, the landing gear would have had a normal appearance. However, on the subject flight it is possible that the piston tube may have exited the outer cylinder on takeoff or, more likely, that the heavier than normal touchdown loads allowed the tube to deflect rearwards and separate from the leg, before sliding back in to the outer casing and operate apparently normally. The failure of the torque link bolt and brake hose appeared to have occurred after the separation of the piston tube from the outer cylinder.

The origin of the fatigue cracking and/or the initiating event could not be established due to damage to the fracture surfaces brought about by the gear remaining in service after the piston tube had completely failed.

Figure 2
Right Main Landing Gear oleo piston tube

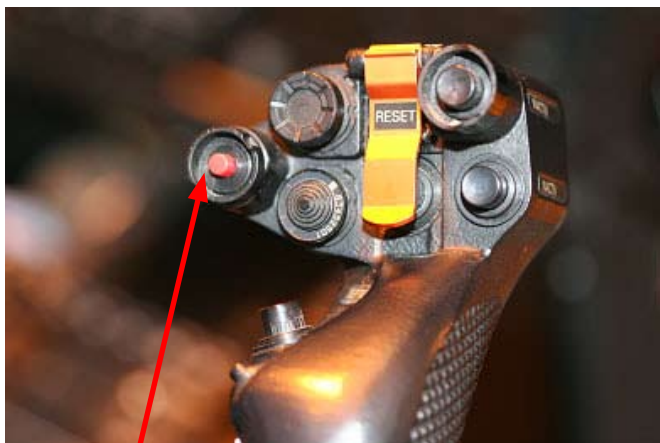
Figure 1

A SAS DCPL switch is mounted on top of each cyclic grip and, whilst it is protected from inadvertent operation by an annular guard, the switch sits about 1 mm proud of the guard (see Figure 1). Tests were undertaken, on the ground, to establish if either of the front seat occupants could have inadvertently operated this switch. In the first test the corner of the magazine which the passenger had been reading was knocked against the switch. The test proved that it is possible for the corner of a heavy magazine to operate the switch. The second test simulated the pilot turning to place a book in the right door stowage. This test proved that it is possible for an elbow to operate the switch. On both tests the pressure to operate the switch also caused the cyclic stick to move forwards.

SAS DCPL SWITCH

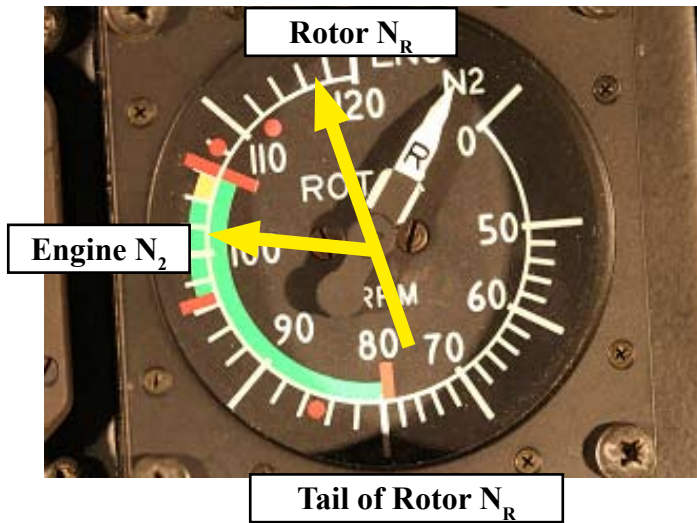
Figure 3

The Triple tachometer gauge with the positions of the pointers, as determined by the investigation, superimposed in yellow. The N₂ pointers are not visible as, in this photo, they are hidden by the NR pointer
