**REPORT
ON THE WRECK OF THE
SS RICHARD MONTGOMERY**

Maritime and Coastguard Agency
Spring Place
105 Commercial Road
Southampton
SO15 1EG

May 1999

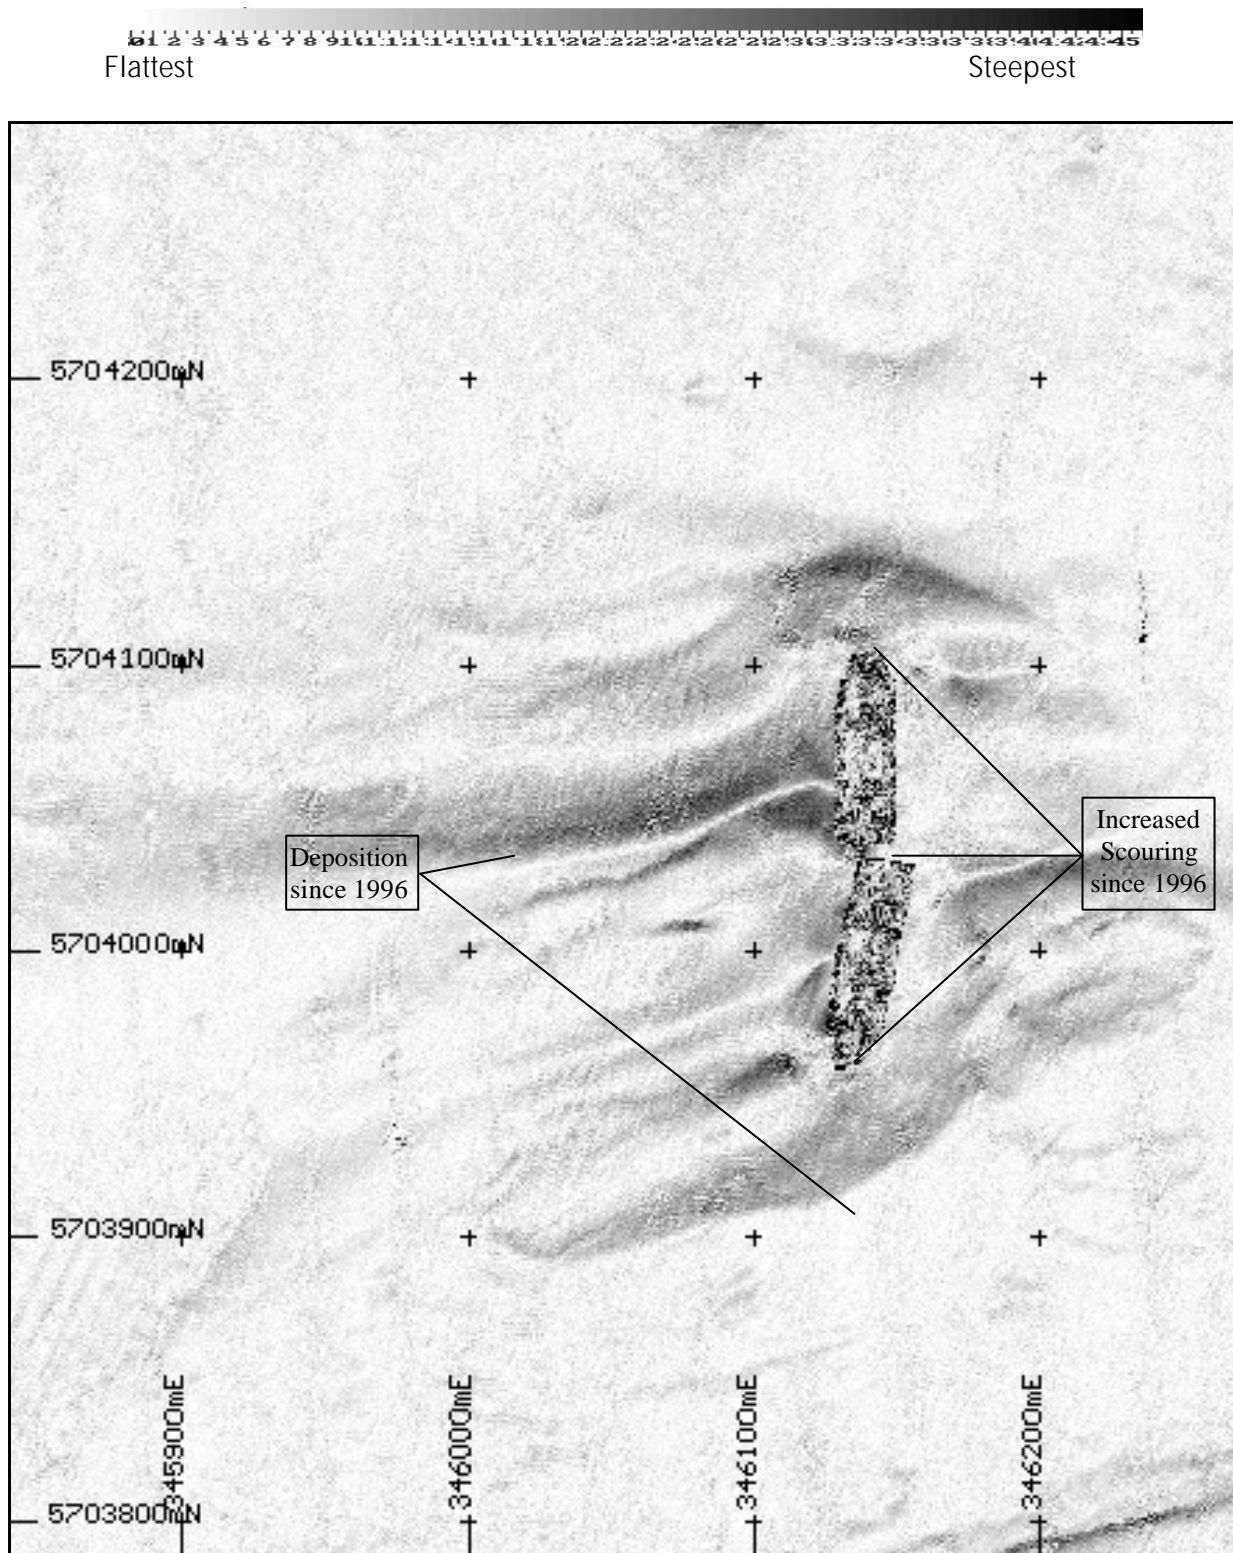
Report of Survey 1997

7. The monochromatic gradient plots at Annex C reveal details of the ship's structure. These plots also reveal details of small seabed topographical features such as sand ripples over the area.

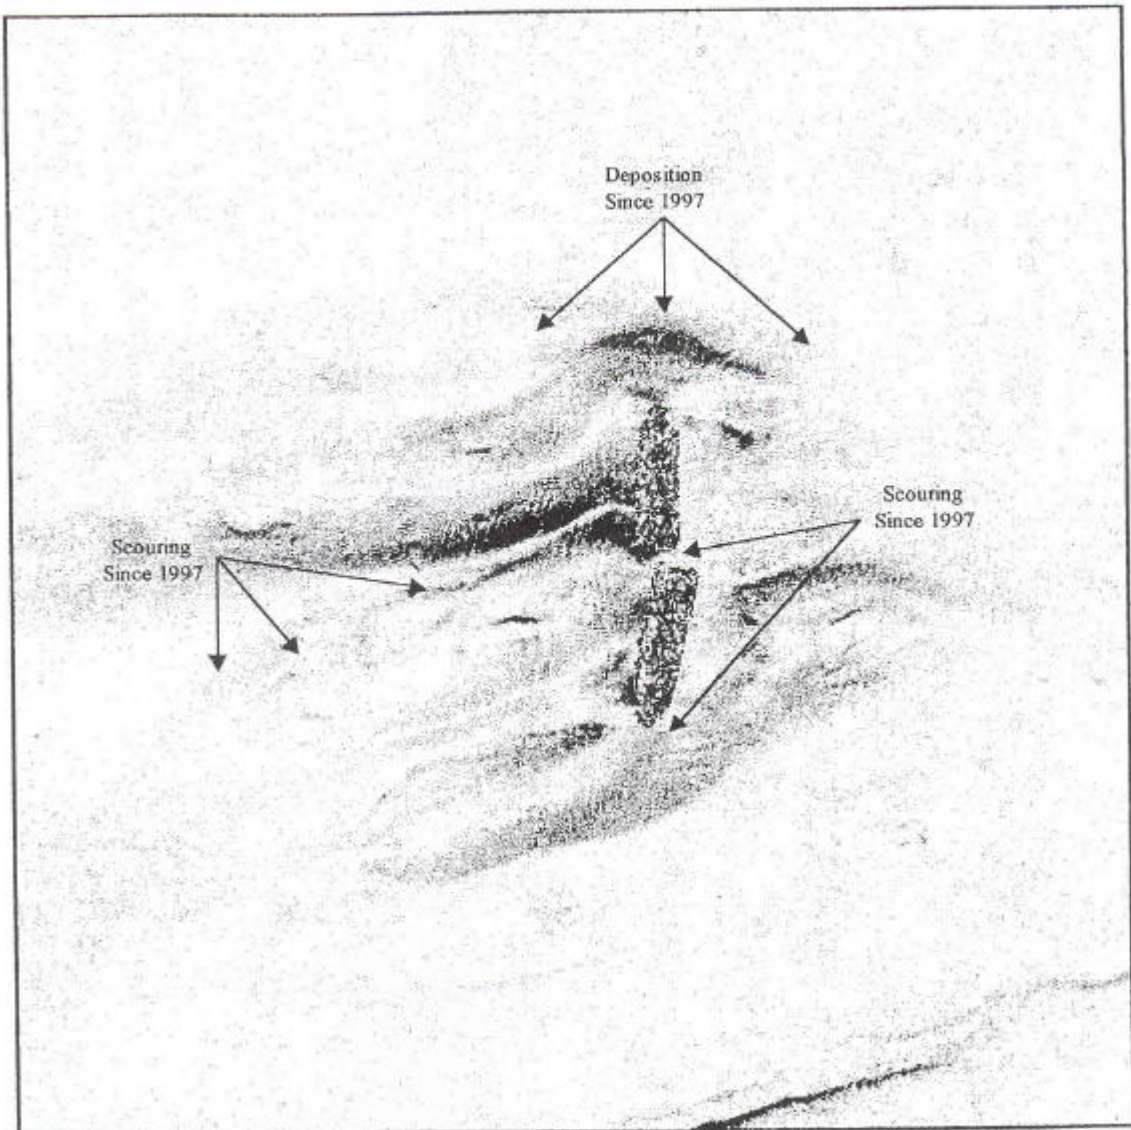
Report of Survey 1998

- The objects situated to the west of the aft section were visible on the gradient chart. Inspection of the raw survey data had again revealed that the objects were not exposed but were affecting the surrounding seabed.
