CONTENTS

SERIOUS INCIDENT

Aircraft Type and Registration:	Cessna 550 Citation II, G-JBIZ
No & Type of Engines:	2 Pratt & Whitney Canada JT15D-4 turbofan engines
Year of Manufacture:	1979
Date & Time (UTC):	14 March 2008 at 1433 hrs
Location:	On approach to Edinburgh Airport
Type of Flight:	Commercial Air Transport (Passenger)
Persons on Board:	Crew - 2 Passengers - None
Injuries:	Crew - None Passengers - N/A
Nature of Damage:	None
Commander's Licence:	Airline Transport Pilot's Licence
Commander's Age:	32 years
Commander's Flying Experience:	5,450 hours (of which 750 were on type) Last 90 days - 200 hours Last 28 days - 52 hours
Information Source:	AAIB Field Investigation

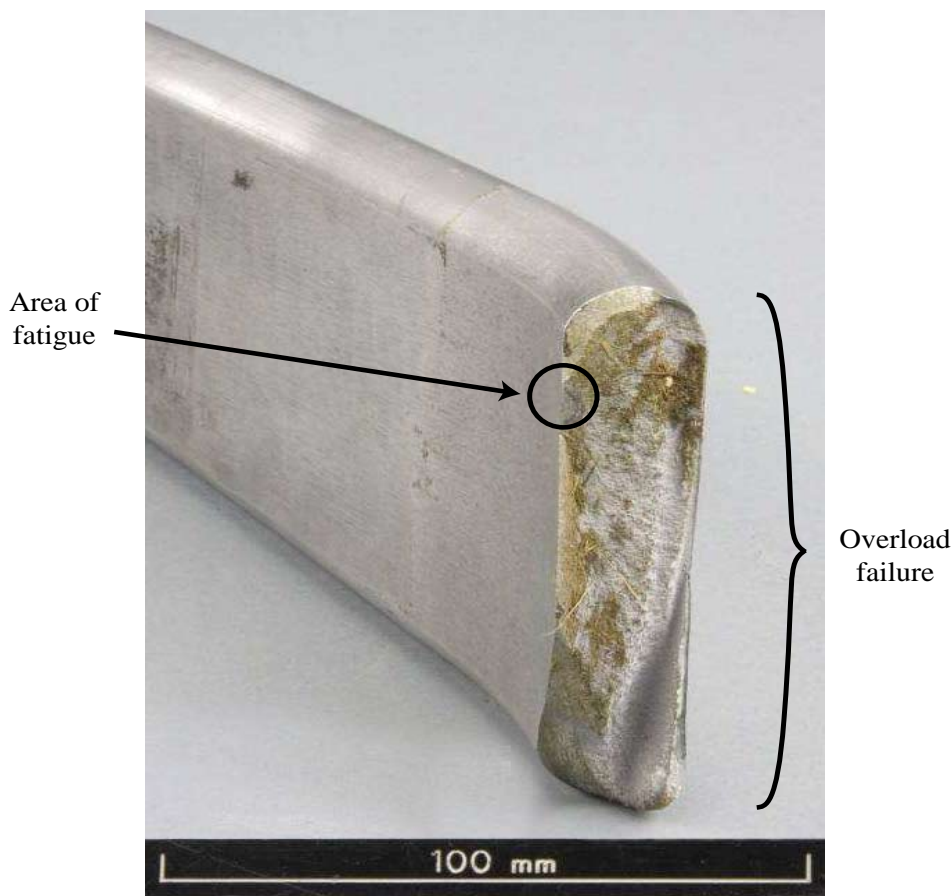
Figure 1

Initial examination of the failure surface of the aluminium landing gear indicated an area of fatigue (Figure 1).
