AAIB Bulletin

11/2014

Aircraft Type and Registration:	Cessna 310Q, G-BXUY	
No & Type of Engines:	Two Continental IO-470-VO piston engines	
Year of Manufacture:	1970 (Serial No: 310Q-0231)	
Date & Time (UTC):	15 November 2013 at 1158 hrs	
Location:	Hawarden Aerodrome, Chester	
Type of Flight:	Private	
Persons on Board:	Crew - 1	Passengers - 1
Injuries:	Crew - 1 (Fatal)	Passengers - 1 (Fatal)
Nature of Damage:	Aircraft destroyed	
Commander's Licence:	Commercial Pilot's Licence	
Commander's Age:	58 years	
Commander's Flying Experience:	1,645 hours (of which 261 were on type) Last 90 days - 18 hours Last 28 days - 6 hours	
Information Source:	AAIB Field Investigation

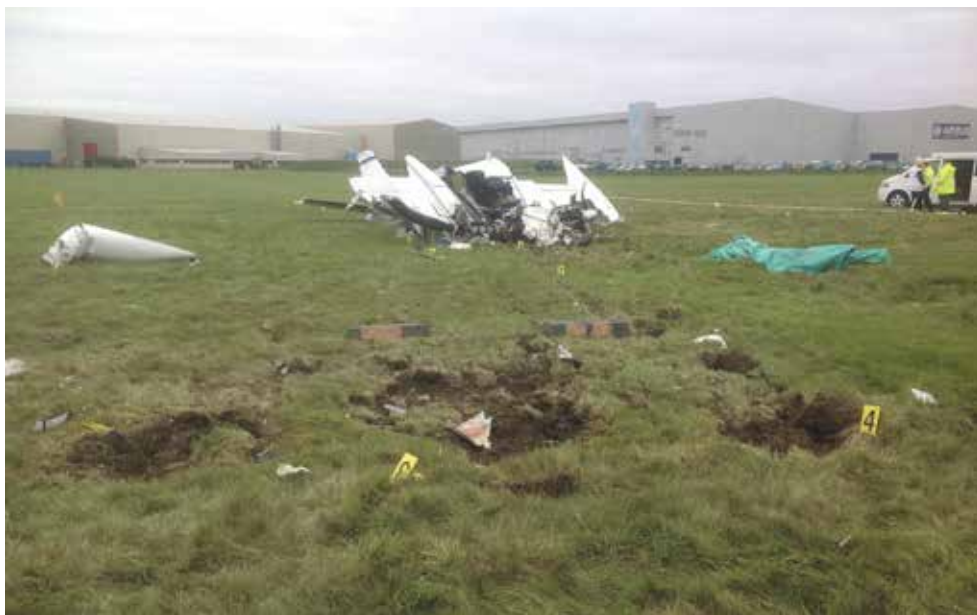
Figure 5
Accident site

Ground marks indicated that the aircraft first struck the ground inverted, in a steep nose-down attitude 115 m beyond the left edge of Runway 22 and 15 m before the threshold markings. After the initial impact the aircraft travelled backwards on its main landing gear for approximately 20 m before coming to rest (Figure 5). The fuselage of the aircraft had failed immediately aft of the main spar and the nose of the aircraft had been severely damaged. The right tip tank had ruptured and separated from the wing and the right wing exhibited compression damage to the outboard leading edge. The right propeller had dug into the ground during the initial impact which had resulted in a failure of the engine crankshaft and separation of the propeller. The left propeller remained attached to its associated engine.

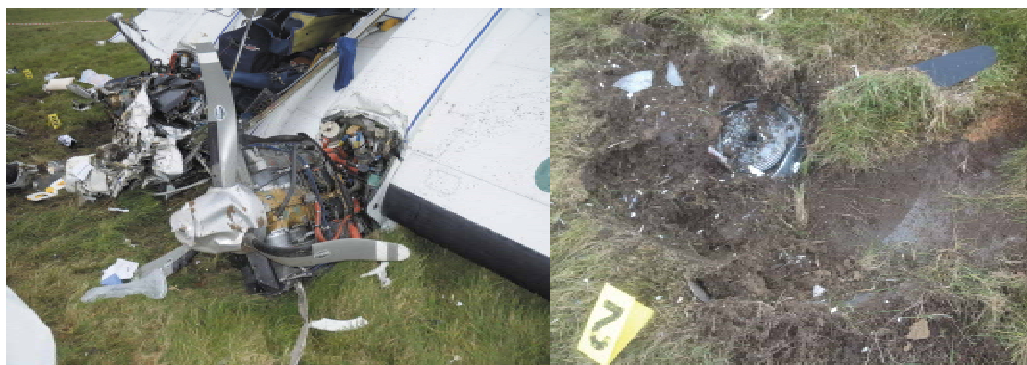
Figure 6

Examination of the right propeller showed that rotation of the propeller during the initial impact had caused all three blades to dig into the ground; two of the blades exhibited significant rearwards bending of the blades at approximately half span as a result of rotation through the soil (Figure 6). The left propeller exhibited significantly different damage from the right; one blade had been bent backwards and the remaining two blades had been bent forward at mid-span. There was little evidence of rotational damage to any of these blades.

Left and right propellers

Two of the blades fitted to the right propeller showed chordwise witness marks and exhibited significant twisting and rearward bending along the span of the blade. One of these blades, the first to enter the ground, was found to be at a higher pitch setting when compared to the other two blades, which appeared to be at or close to the FINE pitch position.

The damage to the left propeller showed significant differences from that observed on the right. Damage to the propeller spinner was restricted to one third of the circumference, corresponding to the position of the propeller blade which had been bent backwards and little evidence of rotational damage was observed. All three of the blades on the left propeller appeared to be at or close to the FINE pitch position.

The witness marks observed on the faces of the right propeller preload plates indicted that all three propeller blades were at the same pitch angle of 15° at the start of the impact sequence. The damage observed to the right propeller blades and the failure of the right engine crankshaft was consistent with the engine operating at high rpm at impact. Analysis of the blade pitch angle data by the propeller manufacturer confirmed that a blade pitch angle of 15° was consistent with a Continental IO-470-VO engine operating at its maximum governed speed of 2,625 rpm, as may be expected during the early stages of a go-around. Given that the No 3 blade of the right propeller was the first blade to enter the ground, it is thought that the forces acting on the blade were sufficient to twist the blade in the hub, resulting in the failure of the pitch change knob and an increase in blade pitch when compared to the remaining two blades.

The lack of rotational damage to the left propeller, and the deformation of its blades, was consistent with the left engine operating at low power at impact despite all of the engine controls being in the 'full power' position. The closure of the left propeller blade pitch locks

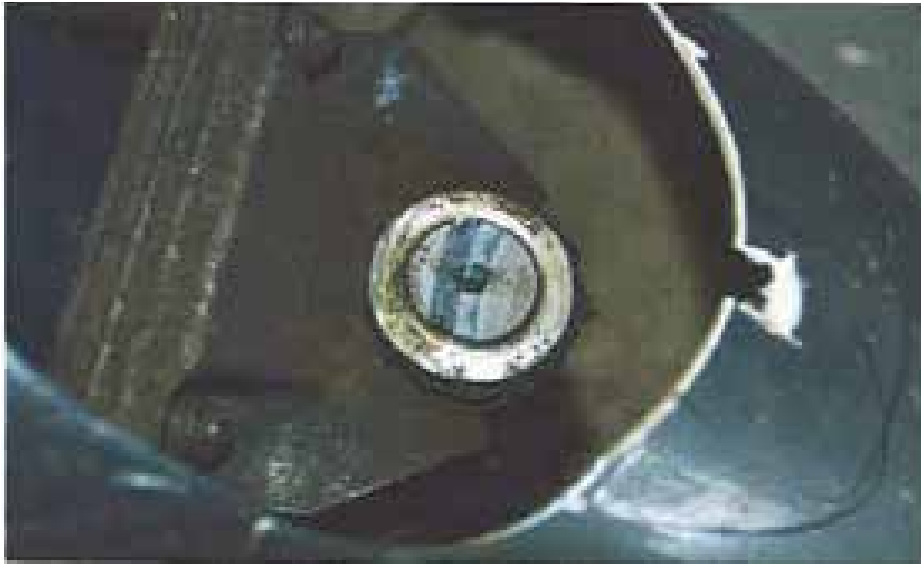
Figure 1

Following a normal approach and touchdown at a private grass airstrip, the nose landing gear failed. The nosewheel detached and the aircraft came to a rest within a short distance. Examination of the failed components showed what appeared to be a fatigue failure in the nose landing gear leg.

The pilot explained that the nosewheel assembly had detached following a failure in the nose leg. The failure occurred in a vertical spindle at the forward, lower end of the leg, which entered an upper bushing on the nosewheel bracket. The pilot attributed the failure of the vertical spindle to fatigue, and noted that no corrosion was visible on the leg. A photograph of the failed component is shown at Figure 1.

Photograph of the failed vertical spindle, taken from above

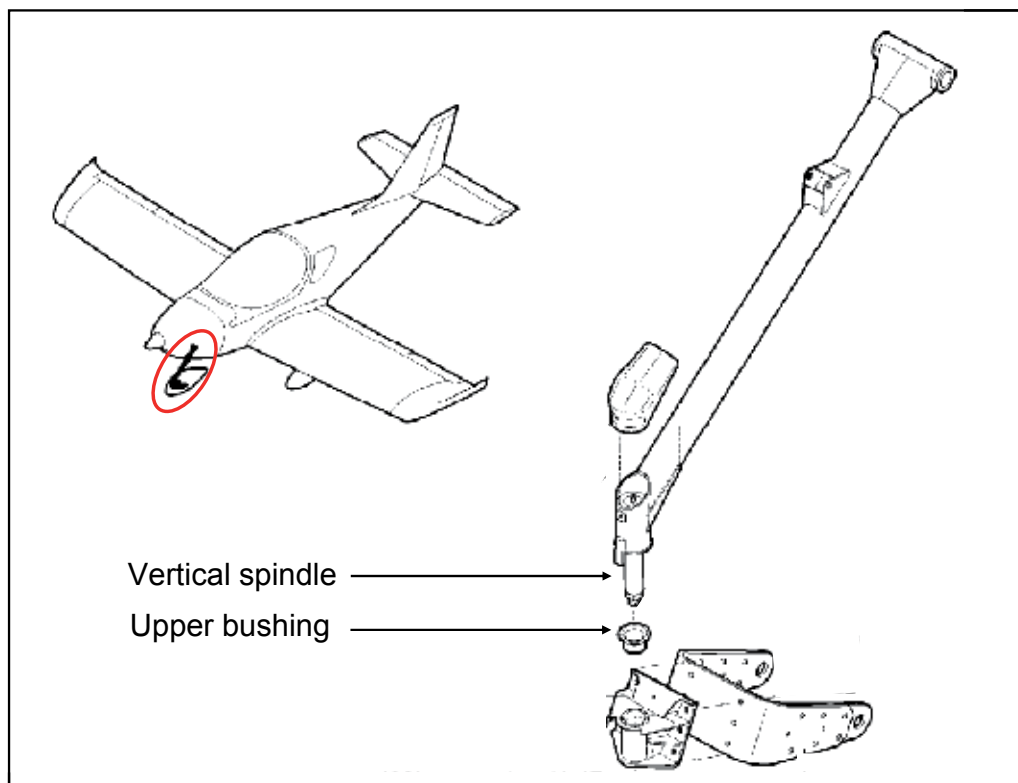
Figure 2

Nose landing gear assembly (simplified, nosewheel omitted)

'Some SportCruiser / PiperSport / PS-28 Cruiser aircraft have developed cracks in the bottom side of the lower section of the nose landing gear (NLG). The cracks develop on the NLG assembly along the weld of the tube and the bracket. Furthermore, on several aircraft it was found bending of the pivot connecting the fork with leg. To address this potential condition, an inspection of the bottom side of the lower section, in the place of the weld of the tube and the bracket and the pivot is required.'

The SB went on to identify, with the aid of diagrams, the correct method of inspection. A further SB (SB-CR-021) was issued on 10 July 2014, containing instructions for replacement of the NLG. The SB included the following text:

'Some PS-28 Cruiser / SportCruiser / PiperSport aircraft have developed cracks in the bottom side of the lower section of the nose landing gear (NLG) SG0270N. To address this potential condition, CSA has issued service bulletin SB-CR-016 that prescribes an inspection of the nose landing gear SG0270N. Subsequently, CSA have developed an improved NLG SG0300N, which has better fatigue resistant properties. For the reasons described above, CSA recommends replacement of the NLG SG0270N with an improved NLG SG0300N especially on aircraft used in intensive flight training activity and operated from unpaved runways.'
