## CONTENTS

### COMMERCIAL AIR TRANSPORT

**INCIDENT**

<b>Aircraft Type and Registration:</b>	Avro 146-RJ100, G-JEAV (and others and Embraer 145)
<b>No &amp; Type of Engines:</b>	4 Lycoming ALF502R-5 turbofan engines
<b>Year of Manufacture:</b>	1986
<b>Date &amp; Time (UTC):</b>	17 January 2006 at 1600 hrs
<b>Location:</b>	Between Southampton and Manchester
<b>Type of Flight:</b>	Public Transport (Passenger)
<b>Persons on Board:</b>	Crew - 5                      Passengers - 37
<b>Injuries:</b>	None
<b>Nature of Damage:</b>	None
<b>Commander's Licence:</b>	Airline Transport Pilot's Licence
<b>Commander's Age:</b>	N/A
<b>Commander's Flying Experience:</b>	N/A
<b>Information Source:</b>	Aircraft Accident Report Forms submitted by pilots and subsequent enquires by the AAIB

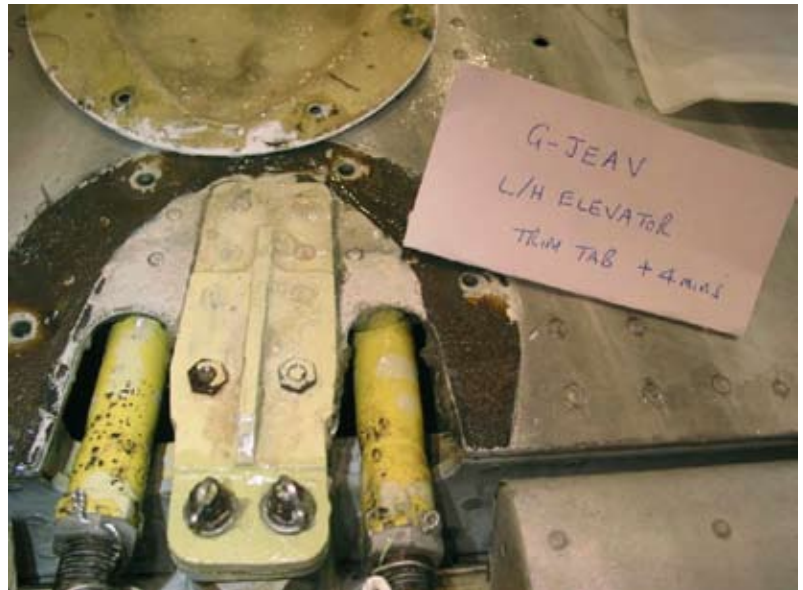
**Figure 1**

Following the recent discovery of accumulations of thickened de/anti-icing fluid residues under the elevator trim tab rod fairings on Avro 146/RJ aircraft, Figure 1, the aircraft manufacturer issued an All Operators Message (AOM) 06/001V on 20 January 2006, recommending that operators inspect the area for fluid residues. A copy of the AOM was included in AAIB Bulletin 4/2006.

G-JEAV Left-hand elevator trim tab control rods, with fairing removed. Residues shown four minutes after re-hydration by water mist.

*It is recommended, that the Joint Aviation Authorities, in consultation with the European Aviation Safety Agency, issue safety documentation to strongly encourage operators of aircraft with non-powered flight controls to use Type I de/anti-icing fluids, in preference to 'thickened' fluids, for de-icing.*

*It is recommended that where the use of 'thickened' de/anti-icing fluids is unavoidable, the Joint Aviation Authorities, in consultation with the European Aviation Safety Agency, ensure that operators of aircraft with non-powered flight controls who use such fluids, invoke controlled maintenance procedures for the frequent inspection for accumulations of fluid residues and their removal.*

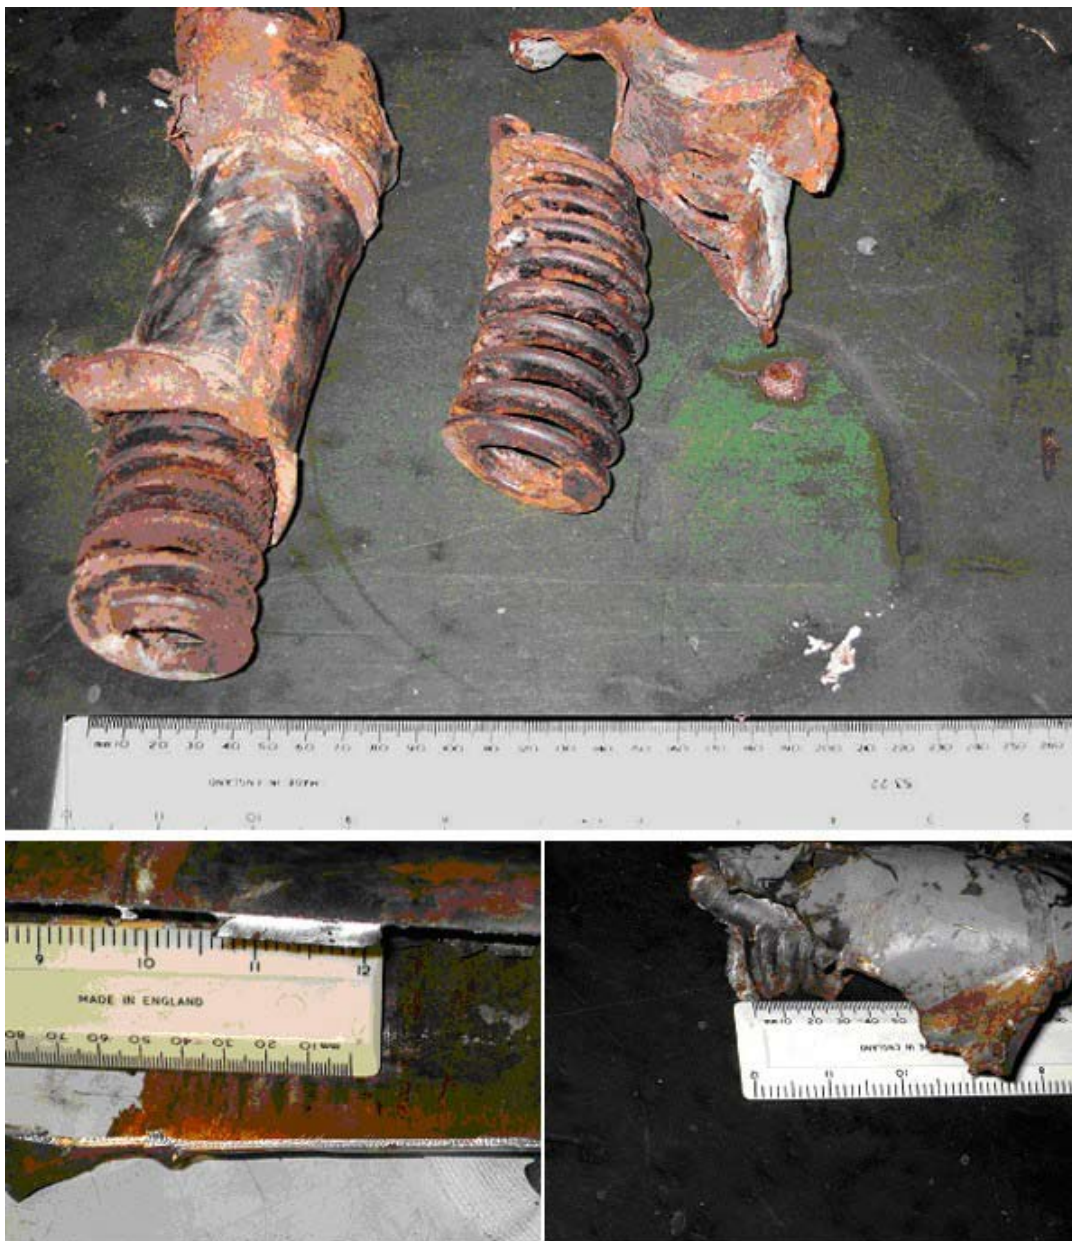
**Figure 2**

coils during the impact. The average spacing between the coil imprints can vary according to the fore-aft position of the dome, which in turn is a function of the propeller blade angle. The imprints were measured (see Figure 2), which revealed that the spacings were the same for both tubes, indicating that the left and right propeller angles were very similar. Using the measured spacing of 8.33 mm, the propeller manufacturer was asked to determine the corresponding blade angle.

Remains of feathering springs, showing coil imprints on tube bores

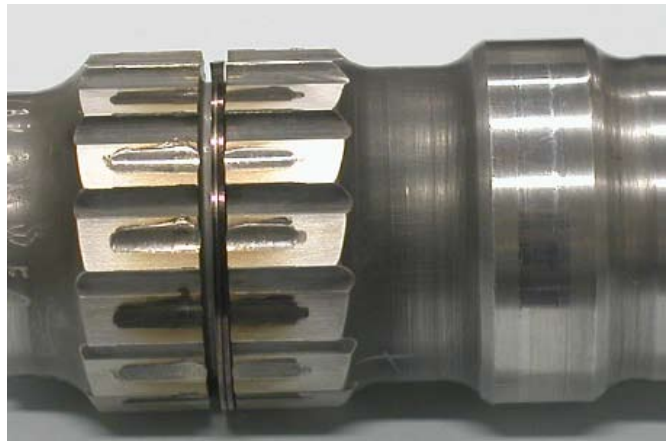
**Figure 4**

The AAIB employed the services of a consultant in tribology (the study of friction, wear and lubrication of bearings) to assist in the laboratory examination of the freewheels. There was no doubt that the left unit distress had been caused by slippage under load. Indeed, it was possible to discern impact marks from rollers on adjacent ramps caused by the rollers being violently 'spat out' of engagement and striking the face of the ramp behind them. The depth of the wear on each ramp was in the order of

Left input shaft showing wear and overheat damage to ramps of the freewheel

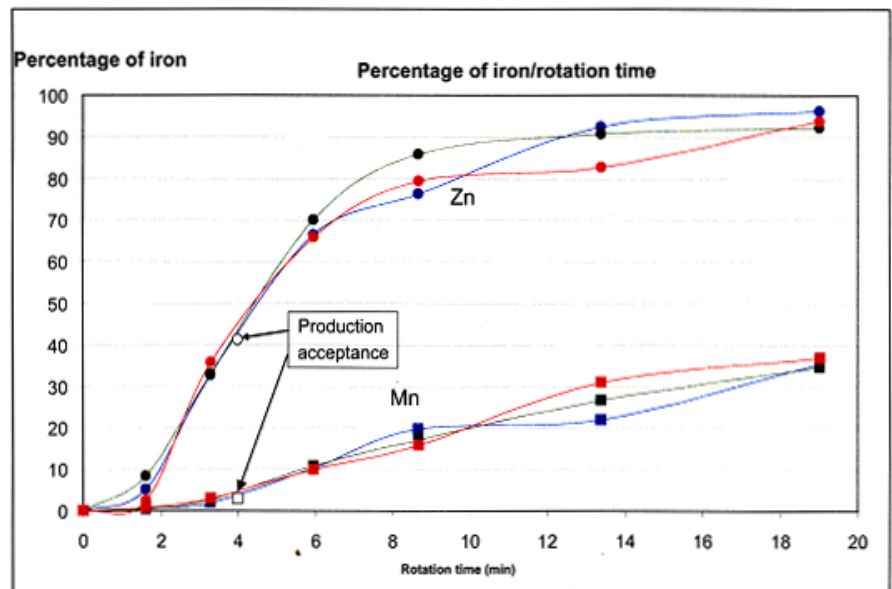
**Figure 5**  
Graph of results from rollers with Manganese and Zinc Phosphate coatings showing percentage of base metal (Iron) visible on the surface plotted against freewheel rotation time

It is Eurocopter’s considered view that this figure of about 35% of base metal visible, *for either type*, is critical; above that figure, slippage under load is unlikely whilst below that figure it is possible. This percentage was reached after about 3.5 minutes of rotation time for the zinc-phosphated rollers but the manganese-phosphated rollers did not reach the ‘critical percentage’ until about 19 minutes. They also related these figures to the known history of slippage events, for which the precise operating times and sequences were recorded since the majority took place under their own flight test operations. This comparison enabled a chart to be plotted, relating slippage occurrences to time of freewheel operation since new. From this it was determined that the slippage events all took place within the range of about 100-700 seconds of freewheel rotation time once fitted in the helicopter.

Eurocopter factory. This was found to equate to four minutes of freewheel rotation time, at which time the percentage of Iron visible on the zinc-phosphated roller surface was measured to be about 40%; only some 4% was visible on manganese-phosphated items. From this it was concluded that, when the bench running time is added to the normal post-installation ground running before flight torques are applied, the surface iron/zinc phosphate ratio is comfortably above 35% and slippage will not occur. With manganese phosphate, however, slippage under load is possible for another 10 minutes or so of freewheel rotation time. Eurocopter calculations showed that this equated to about 3 hours of helicopter operation and that, after applying a safety factor of roughly 3, manganese-phosphated rollers, which had run for more than 10 flight hours, could remain in service.

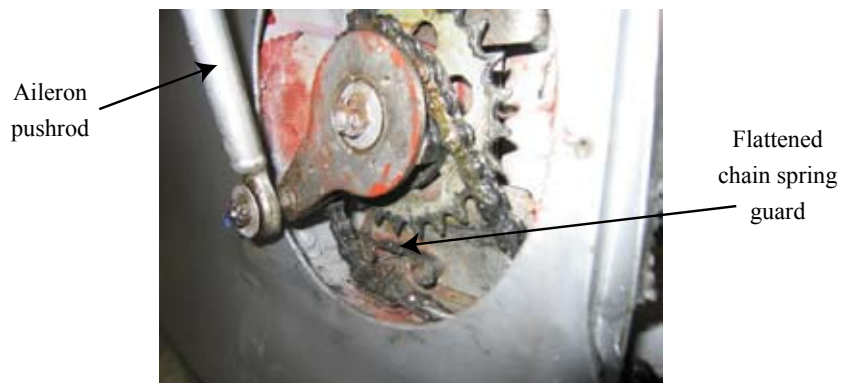
**Figure 2**  
Photograph showing derailed aileron chain in lower left mainplane

The two cover plates were removed from the lower surface of each lower mainplane and the fabric was cut away from above the aileron control mechanisms. The aileron box in the right wing was found to be intact and the chain was properly located on the sprocket wheel. However, in the left wing the aileron box had been disrupted, most probably in the impact, and there was a crack up to 6 mm wide on the forward side of the box. The spring guard was flattened and the chain was derailed from the sprocket and sitting around the inner part of the sprocket assembly – see photograph in Figure 2.

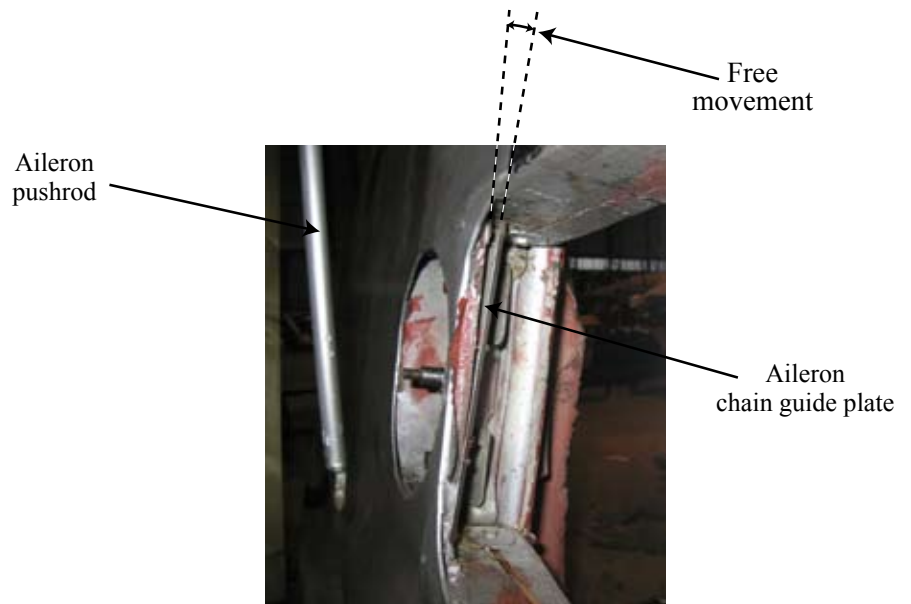
**Figure 3**

three retaining screws only part way in (Figure 3). The fourth retaining screw was found loose inside the box structure. Further inspection of the guide plate on the left wing revealed no evidence of any of the screws that secure the packing strips to the wing structure. This would suggest that the packing pieces were not present prior to the impact, and hence the plate might not have been securely in place before the accident.

Photograph showing loose guide plate in lower left mainplane

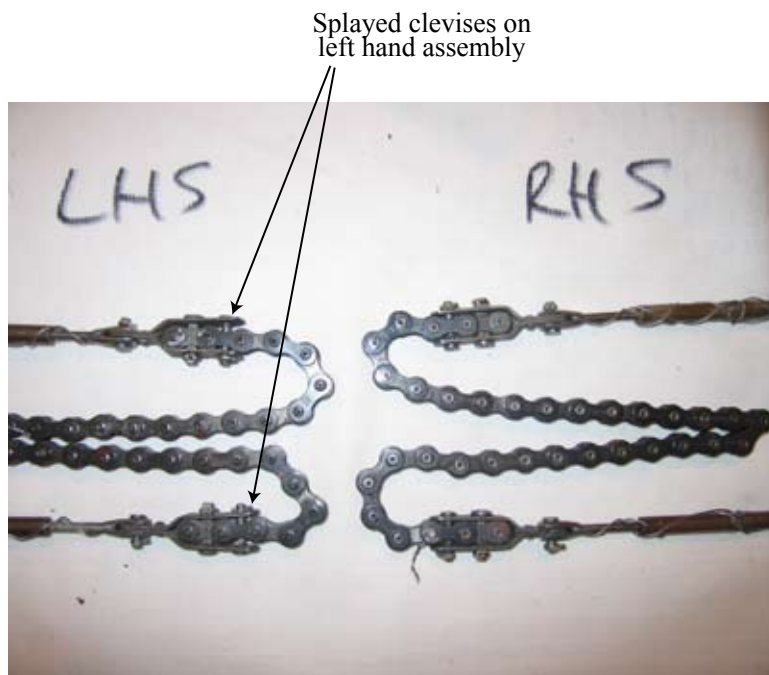
**Figure 4**

Inspection of the chains, sprockets, guide plates and the loose screw showed no evidence of any marks that would indicate a control problem. Attempts were made to derail the chain from the sprocket assembly under a variety of conditions. Even with the flattened chain guard and low cable tension the chain would

not come off the sprocket wheel. Also, with the chain derailed as found on the left mainplane, the shape of the crank and sprocket assembly was such that some restricted movement of the aileron did occur.
