### SPECIAL BULLETINS

S1/2010 Cessna Citation 680 Sovereign	G-CJCC	30-Sep-10	1
---------------------------------------	--------	-----------	---

**Summary of: Air Accident Report No: 6/2010** 89  
Report on the accident between Grob G115E Tutor, G-BYUT  
and Grob G115E Tutor, G-BYVN  
near Porthcawl, South Wales on 11 February 2009

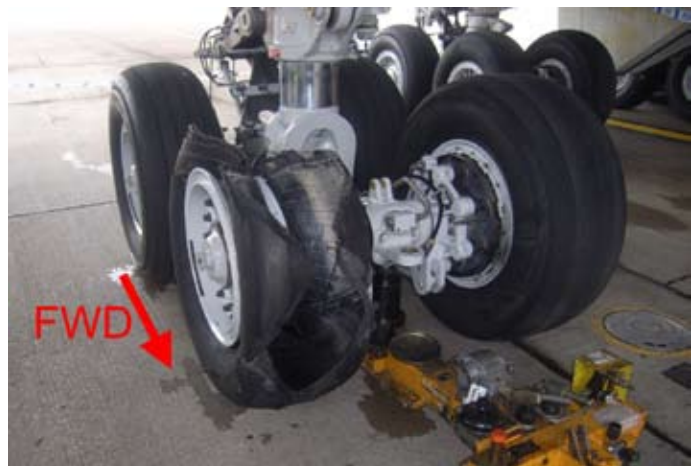
**Figure 1**

Examination of the aircraft revealed that the tyre on the No 14 wheel had burst. The Boeing 747 main landing gear consists of four four-wheeled main landing gear legs, and the No 14 wheel is the outboard front wheel on the right WLG. A large chunk of tyre carcass of almost half the tyre's circumference was missing (Figure 1). Part of the right WLG shock strut inboard door had separated and was found near taxiway A9 adjacent to Heathrow's Runway 27R. This door sits directly above the No 14 wheel and there were black tyre marks on its underside (Figure 2). The aircraft had also suffered impact damage to its right wing inboard flap fairing and to the leading edge and underside of the right inboard aft flap. A wishbone-shaped support bracket (p/n 65B13644-6) which forms part of the connection between the right WLG shock strut and the right WLG outboard door had failed at its lower forward lug. A rod (p/n 65B12747-1) connected to the forward hinge of the right WLG door had also failed. There was also some damage to clamps on the shock strut and drag strut of the right WLG.

Damaged No 14 tyre on G-VROC after landing at Heathrow

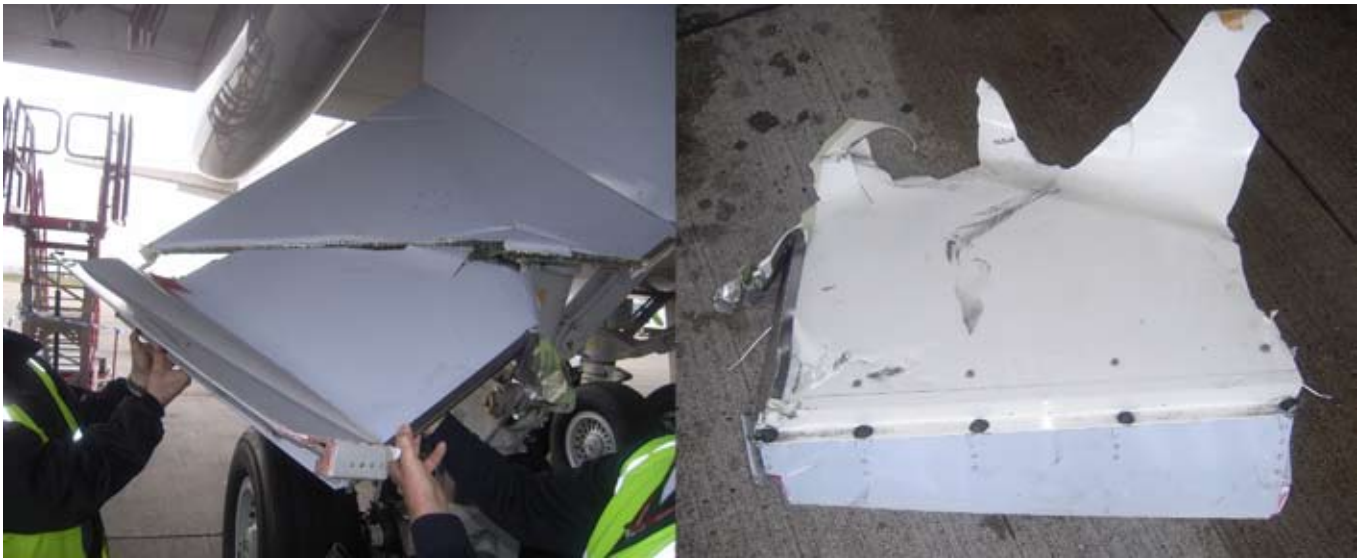
**Figure 2**

Separated section of the right WLG shock strut inboard door  
(left: held in position against the rest of the door; right: black tyre marks visible on its underside)

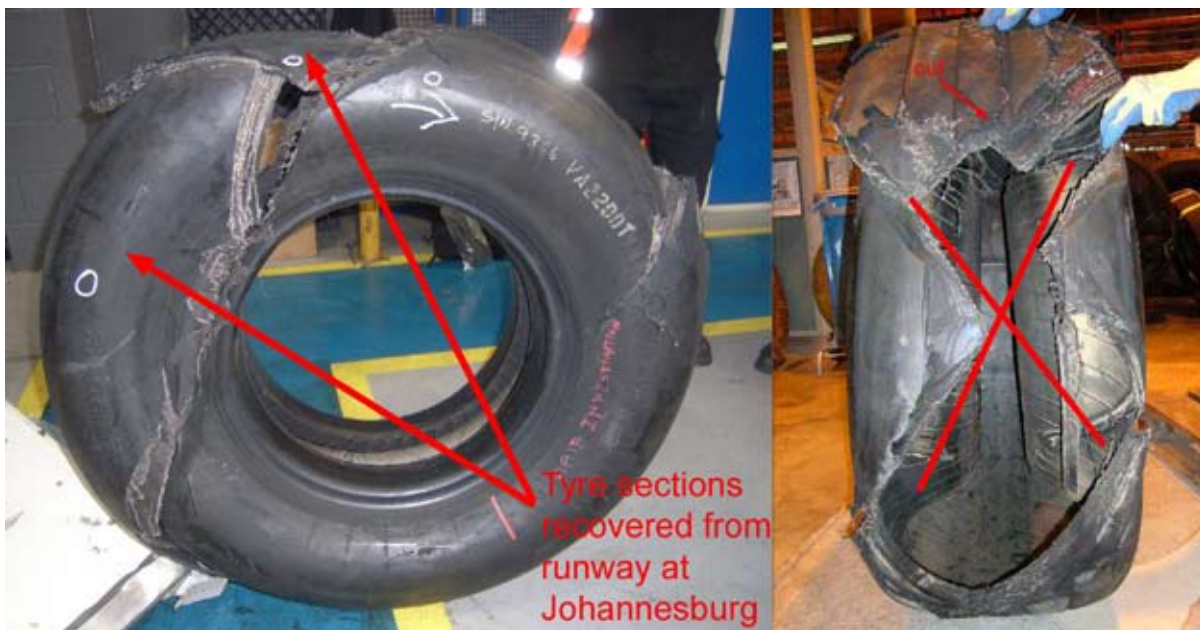
**Figure 4**

pattern was revealed (Figure 4). An X-type rupture indicates a high pressure blowout, and therefore the tyre had not burst in a low pressure 'run-flat' condition. On one of the separated sections there was an area in the centre of the crown where there was a straight break between almost all the casing plies (Figure 5), as if they had been cut. The area surrounding this straight 'cut' exhibited plies that had the appearance of having failed in tensile overload.

No 14 tyre reconstructed with the two large sections found on runway at Johannesburg.  
Right: classic X-type burst pattern and 'cut' in upper section

The No 14 tyre burst during the takeoff ground roll at approximately 160 kt, which was well below the 204 kt rated tyre speed. The X-type burst pattern of the tyre indicated that it had ruptured at high pressure. Such ruptures can occur during a heavy landing, but this event occurred during the takeoff roll and the FDM data revealed no exceedences during the previous 57 landings. The adjacent tyre to the No 14 tyre was in satisfactory condition and its pressure was within limits, which meant that the No 14 tyre would not have been carrying excessive load. There was no evidence of a manufacturing defect in the tyre or overheat within the liner, and therefore the most probable cause of the tyre burst was penetration by a foreign object. The missing tyre material in the vicinity of the X made it impossible to determine what type or shape of object caused the

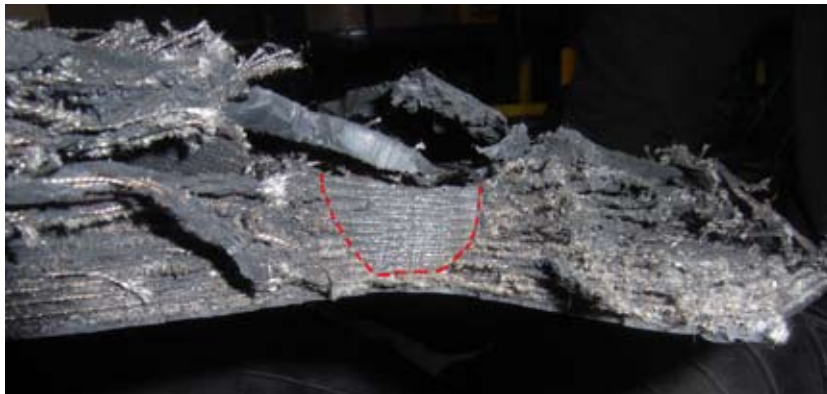
**Figure 5**

Close-up of 'cut' area highlighted in top right section of Figure 4

The manufacturer determined that there were no defects in the construction of the tyre and there was no evidence of internal heat or inner liner wrinkling. Because there were missing pieces in the area of the X-type rupture, the manufacturer could not determine a definitive cause, but they considered that impact from a foreign object was the most probable cause of the tyre burst. They considered that the section of tyre with the straight 'cut' was probably caused by a sharp object, but because the 'cut' was not located near the centre of the X, it is probable that this cut occurred after the initial tyre burst.

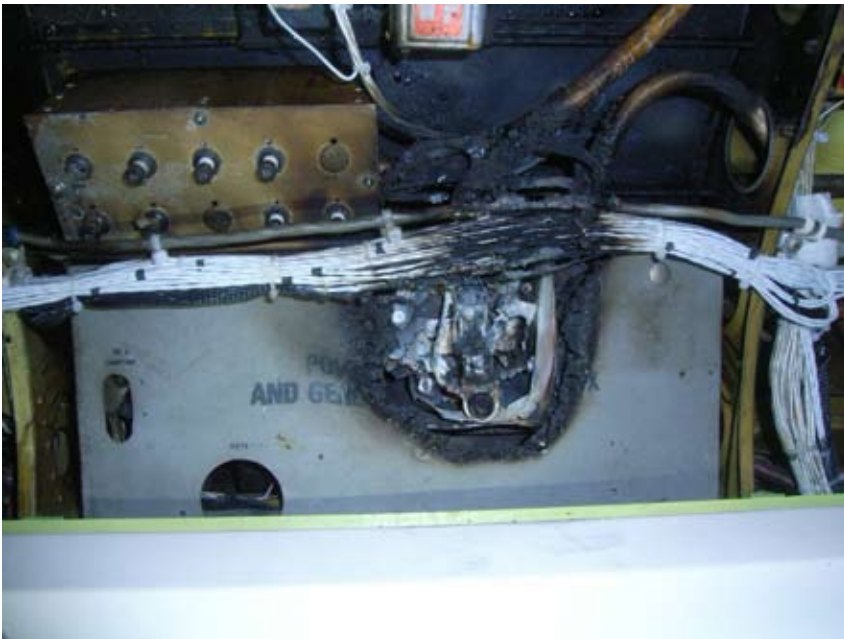
**Figure 3**

Examination of the aircraft revealed that there had been an electrical fire, which had almost consumed the left RCR, Figure 3. The fire had burnt through the cover of the power distribution and generator control box and, whilst the heat had caused the trim in the cabin to blister,

Damage to power distribution box and generator control box

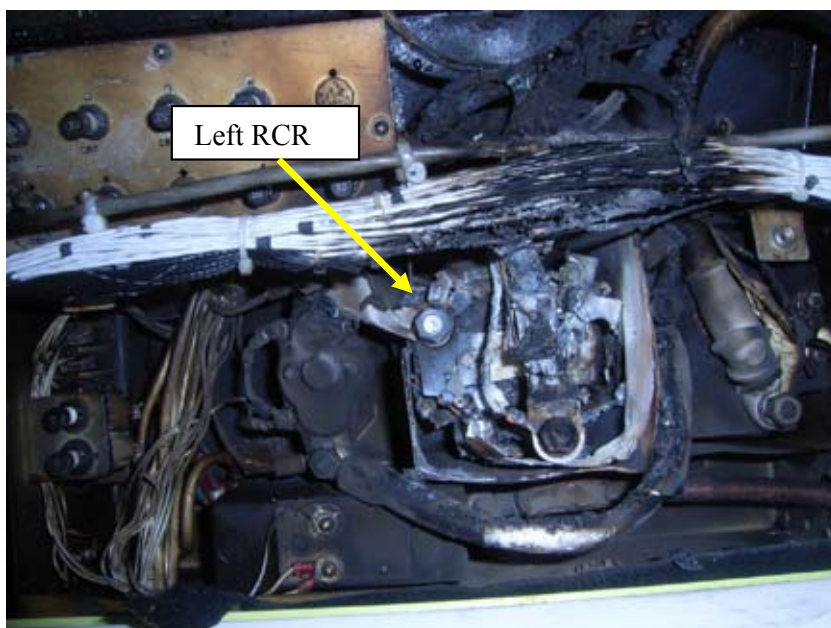
had light pitting. This pitting was similar to that seen on the faces of the main contact in the right RCR which had been removed at Calgary. While the data plate had been destroyed, the components in the left RCR, and the design of the main contacts (R3), were found to be identical to the components in the right RCR that had been replaced at Calgary; the right RCR had a data plate identifying it as an A-700A relay. The documentation for the left RCR also identified it as an A-700A relay rated at 300 amps.

**Figure 4**  
Damage to left RCR

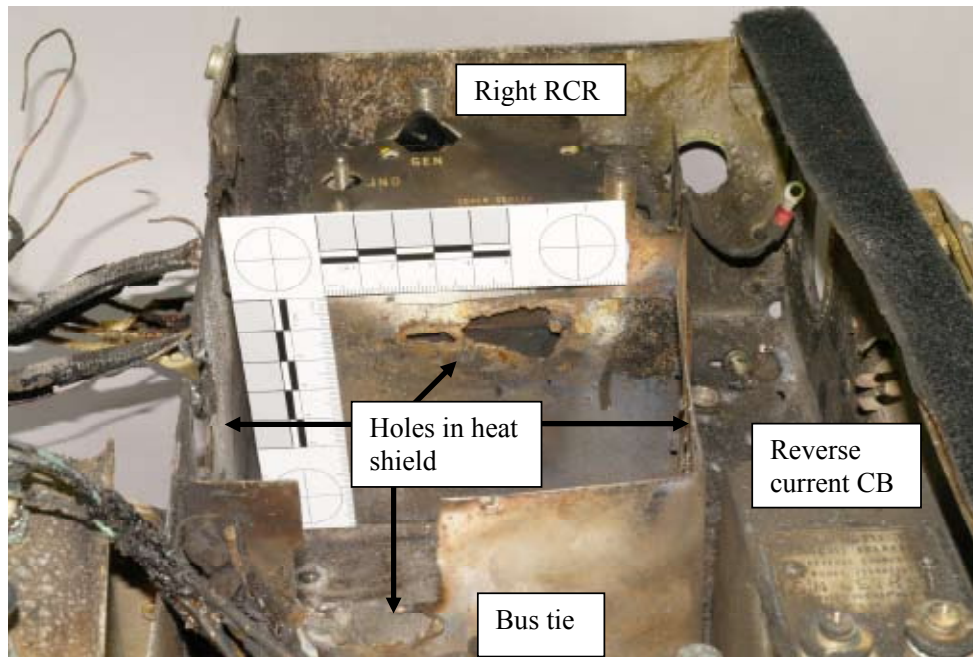
**Figure 5**

Four holes had been burnt through the stainless steel heat shield positioned around the left RCR, Figure 5. The holes were the result of arcing between the metal components in the left RCR and the heat shields; three of the holes were approximately 10 mm high and 20 mm long, the fourth was slightly smaller. The sides of the DC bus tie and the right RCR, which were mounted adjacent to the left RCR, had also been damaged by heat. The insulation on all the electrical control wires to the left RCR had melted and there was evidence of arcing having occurred between some of the wires

Damage to heat shield

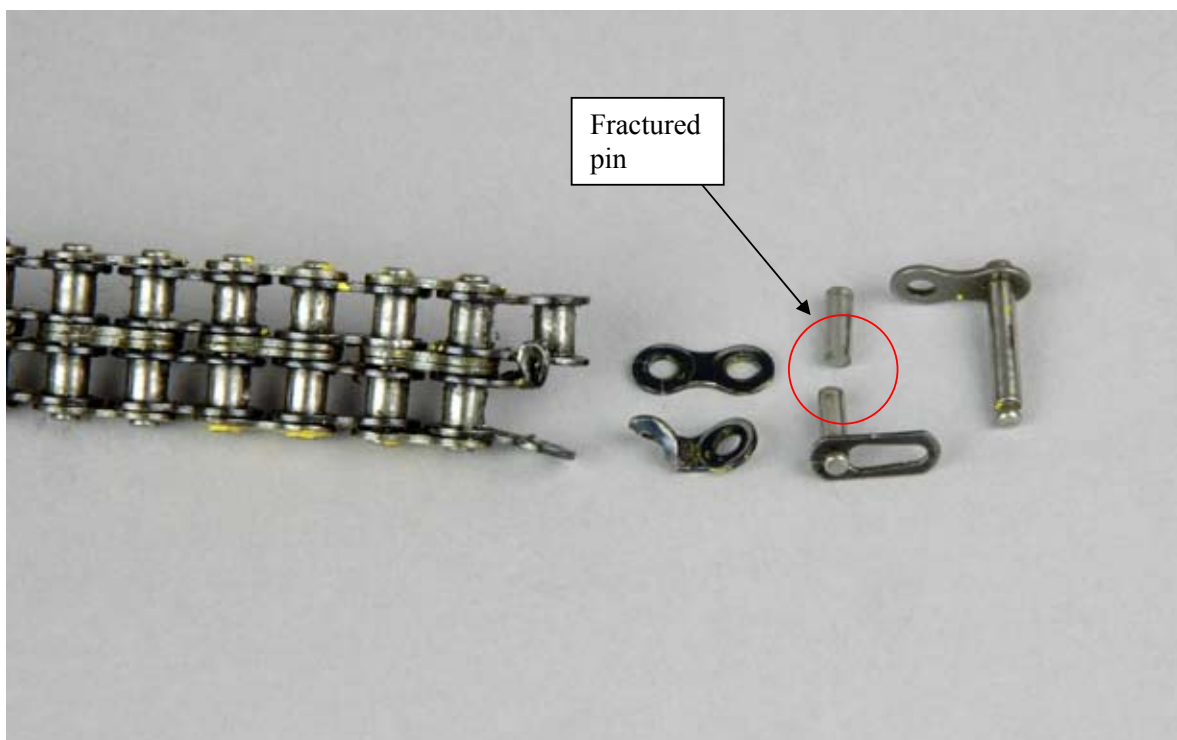
After removing the cabin floor to access the gearbox, it became evident that the nose gear chain had separated. The point of separation was a connecting master link used to remove the chain for maintenance. The pins, plates and the spring clip which made up this link had detached, but the parts were recovered from the aircraft. The chain was visually inspected in accordance with the manufacturer's Aircraft Maintenance Manual (AMM) and the general condition was considered to be within limits. Detailed inspection of the detached parts showed that one of the pins had fractured at its mid point and two of the connecting plates were distorted upwards, with a third plate distorted outwards (Figure 1).

**Figure 1**  
Failed chain link

The failed pin was sent for metallurgical analysis. Inspection of the pin, under a scanning electron microscope, showed evidence on the fracture surface that the failure was due to overload. No evidence of fatigue was identified. Several other cracks, which had not propagated to failure, were also identified when the pin was sectioned. The pin material composition and hardness were also tested and met the required specification.

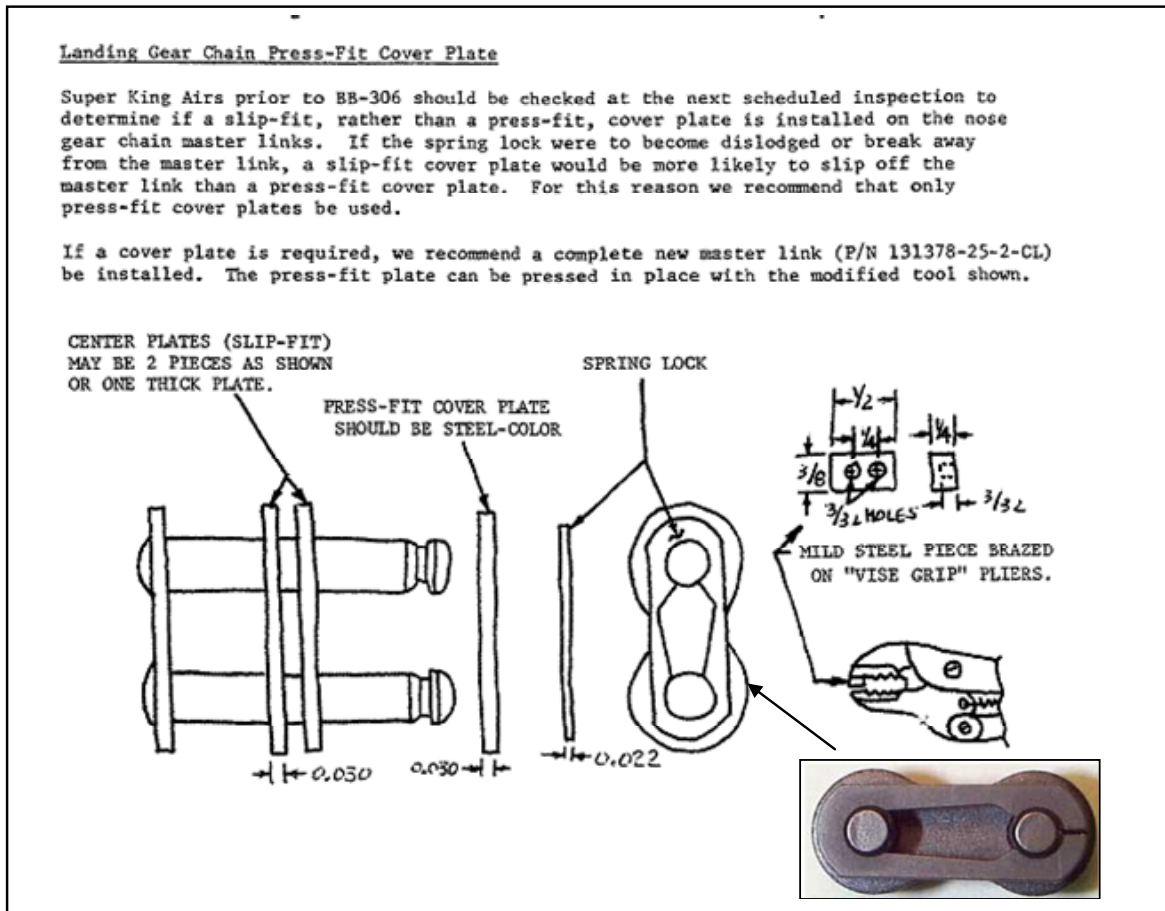
Figure 2

Model Communiqué No 16, dated 13 January 1978 was issued by the aircraft manufacturer advising replacement of a 'slip-fit' plate on the master link, with a 'press-fit' plate to retain the master link in the event of the spring lock becoming detached. This communiqué was applicable to aircraft serial numbers prior to BB-306. The accident aircraft serial number was BB-568, suggesting that the chain master link should be the same as the arrangement shown in Figure 2. Examination of the recovered parts of the chain indicated that the pins may not have been pressed through the rear cover plate to the full extent; as such there was insufficient gap remaining for the front 'press-fit' cover plate to be fitted underneath the spring clip. A front cover plate was not recovered from the aircraft following the accident (Figures 1 and 2).

Master link modification

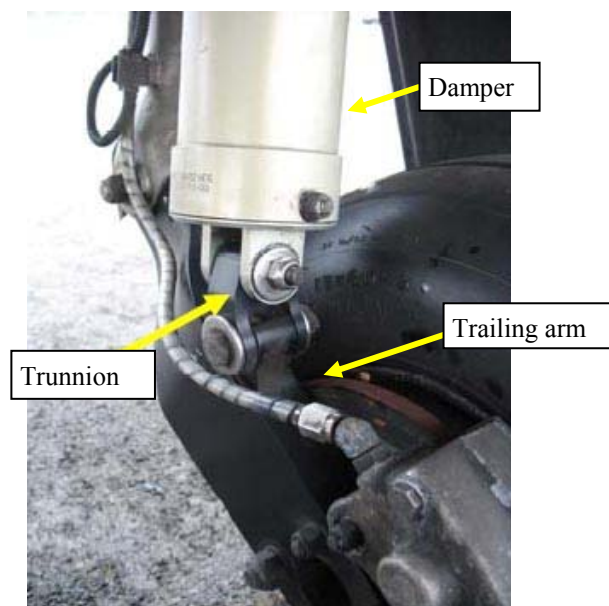
**Figure 1**

The aircraft was recovered and examined by the operator's maintenance organisation who advised the AAIB that the trunnion (Part No D60-3217-23-51) that connected the landing gear damper to the wheel trailing arm on the right landing gear leg had failed, Figure 1. This allowed the trailing arm to hang lower than normal, causing the landing gear to foul on the inside of the wheel well and prevented it from extending.

Location of failed trunnion on right landing gear

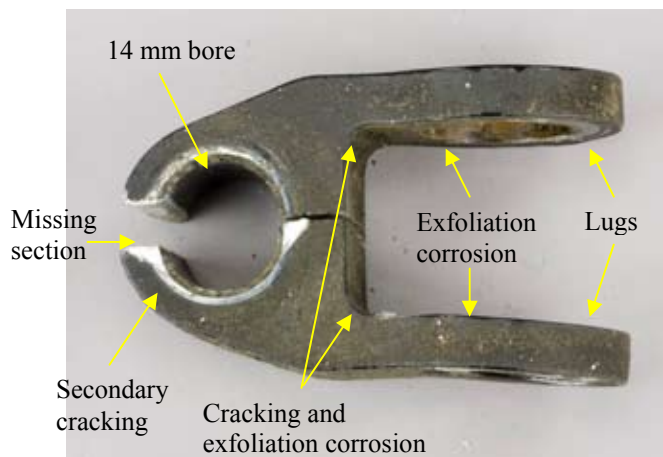
**Figure 2**

Failure of the right trunnion had occurred as a result of a fracture running along the 14 mm bore through which the attachment bolt that connects the trunnion to the damper was fitted. A section from this part of the trunnion, approximately 5 mm wide, had broken away and was not recovered from the accident site, Figure 2.

Damage to right trunnion

The metallurgist concluded that the failure of the right trunnion was as a result of SCC, which started in the 14 mm bore where the protective anodising had been damaged. Movement of the attachment bolt in the bore might have resulted in surface damage which compromised the anodised layer and accelerated the onset of SCC. The metallurgist also commented that the material from which the trunnion was manufactured is known to be susceptible to SCC, particularly when, as in this case, the component has been machined from plate stock or a forging resulting in exposed grain boundaries.

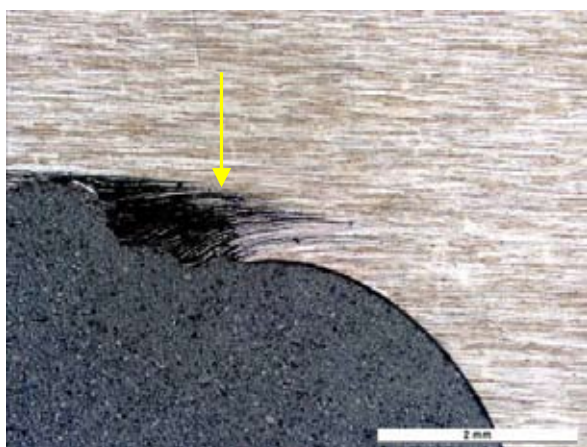
The trunnion had suffered extensively from exfoliation corrosion on the inner and outer faces of both lugs, Figure 3, to a depth of 4.8 mm. Cracking and exfoliation corrosion to a depth of 1.6 mm was also found along the inner radius at the base of both lugs, Figure 4.

**Figure 3**  
Exfoliation corrosion

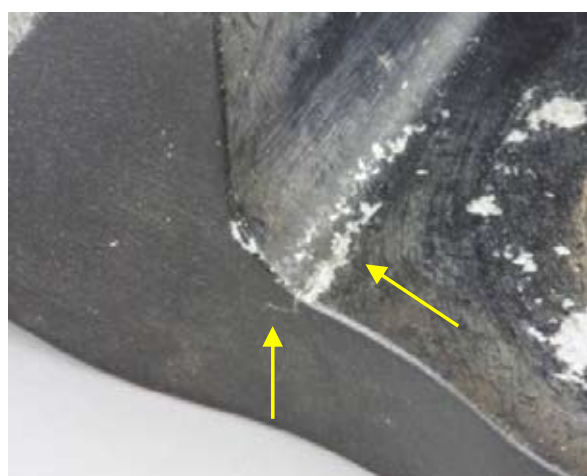
**Figure 4**  
Cracking at base of lugs

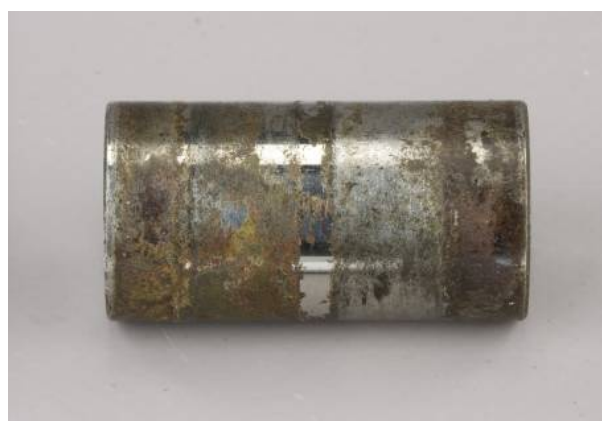
The bush (Part No BU1-18-10-0342) that fits into the lugs and the fitting on the landing gear trailing arm, Figure 5, had suffered from corrosion damage which appeared to be confined to the surface and did not penetrate the section, or show any evidence of pitting. There was no evidence of wear or gross loss of material. The bolt, which is fitted in the bush, was assessed as being in relatively good condition with no evidence of corrosion or damage.

**Figure 5**  
Condition of bush

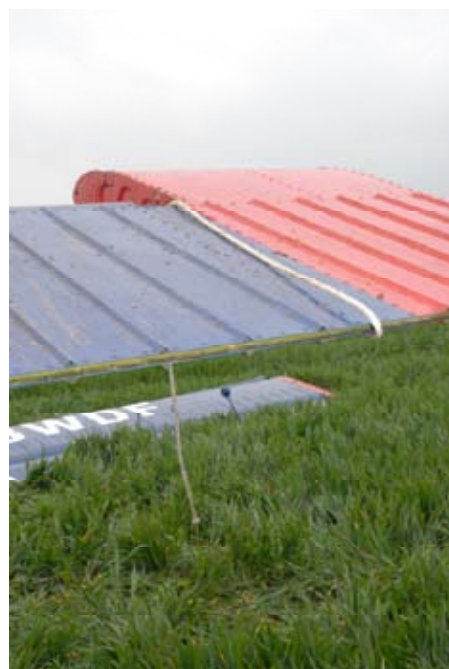
Figure 1.

Other photographs showed that the tow line was wrapped around the left elevator from the trailing edge to the hinge between the elevator horn balance and the tailplane (see Figure 1, which shows the tow line after cutting by personnel on the ground). Marks on the paint in the internal gap between the tailplane and horn balance were consistent with the tow line rubbing against the two surfaces.
