# ***AAIB Bulletin***

# ***10/2014***

BAE Systems Jetstream 31	G-GAVA	15-Aug-14	3
--------------------------	--------	-----------	---

<b>Aircraft Type and Registration:</b>	BAE Systems Jetstream 31, G-GAVA
<b>No &amp; Type of Engines:</b>	2 Garrett Airesearch TPE331-10UGR-516H turboprop engines
<b>Year of Manufacture:</b>	1987 (Serial no: 785)
<b>Location:</b>	Doncaster Sheffield Airport, Yorkshire
<b>Date &amp; Time (UTC):</b>	15 August 2014 at 1836 hrs
<b>Type of Flight:</b>	Commercial Air Transport (Passenger)
<b>Persons on Board:</b>	Crew - 2                      Passengers - 1
<b>Injuries:</b>	Crew - None                      Passengers - None
<b>Nature of Damage:</b>	Left main landing gear, left propeller, fuselage and wing
<b>Commander's Licence:</b>	Airline Transport Pilot's Licence
<b>Commander's Age:</b>	54 years
<b>Commander's Flying Experience:</b>	8,740 hours (of which 3,263 were on type) Last 90 days - 147 hours Last 24 hours - 6 hours
<b>Information Source:</b>	AAIB Field Investigation

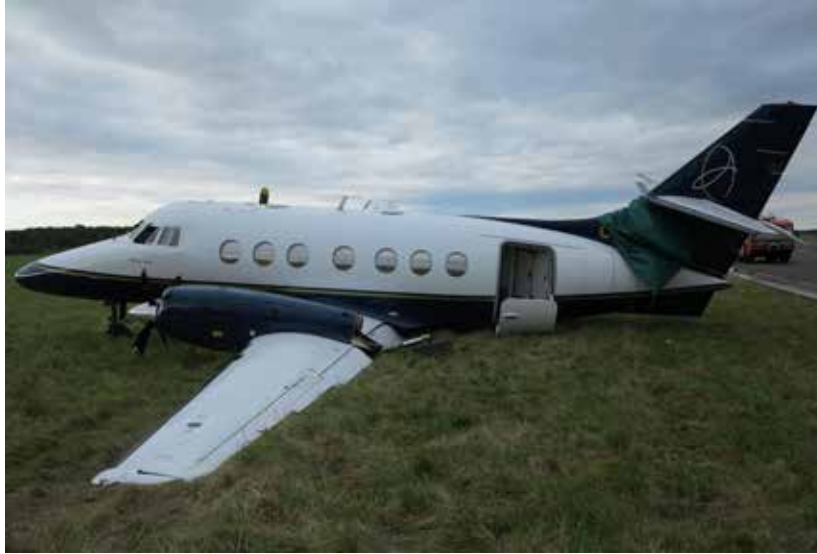
**Figure 1**

The aircraft as it came to rest

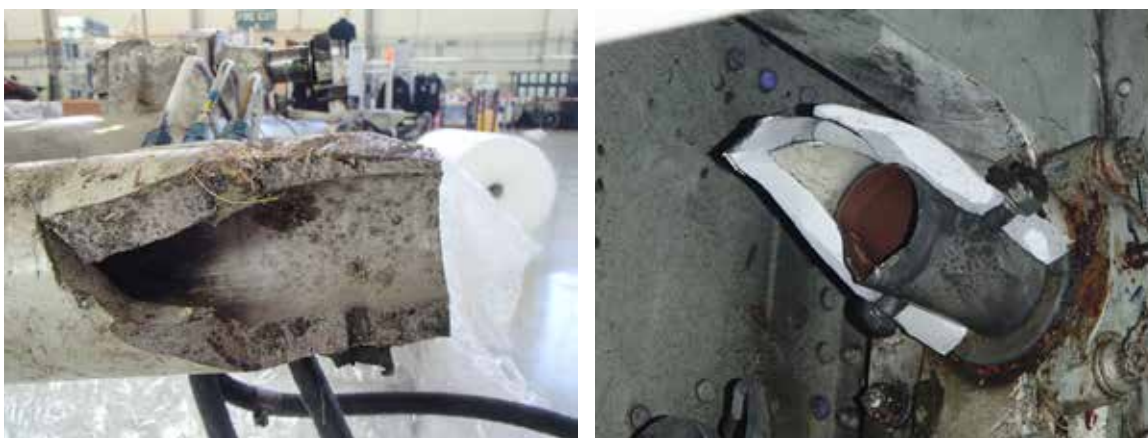
**Figure 2**

The left landing gear had broken away from its trunnions as a result of the failure of the forward yoke pintle housing; two sections of the pintle housing stayed attached to the pintle spigot (Figure 2). However, the landing gear remained attached to the aircraft by the radius arm (retraction jack) and hydraulic pipelines.

Left main landing gear yoke forward pintle

Preliminary metallurgical examination of the fracture faces on G-GAVA's left landing gear has established that the failure initiated at the top outer edge of the forward yoke pintle and that the crack propagated axially along the top of the pintle, before final overload failure occurred. The presence of corrosion has been identified at the crack initiation site. The forward face of the yoke pintle housing exhibits rotational wear marks and corrosion pitting. There is also evidence of rotational wear marks on both the forward and aft faces of the special washer; further work is required to fully understand the origin of these marks. There was no visual evidence of the presence of gasket material on either of the mating faces of the washer or pintle housing although some gasket material was present on the top machined flat of the housing. Additionally the fracture faces exhibit considerable similarities to those from the G-CCPW accident. This provides strong evidence that the crack initiated due to stress corrosion cracking.

Metallurgical analysis has determined that a crack initiated at the top edge of the forward yoke pintle and propagated axially along the top of the pintle housing, ultimately resulting in an overload failure of the pintle yoke. Further analysis is required to understand the specific characteristics of the failure and how long the crack took to grow to failure. However, there is sufficient evidence to indicate that the failure was precipitated by stress corrosion cracking

It is recommended that the European Aviation Safety Agency take action to assure the continued airworthiness of those BAE Systems Jetstream 31 main landing gear legs that are manufactured from DTD 5094 aluminium alloy and have SB 32-JM7862 embodied.

It is recommended that the European Aviation Safety Agency take action to mandate an effective inspection regime for the Jetstream 31 that will detect cracking and prevent failure of the yoke pintle of main landing gear legs manufactured from DTD 5094 aluminium alloy.

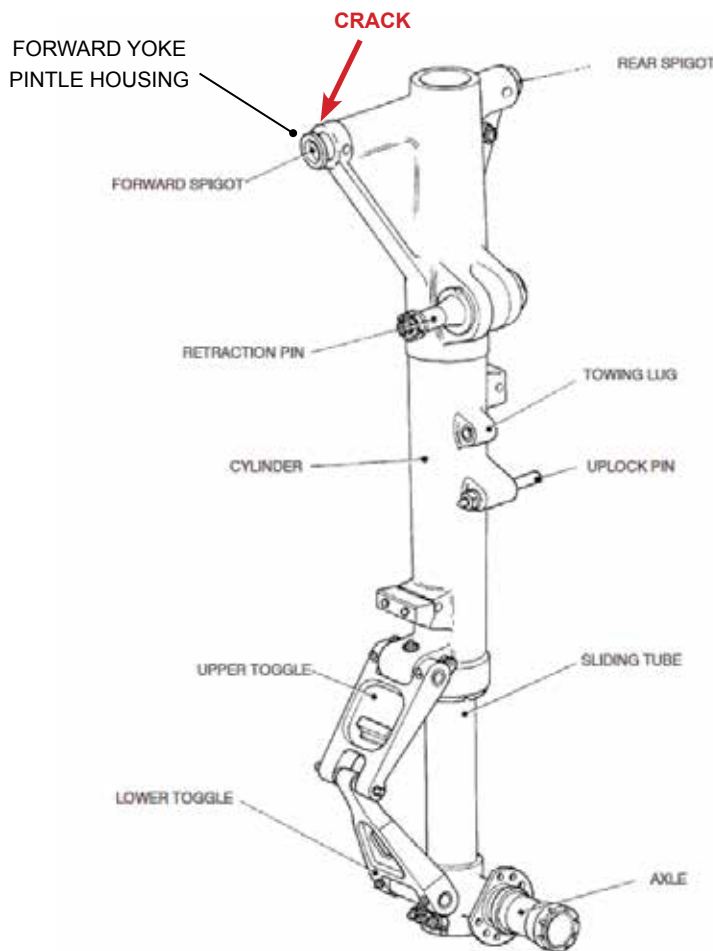
**Figure 3**

The landing gear is attached to the airframe by trunnions that fit into steel spigots that are bolted to the inside of the yoke pintles. The upper surfaces of the pintles are machined flat to introduce a weak link that, in the event of the landing gear being subjected to a force outside of its design limits, will fail without damaging the fuel tanks. During the accident, the forward yoke pintle failed along this machined flat (Figure 3).

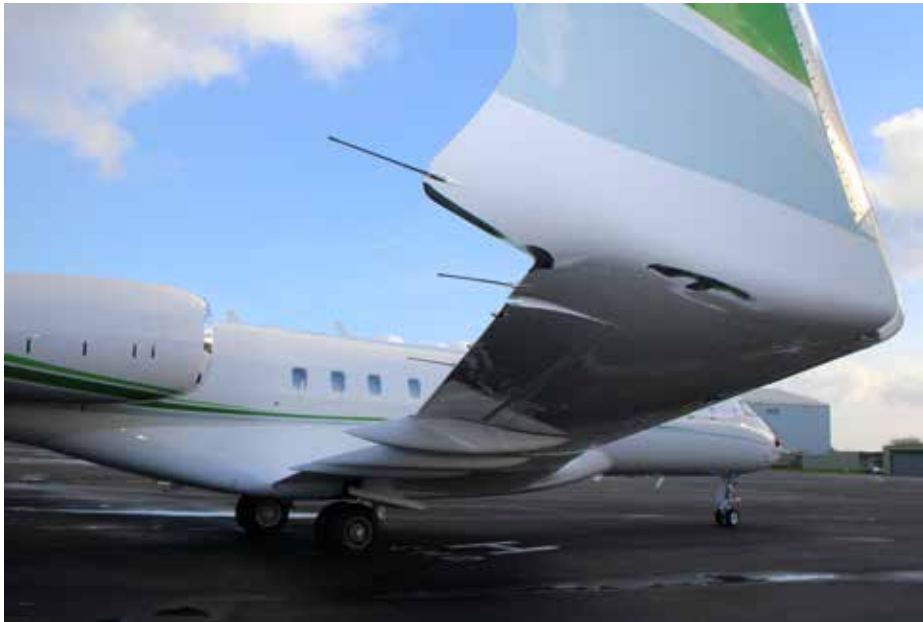
**Figure 2**  
Damage to EC-LTF

wicks fitted to the aileron. No pre-impact technical issues were identified that may have affected the aircraft's handling.

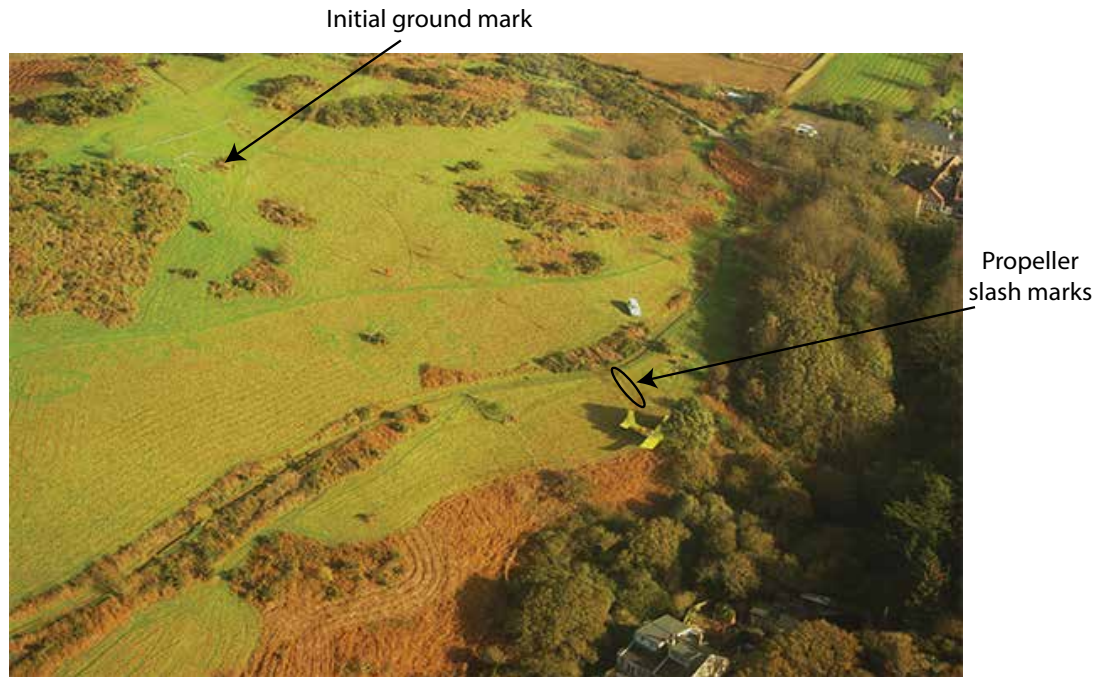
**Figure 2**

The left main gear leg had been distorted aft at its mounting in the wing. The propeller blades on the left engine showed signs of having been rotating whilst striking the ground but, due to the rearward deflection of the propeller blade tips, showed little signs of power. There was some rotational scoring on the spinner hub from a damaged piece of engine cowling. The propeller on the right engine had been feathered.

There were ground marks covering 140 m from the brow of the hill down to where the aircraft had come to rest that were made by the landing gear, and approximately 20 m from the aircraft there was a wider ground mark followed by a series of regularly-spaced slash marks. The left main gear had been distorted rearward and made the large ground mark, and the left propeller blades, which were rotating, caused the slash marks. It was estimated from the slash marks that the rotational speed of the left engine was well below 1,000 rpm.

General view of the wreckage site

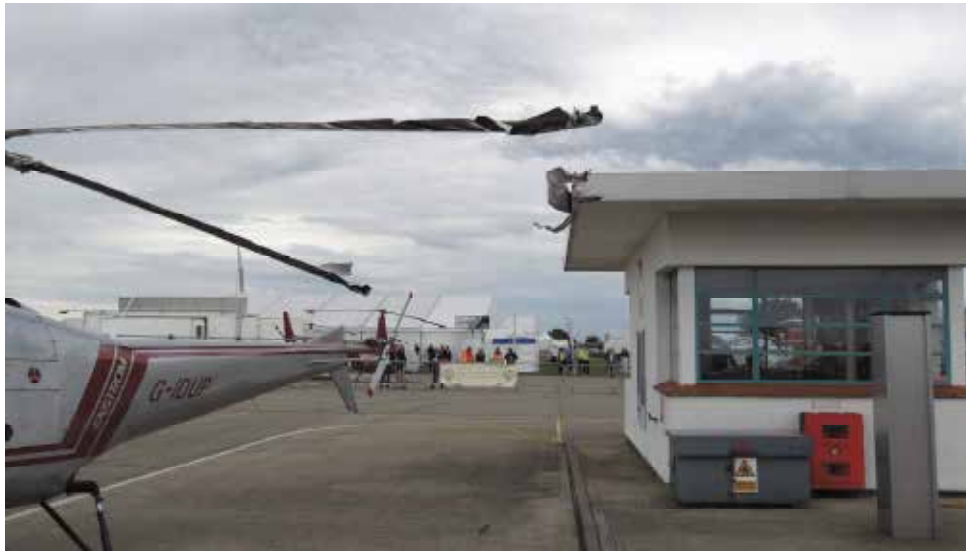
**Figure 1**

The position of the point of impact on the building meant that it was outside the pilot's field of view when he was looking ahead, to land (see Figure 1).
