CONTENTS

ACCIDENT

Aircraft Type and Registration:	Boeing 777-236ER, G-YMMM	
No & Type of Engines:	2 Rolls-Royce RB211 Trent 895-17 turbofan engines	
Year of Manufacture:	2001	
Date & Time (UTC):	17 January 2008 at 1242 hrs	
Location:	Runway 27L, London Heathrow Airport	
Type of Flight:	Commercial Air Transport (Passenger)	
Persons on Board:	Crew - 16	Passengers - 136
Injuries:	Crew - 4 (Minor)	Passengers - 1 (Serious) 8 (Minor)
Nature of Damage:	Aircraft damaged beyond economic repair	
Commander's Licence:	Airline Transport Pilot's Licence	
Commander's Age:	43 years	
Commander's Flying Experience:	12,700 hours (of which 8,500 hours were on type) Last 90 days - 85 hours Last 28 days - 52 hours	
Information Source:	Inspectors Investigation	
	All times in this report are UTC

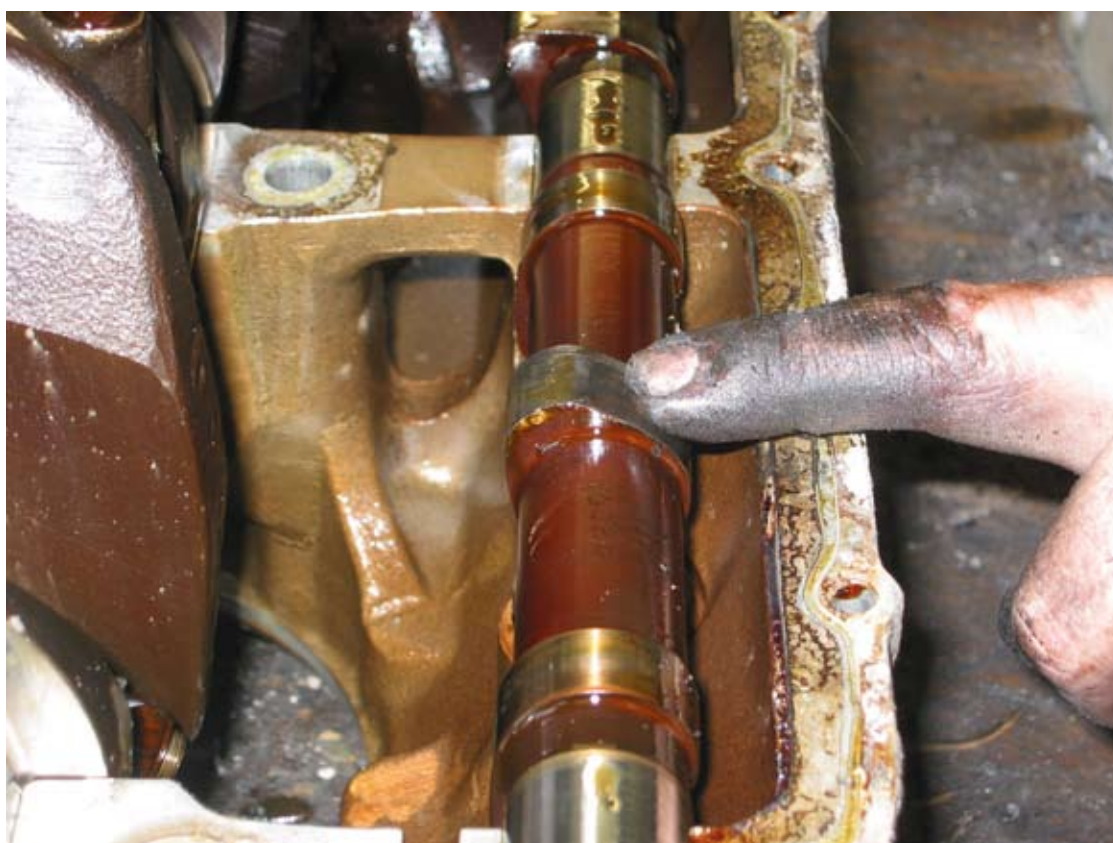
Figure 1

Worn cam lobe, as found during engine strip

Valve operation and camshaft details

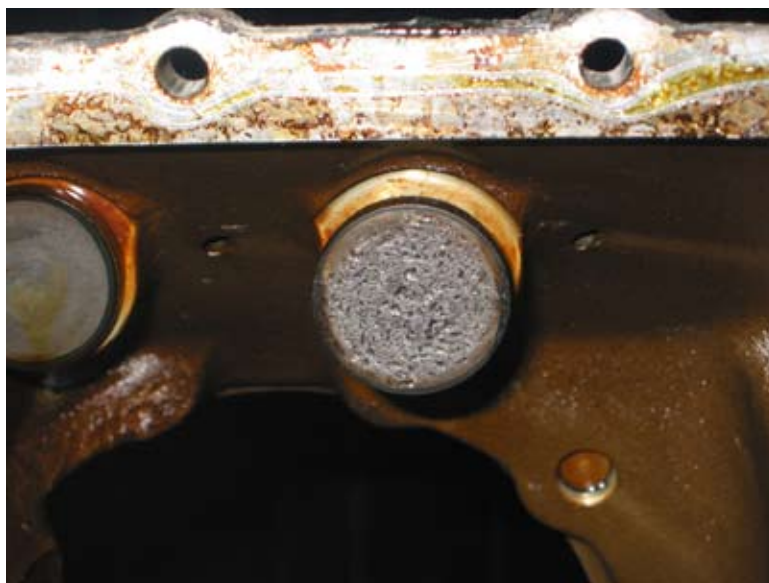
View of spalling on one of the cam followers

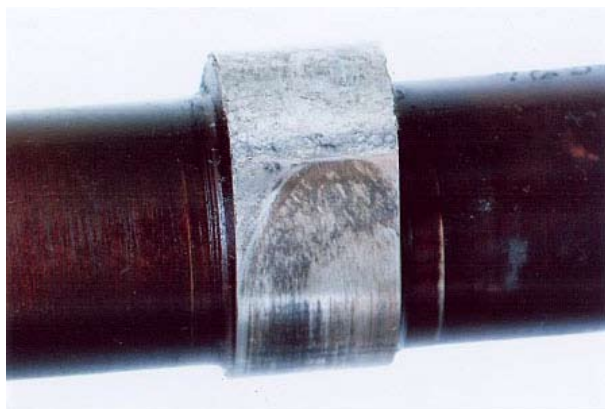
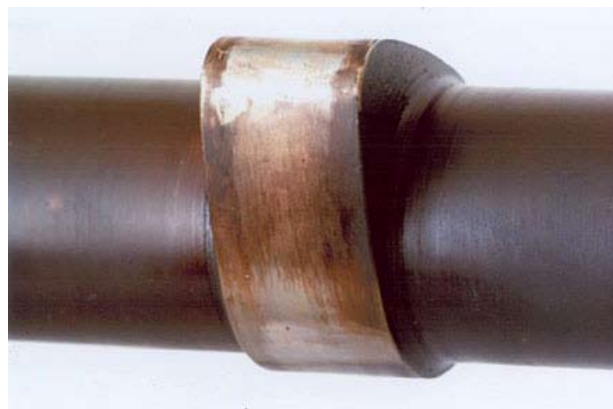
Comparison of worn and normal cam lobes

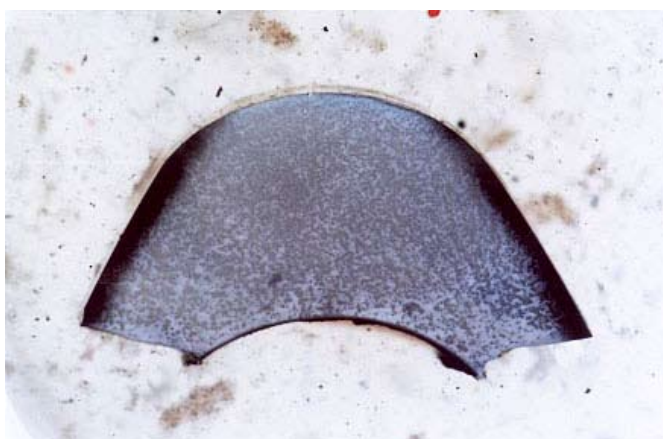
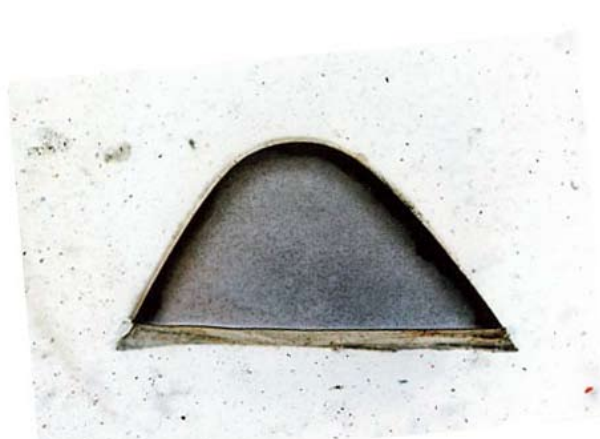
Section through worn and normal cam lobes. Note hardened layer showing as dark areas

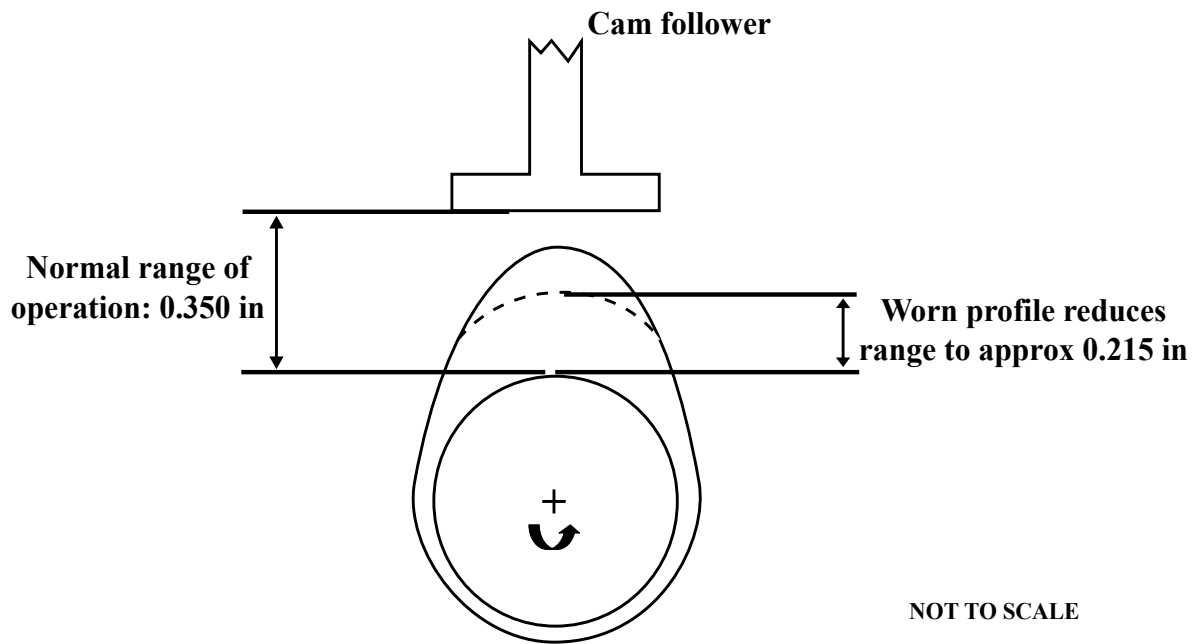
The effect of the cam wear in this case was to reduce the cam follower range of movement by approximately 40%. This in turn would reduce the amount by which the inlet valves opened during the induction stroke, thus possibly resulting in a lower volume of fuel/air mixture and ultimately, reduced engine power output.

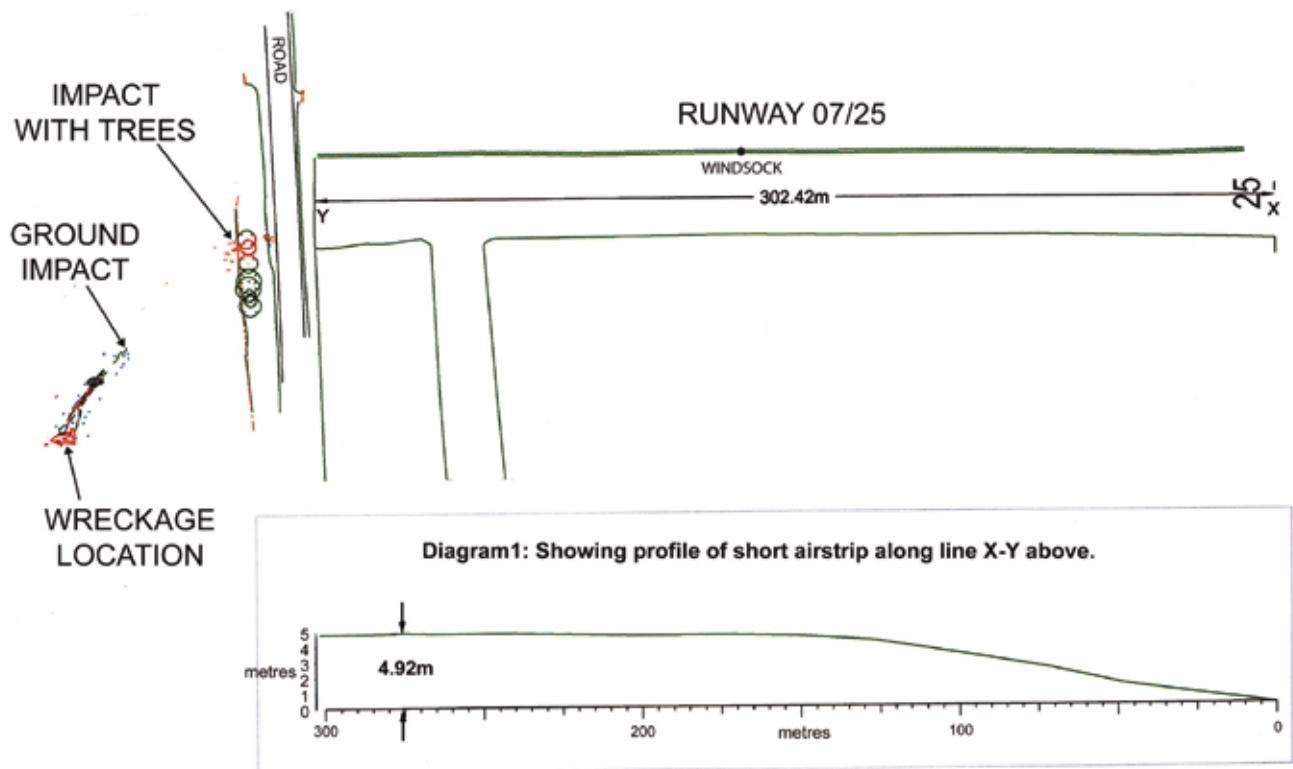
Figure 4

The aircraft wreckage was found lying inverted in a field beyond the end of Runway 25. The ground scars and wreckage distribution were consistent with the aircraft having hit the ground with its left wing tip first, in a steep left bank, before impacting on its nose and cartwheeling to the right. Both wing spars failed during the impact sequence. There was evidence that the aircraft's left wing had struck trees that were approximately 30 metres from the end of Runway 25, as depicted in Figure 4. The aircraft's left wing tip strobe light housing was found at the base of these trees which were approximately 30 to 40 ft high.

There were three propeller slash marks in the ground where the nose of the aircraft had hit. All three propeller blades had separated from the hub. One blade was embedded in the ground by the slash marks. Another blade was resting on the ground 24 metres further along the wreckage trail, and the third blade was resting on the ground 95 metres south-east of the aircraft wreckage. All three blades had chordwise scratches consistent with rotation at impact. The distance between the first two propeller slash marks was measured at 25 cm which meant that a linear relationship between ground impact speed and engine rpm could be established. If one assumed that the engine was turning at the normal takeoff rpm of 2,700 then the ground impact speed was approximately 66 kt. If one assumed a low impact speed of 40 kt then the rpm could have been as low as 1,650. However, the extent of damage to the aircraft and injuries to the pilot would suggest a ground speed of greater than 40 kt and closer to 66 kt, so an engine rpm of greater than 1,650 was likely, which would indicate that the engine was producing power.

Runway length and profile with relative impact and wreckage locations.
(Note that the x and y axes in the vertical profile have different scales;
the total upslope gradient is 1.6%.)
