AAIB Bulletin

2/2018

Published 8 February 2018

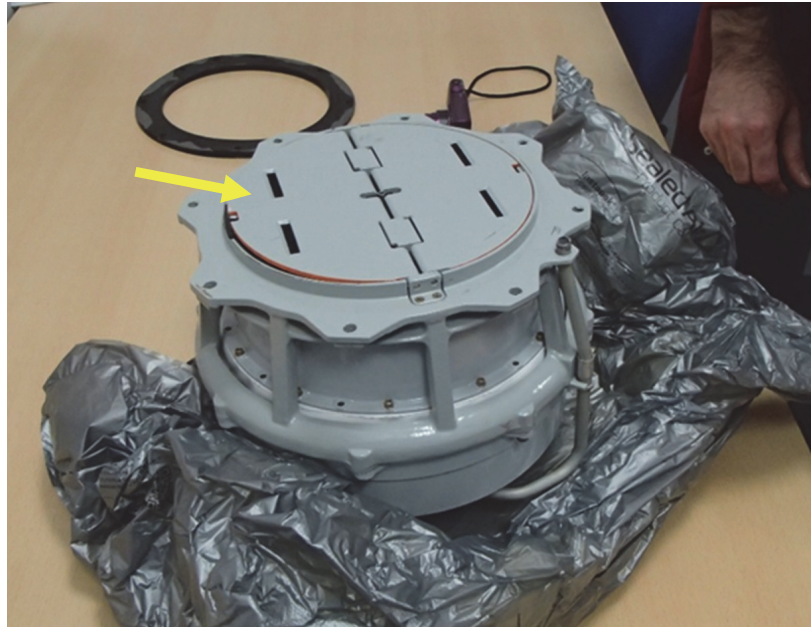
Figure 1

Testing and strip examination of the faulty valve proved inconclusive, with no obvious reason for the malfunction being found. The possibility of debris trapped in a metering section of the valve could not be ruled out, although no evidence of this was found.

External inspection of the aircraft revealed that the indicator flag on the upper PPRV upper door flap was visible (Figure 1, arrowed), indicating that the valve had operated in flight, allowing cabin air to leak overboard.

Defective positive pressure relief valve,
as removed from G-POWD

The investigation concluded that there was a fault in one PPRV that would result in gradual cabin air leakage. The reason for the fault was not identified, despite testing and careful strip examination. The valve manufacturer surmised that a small piece of debris could have become trapped in a metering unit ball valve, thus propping it open. However, it was not established how such debris could have entered the valve after it was tested as serviceable following overhaul.

The failure of the cabin to pressurise correctly resulted from a faulty PPRV which was installed during recent maintenance. The maintenance checks of the replacement valves did not identify the defect with the faulty PPRV.

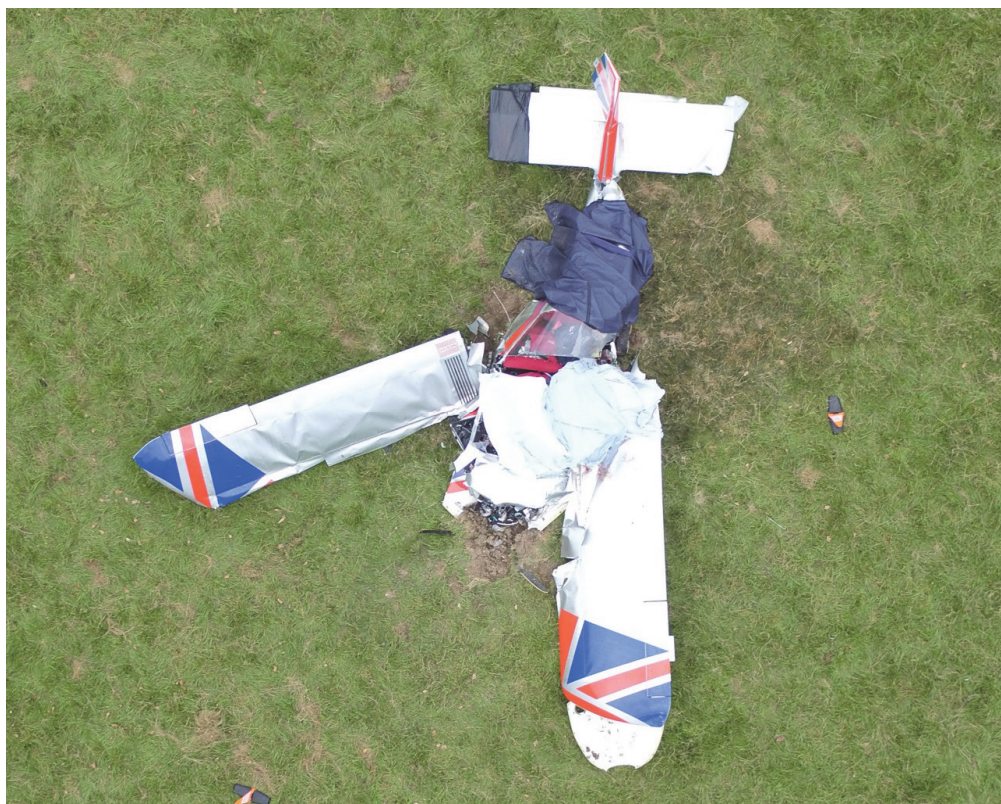
Figure 2

The aircraft wreckage was found in a field near Builth Wells, about 360 m and 102° from the last recorded radar return. The wreckage was resting in its initial impact crater, indicating that it had a high vertical speed and low forward speed at impact (Figure 2). The left wing had folded forwards and had sustained significant impact damage to its leading edge near the root but no damage to the outer portions. The right wing had suffered leading edge compression damage along its entire length, and there was an imprint from the right wing in the ground, indicating a steep nose-down impact. Behind the tail, about 50 m away, was a section of the left wing belly fairing (Figure 3). Between this point and the main wreckage site there were no other parts of wreckage.

Overhead view of the aircraft wreckage at the accident site

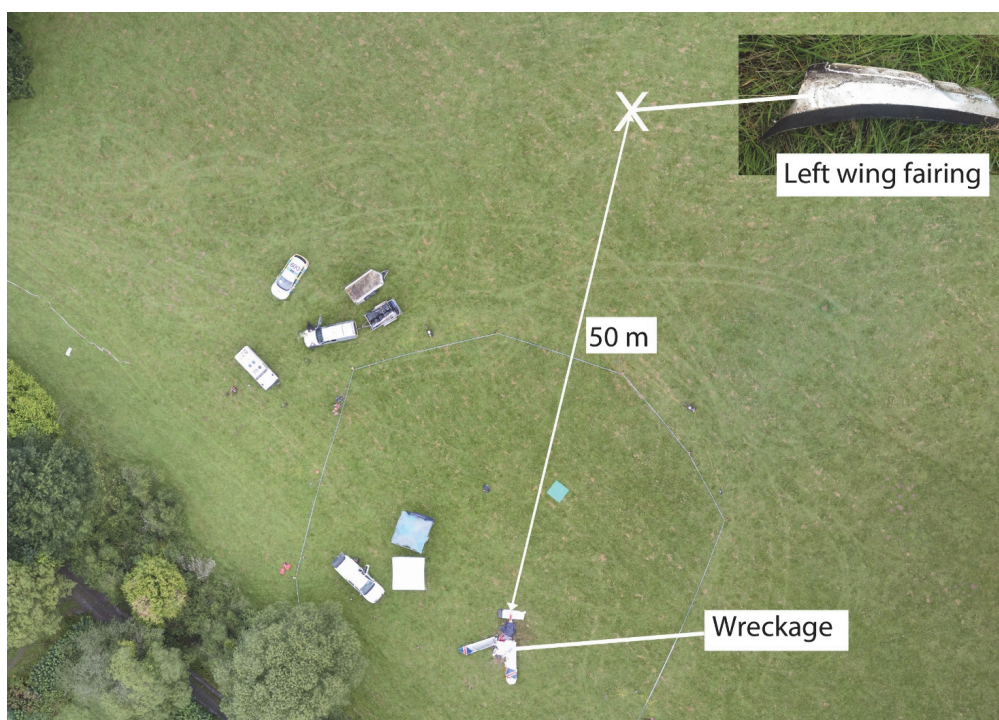
Figure 3

Overhead view of the accident site showing distance to the left wing lower fairing

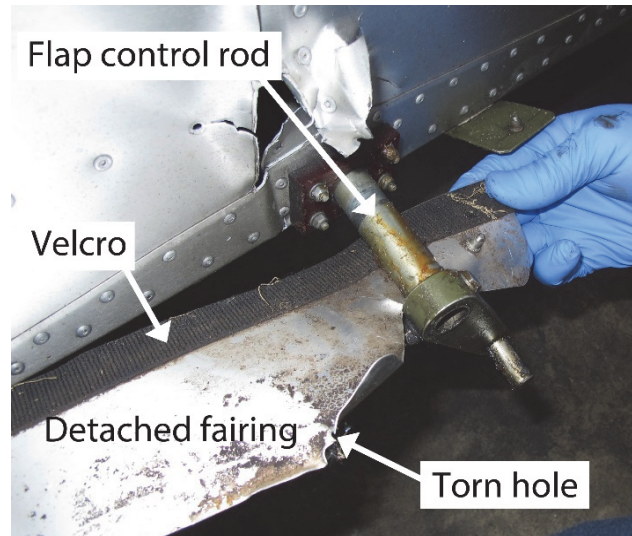
Figure 7

The section of left wing belly fairing, which was found 50 m away from the main wreckage, had torn holes where it had been attached by screws to the underside of the left wing. This fairing is not physically attached to the fuselage, but rests against its underside with a strip of Velcro to avoid fretting. There was an indentation in the fairing consistent with it having been pulled against the flap control rod (Figure 7).

Detached left wing belly fairing held alongside the left fuselage of a different EV-97 aircraft

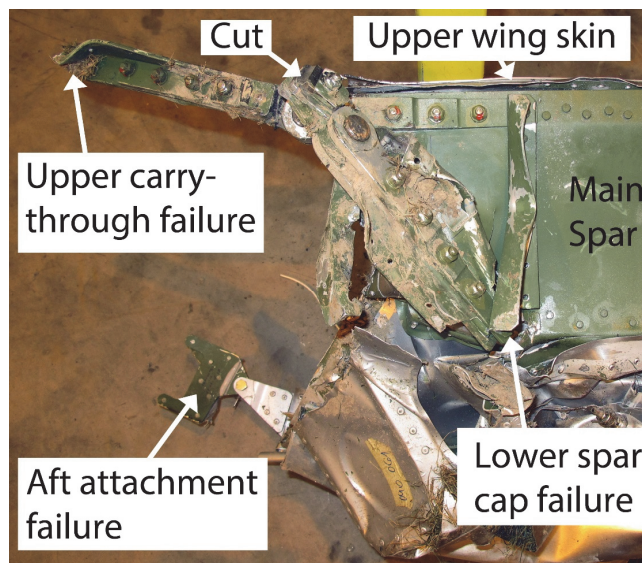
Figure 8

The right wing had remained attached and had suffered some internal damage as a result of crushing damage along the length of its leading edge. The left wing had suffered from a structural failure of its lower spar cap and the upper 'carry-through' spar cap in the fuselage had also failed (Figure 8). Both the upper and lower 'main-spar-to-fuselage' attachment fittings were intact; the lower fitting was cut on the fuselage side to enable the wing to be removed. The left wing aft attachment fitting had separated from inside the fuselage. These parts were sectioned and taken to a forensic organisation for detailed metallurgical examination.

View of the forward face of the left wing main spar showing the three failure locations and where the lower forward fuselage attachment was cut in order to remove the wing

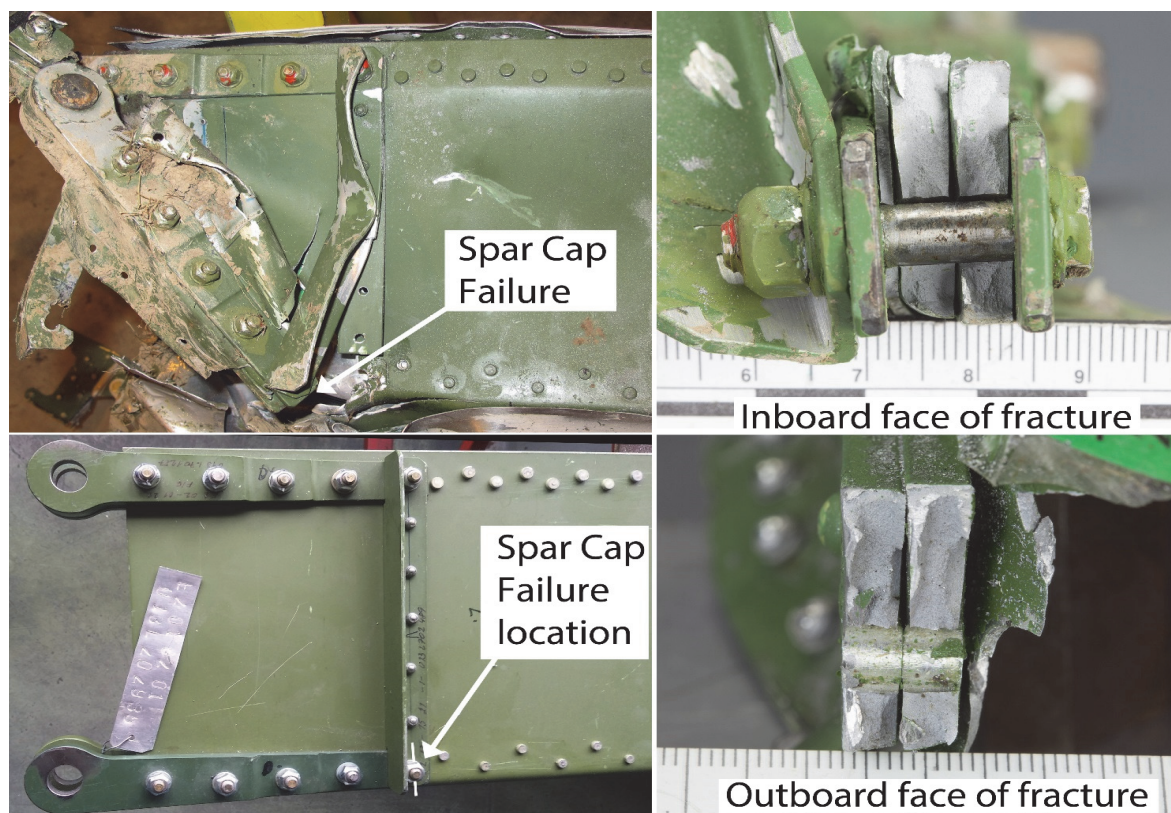
Figure 9

The lower wing spar cap consisted of two strips of 2024 T3 aluminium plate fastened together. Each strip had a cross-section of 25 x 5 mm, with the forward facing strip, known as the 'long cap', having a machined radius on one edge. The aft facing strip was known as the 'short cap' due to its shorter length. At the inboard end of the cap, the two strips, along with the web, were sandwiched between two steel attachments which were held together by five 6 mm diameter bolts. The fracture of the spar cap had occurred at the fifth outer bolt (Figure 9).

There was mechanical damage on the forward face of the web in the area of the fracture which suggested that there had been forward movement of the outboard section of the spar cap relative to the inboard section after failure, when the outboard section of spar was inclined upwards by about 25°. Both spar cap fracture surfaces were found deformed in a manner consistent with upwards bending, and there was 'necking' which is characteristic of overload failure. The fracture surfaces were examined in a scanning electron microscope (SEM) which revealed that both had failed in tensile overload with no evidence of fatigue or corrosion.

Top left: view of spar cap failure.
Bottom left: location of spar cap failure on a new main spar.
Top right: View of spar cap fracture looking inboard.
Bottom right: View of spar cap fracture looking outboard

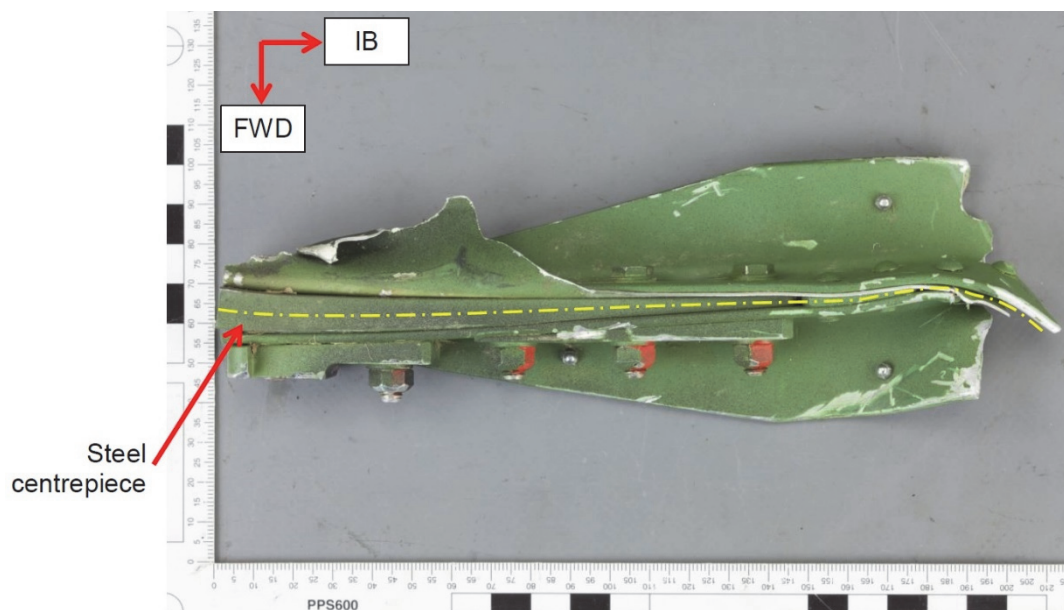
Figure 10

The upper carry-through spar had failed inside the fuselage beneath the left pilot's seat and this area had suffered significant crushing damage during the impact after the landing gear collapsed. There was extensive deformation of the lightweight aluminium structure around the fracture, which was consistent with the left wing moving forward. The steel centrepiece (Figure 10) was also found deformed, with an 'S' shape characteristic of buckling. However, SEM examination revealed that the fracture surfaces had ductile 'dimples' characteristic of tensile overload failure with no evidence of shear or compression. It appears that the upper spar was deformed in compression before failing in tension. There was no evidence of fatigue or corrosion.

Lower surface of upper carry-through spar. Cut on left side and fractured on right side. Centre section is made of steel. Fractured parts are aluminium

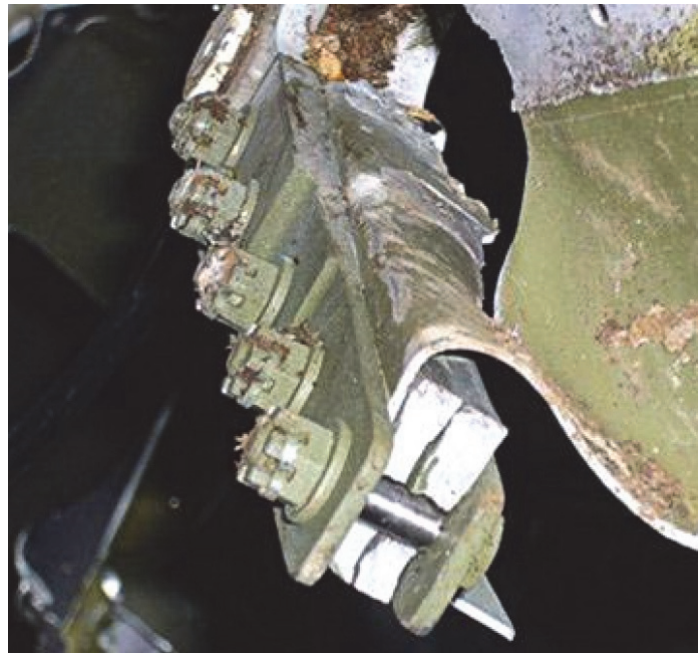
Figure 11

Left wing lower spar cap failure of EV-97 registration 9-249 in Switzerland in 2006

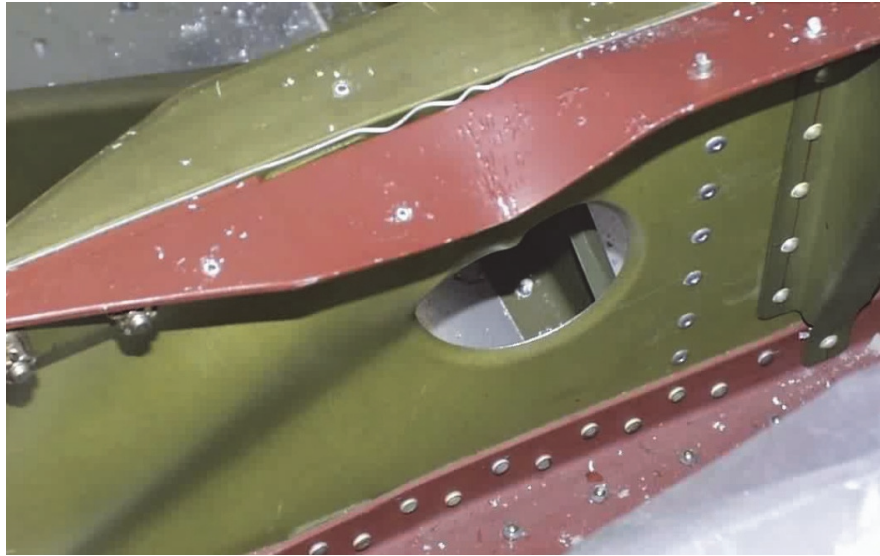
Figure 12

Upper carry-through spar buckling which occurred at 1.6 times limit load during the wing strength static test

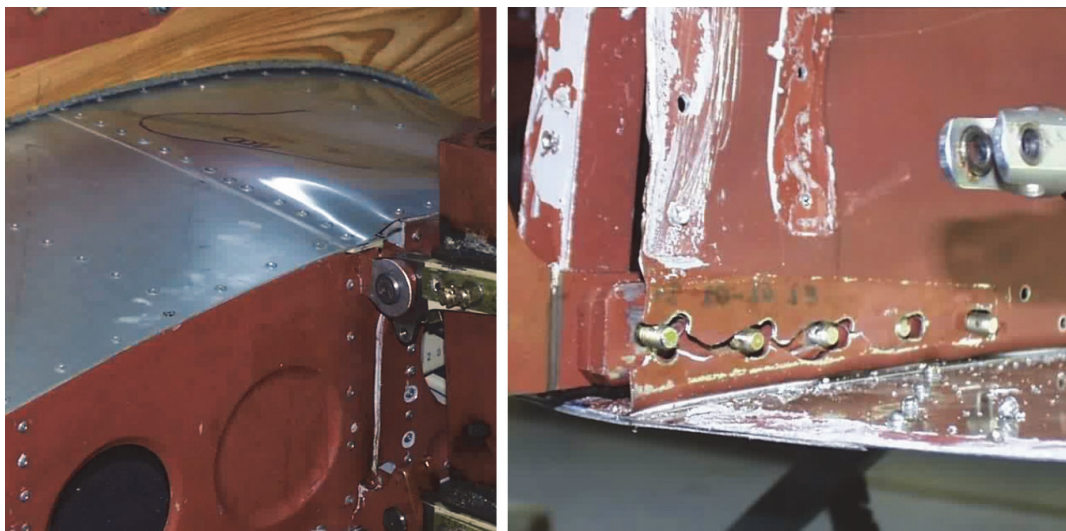
Figure 13

Upper wing skin buckling (left) and main spar web failure (right) at 1.68 times limit load during the wing strength static test

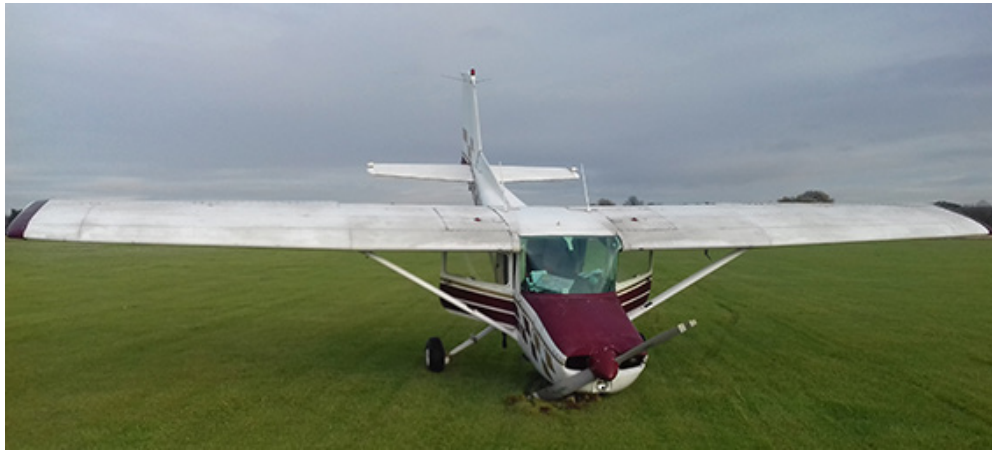
Figure 1

G-BABC resting on its lower engine cowling
