CONTENTS

ACCIDENT

Aircraft Type and Registration:	BAe.ATP, G-MANH
No & Type of Engines:	2 Pratt & Whitney Canada PW126 turboprop engines
Year of Manufacture:	1989
Date & Time (UTC):	9 April 2011 at 0147 hrs
Location:	Cardiff Airport
Type of Flight:	Commercial Air Transport (Cargo)
Persons on Board:	Crew - 2 Passengers - None
Injuries:	Crew - None Passengers - N/A
Nature of Damage:	Both right main landing gear tyres, gear leg components, hydraulic pipes and flap/nacelle fairings damaged
Commander's Licence:	Airline Transport Pilot's Licence
Commander's Age:	56
Commander's Flying Experience:	10,138 hours (of which 1,379 were on type) Last 90 days - 85 hours Last 28 days - 28 hours
Information Source:	AAIB Field Investigation

Synopsis

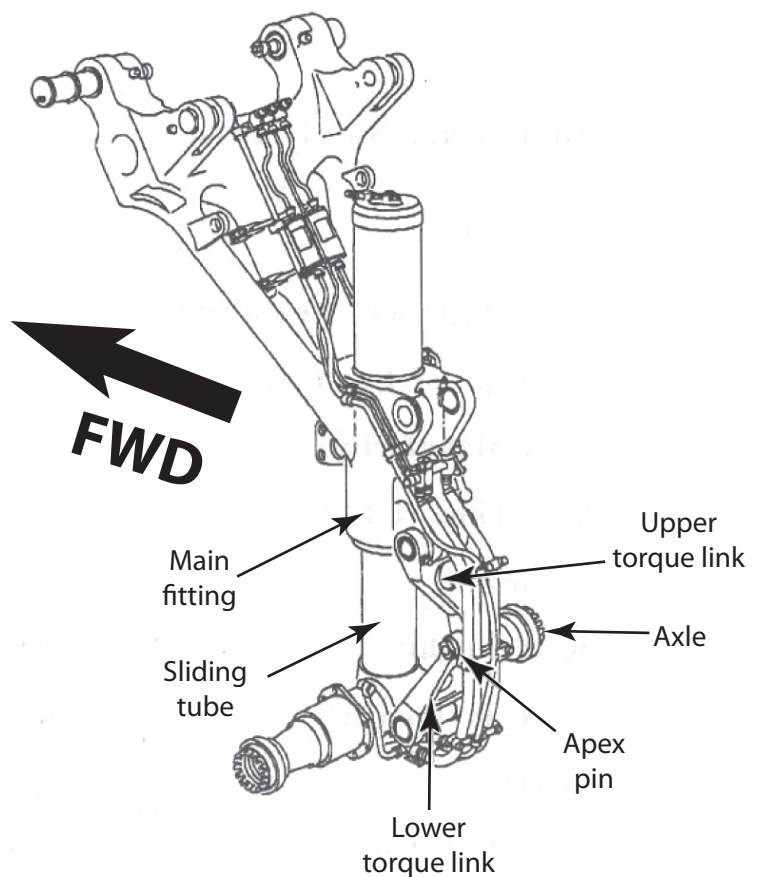
Figure 1

The main landing gear leg of the ATP has conventional torque links attaching the sliding tube (sometimes known as the sliding member) and axle assembly, together with the wheels and brakes, to the upper section (main fitting) of the leg. The link system constrains the axle against rotating in the horizontal plane.

General view of leg with wheels and brakes removed

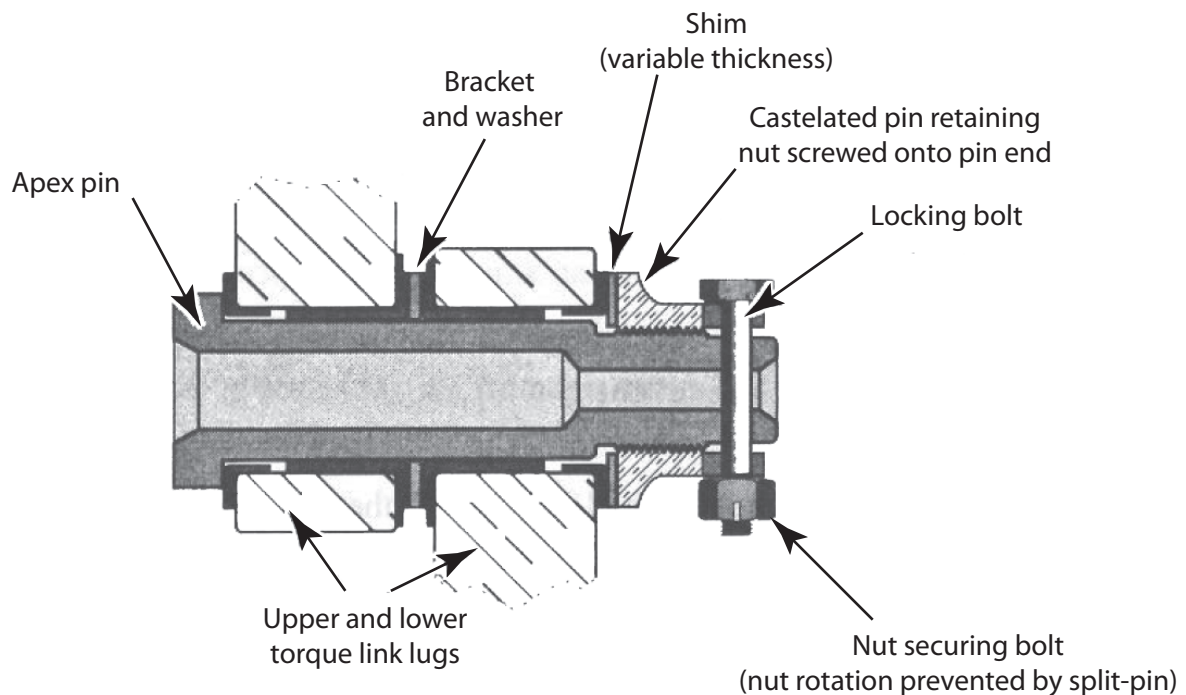
Figure 2

The lugs at the aft end of each link have bushed horizontal bores. The apex pin attaching the aft lugs together is secured in position by a large castellated nut screwed onto a threaded end portion of the pin. The pin also passes through a bracket and a washer fitted between the lugs and a shim positioned beyond the lug of the upper link directly secured by the castellated nut. (The bracket locates flexible hydraulic pipes routing to and from the brake units.) The castellated nut is prevented from rotating on the pin threads by a small diameter threaded locking bolt passing through the castellations and through one of two bores in the pin. These are orientated at 90° to the pin axis and 90° to one another. The shim thickness is varied to enable the backlash of the installed apex pin to be controlled on assembly, since the axial position of the castellated nut on the threads of the apex pin is dictated by the presence of the locking bolt and can only be varied in discrete steps corresponding to approximately $1/12$ of a

Section through apex pin, torque link lugs, castellated nut and locking bolt

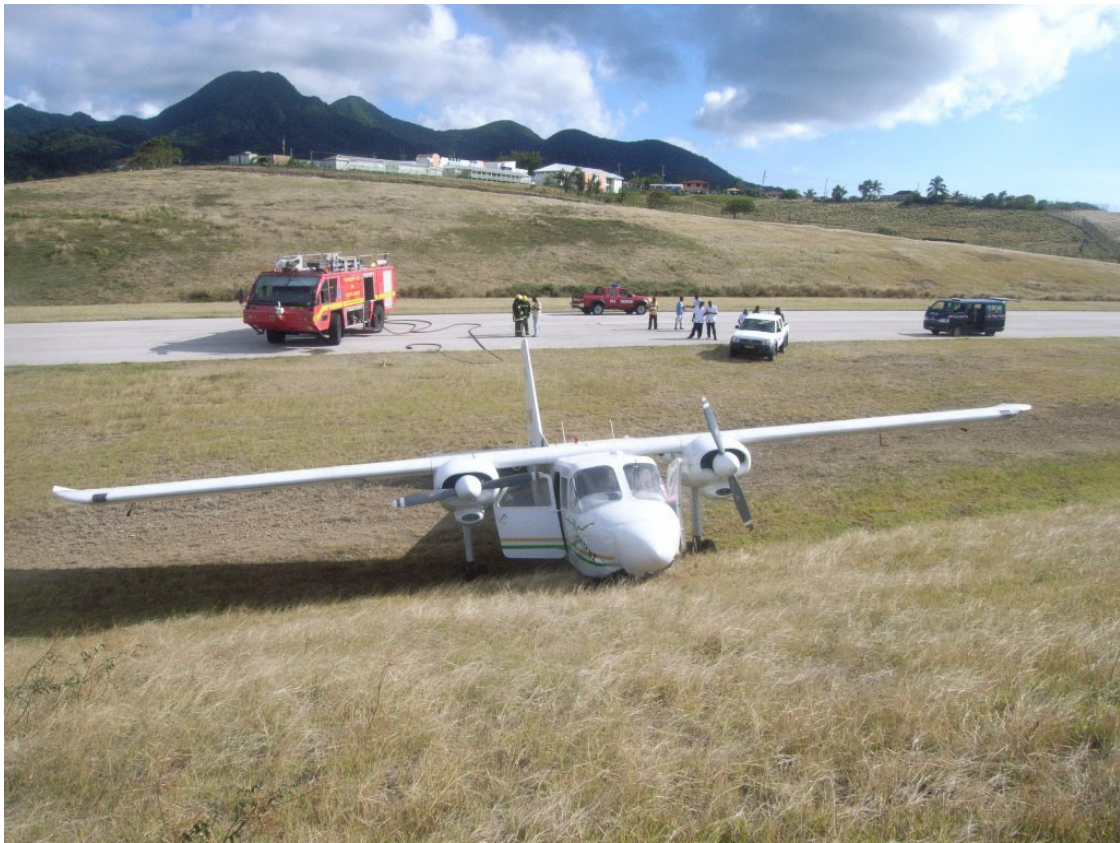
Figure 1
Accident site

in damage to the nose structure and caused the nose landing gear leg to collapse. The left wing tip leading edge was also damaged when it struck the embankment. After the aircraft came to rest the passengers were able to exit the aircraft via the main door.

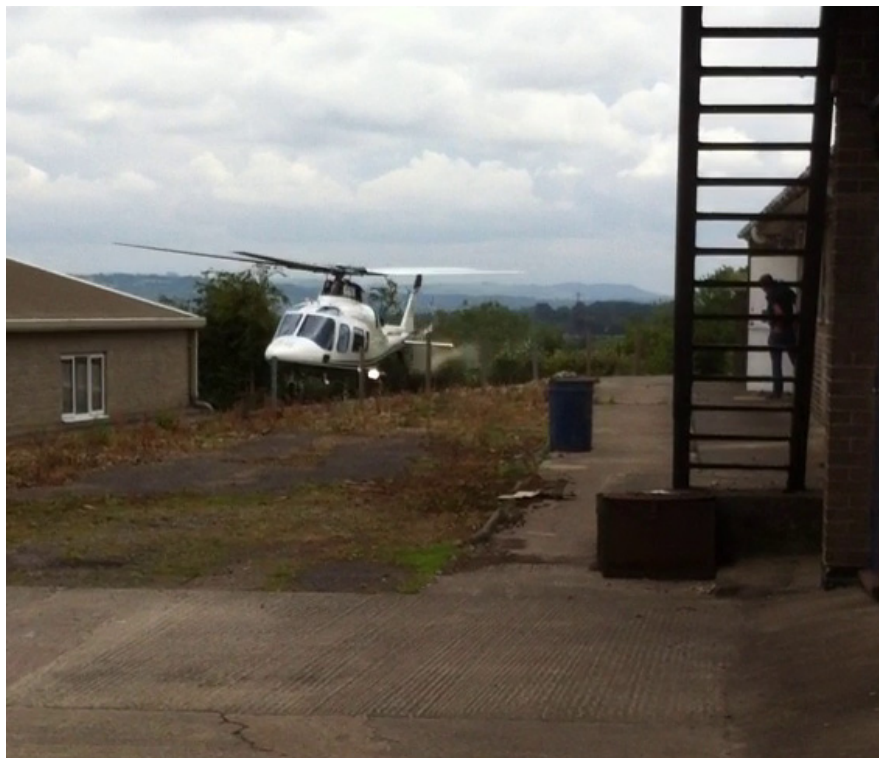
A video of the accident was filmed by an occupant of one of the adjacent buildings who was standing about 35 m from the helicopter and shows details of the event consistent with the pilot’s recollection. Another person can be seen observing approximately 15-20 m from the helicopter. Figure 1 shows a still from the video at the moment the tail rotor struck the concrete post.

G-GCMM at the moment its tail rotor struck the concrete post

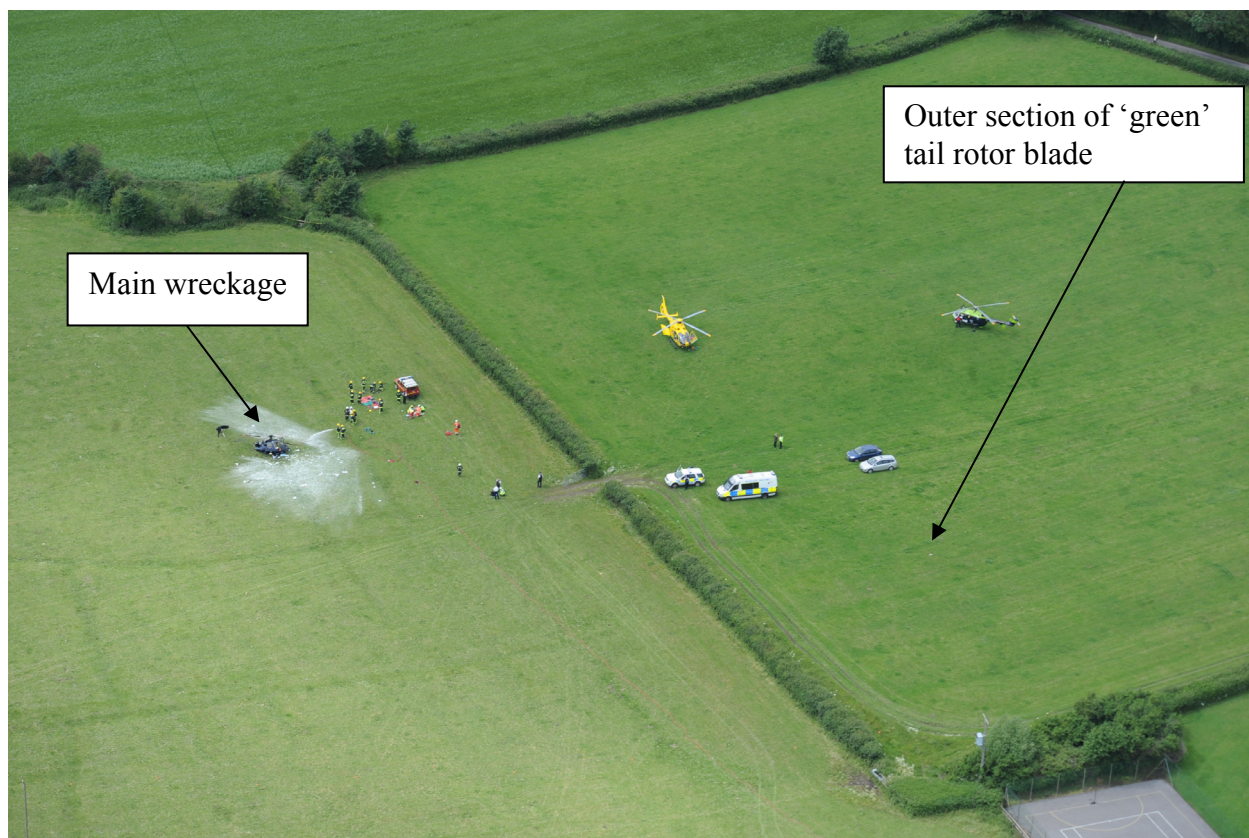
Figure 4

Accident site

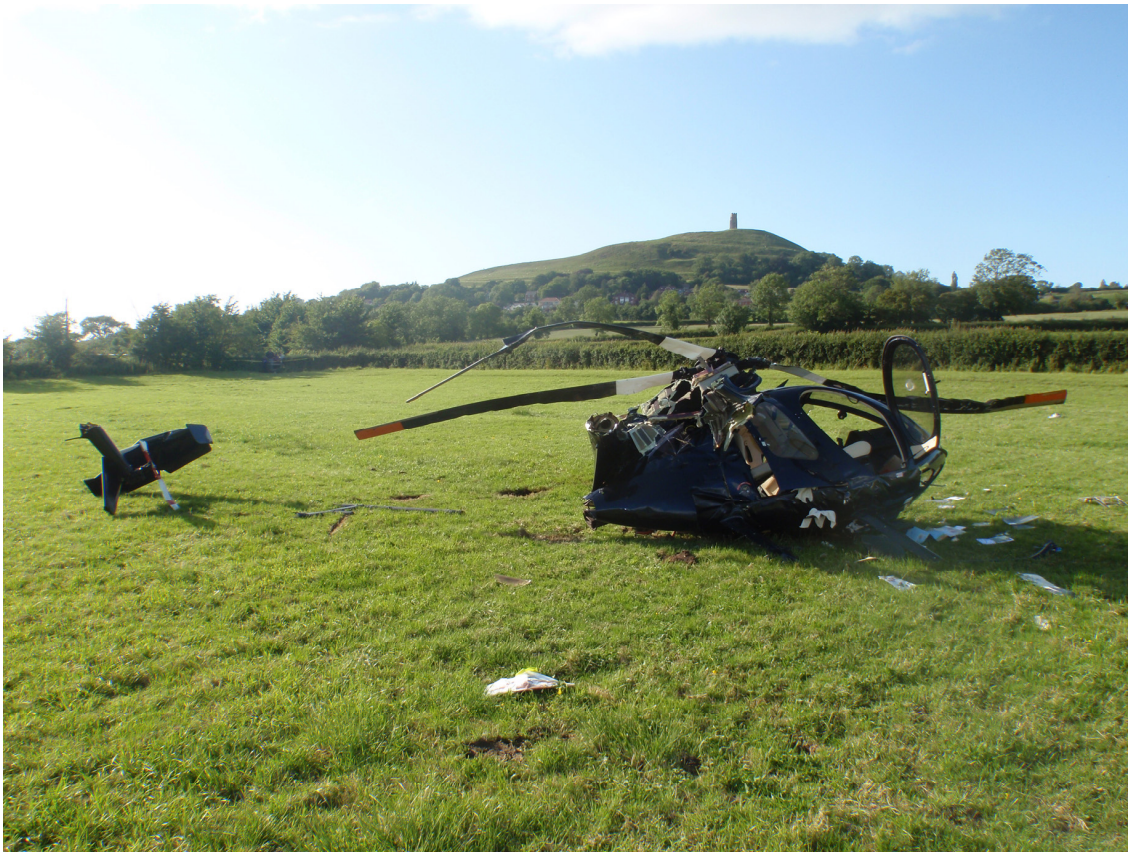
Figure 5

Helicopter wreckage, as found

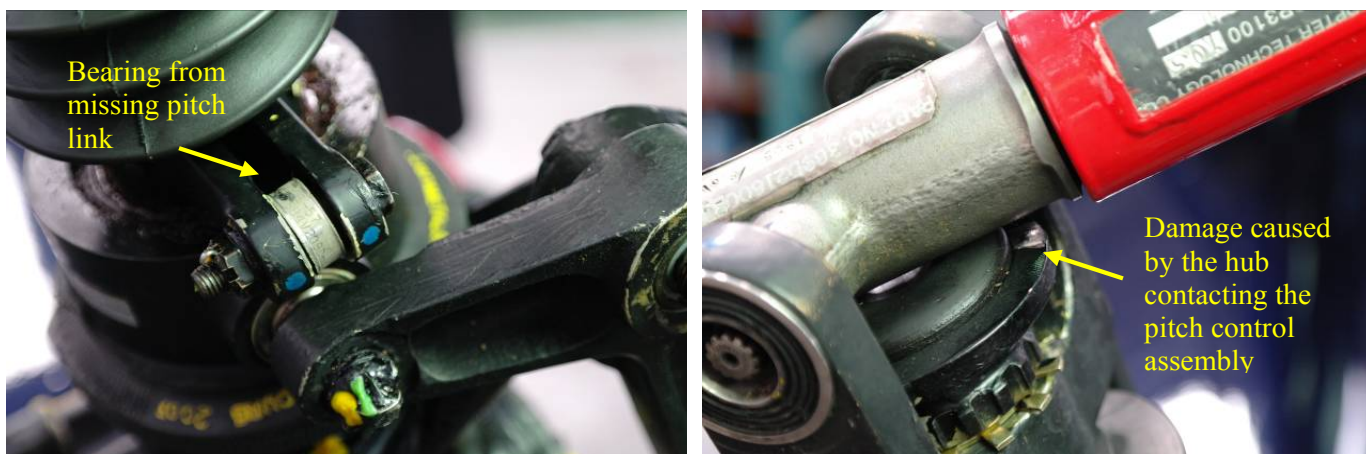
Figure 7
Tail rotor assembly

The bearing from the missing 'blue' pitch link, which connects the pitch link to the pitch control assembly fork end, had been retained by the securing bolt. Apart from some slight play, the bearing was found to be in relatively good condition and was free to rotate with no evidence of it having seized. There was some mechanical damage and missing paint at the end of the fork end that was believed to have occurred during the accident sequence.

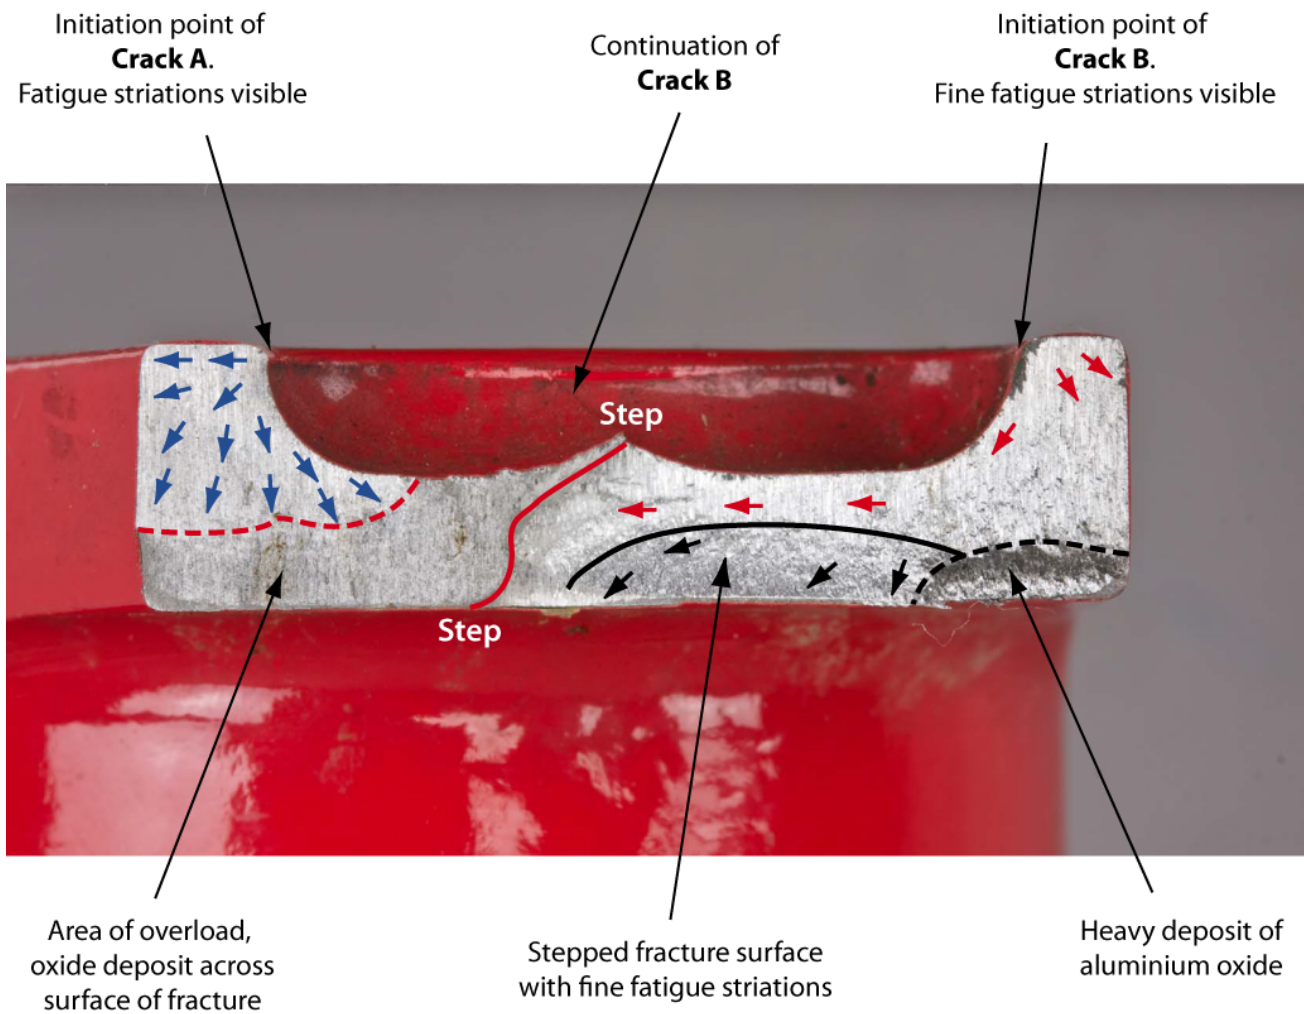
Figure 8
Significant features on the fracture face of the pitch horn

- A fatigue crack, identified as ‘Crack A’, which started at a corrosion pit on the lip of the pocket. The fracture surface in this area was flat with visible striations, from which it was possible to identify the direction of propagation that is highlighted by the blue arrows. The corrosion pit was 0.146 mm deep and 0.153 mm wide at the widest point.
- A fatigue crack, identified as ‘Crack B’, which started at a corrosion pit on the lip of the pocket. The fracture surface in this area

was flat, with visible signs of heavy and fine striations which were difficult to resolve. The direction of propagation is highlighted by the red arrows. The corrosion pit was 0.487 mm deep and extended 1.8 mm around the radius into the pocket and 0.9 mm along the external surface.

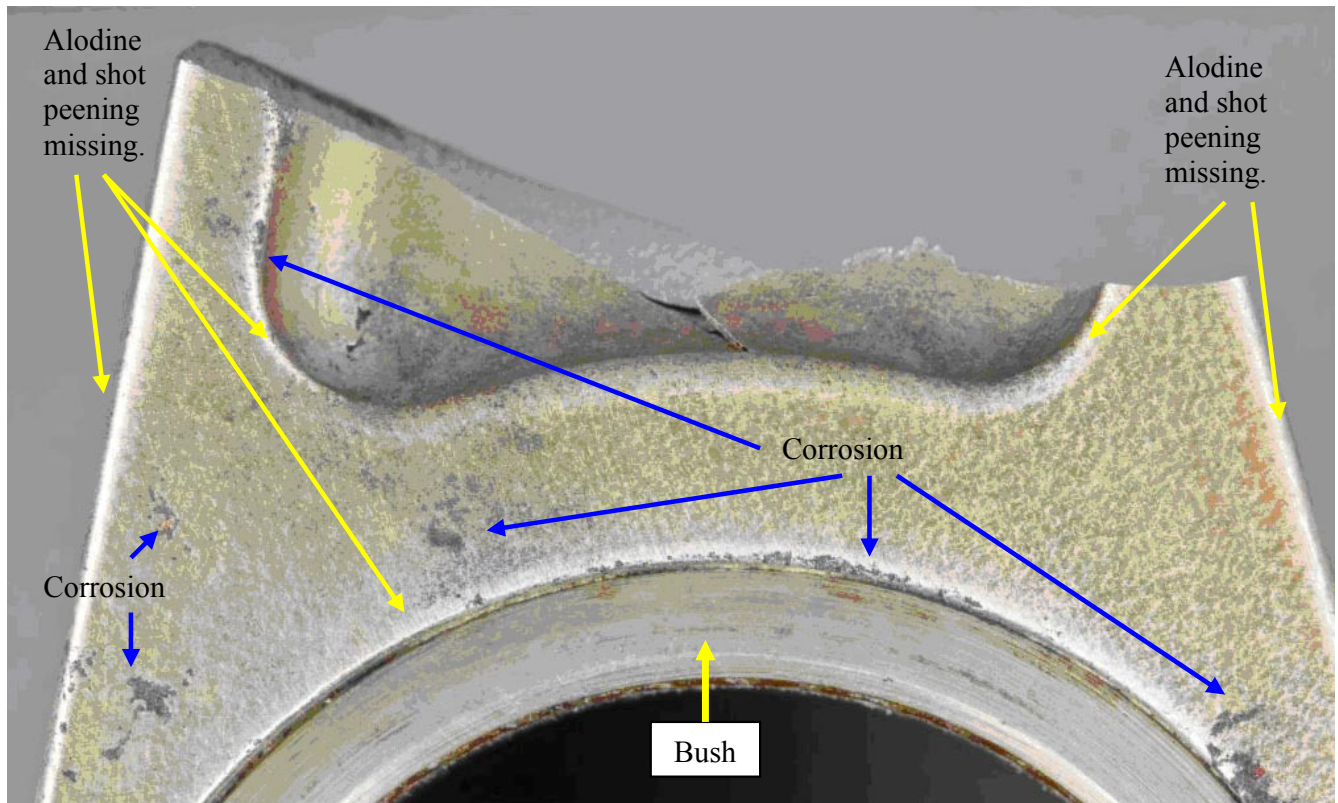
Figure 9

Pitch horn with paint removed

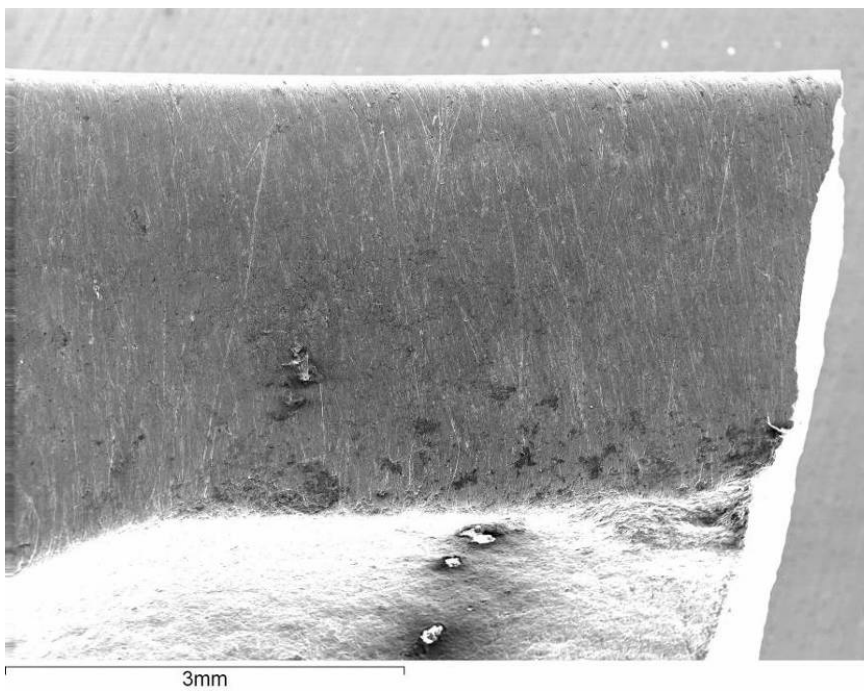
Figure 10

It could also be seen from the SEM image, reproduced at Figure 10, that the surface of the pitch horn was covered with scratch marks that appear to have

SEM image showing scratch marks on the surface of the pitch horn

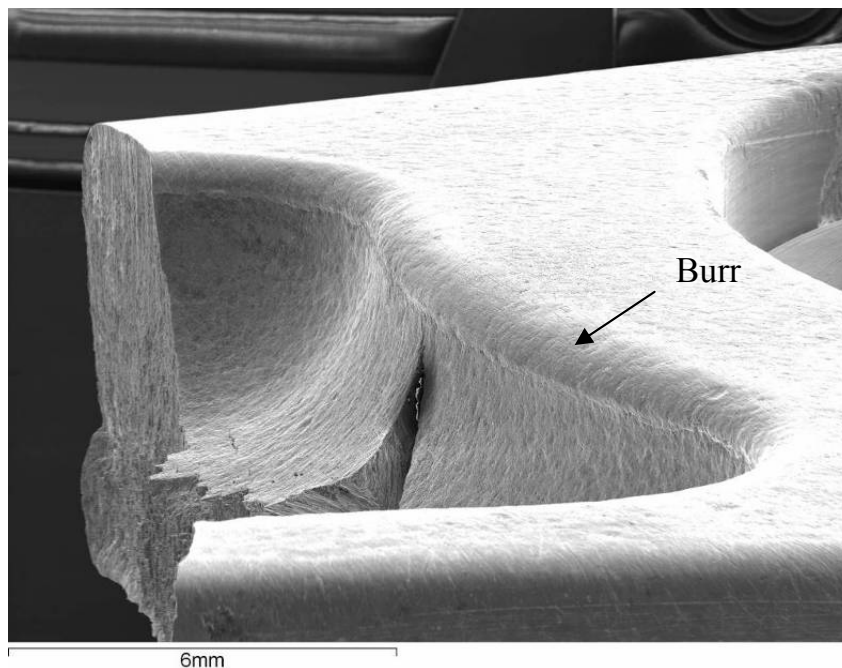
Figure 11

There was also a burr around the lip of the pocket where, in places, the metal appeared to have folded over on itself: it was from this area that 'Cracks A' and 'B' appear to have originated. See Figure 11. The blade manufacturer advised the investigation that the burr can be formed during the shot peening process.

SEM image showing burr around the edge of the pocket

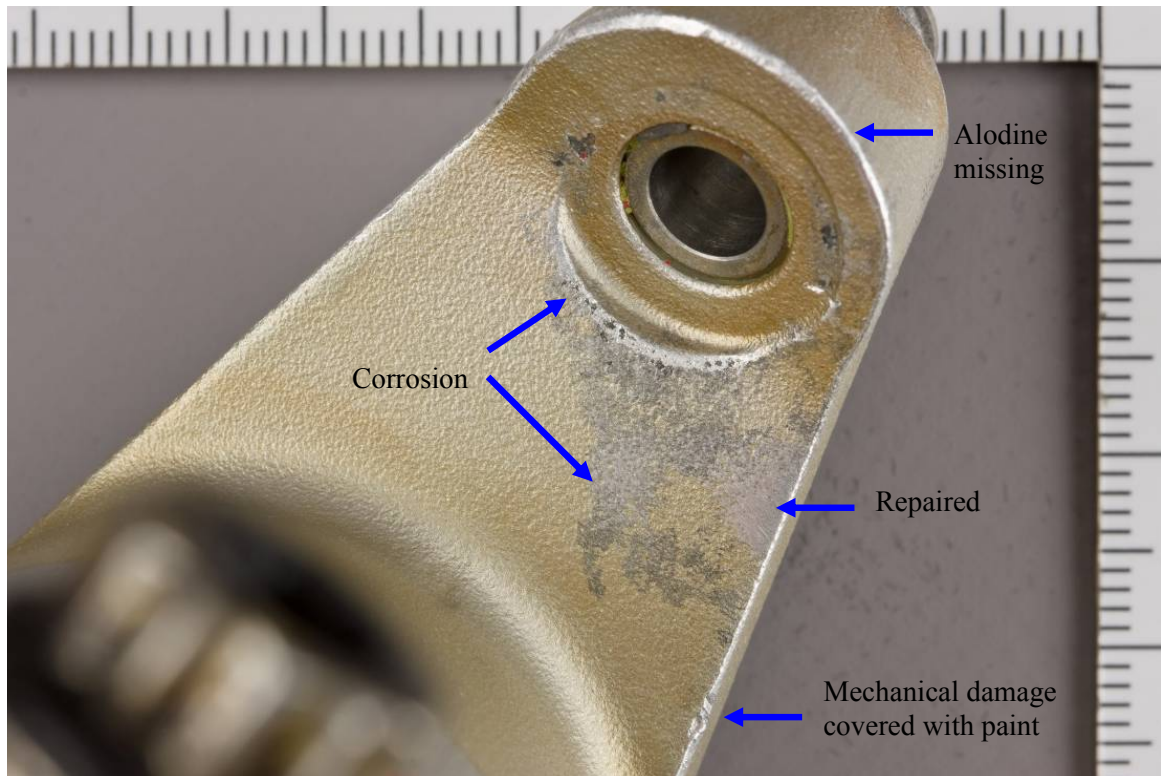
Figure 12

Damage on 'green' blade pitch horn

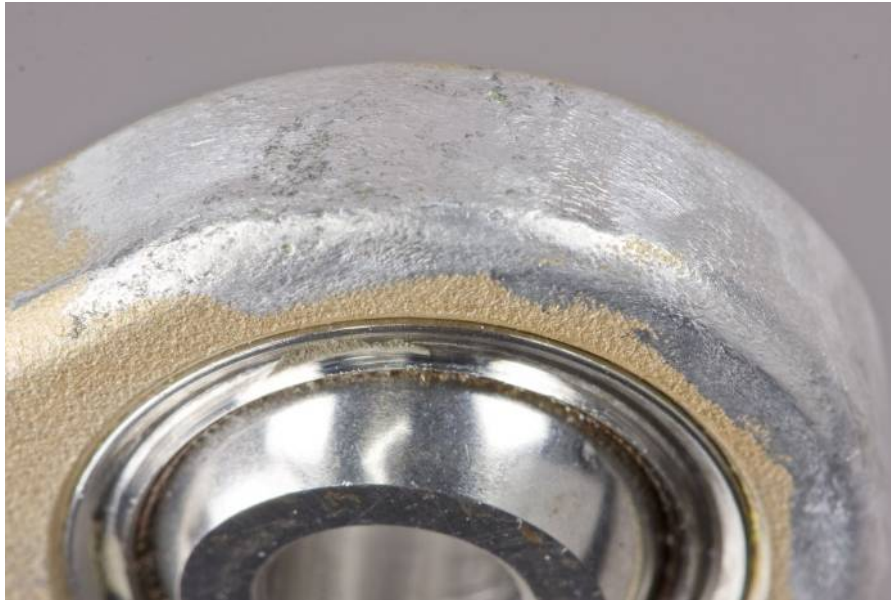
Figure 13

Section of 'green' pitch link with paint removed

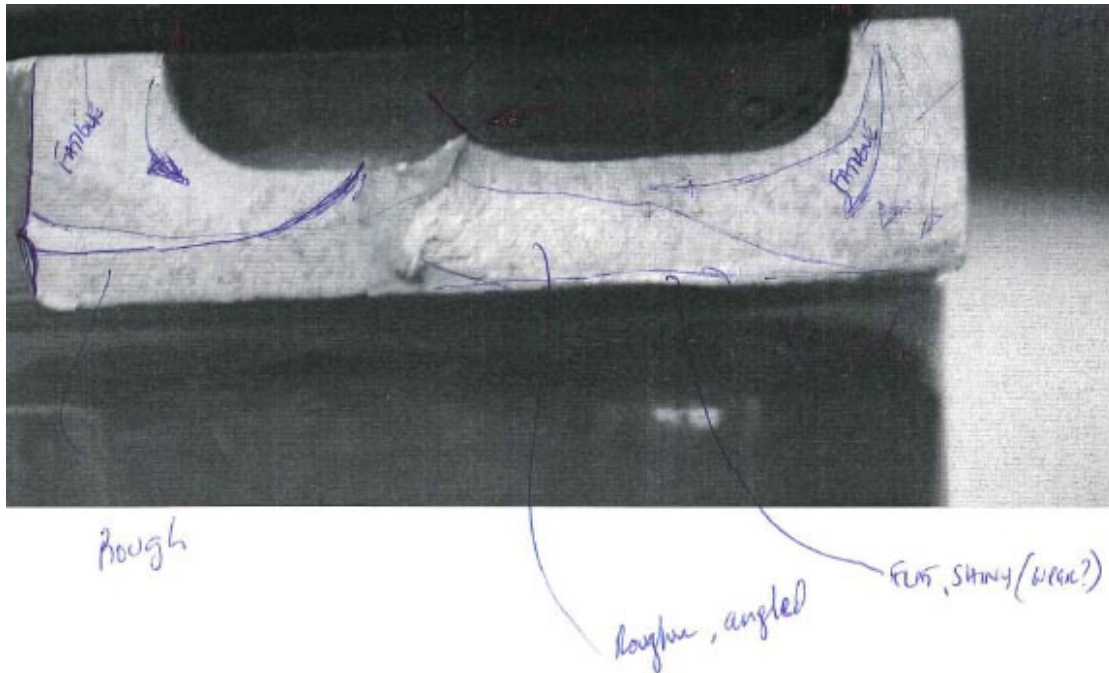
Figure 14

Fracture face of pitch horn that failed on N234RF in February 2003

As a result of these findings, the blade manufacturer reviewed the stresses in the area of the pockets. This resulted in the FAA issuing an Emergency Airworthiness Directive (2003-08-51), in April 2003, to reduce the service life of these blades from 5,140 hours to 400 hours. In June 2003, the FAA issued an alternative means of compliance that allowed the original life to be restored.

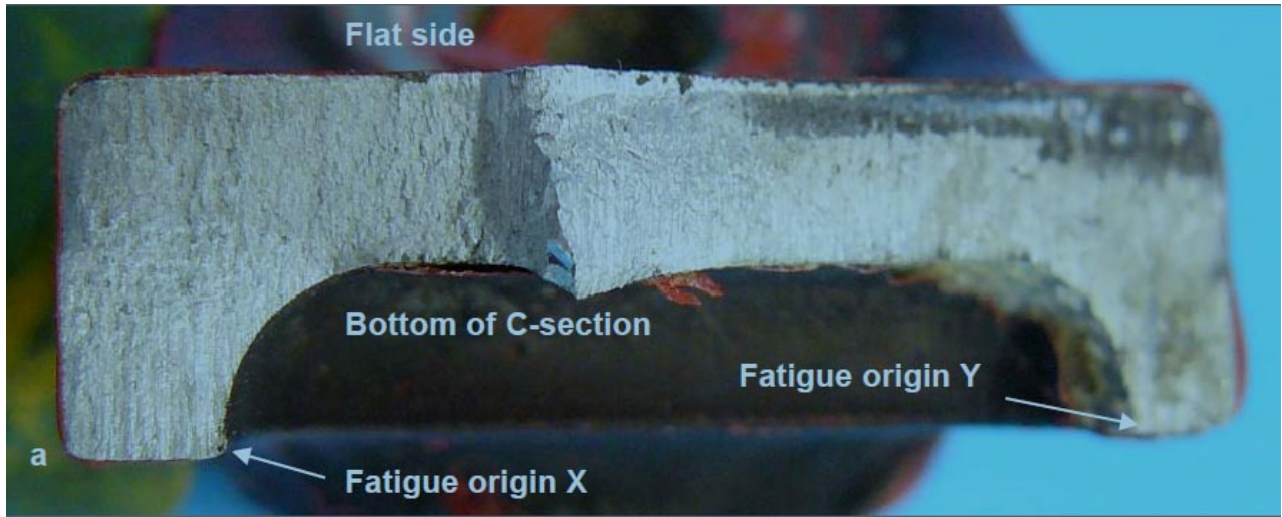
Figure 15

Fracture face of pitch horn that failed on the 24 February 2010

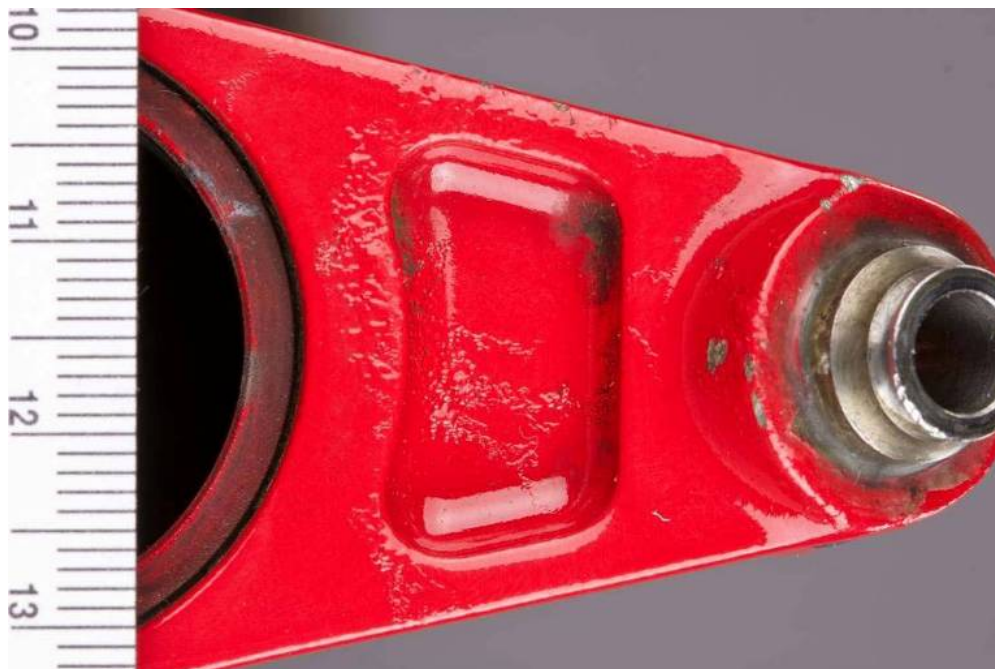
Figure 17

The paint finish was removed from the pitch horn on one of the blades using a chemical paint stripper in order not to damage the metal surface or remove any of the corrosion products. The majority of the corrosion discovered in the area of the pocket had been visible through the paint layer as blisters. However, there were patches that were not detectable with the

Corrosion in the area of the blade pocket
