**SECTION 1.4.6 – OTHER**

1.4.6.1 The accident involved two aircraft from different formations. Together, the formations numbered four aircraft and eight crewmembers. The actions of the eight crewmembers, interwoven with the maintenance and Flypro of the four aircraft, create a complex picture. Further complication was added by personnel performing multiple supervisory duties due to half of the Sqn having deployed to Cyprus on exercise. The similarity of the formation call signs, ASTON and ABBOT, can also create confusion.

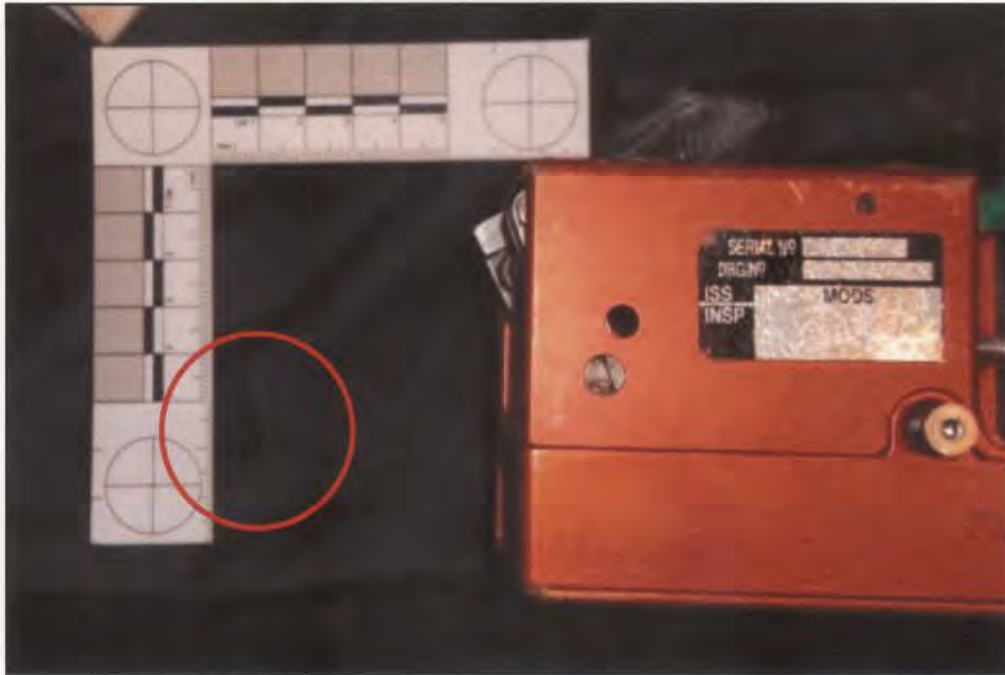
Figure 55. ABBOT 2 RS Pilot ALIU and Adjacent Puncture.

1.4.6.24 After operation the operating levers of the three recovered ALIUs seized in different positions. The head of each operating lever protruded beyond the end of the ALIU. Figure 55 identifies the location of the puncture mark in relation to ABBOT 2 RS Pilot ALIU on the raft. Of note, Figure 55 shows the ALIU after investigative disassembly, and the position of the operating lever is not representative of how it was found (it was found with the lever protruding further). ABBOT 2 RS Pilot's liferaft had operated as designed.

1.4.6.28 The hazard is only realised when an external force causes the two to come together. Although there is a possibility that a crew member of the ERIC 2 pierced the liferaft in order to minimize its size on deck, the Panel believes the most likely cause for the laceration to the liferaft buoyancy chamber was the ALIU operating lever being brought in to contact with the liferaft during the recovery and stowage by the ERIC 2. The design of the ALIU poses a possible risk to the integrity of the buoyancy lever due to the operating lever protruding from the ALIU.

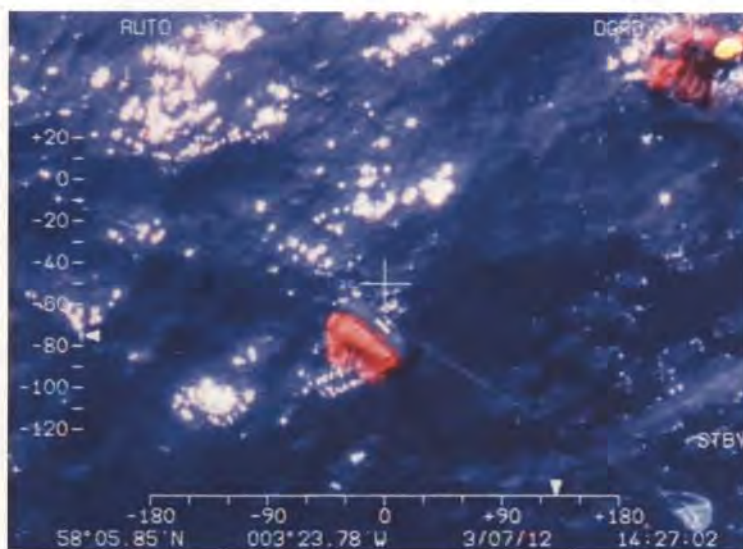
Figure 56. ABBOT 2 FS Pilot's Liferaft on Discovery.

1.4.6.29 The ABBOT 2 FS Pilot's Liferaft was found with one end protruding from the sea. It was described by the crew of R137 as being inflated but weighted down in the sea. (Figure 56).

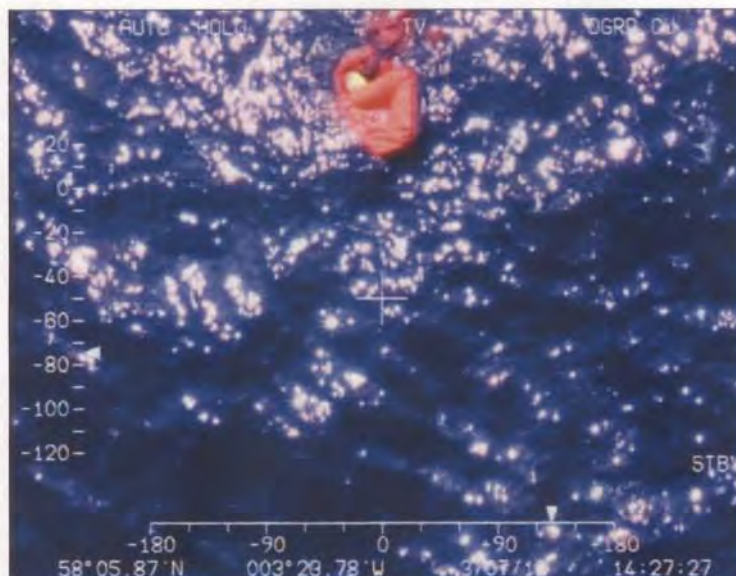
Figure 57. ABBOT 2 FS Pilot's Liferaft Reacts to Intervention by R138 Winchman Paramedic.

1.4.6.30 In the ensuing rescue attempt, the liferaft could be seen to react to the intervention of the winchman paramedic (Figure 57). When it moved, the section below the surface was not inflated, and only the top section acted in a buoyant manner. The point at which the valve attaches the ALIU to the side of the liferaft was below the surface of the water and could not be seen.

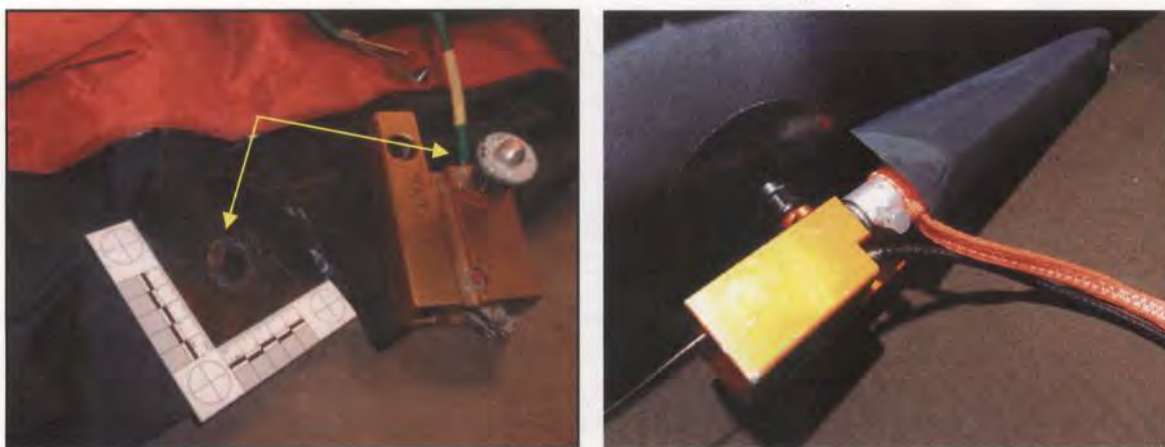
Figure 58. Valve Body Screwed onto ALIU and Normal Position.

1.4.6.32 The CO<sub>2</sub> cylinder, ALIU and the metal valve body of the liferaft valve assembly were recovered eight days later from the sea bed. They were still assembled, and attached to the PSP lowering line at the neck of the CO<sub>2</sub> cylinder. On inspection it could be seen that the liferaft valve assembly had broken in two. The metal valve body remained screwed onto the ALIU, illustrated in Figure 58 with the normal connection shown alongside.

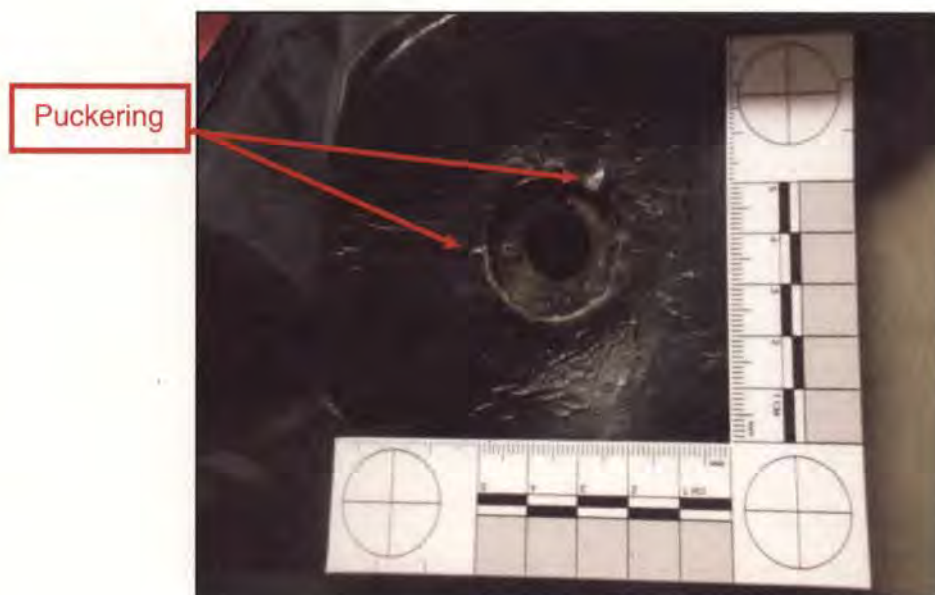
Figure 59. Rubber Section of Valve Assembly retained in Liferaft.

1.4.6.33 On further inspection of the liferaft, the circular rubber patch of the liferaft valve assembly was found still attached to the buoyancy chamber, shown in Figure 59. The liferaft valve assembly had failed at the point where the metal valve body is moulded into the rubber section of the assembly. The patch securing the valve assembly to the liferaft exhibited puckering around its inner edge, evidence that it had been stretched and failed to return to its original shape (plastic deformation).

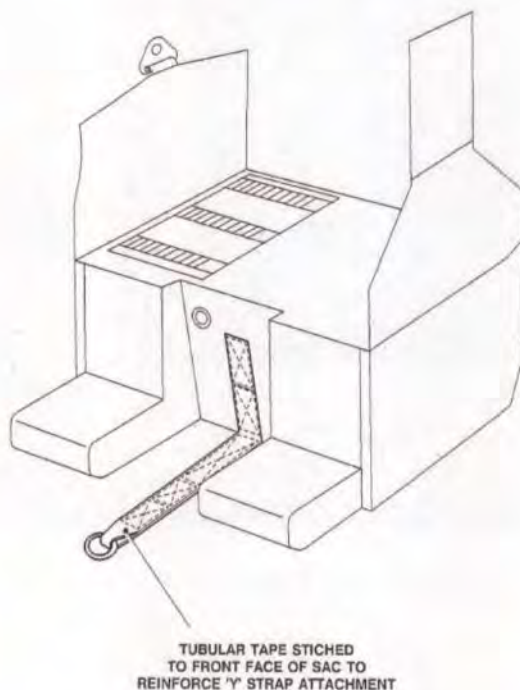
Figure 60. Post Modification 02266 SAC.

1.4.6.38 The fitment of webbing to the “Y” strap and SAC to provide a stronger attachment point is shown in Figure 60. The liferaft is now attached to the to the “Y” strap

attachment ring via the liferaft lanyard. The liferaft was previously attached to a becket on the rear of the SAC.

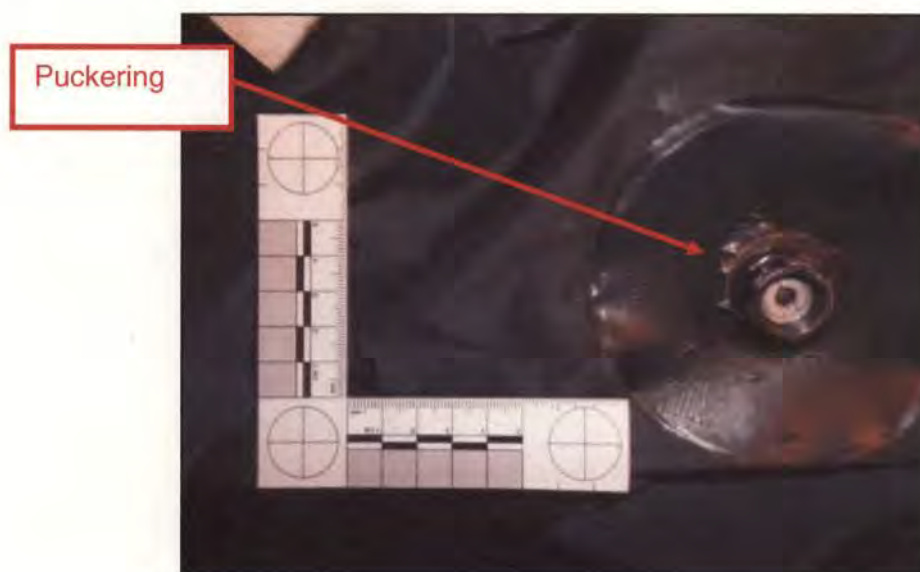
Figure 61. ABBOT 2 RS Pilot Liferaft Valve Assembly

1.4.6.45 The valve assembly of the ABBOT 2 RS Pilot's liferaft (Figure 61) also exhibited puckering around the inner edge of the patch securing the valve assembly to the liferaft; evidence of potential deformation of the valve assembly under load. The RS Pilot did not complete the full ejection sequence<sup>3</sup>, but entered the sea at a descent rate of less than 9 m/sec.

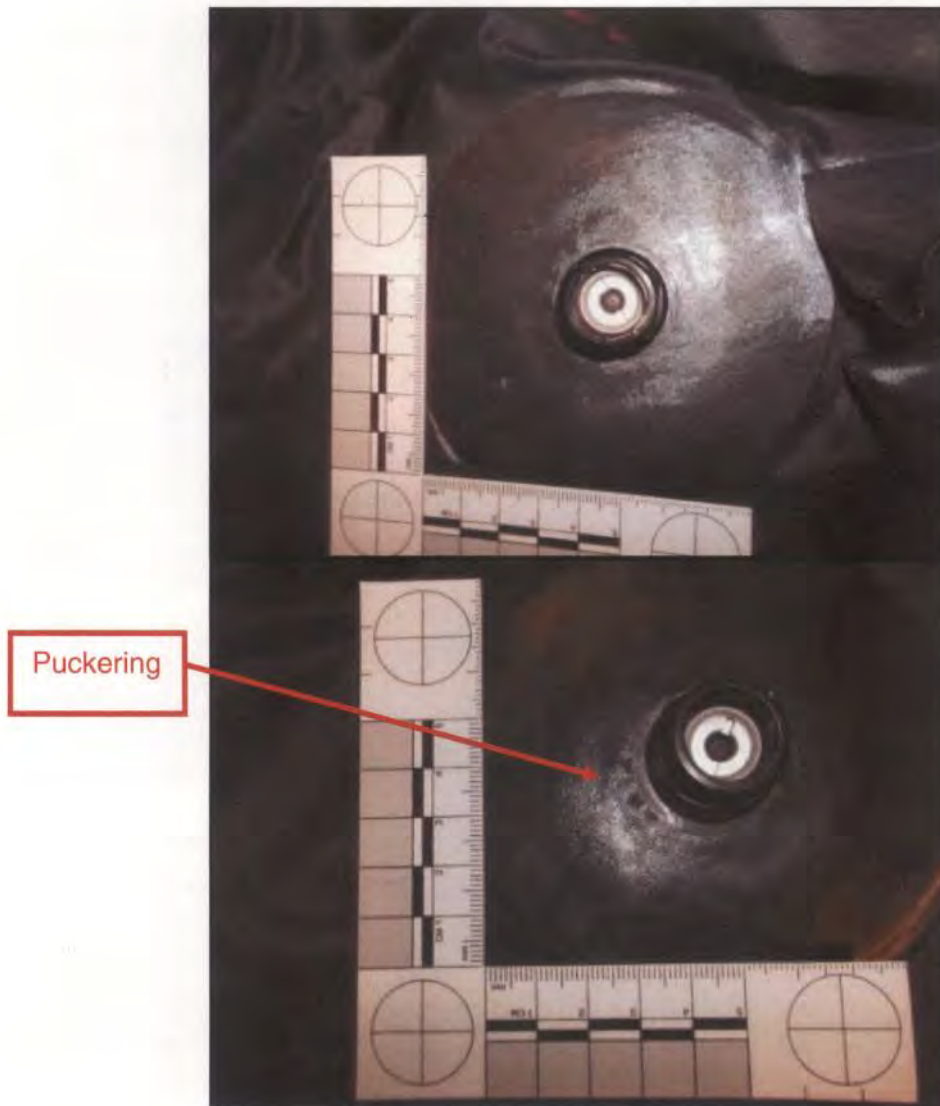
Figure 62. The Front (top picture) and Rear Seat (bottom picture) Liferaft Valve Assemblies from ZD792 following Ejection.

1.4.6.46 The liferaft valves from the previous Tornado ejection (ZD792) are shown in Figure 62. The front seat liferaft valve exhibits no visible evidence of damage. The patch covering the rear seat liferaft valve is puckered around one side of the inner edge; evidence of potential deformation of the valve assembly under load. The ejection from ZD792 was comfortably within the safe height/speed/rate of descent criteria in the aircrew manual, and thus both pilots are expected to have entered the sea at a descent rate of less than 9 m/sec.

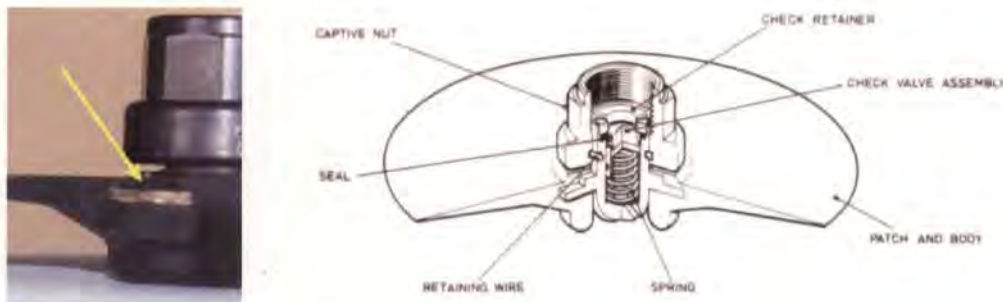
Figure 63. Sectioned Valve Assembly and Component Diagram.

1.4.6.50 The valve assembly has not been designed to resist large forces in tension. The patch and body are secured to the liferaft using adhesive. The rubber of the patch is moulded onto the metal valve assembly; it is not chemically bonded or mechanically retained. The tensile strength of the valve assembly is the strength at its weakest point. Test work is ongoing, but it is the Panel's view that the weakest point in tension is the thinnest section of rubber retaining the metal valve body. This can be seen on the sectioned valve assembly and component diagram in Figure 63.

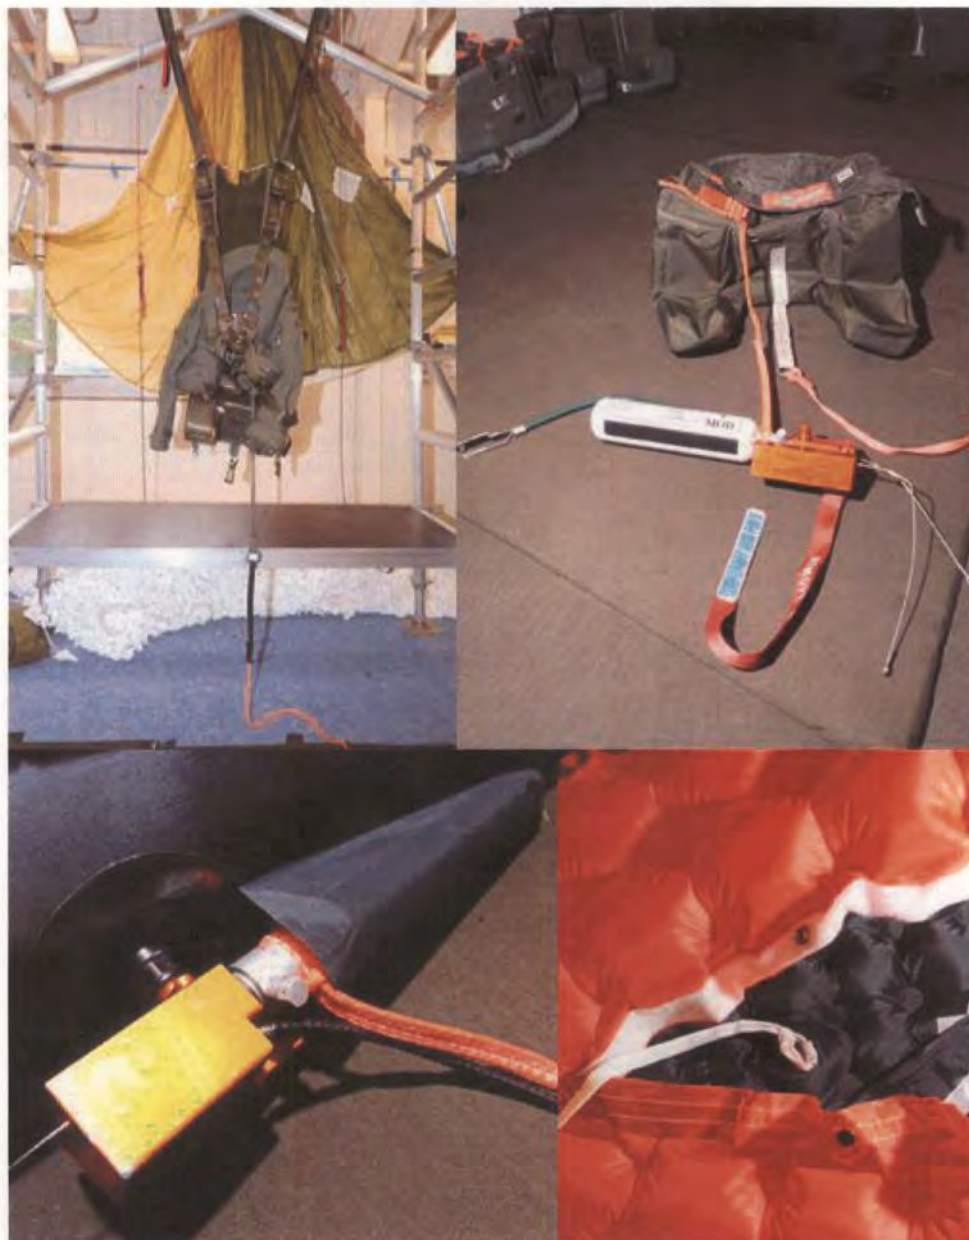
Figure 64. Liferaft/PSP configurations.

1.4.6.51 Similarly, failure of the valve assembly in tension would always have resulted in deflation of the liferaft buoyancy chamber. In normal operation, the weight of the CO<sub>2</sub> cylinder and ALIU is borne between the CO<sub>2</sub> cylinder sleeve and the valve assembly. This is the load that the valve assembly was intended to support. The valve assembly exhibits no deformation when supporting that load on a fully inflated liferaft (see figure 64).

1.4.6.52 In Mod 02266, the liferaft lanyard is fastened to the floor of the liferaft at one end and to the SAC "Y" strap at the other. This provides one means of exerting an opposing force. The liferaft was previously at the end of the chain of PSP components, and only had to support its own weight/drag. The force from its own weight/drag acted through the floor of the liferaft to the liferaft lanyard. Mod 02266 now places the liferaft within the chain and it is now required to support the weight/drag of the SAC. If a force is applied at the SAC end of the chain (i.e. weight/drag), that force is applied through the floor of the liferaft, and acts across the body of the liferaft through the valve assembly to the CO<sub>2</sub> cylinder, and through the CO<sub>2</sub> cylinder to the PSP lowering line. The attachment points are shown in Figure 64.
