CONTENTS

ACCIDENT

Aircraft Type and Registration:	Boeing 737-8AS, EI-DLR	
No & Type of Engines:	2 CFM56-7B turbofan engines	
Year of Manufacture:	2006	
Date & Time (UTC):	13 November 2008 at 1920 hrs	
Location:	Stand D 61, London Stansted Airport, Essex	
Type of Flight:	Commercial Air Transport (Passenger)	
Persons on Board:	Crew - 4	Passengers - 164
Injuries:	Crew - None	Passengers - None
Nature of Damage:	No 1 engine cowling damaged, tow bar attachment broken	
Commander's Licence:	Airline Transport Pilot's Licence	
Commander's Age:	53 years	
Commander's Flying Experience:	14,000 hours (of which 2,500 were on type) Last 90 days - 270 hours Last 28 days - 23 hours	
Information Source:	AAIB Field Investigation

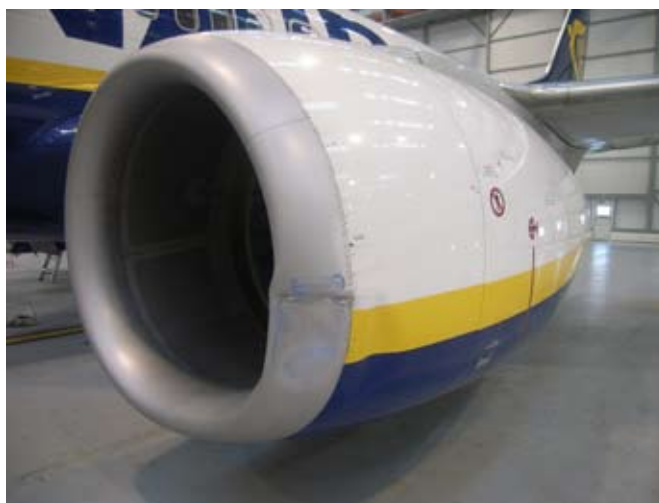
Figure 3
Cowling damage

A large dent and a crease along the outside edge of the cowl, at the four o'clock position looking aft, was present on the aircraft's No1 engine nose cowl, together with an open crack along the circumference of the nose cowl leading edge where the cowl had distorted. Paint had been removed along the line of the crease and blue paint from the tug had transferred onto the cowling across the whole depth of the dent, Figure 3. The left nosewheel tyre tread exhibited a large cut and missing sections of tread. The towbar attachment bar on the front of the nose landing gear had been distorted.

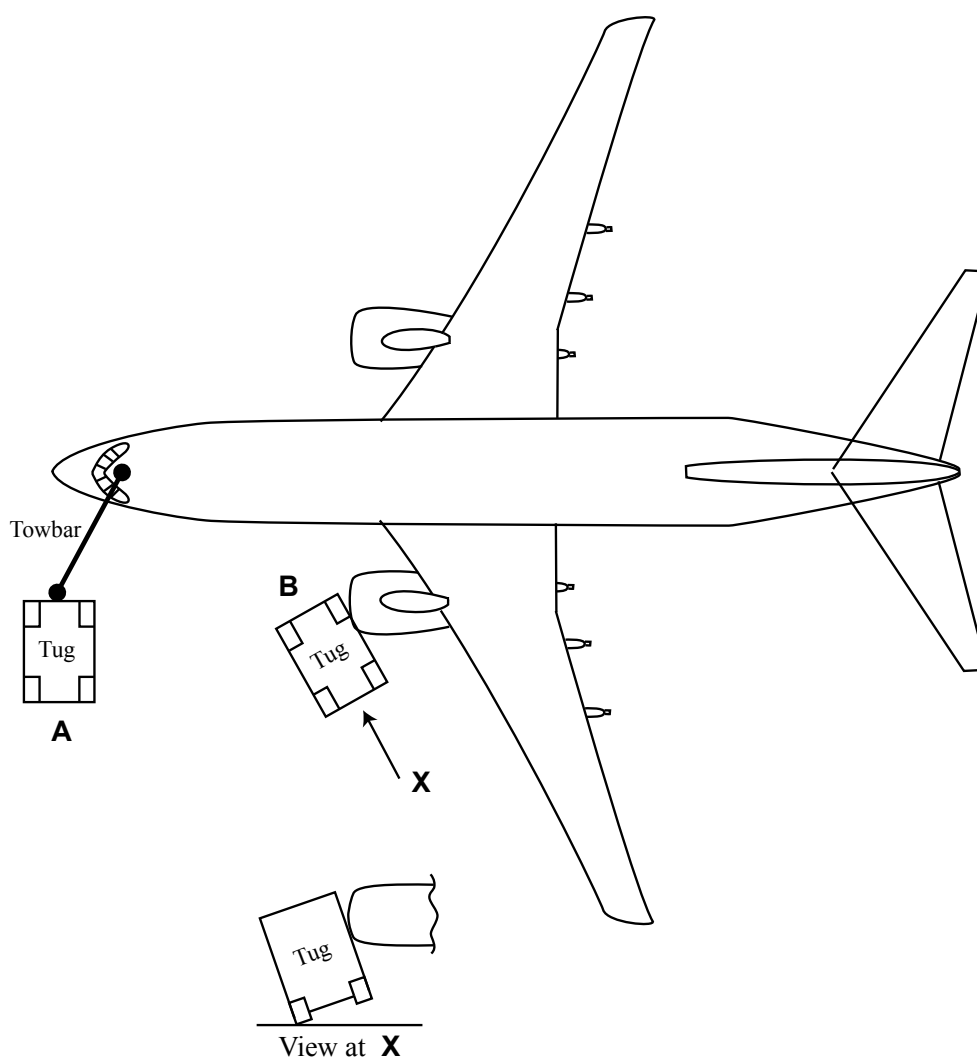
Figure 4

- A** Approximate position of tug relative to the aircraft when the aircraft began to move forward
B Position of tug relative to the aircraft when the aircraft came to rest

the aircraft began to move forward the resistive force applied by the tug was acting almost perpendicular to the aircraft thrust line and quickly resulted in an overload of the towbar attachment. This removed any ability of the tug to prevent further forward movement of the aircraft. Although the tug in use was relatively lightweight and the taxiway conditions were wet, these were not considered to be significant contributory factors in this case.

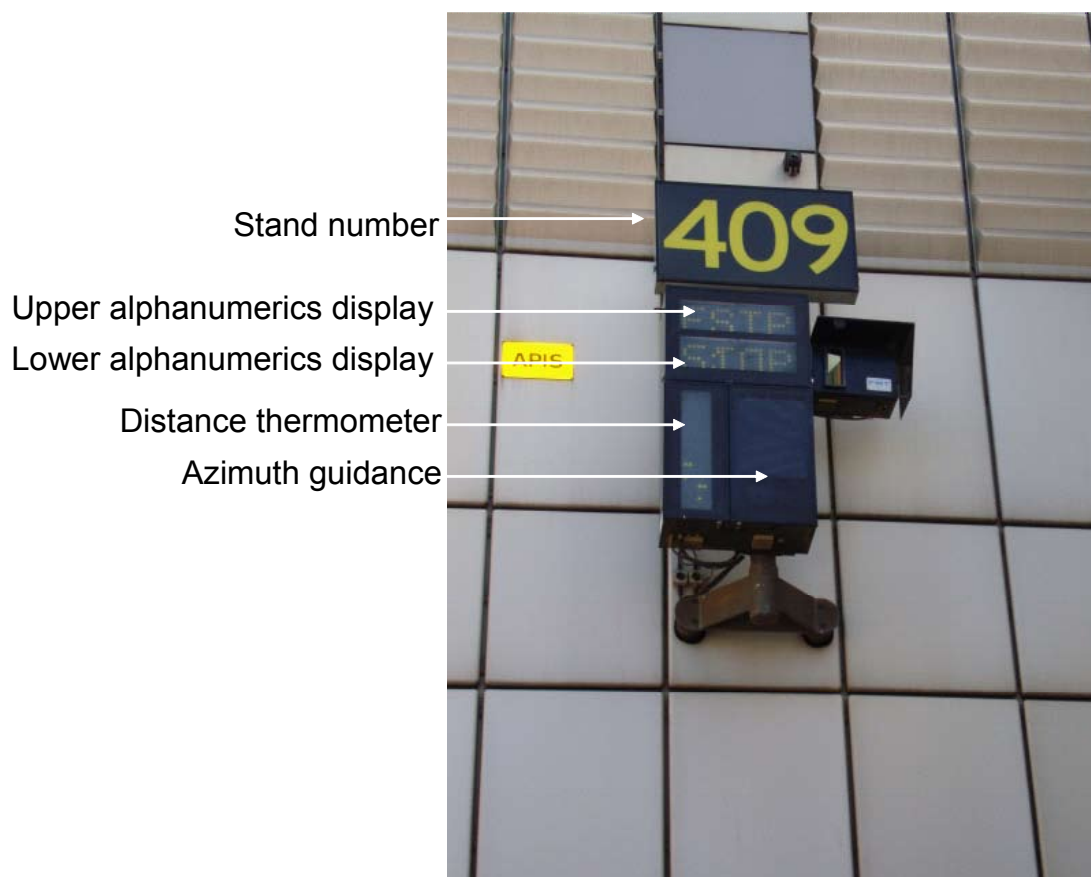
Figure 1

The APIS had not been activated but due to a wiring defect, the lateral guidance was illuminated which it should not have been.

Stand 409 Aircraft Parking Information System (APIS)

A fault history of the APIS is recorded by the logic computer and this was downloaded for the investigation. It provided no record of when the fault which caused the lateral guidance board to remain illuminated when the system was de-activated. Further inspection of the faulty APIS showed that a wire in the lateral guidance module was defective and this caused the board to remain illuminated. It could not be established when the fault had occurred but there were no recorded reports of the problem.

HAL then withdrew use of the APIS and following an internal investigation, changed the unit. It also undertook to inspect the remaining systems to ensure no others were defective. This would include a visual check of the display windows before the SEGS was activated to ensure they were indicating correctly.

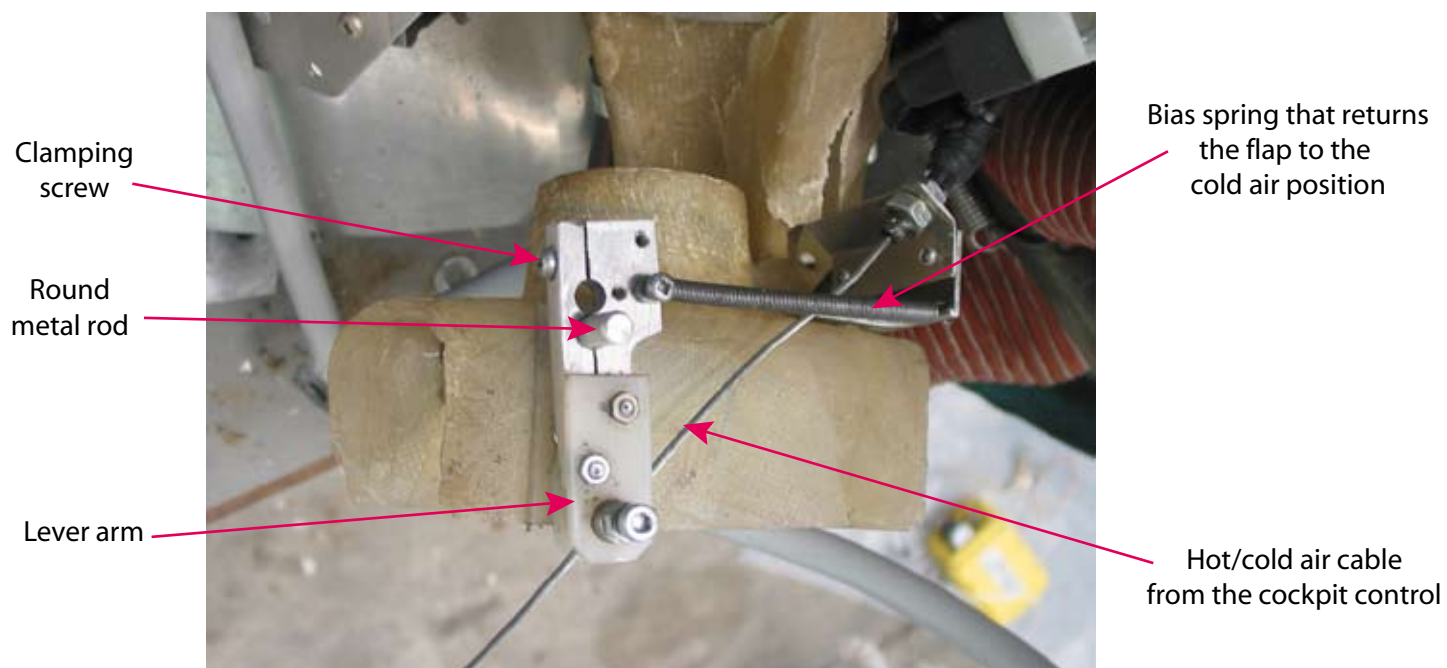
Figure 2
Hot/cold air lever arm mechanism

Examination of the system showed that, although all the components were connected, the lever arm was loose on the flap pivot rod. When the two 'U' shaped channels were separated it was seen that the movable flap was in the cold air position and was catching against one side of the lower 'U' channel, tending to cause the flap to stick in the cold air position. There was good evidence that the movable flap had been rubbing against the inside of the lower 'U' channel over its full range of travel for a considerable period of time. Detailed examination of the lever arm to metal rod connection showed that the arm had become loose as a result of the flap interference with lower 'U' channel, Figure 3.

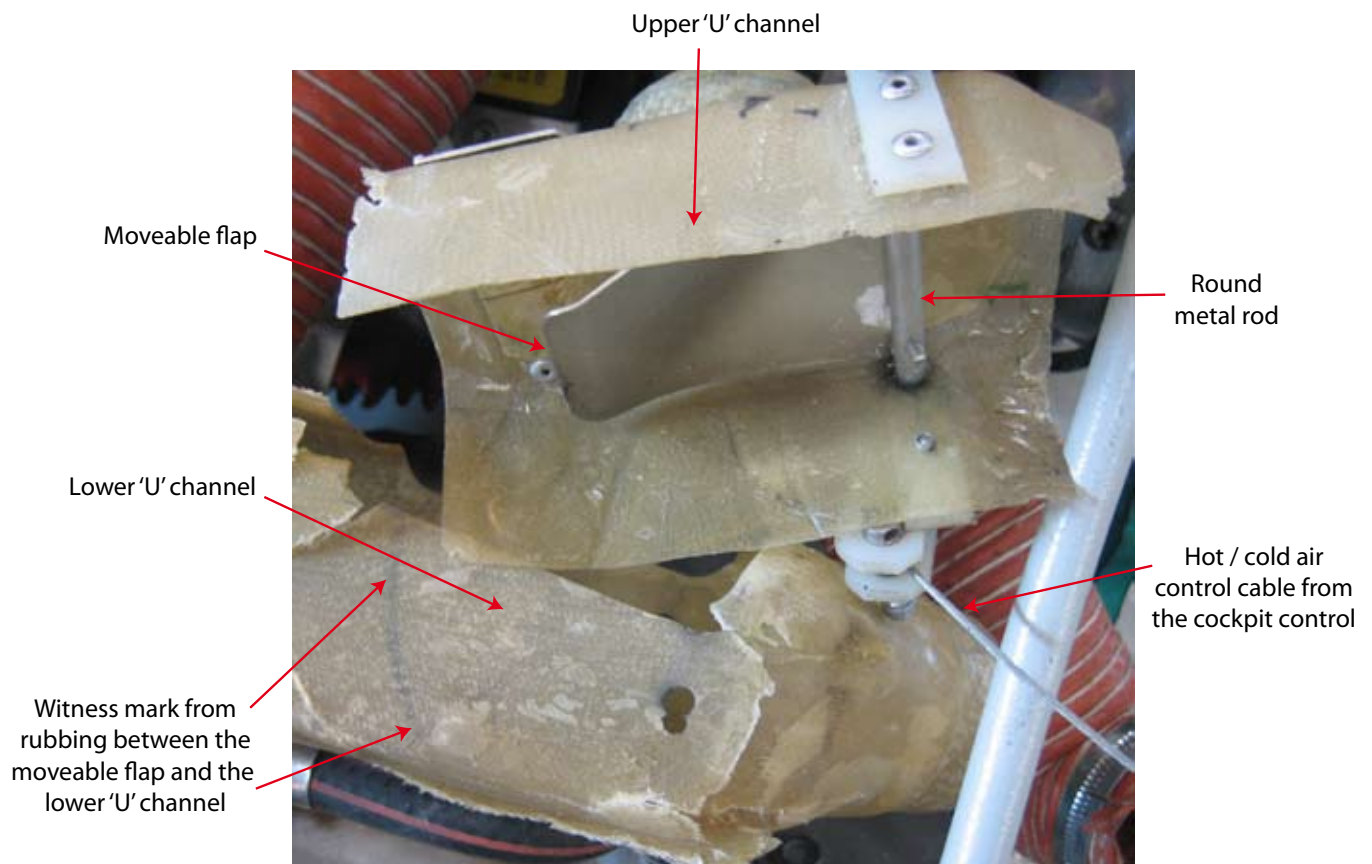
Figure 3

Inside the hot/cold air box

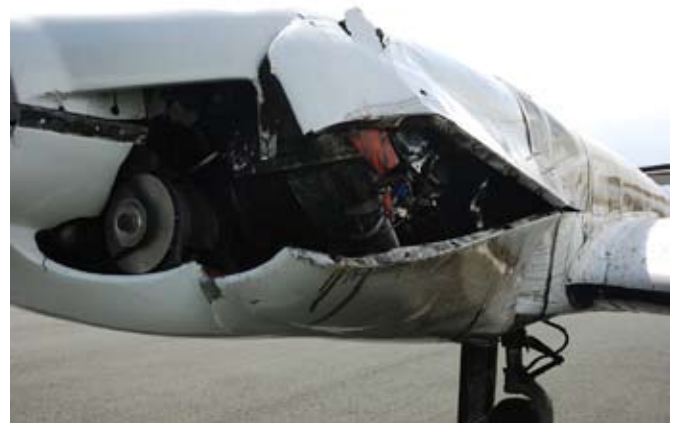
Figure 1

Six of the eight studs that had retained the No 2 cylinder had failed in overload and the remaining two studs had been stripped from the casing. The small end of the No 2 connecting rod had failed and its

Right engine cowling revealing the separated No 2 engine cylinder

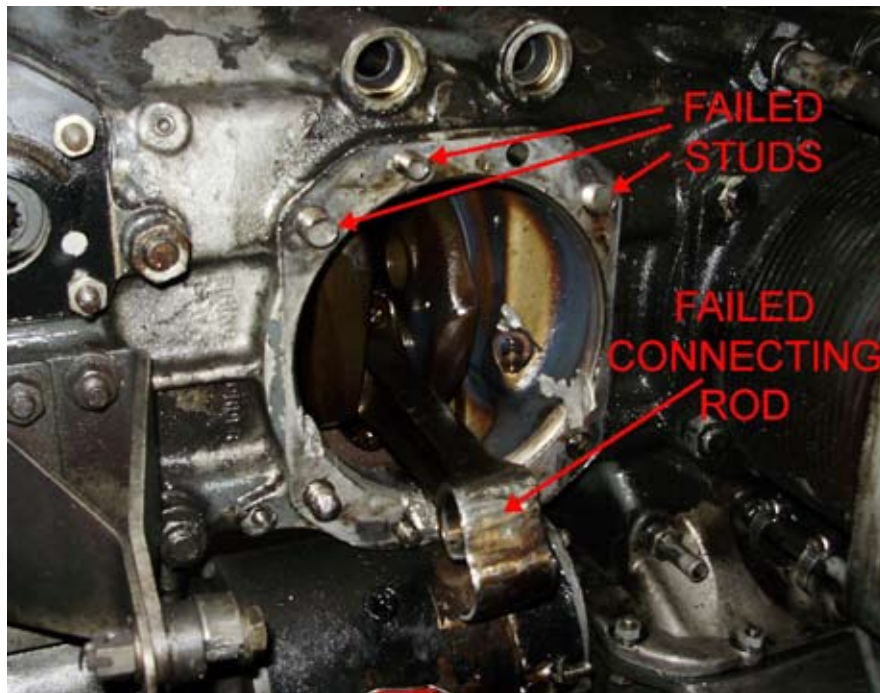
Figure 2

failed end had been crushed in subsequent impacts with the piston, while the engine continued to turn see Figure 2. The big end of the connecting rod was still securely attached to the crankshaft.

The No 2 piston was found seized inside the cylinder. To remove the piston the top half of the cylinder was cut away and a press was applied against the piston head. A force of 2,000 lb was required to free the piston. The piston appeared to have seized as a result of distortion to its lower sidewall where it had suffered multiple impacts from the failed connecting rod; a large piece of the piston sidewall had broken off as a result of these impacts. All three piston rings were found broken in half at their approximate mid-points and parts of the remains of these piston rings were later retrieved from inside the engine crankcase. There was no evidence on the piston sidewall of overheating distress and the cylinder bore was in good condition, with no evidence of overheating distress. The piston gudgeon pin was in good condition with no evidence of overheating, as was the inner surface of the connecting rod small end.

Location of detached No 2 cylinder revealing failed studs and failed connecting rod small end

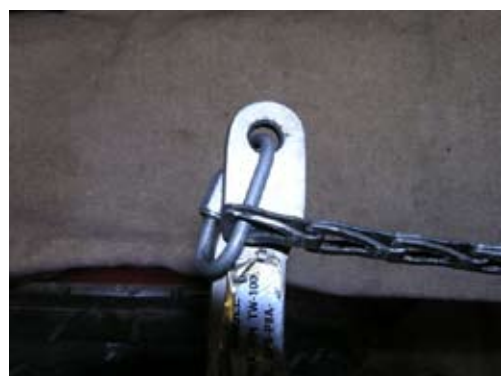
Figure 3

Subsequent discussion of the issue at his local LAA Strut meeting produced a consensus opinion that the tailwheel offset most probably had something to do with the springs in the tailwheel operating linkage. After some experimentation at home, the pilot found that it was possible for the disconnect links in the tailwheel operating horn to become displaced and shorten the effective length of the associated tailwheel control, producing an offset tailwheel with the rudder in the neutral position. Figures 2 and 3 respectively illustrate the implicated link in its normal and displaced positions.

Displaced position

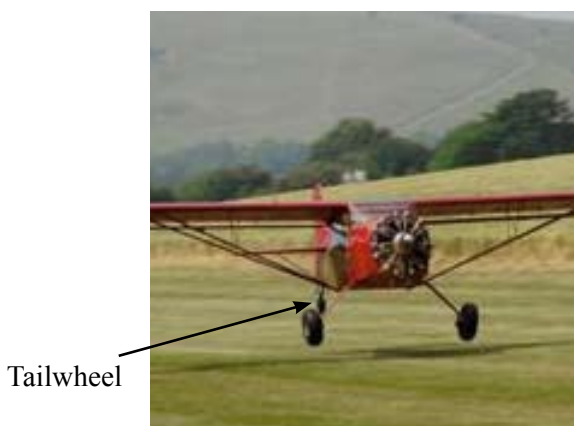
Figure 1

G-LESZ on takeoff, with the tailwheel apparently displaced slightly to the left
