CONTENTS

(ALL TIMES IN THIS BULLETIN ARE UTC)

Aircraft Type and Registration:	Airbus A321-211, G-DHJH
No & Type of Engines:	2 CFM56-5B3 turbofan engines
Year of Manufacture:	2000
Date & Time (UTC):	17 February 2008 at 1527 hrs
Location:	Manchester Airport
Type of Flight:	Commercial Air Transport (Passenger)
Persons on Board:	Crew - 7 Passengers - 220
Injuries:	Crew - None Passengers - None
Nature of Damage:	Nose landing gear damaged
Commander's Licence:	Airline Transport Pilot's Licence
Commander's Age:	55 years
Commander's Flying Experience:	18,000 hours (of which 7,000 were on type) Last 90 days - 150 hours Last 28 days - Not known
Information Source:	AAIB Field Investigation

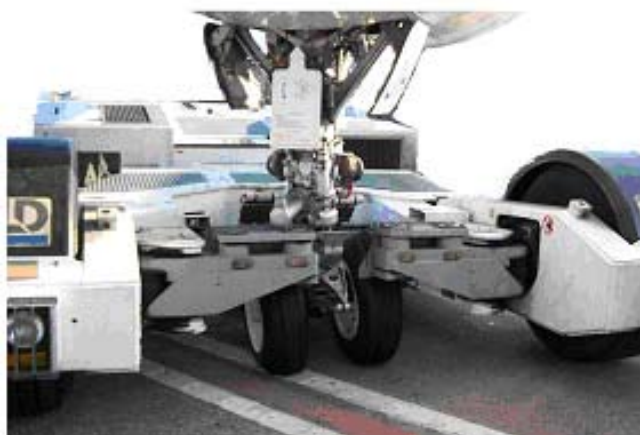
Figure 1

The operator's engineers found that the nosewheels had fallen from the towbarless tug's hydraulic-powered

‘grab and retention’ mechanism and were in contact with the apron surface (Figure 1). Both of the nosewheel steering motors mounted on the landing gear leg had been damaged by the tug’s structure, which required the complete nose landing gear to be changed prior to the next flight.

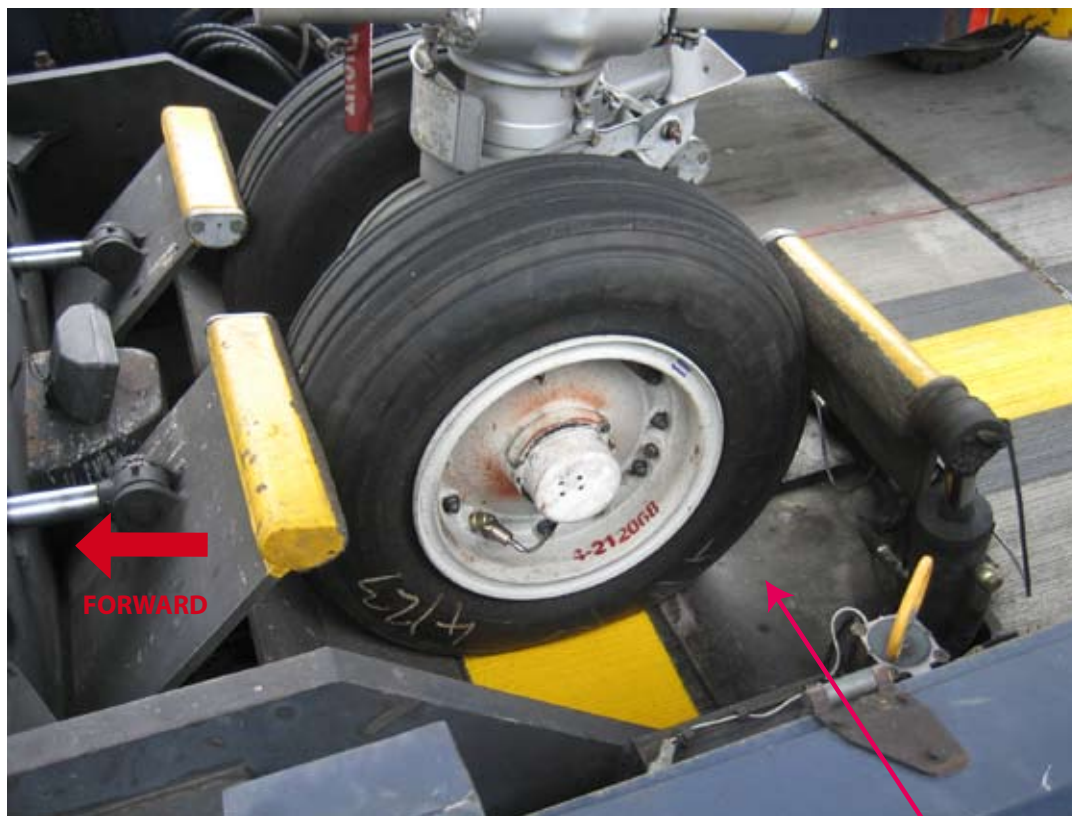
Figure 2

Inspection of another manufacturer’s towbarless tug found that it had a safety feature that would not allow the aircraft nosewheel tyres to contact the ground if the

Wheel retention plates

Another manufacturer's towbarless tug

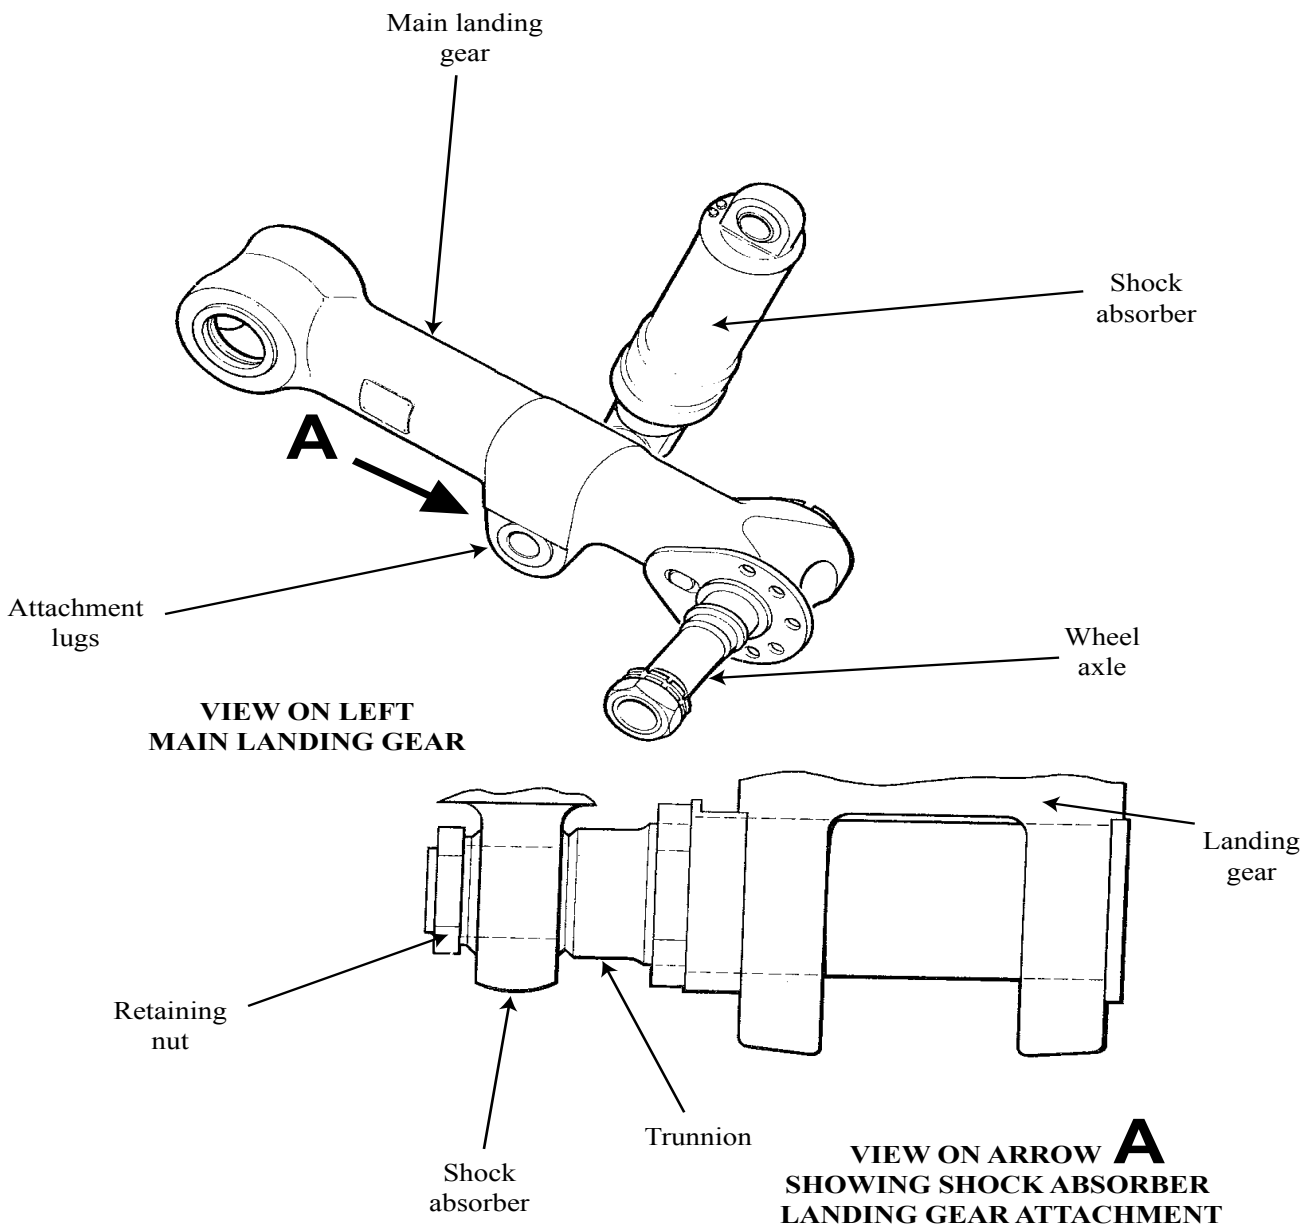
Figure 1
Landing gear shock absorber attachment

Examination of the right landing gear showed that the shock absorber had become disconnected from the lower trunnion on the landing gear and that the retaining nut was missing.

Examination of the screw threads at the end of the trunnion on which the retaining nut (Figure 1) is fitted showed no evidence of deformation or stripping. There was a large area of impact damage on one side of the threaded part of the trunnion, consistent with what would have occurred during the final landing, but the threads on the undamaged side were in very good condition. There was no locking wire present. The retaining nut was found at the initial impact

point, by the right landing gear, on the grass runway. Examination showed no deformation, damage or stripping of the screw threads and there was no locking wire present. The holes in the retaining nut, through which the locking wire should have passed, were clogged with hardened grease and general debris associated with landing gear areas, and this appeared to have accumulated over a long period of time.

The aircraft's logbooks and worksheets were examined in detail and the last recorded time that the main landing gear shock absorbers were recorded as being disturbed was in March 2000, when Dowty Rotol Mandatory Service Bulletin 32-14M was carried out. This Service Bulletin required the removal of the main landing gear shock absorbers to check for cracking of the lower shock absorber attachment trunnion. The aircraft had flown 2,414 hours over 4,985 flights since the Service Bulletin had been carried out. It appears likely that the recorded maintenance work, or subsequent undocumented maintenance work, did not include completion of the wirelocking task.
