CONTENTS

(ALL TIMES IN THIS BULLETIN ARE UTC)

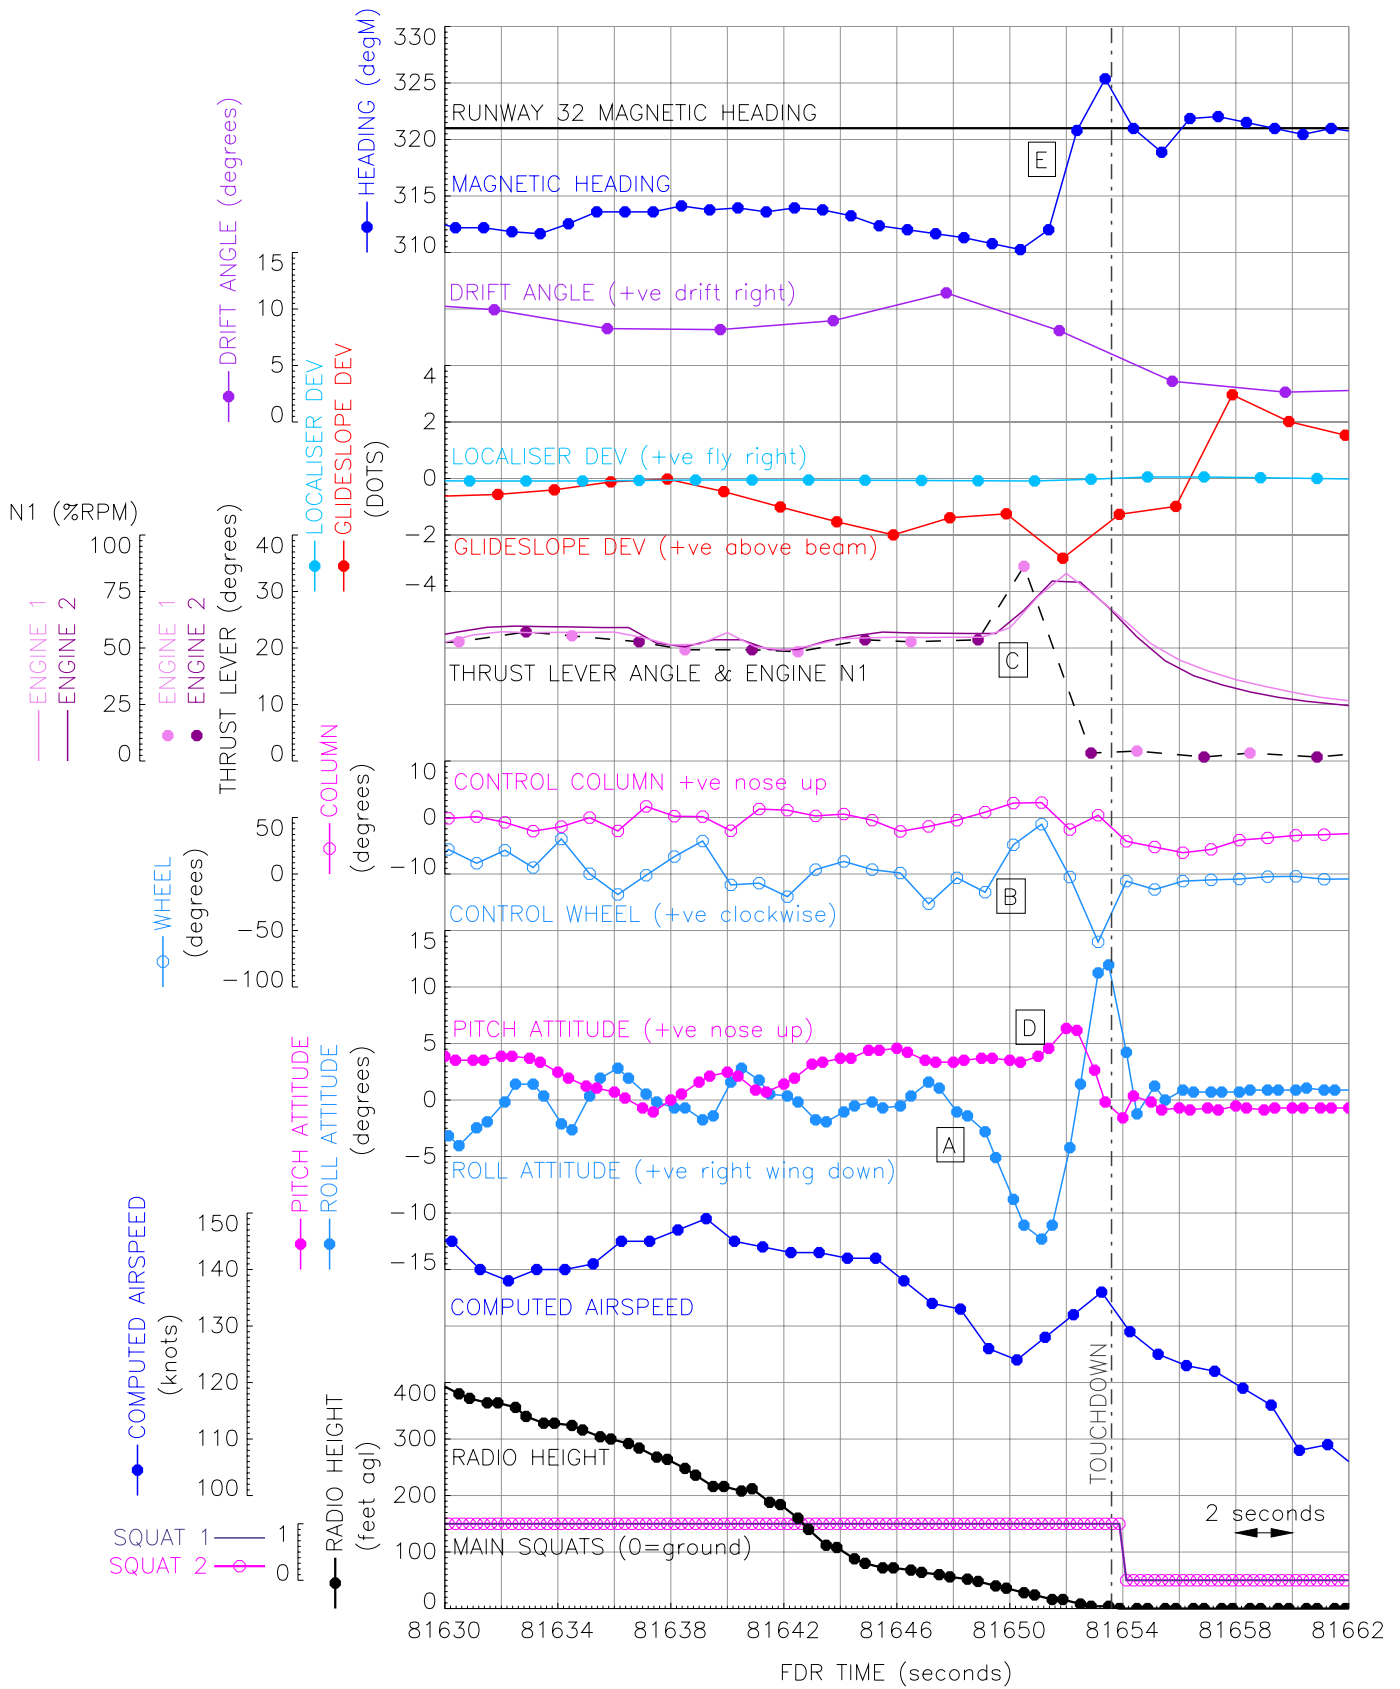
Figure1

In the final part of the approach, a significant amount of thrust was applied to counter the speed reduction induced by the wind. This resulted in the aircraft pitching up initially and when the thrust was rapidly reduced, the pitch attitude reduced, leading to some pitch instability.

The aircraft had maintained 8-10° of starboard drift during the approach and this drift was ‘kicked off’ in the flare to align the aircraft with the centreline; this induced a right roll. The FDR recorded that this roll was not anticipated with an opposite aileron input. As a result, this roll, induced by the yaw, caused the aircraft to achieve sufficient right bank for the nacelle to strike the ground. Confusion as to which pilot had control,

Salient FDR Parameters for Incident Landing to G-CELD

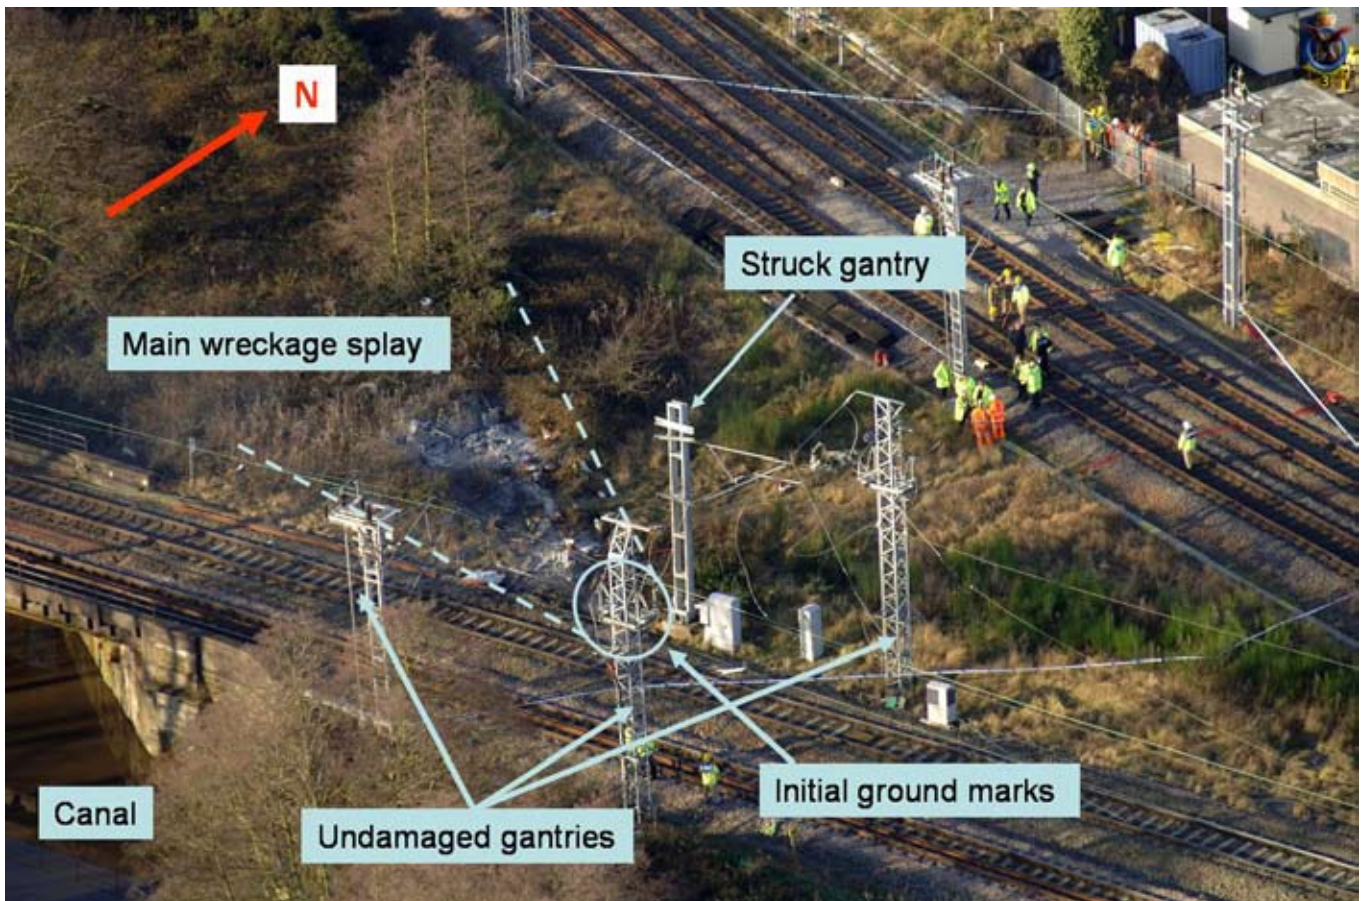
Figure 1

of one blade; this missing piece was located a short distance from the main wreckage and damage indicated it had become detached during the impact. Both blades were bent rearwards, with chord-wise scratching and indentations to the blade leading edges, indicating propeller rotation at impact.

The core of the engine was found just outside the crater. It had suffered substantial damage and most of the external auxiliary components were detached. Parts of a cylinder head and its valve gear were found in the crater. No evidence of pre-existing defects was seen and the aircraft wreckage was recovered to the AAIB's facilities for detailed examination.

G-AWPS accident site (courtesy Central Counties Air Operations Unit)

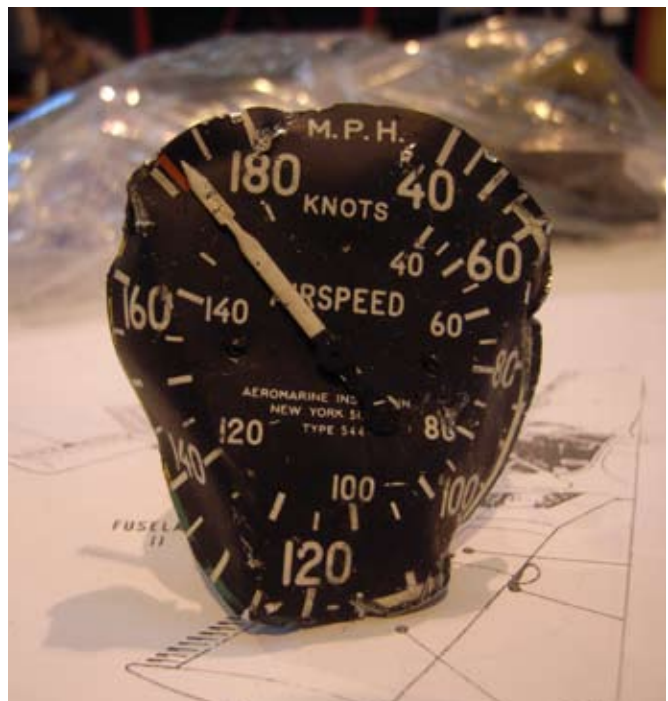
Figure 2

Face of airspeed indicator (ASI)

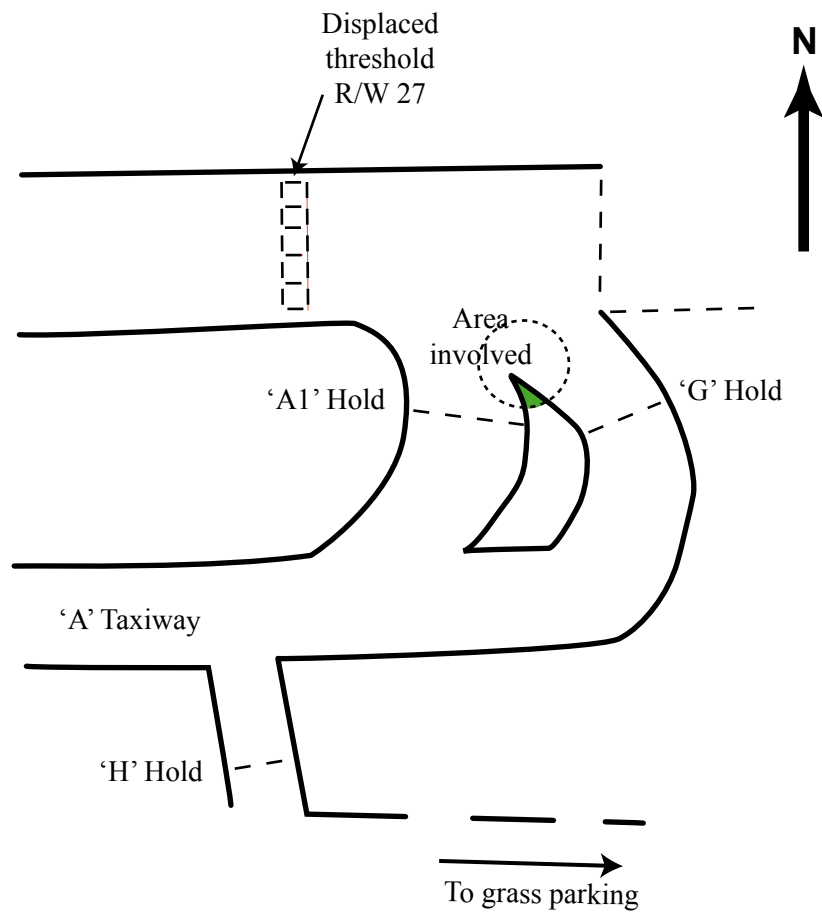
Figure 1

The pilot shut down the engine and called for assistance from the airport fire service. With their help, and that of an engineer from the local maintenance organisation, the aircraft was pushed back to the flying club area. It was found that the left mainwheel torque link had broken.

Sketch diagram of holding points, Runway 27 at Jersey Airport

The airport authority has since filled the area in question with a substantial fillet of sand.

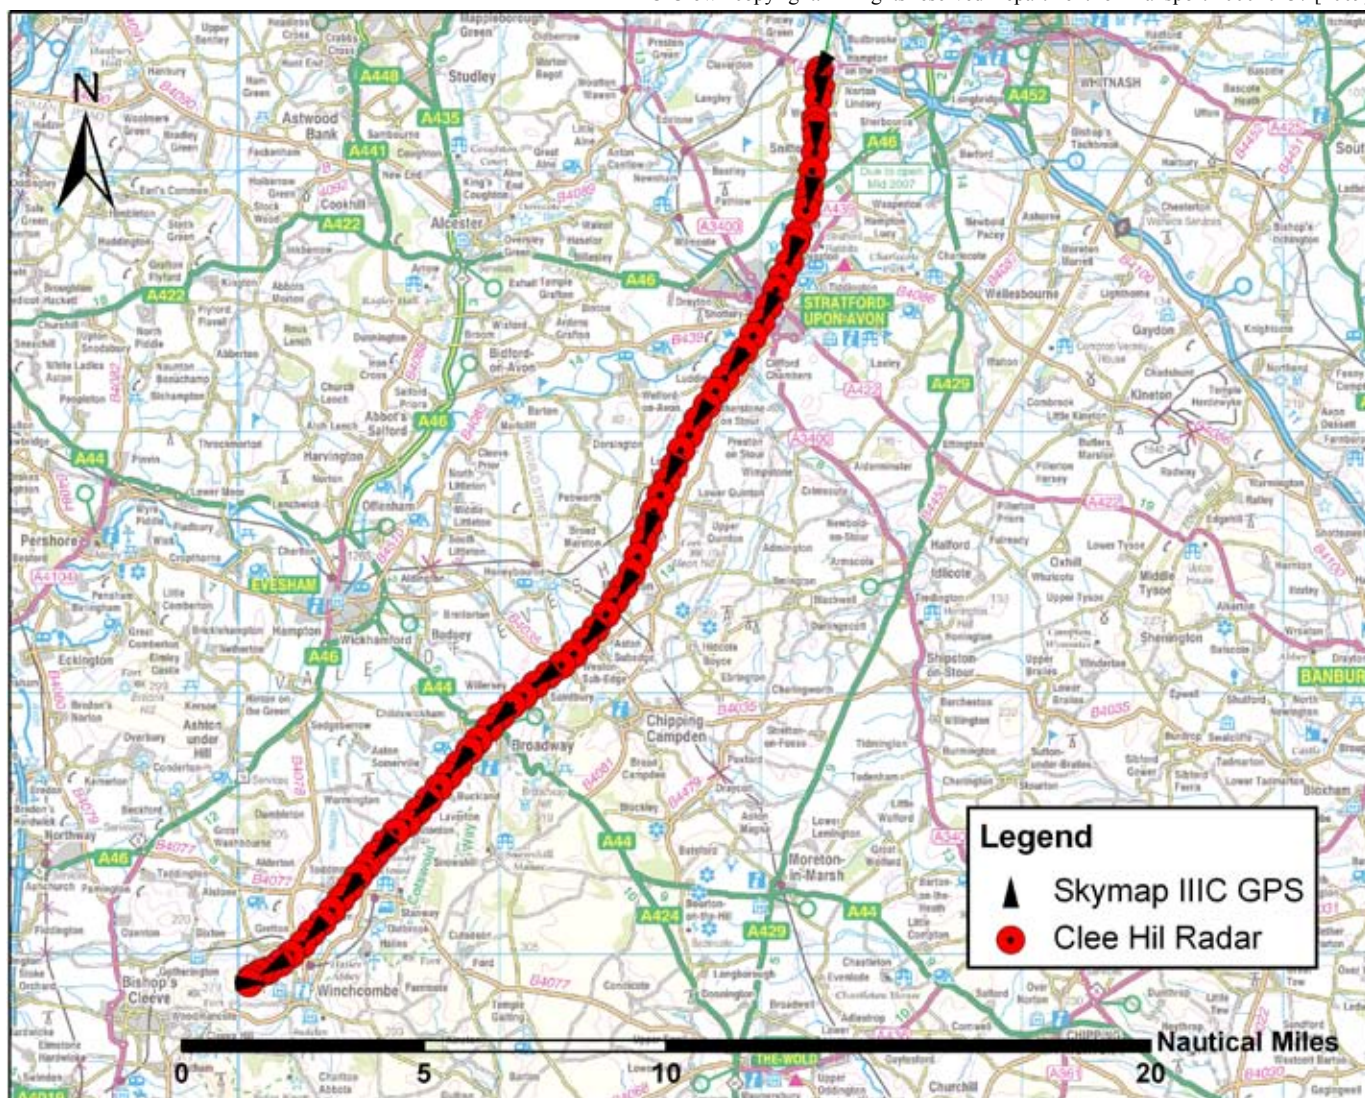
Figure 1

Radar and GPS tracks

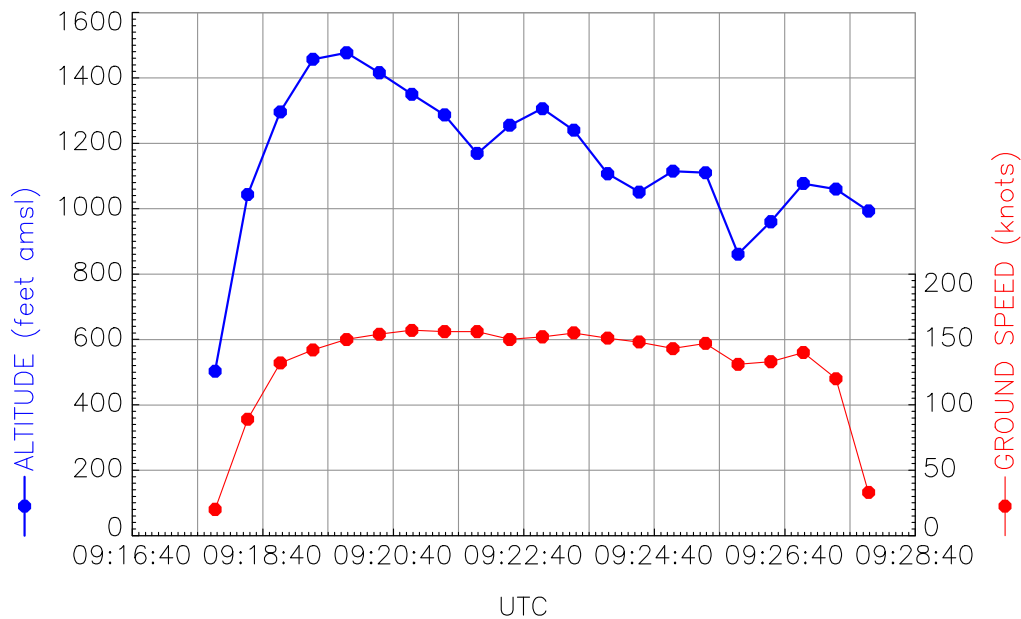
Figure 2

Accident track altitude and ground speed from GPS

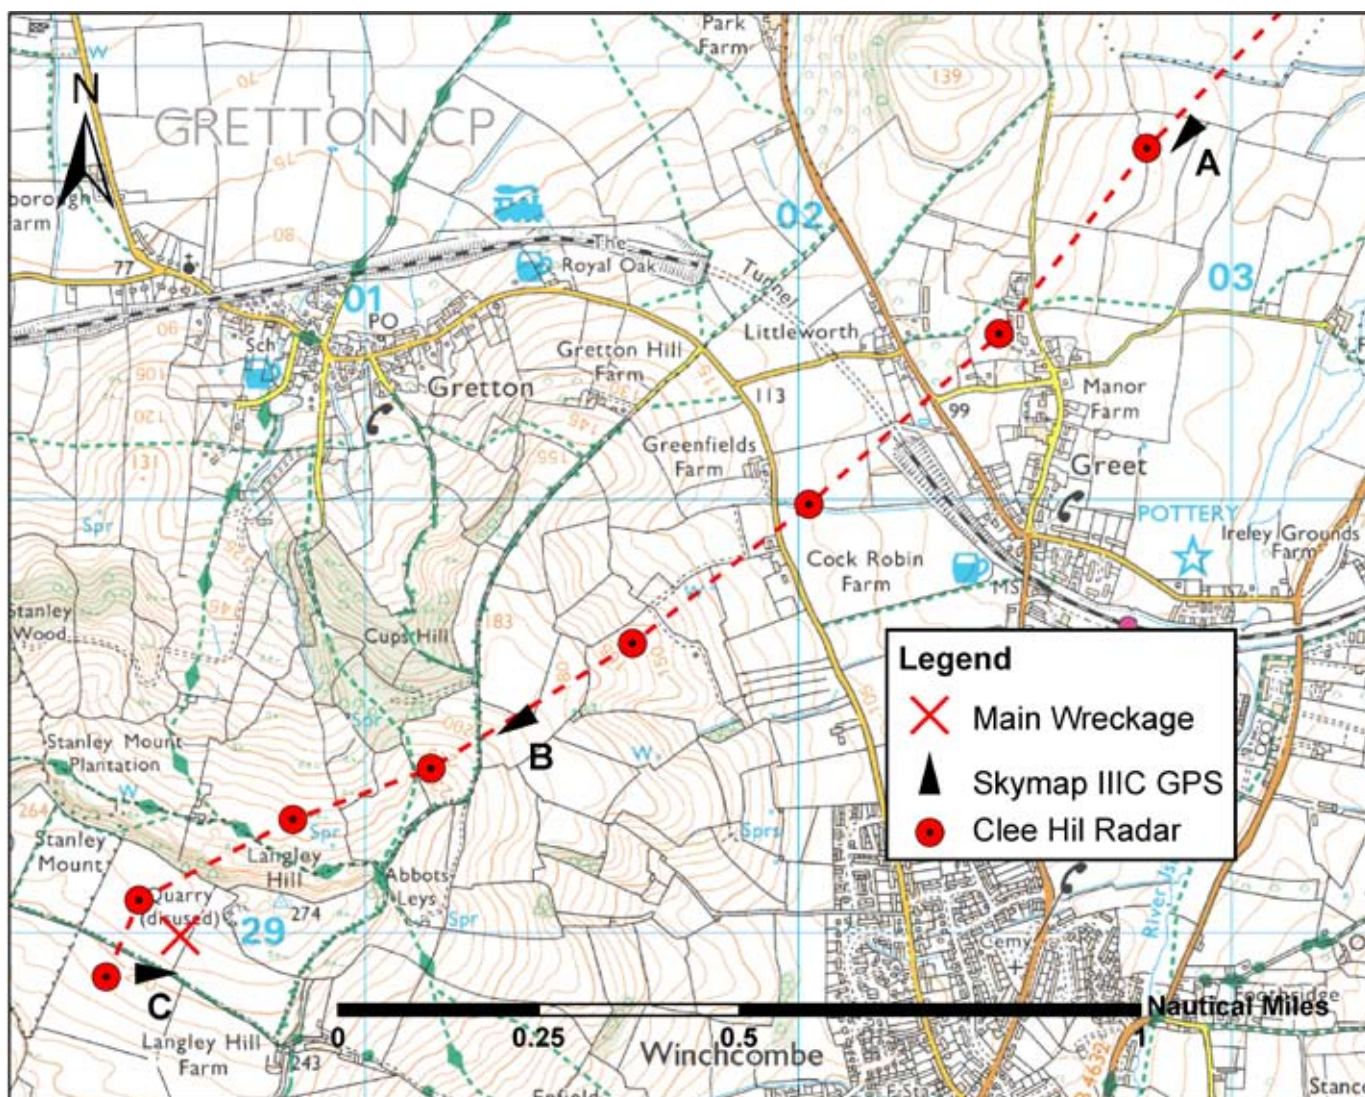
Figure 3

Close-up of the end of accident-flight track

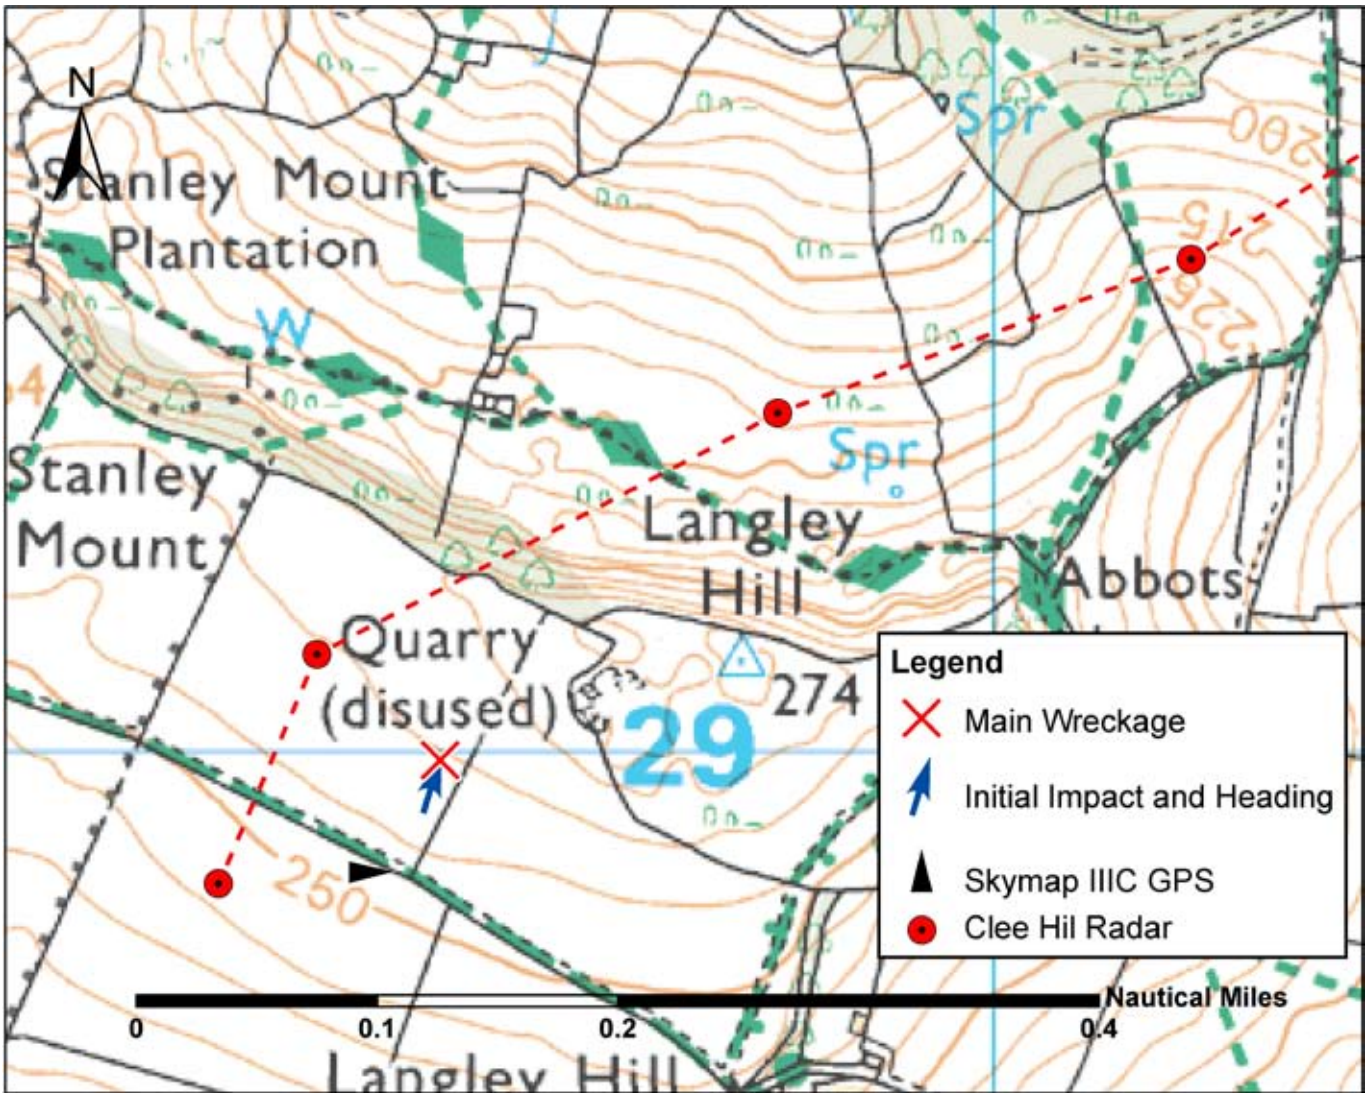
Figure 4

Crash site position with direction of ground marks

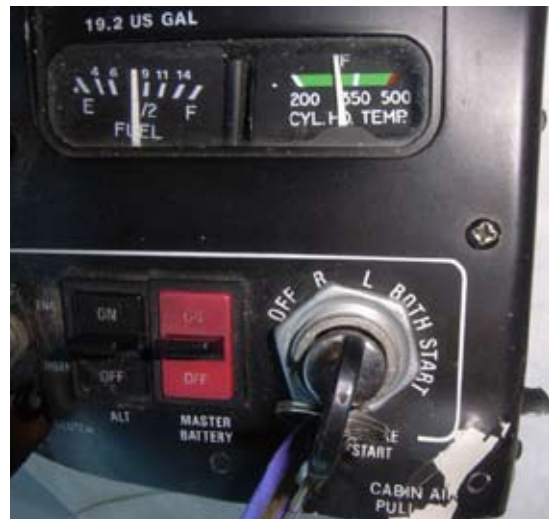
Figure 1

Position of ignition switch

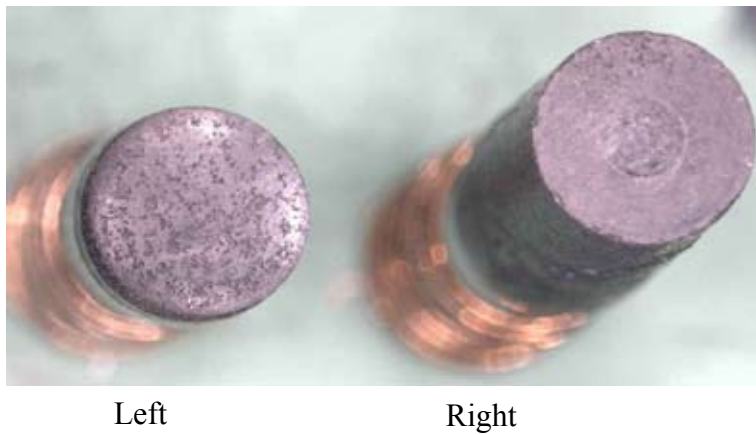
Figure 2

Wear pattern on carbon brushes

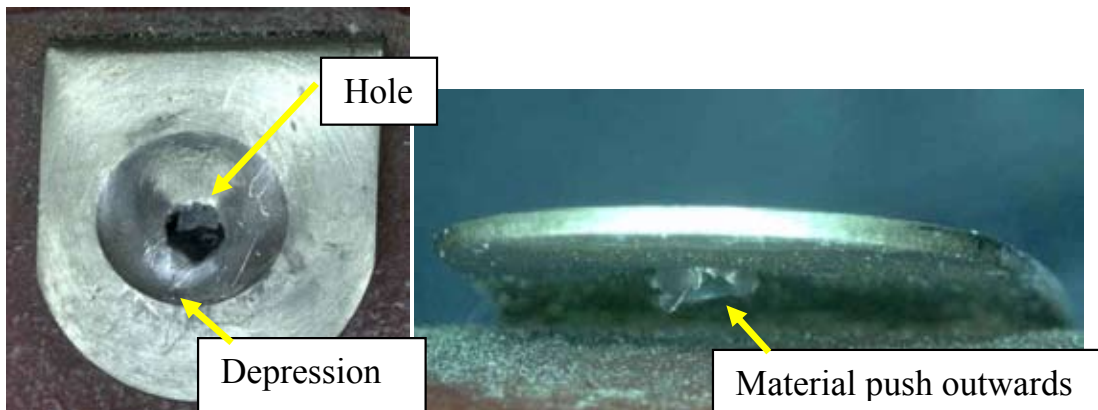
Figure 3

Copper outlet tab on left magneto coil

The last 2,200 hour field overhaul was carried out in May 2007, approximately 462 hours prior to the accident, during which a 500 hr inspection was carried out on the left magneto. This inspection required the carbon brush to be checked for unusual wear and for the outlet tab on the coil to be checked for a visible depression. The maintenance organisation which undertook the work advised the AAIB that during this inspection the carbon brush was replaced and there was no evidence of excessive wear on the coil outlet tab.

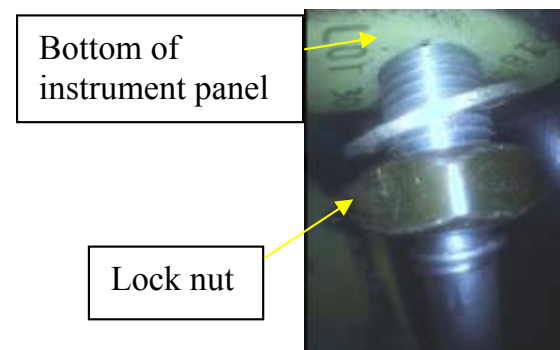
Figure 4

Carb heat cable end fitting
