## CONTENTS

## ACCIDENT

<b>Aircraft Type and Registration:</b>	Airbus A320-232, G-EUUF
<b>No &amp; Type of Engines:</b>	2 International Aero Engine V2527-A5 turbofan engines
<b>Year of Manufacture:</b>	2002
<b>Date &amp; Time (UTC):</b>	26 June 2006 at 1645 hrs
<b>Location:</b>	Taxiway Kilo, London Heathrow Airport
<b>Type of Flight:</b>	Commercial Air Transport (Passenger)
<b>Persons on Board:</b>	Crew - 7                      Passengers - 83
<b>Injuries:</b>	Crew - None                      Passengers - None
<b>Nature of Damage:</b>	Damage to right engine and to tractor
<b>Commander's Licence:</b>	Airline Transport Pilot's Licence
<b>Commander's Age:</b>	51 years
<b>Commander's Flying Experience:</b>	16,022 hours (of which 4,122 were on type) Last 90 days - 186 hours Last 28 days - 37 hours
<b>Information Source:</b>	AAIB Field Investigation

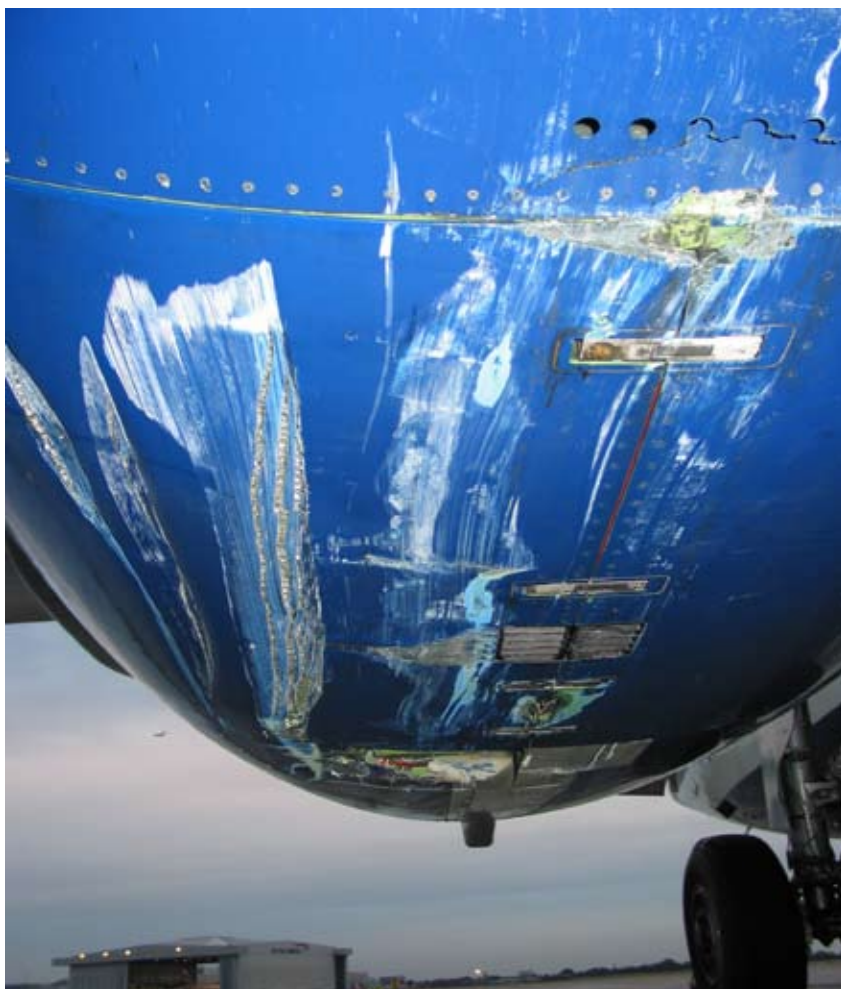
**Figure 2**

The underside of the engine inlet cowl, fan cowl and thrust reverser ‘C’-duct of the aircraft’s No 2 (right) engine were badly damaged (Figure 2) from contact with the rear of the tractor. Scoring on the lower right side of the engine cowls correlated with blue paint transfer and score marks on the tractor legs. From these marks, it was deduced that the tractor had been positioned on the right side of the aircraft, with its longitudinal axis oriented between 70 and 80 degrees to the right of the direction of travel of the aircraft, with the rear of the tractor in line with the No 2 engine.

The engine had initially grazed the right leg of the tractor (aft, looking forward), scoring the lower right side of the

Damage to No 2 engine caused on impact with tractor

cowls, before riding over the top of the left leg, which caused more extensive damage to the underside of the engine. A piece of the thrust reverser 'C'-duct aluminium structure was found embedded in the reinforcing rib on the top of the left leg of the tractor.

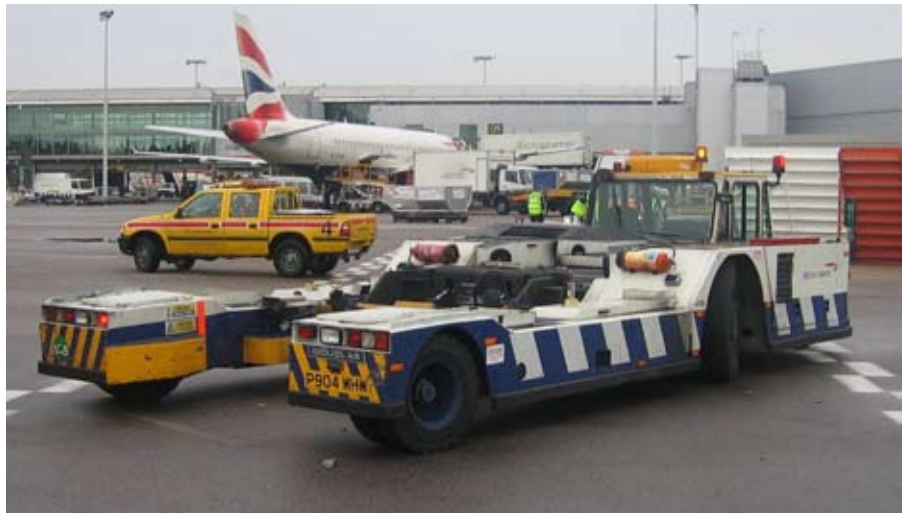
**Figure 4**

The damage to the tractor was largely confined to its left leg. The force of the No 2 engine bearing down on the leg had deformed the wheel spat which is manufactured from 10 mm steel plate, reinforced by a stiffening rib. Two of the mounting bolts attaching the wheel spat to the chassis leg had also sheared.

Post-accident photograph of Tractor AT0858  
(Stand 139 in background)

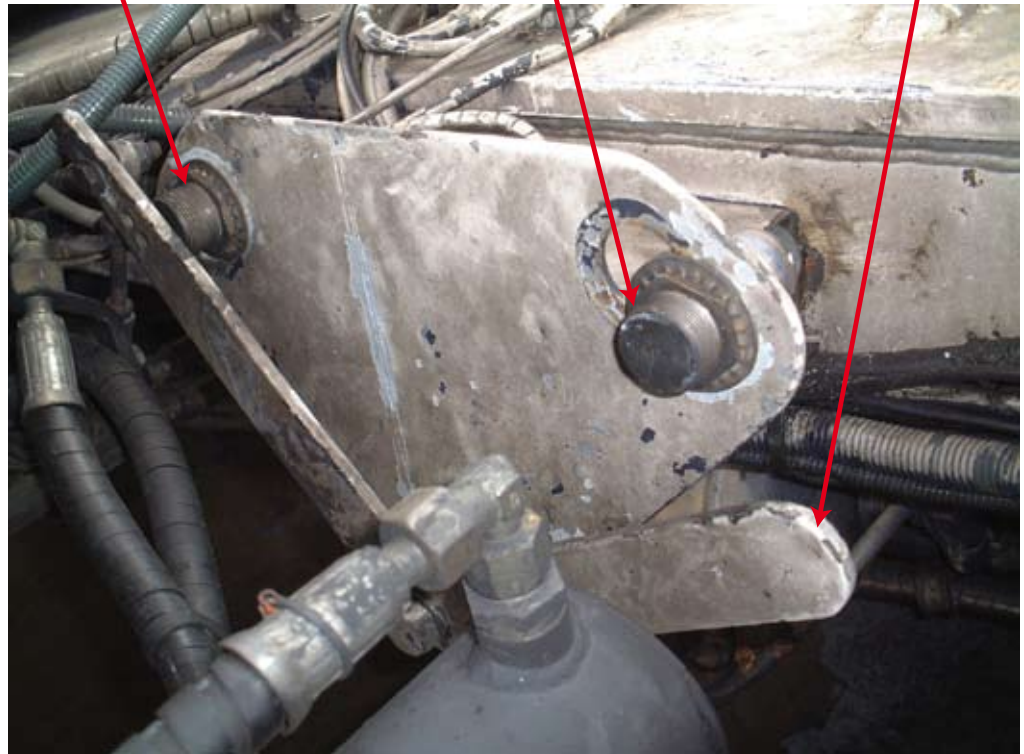
**Figure 5**

Cradle position sensor location showing ‘boomerang’ overtravel

On closer inspection, the target arm of the boomerang was found to have travelled past the ‘cradle up’ proximity sensor, to the extent that the boomerang operating arm was triggering the ‘cradle down’ sensor (Figure 5). During testing, it was found that the cradle overtravel could be reproduced occasionally if the tractor engine was ‘revved’ whilst raising the cradle. The defect was cured by adjusting the ‘cradle up’ and ‘cradle down’ proximity switch air gaps to the manufacturer’s specified gap of 4 mm and reducing the hydraulic fluid flow rate to the cradle rams to slow the cradle raise speed. Following these adjustments, it was no longer possible to reproduce the fault.

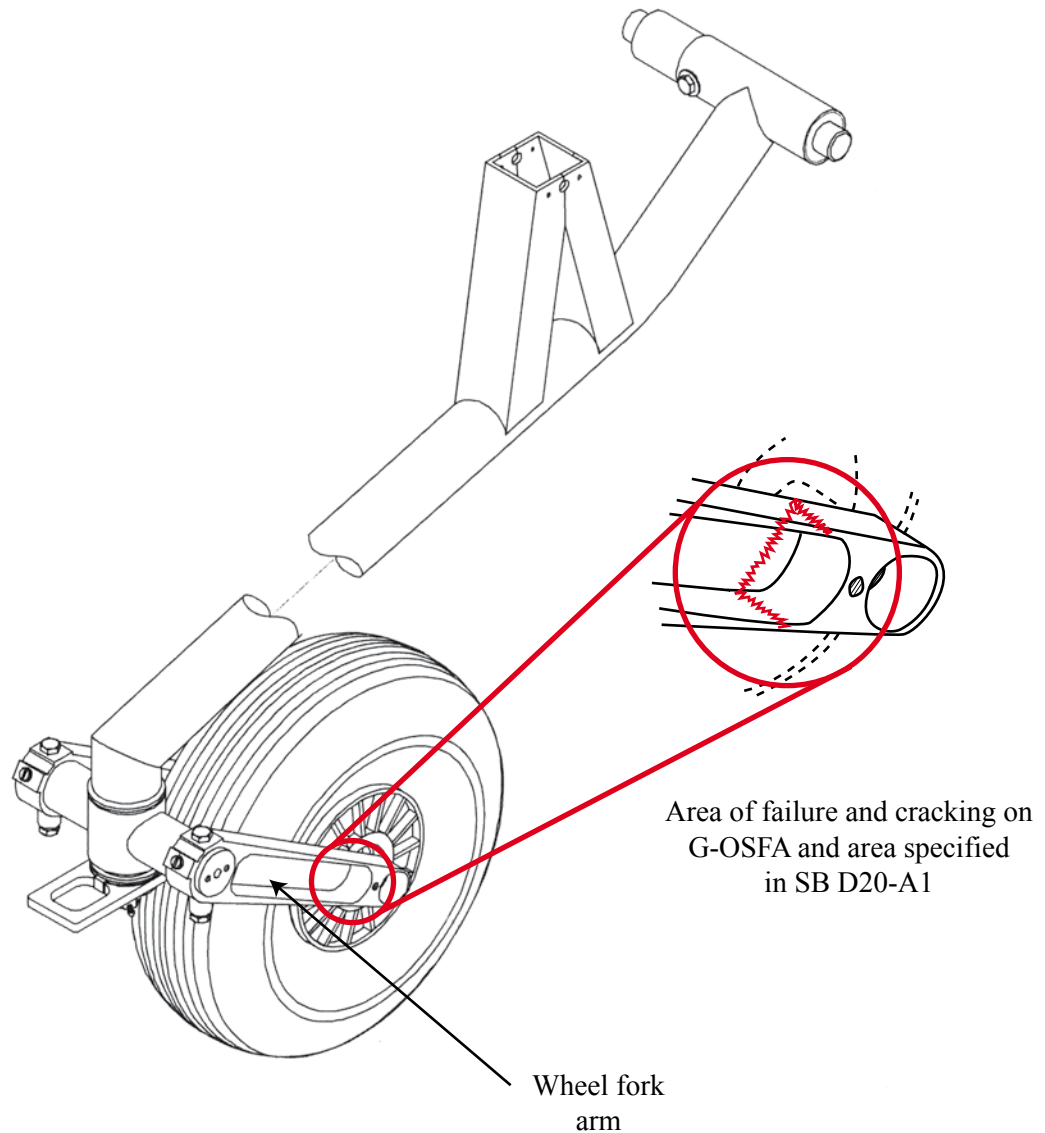
**Figure 1** *Adapted from manufacturer's drawing*

Initial examination showed that the nosewheel fork had failed at both sides approximately 45 mm forward of the wheel's axle hole in the fork (Figure 1). Metallurgical

examination showed that both fork arms had failed in simple upward bending overload with a small amount of torsion in the right fork arm. This suggested that the left arm failed first, placing a twisting load on the unfailed portion of the right arm. Evidence from the failure surfaces indicated that a crack initiation had occurred from an event prior to that which resulted in the final failure. It was not possible to determine what the two events were or the time between them. There were no pre-existing material defects or damage to either of the fork arms. It was seen from the general appearance of the material surfaces that the fork arms had been sulphuric acid anodised. This could have adversely affected their resistance to surface crack initiation and propagation.

It was noted during the examination of the fork arms that there had been heavy contact between the insides of the arms and the sidewalls of the nosewheel tyre. It was also seen that the nosewheel tyre that was fitted was of a larger size (5.00-4) than that specified (4.00-4). With a

the operator and were made available to the AAIB, who submitted them for metallurgical examination. Initial examination showed that both fork arms had cracked approximately 45 mm forward of the wheel's axle hole in the fork (Figure 1). Detailed examination showed that both fork arms had cracked in simple upward bending overload. Both fork arm cracks contained fretting products and debris indicating that the cracks had been present for a considerable time and that they had been subjected to a large number of upward cyclic bending loads. These cyclic bending loads had progressed the crack in the right fork arm. There were no pre-existing material defects or damage to either of the fork arms. It was seen from the general appearance of the material surfaces that the fork arms had been sulphuric acid anodised.

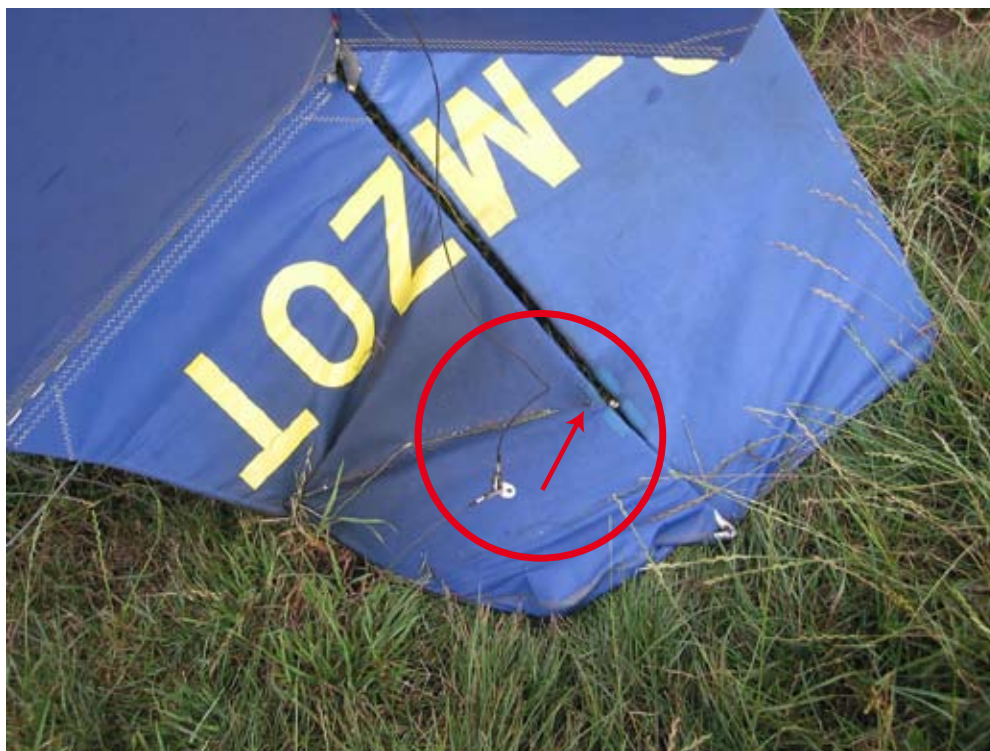
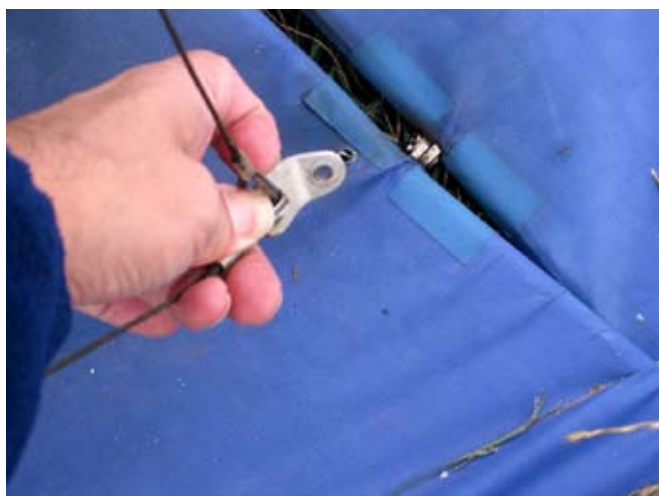
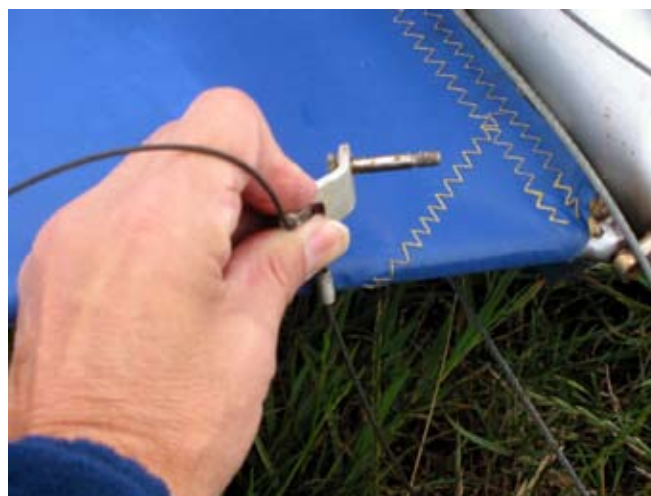
**Figure 2**

The bolt that had attached the tailplane upper bracing-wire tangs to the fin was identical to that removed from an intact aircraft during the investigation. It was thus established that the bolt was of sufficient length to accommodate the stiff nut safely (referred to in the manufacturer's build manual as a 'Lock Nut'). Similar components were used elsewhere on the aircraft. It was noted that removal of the tang necessitated the use of 9 mm and 8 mm spanners for the nut and bolt respectively. A photograph of a stiff-nut is shown at Figure 3, where it can be seen that it has been manufactured with a saw cut extending across approximately half the diameter of the nut, just above the hexagonal section. The top half of the nut has been slightly bent over, in a manner that tended to close the saw cut. This process results in the axes of the threads in the two halves of the nut being at a slight angle to each other, which is how the 'stiff' function is achieved. However, one feature of this type of nut is that when it is turned onto a bolt, no 'stiffness' is encountered until the threads in the upper portion become engaged.

As-found tailplane bracing wires: arrow indicates attachment point on fin

Right tang

Left tang with bolt

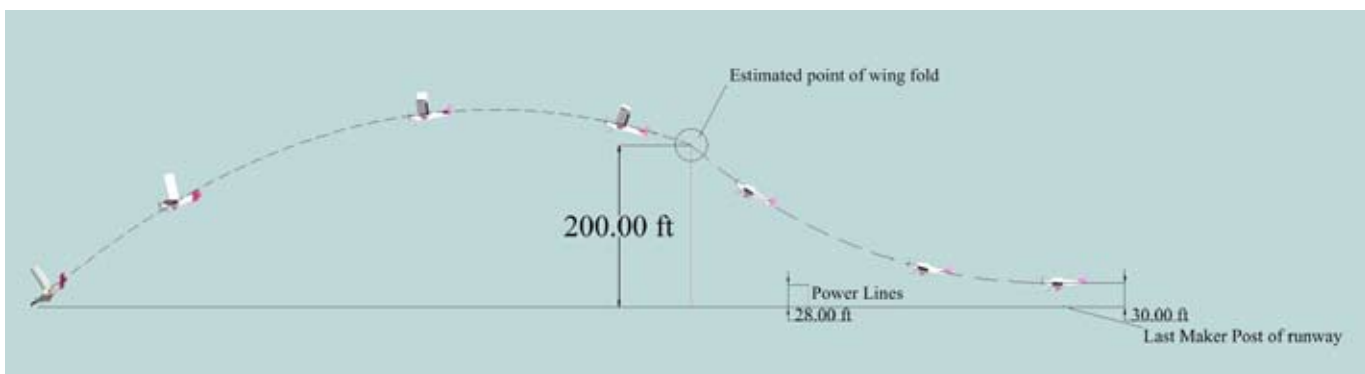
Figure 4

examination. This confirmed that the wing spar shear web, spar caps and doublers on all three sections of the front spar were constructed of 6061 aluminium. Unfortunately, due to the post-crash fire, it was not possible to ascertain if the heat treatment applied to the material at build was to the T6 specification. Examination of the fractures on the upper and lower spar caps of the centre spar section was inconclusive due to the damage of the surfaces caused by the post-crash fire, although the upper spar cap did show some topography suggestive of an overload failure.
