SERVICE INQUIRY INVESTIGATION INTO INCIDENT INVOLVING QINETIQ GAZELLE HT3 XZ936 AT MOD BOSCOMBE DOWN ON 2 JUN 14

MAA DG/SI/01/14 – CONVENING ORDER FOR SERVICE INQUIRY INTO AIRCRAFT OCCURRENCE INVOLVING GAZELLE XZ936 ON 2 JUNE 14 AT 1057Z

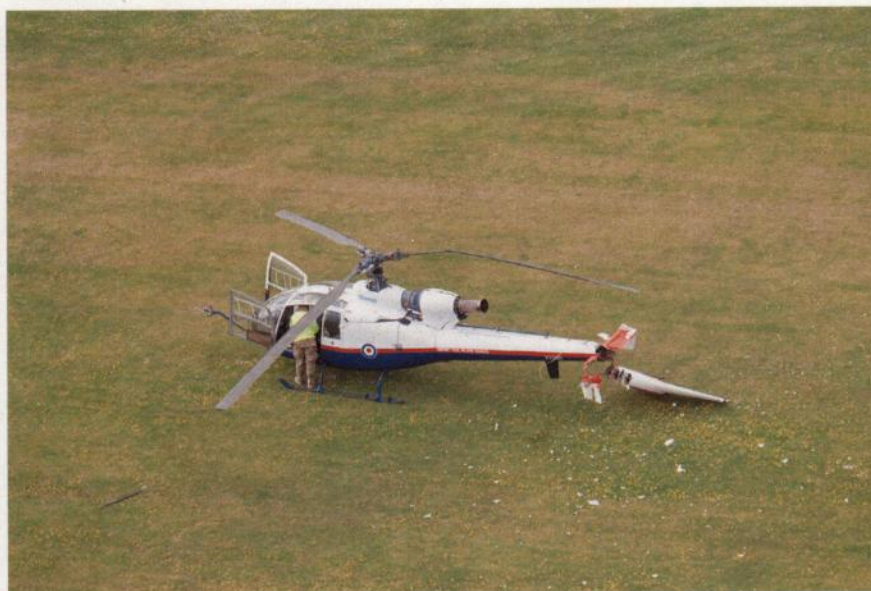
1.3.1 At 1157hrs on 2 Jun 14, Gazelle HT3 XZ936 (TESTER 73) with an Empire Test Pilots' School (ETPS) crew of two was involved in an incident while carrying out Engine Off Landings (EOLs)¹ at Boscombe Down Airfield, Runway (Rwy) 23 Grass (Fig1). During the sortie a number of autorotations and Variable Flare (VF) EOLs were carried out without incident but on the last EOL the aircraft landed on the rear of the skids and rocked back and forward simultaneously with significant control deflections. Shortly after landing, the rear of the tail boom assembly detached due to impact from the Main Rotor Blades (MRBs). Neither crew member was injured.

Fig 1: XZ936 on Rwy 23 Grass – Boscombe Down

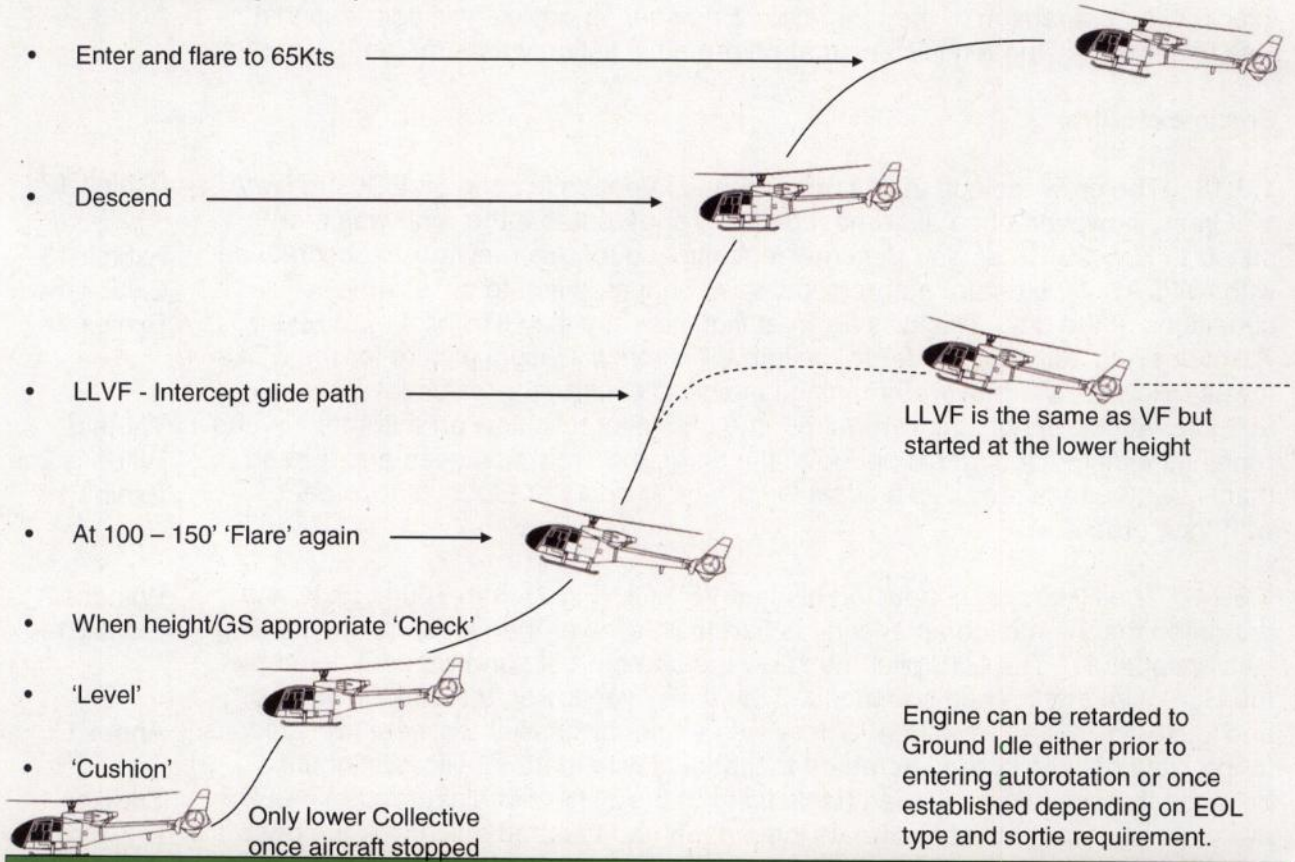
Fig 2 – EOL Profiles
