AAIB Bulletin

7/2014

Published 10 July 2014

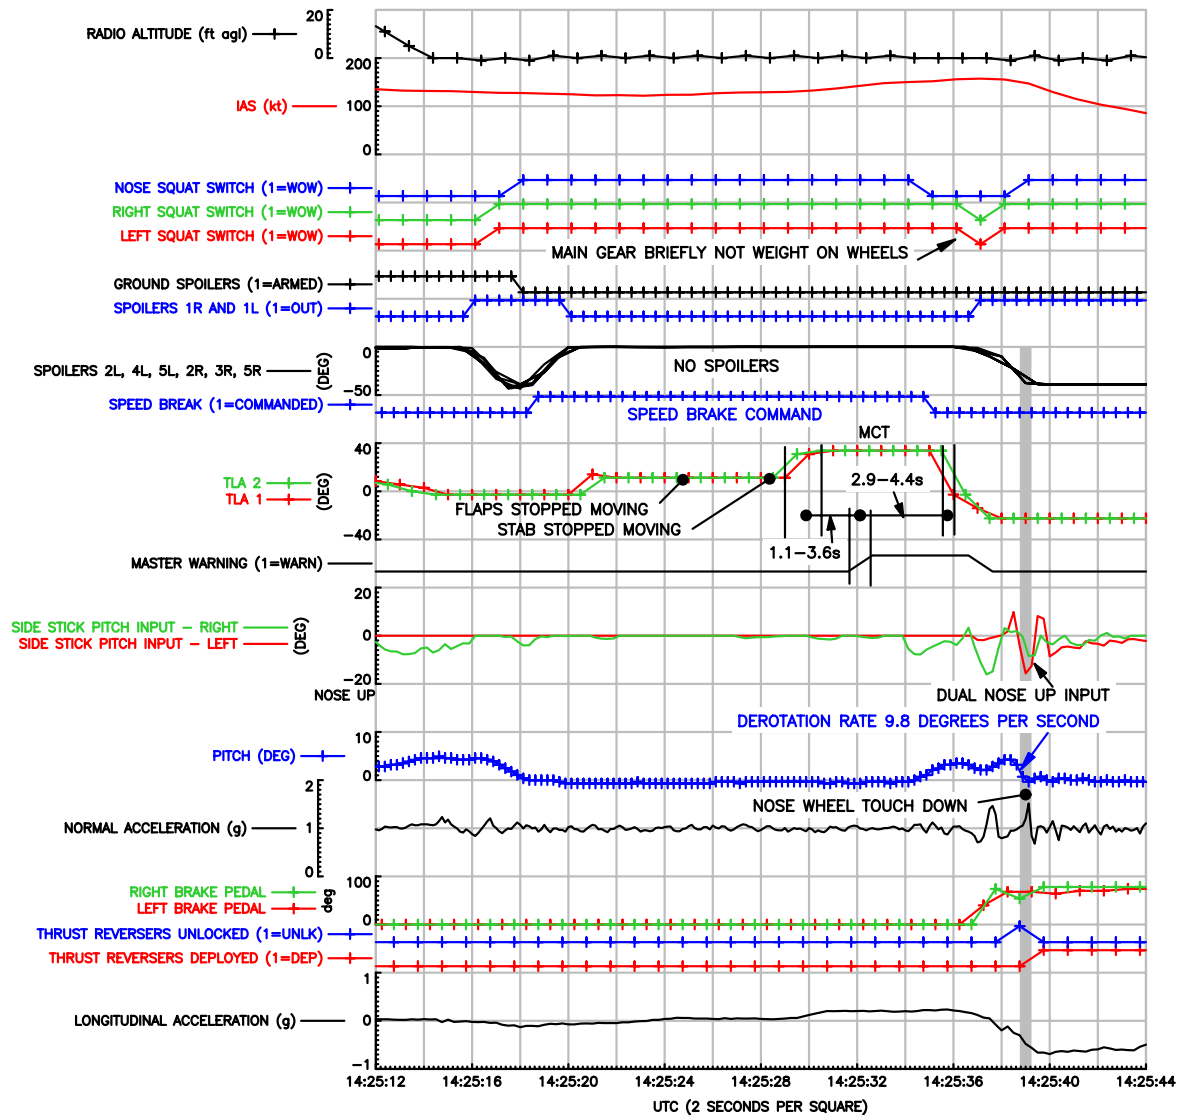
Figure 1

The aircraft was being operated on a flight crew 'base training' detail. While taking off after a touch-and-go landing, a takeoff configuration warning was generated. The commander rejected the takeoff and brought the aircraft to a halt on the remainder of the runway. The nose landing gear sustained some damage as the aircraft de-rotated on to the nosewheel during the manoeuvre. The crew did not consider the touchdown on the nose landing gear to be excessive and were not aware of the damage.

Touch-and-go rejected takeoff

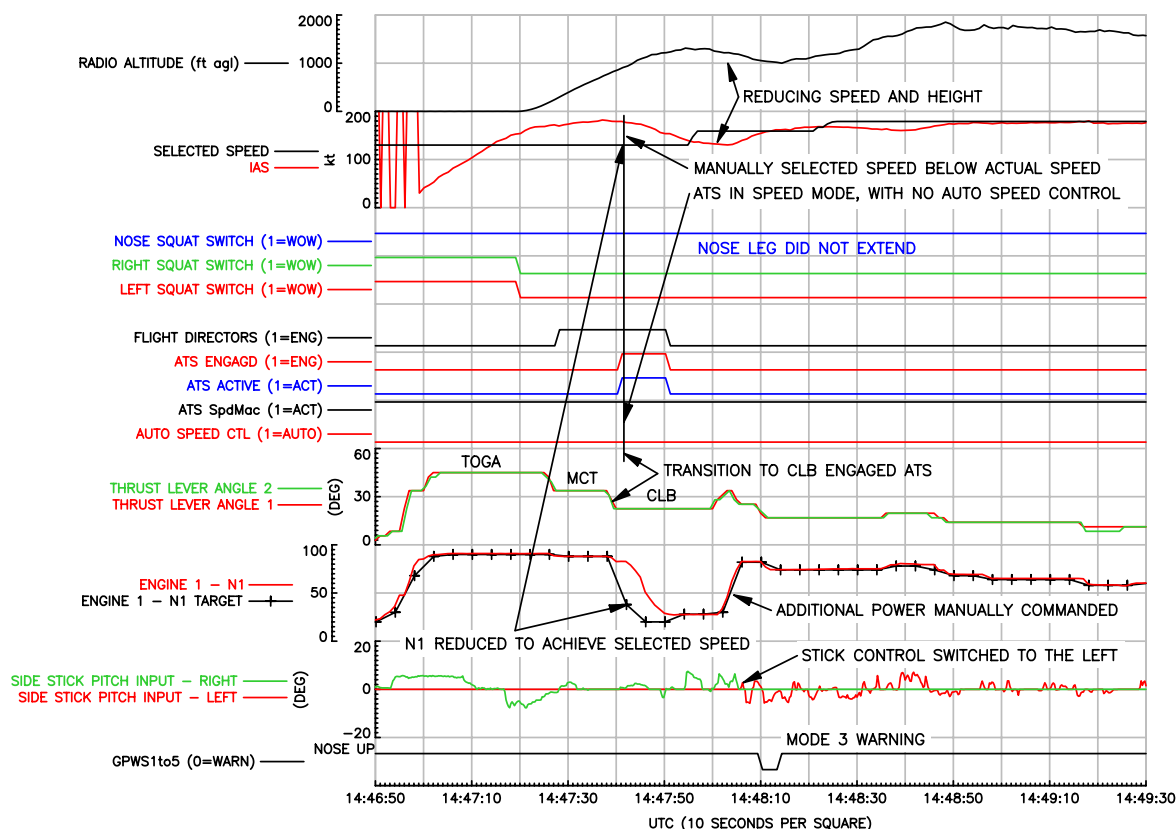
Figure 2

The subsequent flight departed at 1446 hrs. The data recorded at the start of the flight is shown in Figure 2. The nose landing gear proximity switches continued to indicate weight-on-wheels after takeoff and the flight directors were engaged at 200 ft agl. At 800 ft agl, the autothrust engaged in 'speed' mode after the thrust levers were retarded to CLB. With the aircraft speed above the selected speed of 130 kt, the engine target N_1 and, subsequently, achieved N_1 values reduced. The flight director and autothrust systems then disengaged as the aircraft passed 1,200 ft agl, with the aircraft decelerating. Five seconds later, the selected speed was increased to above the aircraft speed. A further five seconds later the thrust levers were advanced and subsequently the sidestick control inputs switched from the right to the left. Shortly afterwards, an EGPWS mode 3 (altitude loss after takeoff), warning was triggered.

Subsequent takeoff

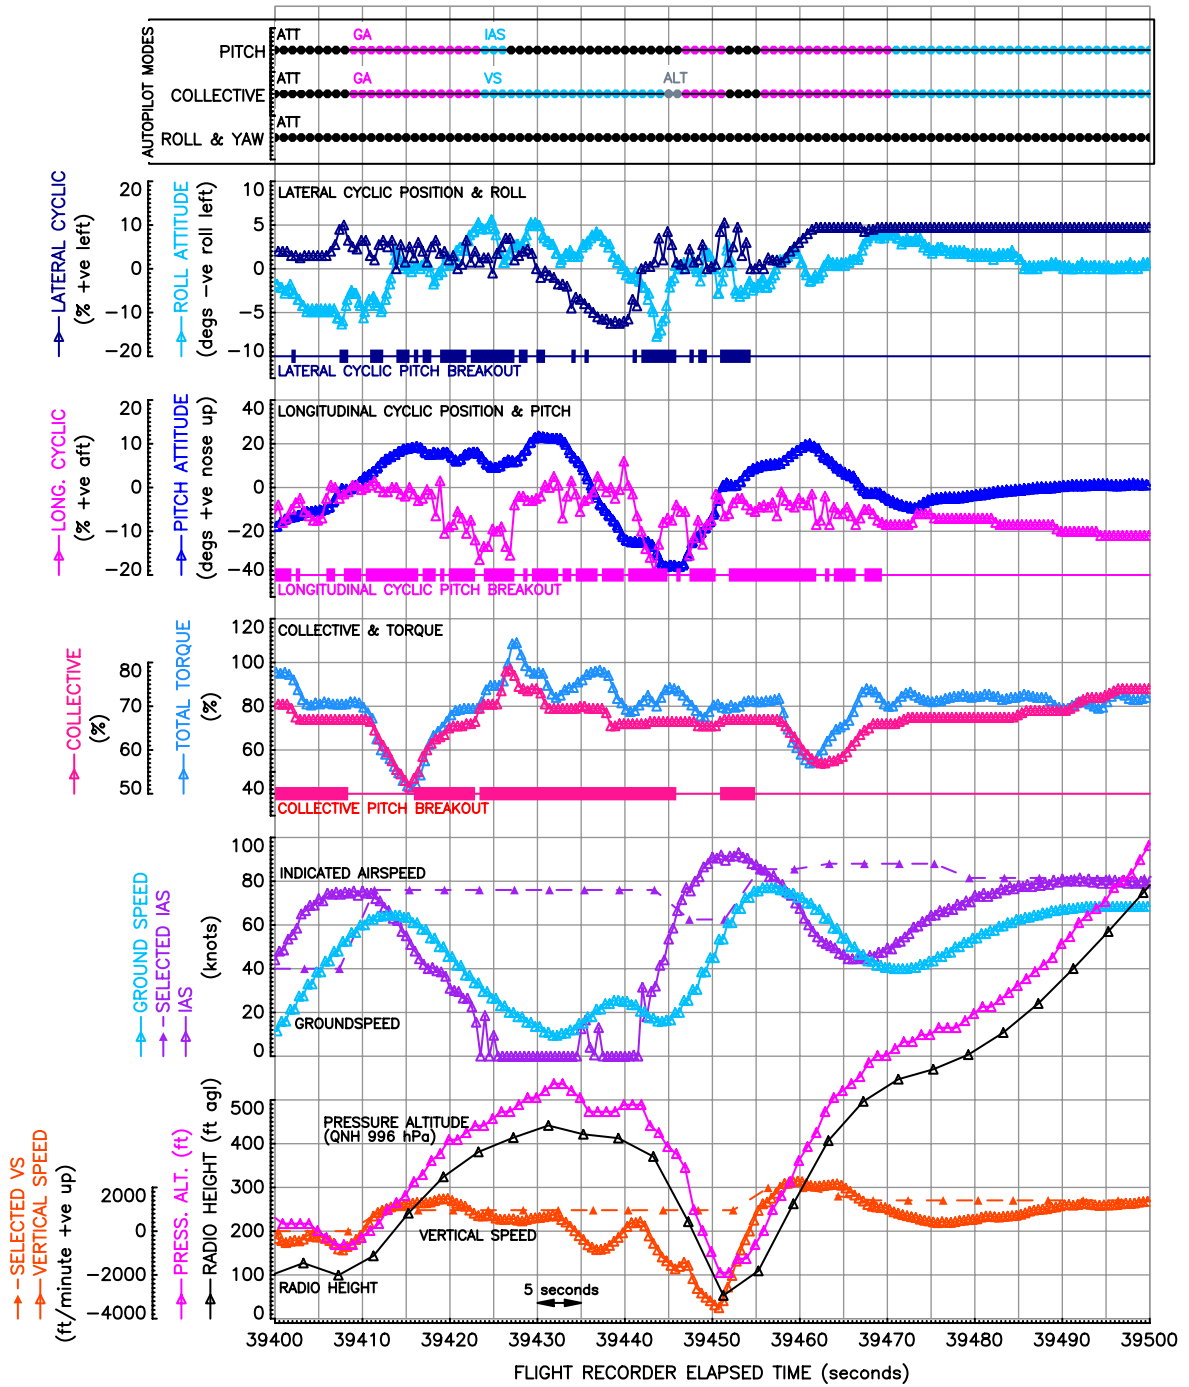
Figure 3

Salient recorded flight data for the incident to OY-HJJ

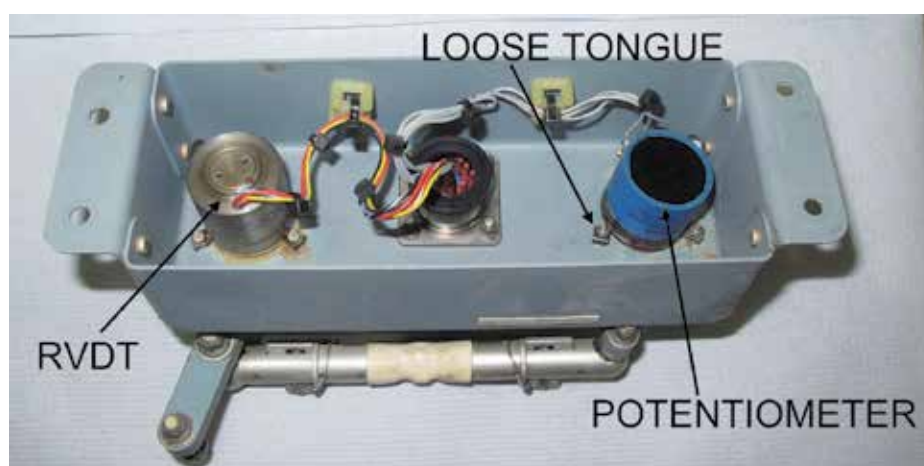
Examination of the collective control system revealed that the potentiometer inside the CLPD had become loose. When the collective was moved the body of the potentiometer moved slightly. The CLPD was removed which revealed that one of the three tongues which secured the potentiometer to the casing had become loose (Figures 4 and 5). This tongue should have engaged into the slot at the base of the potentiometer, but it had become loose and rotated out, enabling the body of the potentiometer to rotate slightly during collective movement. The other two tongues were still securely engaged in the slot.

Figure 4
Inside the CLPD

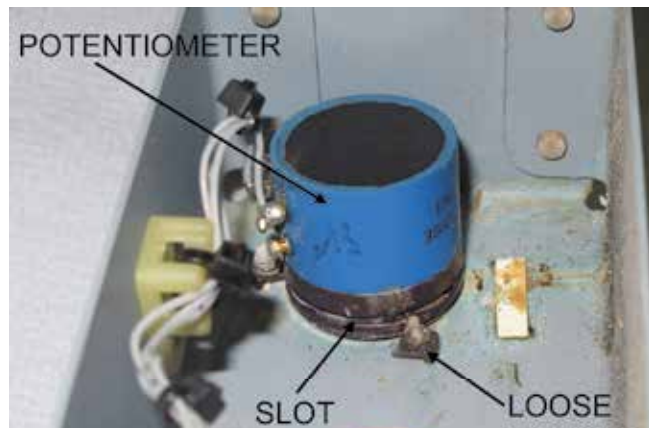
Figure 5

Close-up of potentiometer inside CLPD

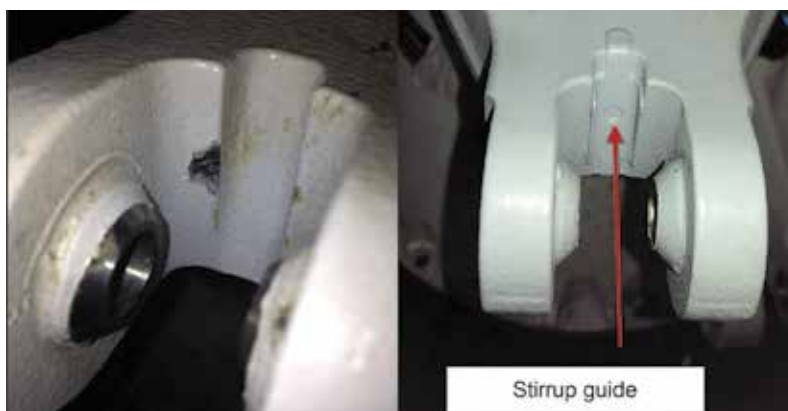
Figure 6

Examination of the stationary swashplate revealed chafing where the main servo rod end was attached to the swashplate (left image in Figure 6). This area of the swashplate should have been protected by a 'stirrup guide' (right image in Figure 6), but this guide was missing. Because the servo rod is a hydraulic actuator, any resistance, due to chafing between the rod end and swashplate, would not have been felt in the pilot controls and would not have affected the AFCS. The swashplate was replaced with a new part with a stirrup guide fitted.

Left image: fixed swashplate from OY-HJJ with missing stirrup guide;
Right image: stirrup guide on another swashplate

Following the aforementioned rectification action the helicopter was returned to service with no further reported AFCS faults.

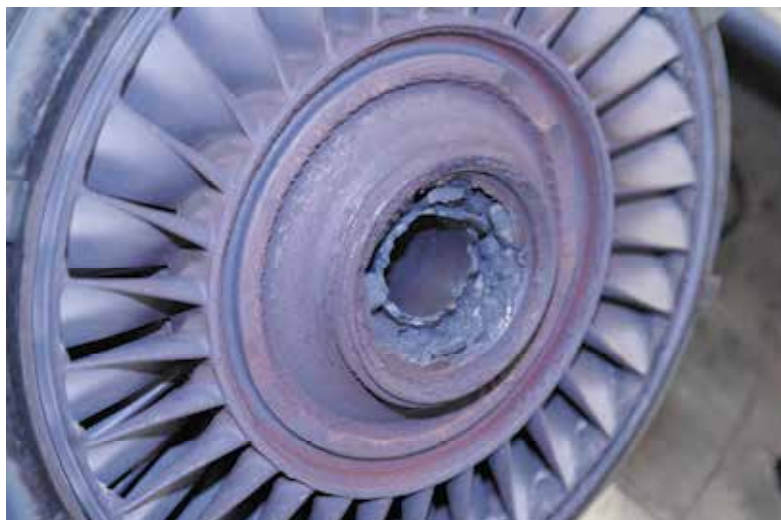
On disassembly, the No 7 main bearing was found to be disintegrated, with evidence of severe heat damage and metal splatter on the turbine disc and casing, Figure 1. The failed parts were returned to the engine manufacturer for a detailed failure analysis. Any significant findings will be dealt with through their normal continued airworthiness processes.

Figure 1
Failed No 7 bearing

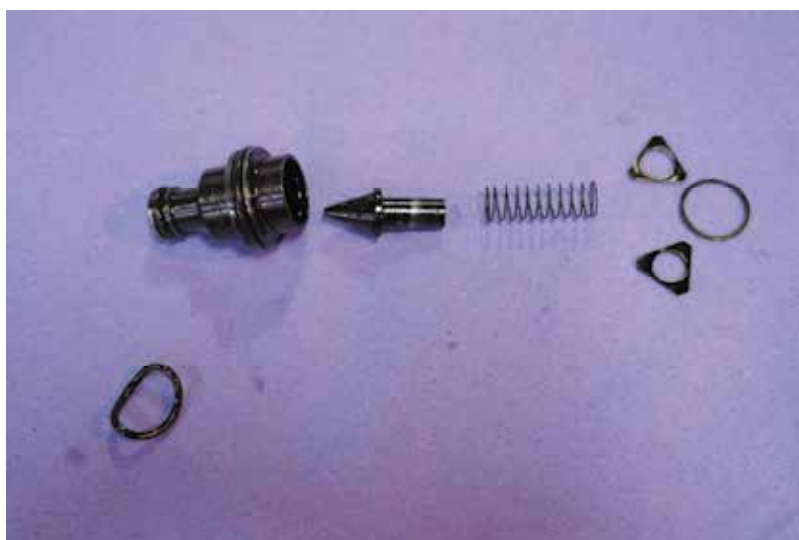
A check valve situated in the output flow from the oil filter was found to contain a foreign body which appeared to be an O-ring similar to that fitted to the oil filter spigot, Figure 2. The O-ring had become lodged in the valve opening, preventing the check valve from operating. The check valve is designed to open whilst the engine is running, to provide a flow of filtered oil from the filter housing to the bearings, and to close on engine shutdown, to retain oil in the filter housing and prevent it leaking into the engine internal cavities.

Figure 2
Oil filter housing check valve (disassembled) with foreign O-ring found inside

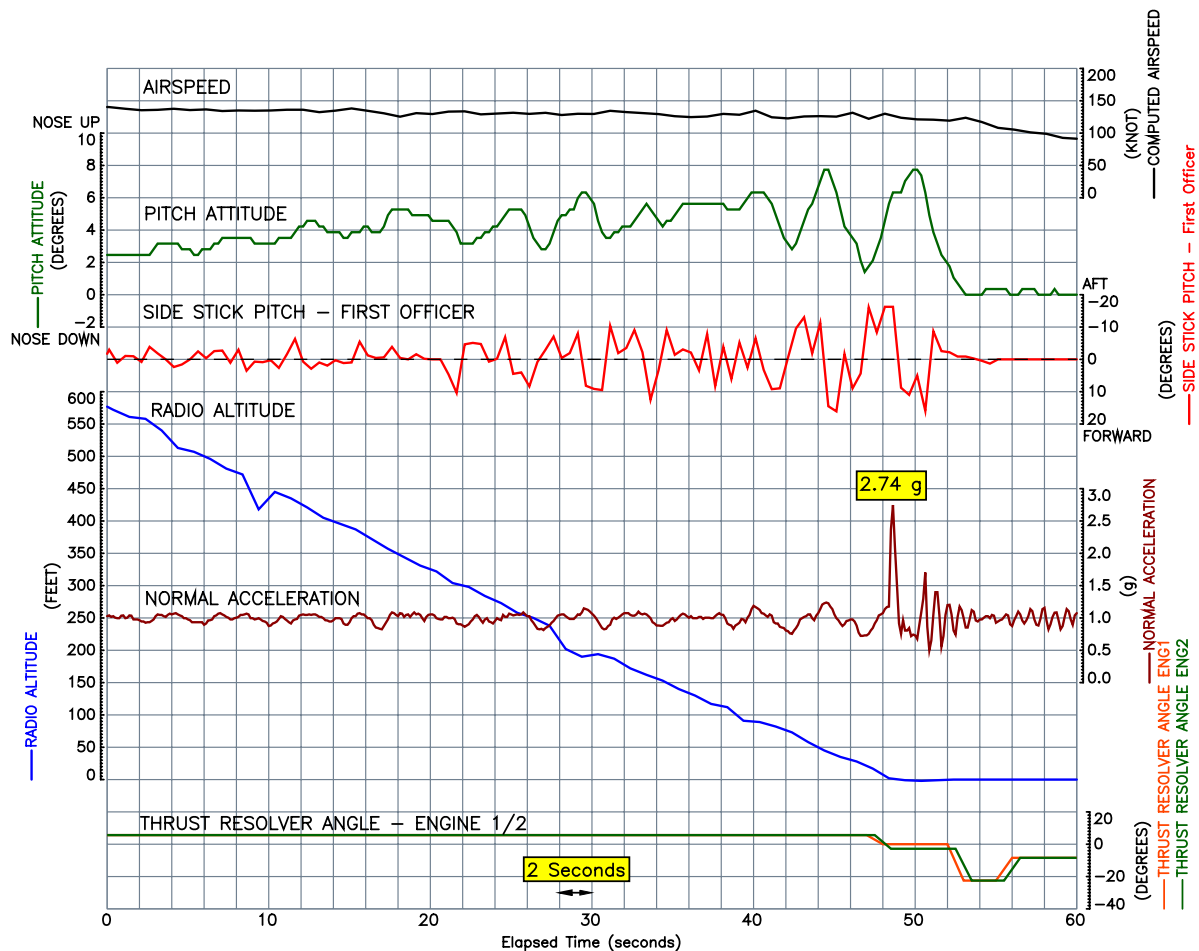
**Figure 1**

The scale for the parameter SIDE STICK PITCH – First Officer in Figure 1 is incorrectly labelled. The scale should show that positive values greater than zero indicate the side stick has been moved forward and that negative values of less than zero indicate that side stick has been moved aft. A revised plot is attached below. The analysis is unchanged.

Flight data from the landing
