## CONTENTS

<b>Summary of:</b>	<b>Aircraft Accident Report No: 1/2010</b>	123
	Report on the accident to Boeing 777-236ER, G-YMMM at London Heathrow Airport on 17 January 2008

**(ALL TIMES IN THIS BULLETIN ARE UTC)**

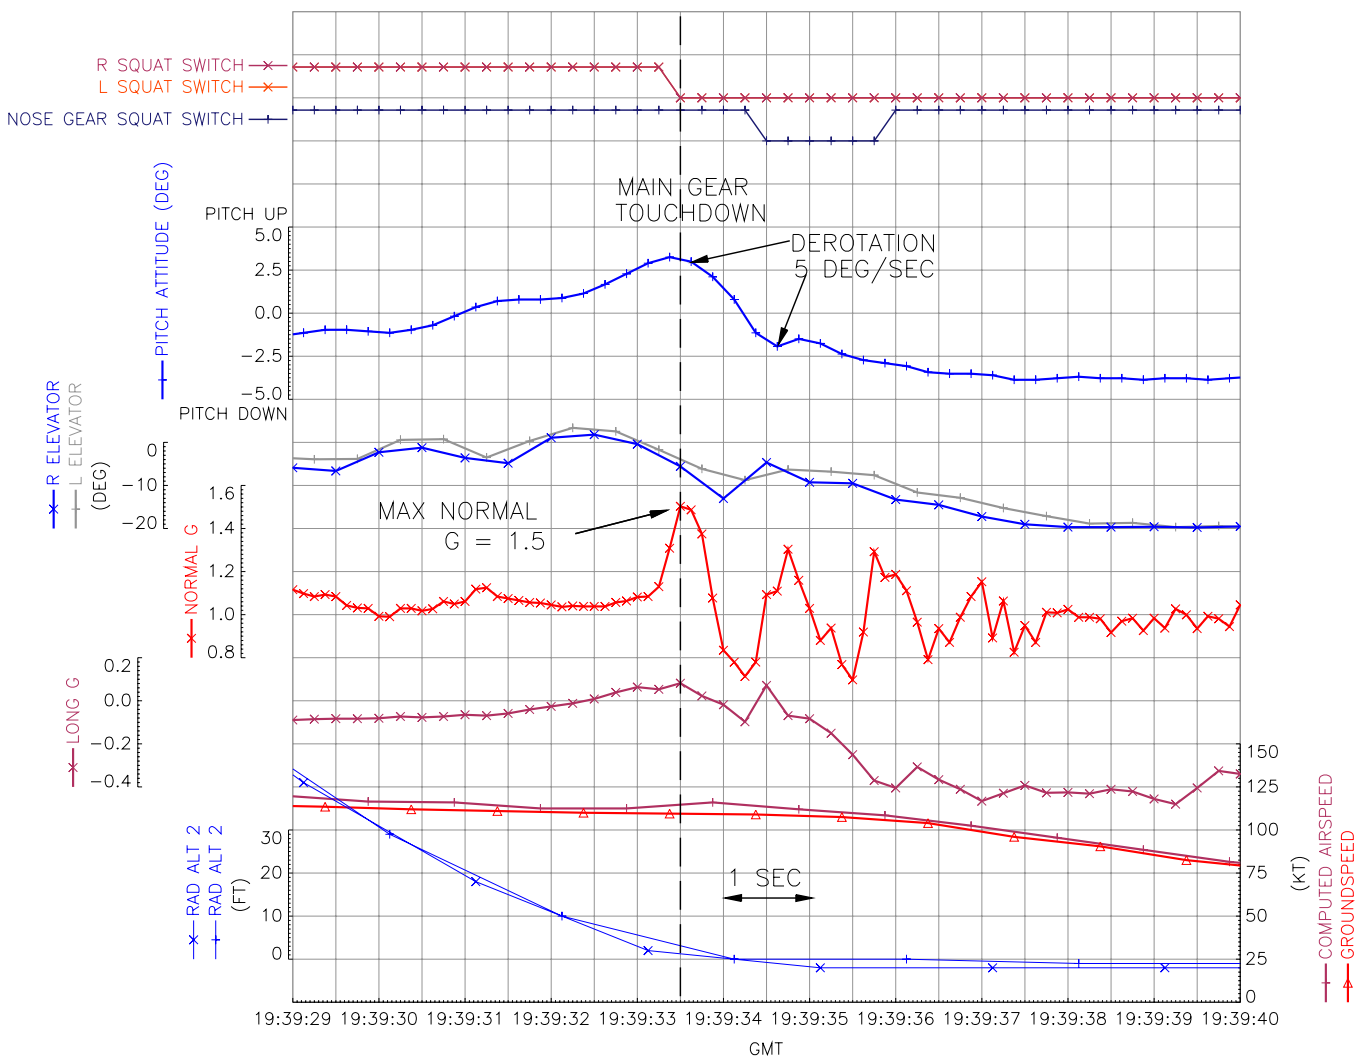
**Figure 1**  
G-BXAR FDR Parameters

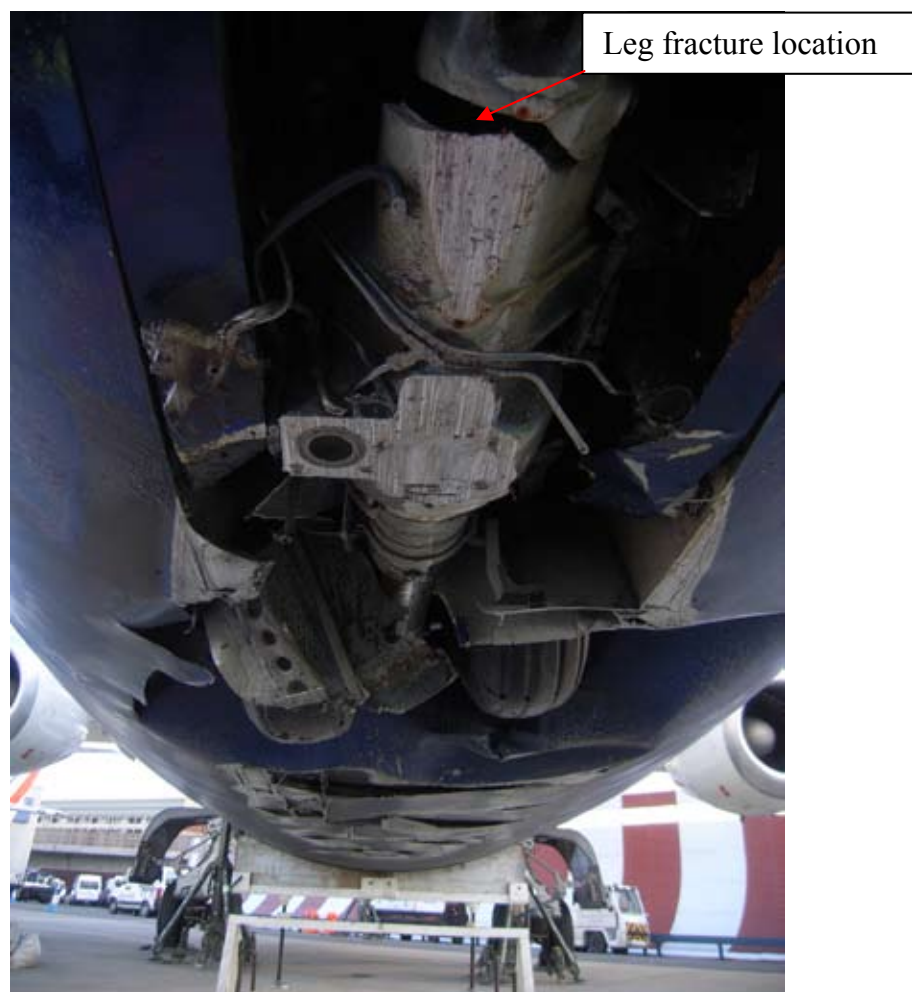
**Figure 2**

The floor of the equipment bay had been destroyed and the aircraft battery had been forced from its mountings, disconnecting one of the battery cables. After jacking up the nose of the aircraft, examination of the landing gear revealed that it had fractured at a point above its pivot and near to the top of the leg, which supports the down and up lock latch, Figure 2.

The retraction actuator and torque links had also broken. The upper portion of the landing gear main fitting was relatively undamaged and visual examination of the fracture surface indicated several relatively small areas of crack progression due to a fatigue mechanism, together with a large area characteristic of a failure in overload.

View showing failed nose landing gear and lower fuselage damage

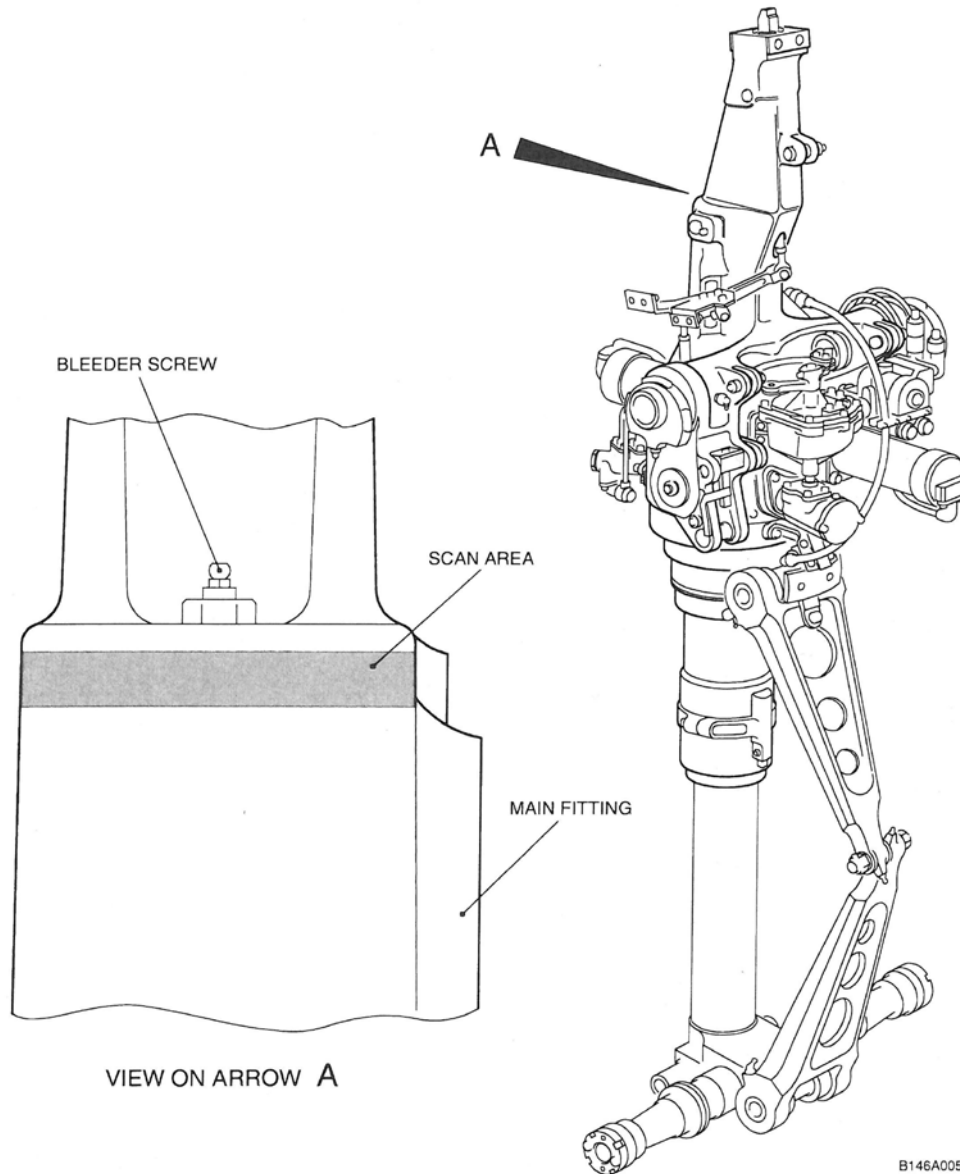
Main Fitting Inspection  
Figure 1

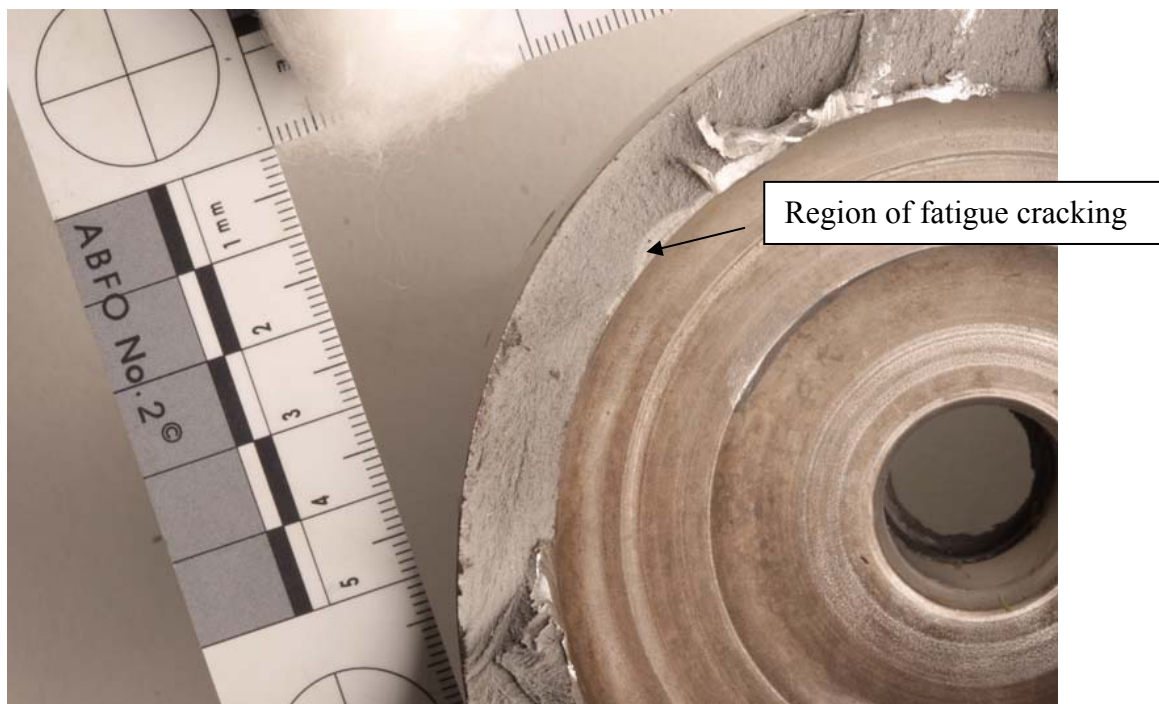
**Figure 4**  
Fracture surface of main fitting

Metallurgical examination of the main fitting confirmed that there were no material or microstructure abnormalities. However, examination of the main fitting fracture surface identified the presence of three fatigue cracks, which had become conjoined to form a single crack extending 23.2 mm around the circumference of the upper section of the internal bore, with a maximum depth of 2.21 mm, Figure 4. The location of the fatigue cracks was the same as found on the two fatigue tests.

A count of the striations within the fatigue cracks indicated that crack propagation had occurred for approximately 2,800 cycles prior to failure. The origin of these fatigue cracks was in the trough of a fine circumferential machining groove produced in the bore at the time the unit was manufactured. Smaller cracks were also found along the same groove and in adjacent grooves. Examination of the inner bore confirmed

that the shot-peening process had been carried out, in accordance with the requirements of SB 146-32-150, but that the surface roughness close to the origin of the fatigue cracks was 9.5 to 10.1 microns, in excess of the finish specified in the service bulletin.

The nose landing gear main fitting failed following the formation of multiple fatigue cracks within the upper section of the inner bore, originating at the base of machining grooves in the bore surface. These had formed because the improved surface finish, introduced by SB 146-32-150, had not been properly embodied at previous overhaul by Messier Services Inc, despite their overhaul records showing its incorporation. The operator had been in full compliance with the Service Bulletin relating to regular inspection of the main fitting, and embodiment of SB 146-32-150 at overhaul removed the requirement for these inspections by the operator.

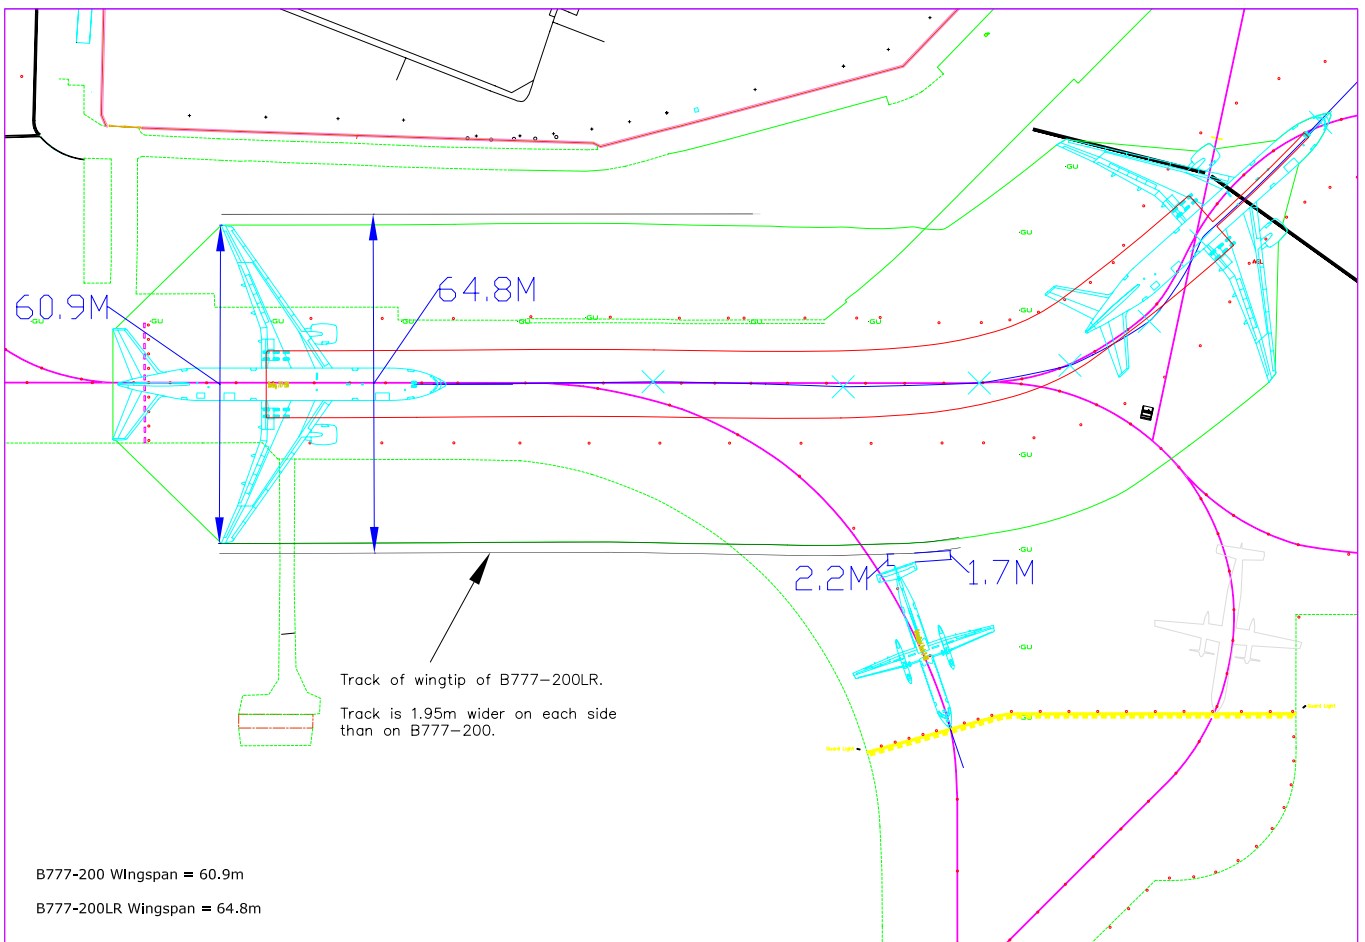
**Figure 2**

The trailing edge of G-JEDR's rudder had been struck just below the level of the horizontal stabiliser by AP-BGY's right wingtip. The impact had bent the trailing edge of the rudder at right angles over a length of about 80 cm. The damage was not repairable and the rudder was replaced.

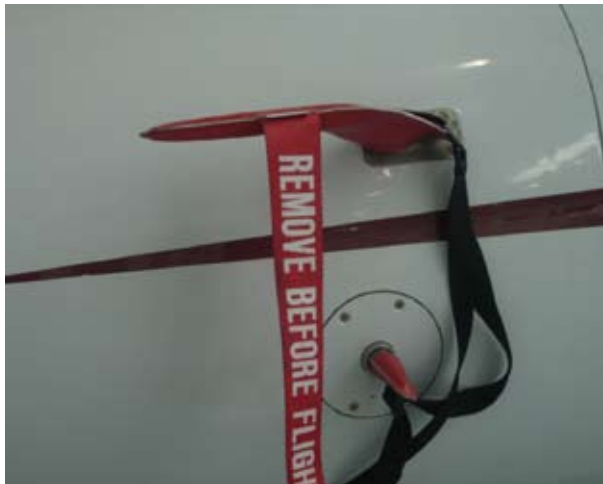
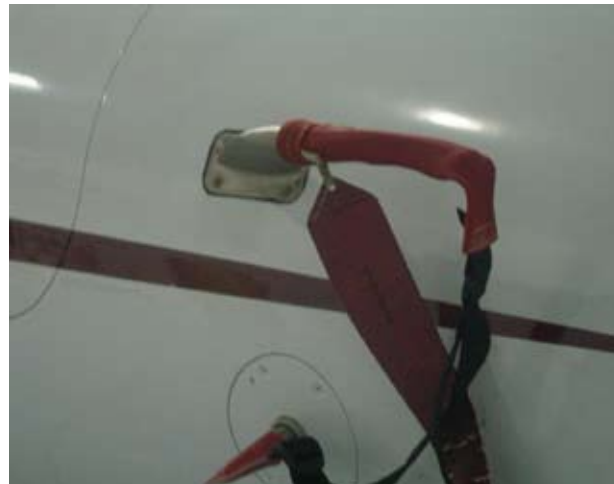
**Figure 6**

There had been three separate checks of the pitot/static drains. Firstly, the drain caps were removed and the drain cocks operated; no water came out. Subsequently, the maintenance organisation carried out a one-way purge of both systems with nitrogen; only one small drop of water came out. The system was then purged both ways with nitrogen and approximately one tablespoon of water (15 ml) was removed. The maintenance organisation also reported that when the pitot/static tubing was dismantled there was a small amount of water around some of the joints, described as "similar to condensation".

Left pitot probe and AOA vane below  
Standard cover

Right pitot probe and AOA vane below  
Kevlar cover

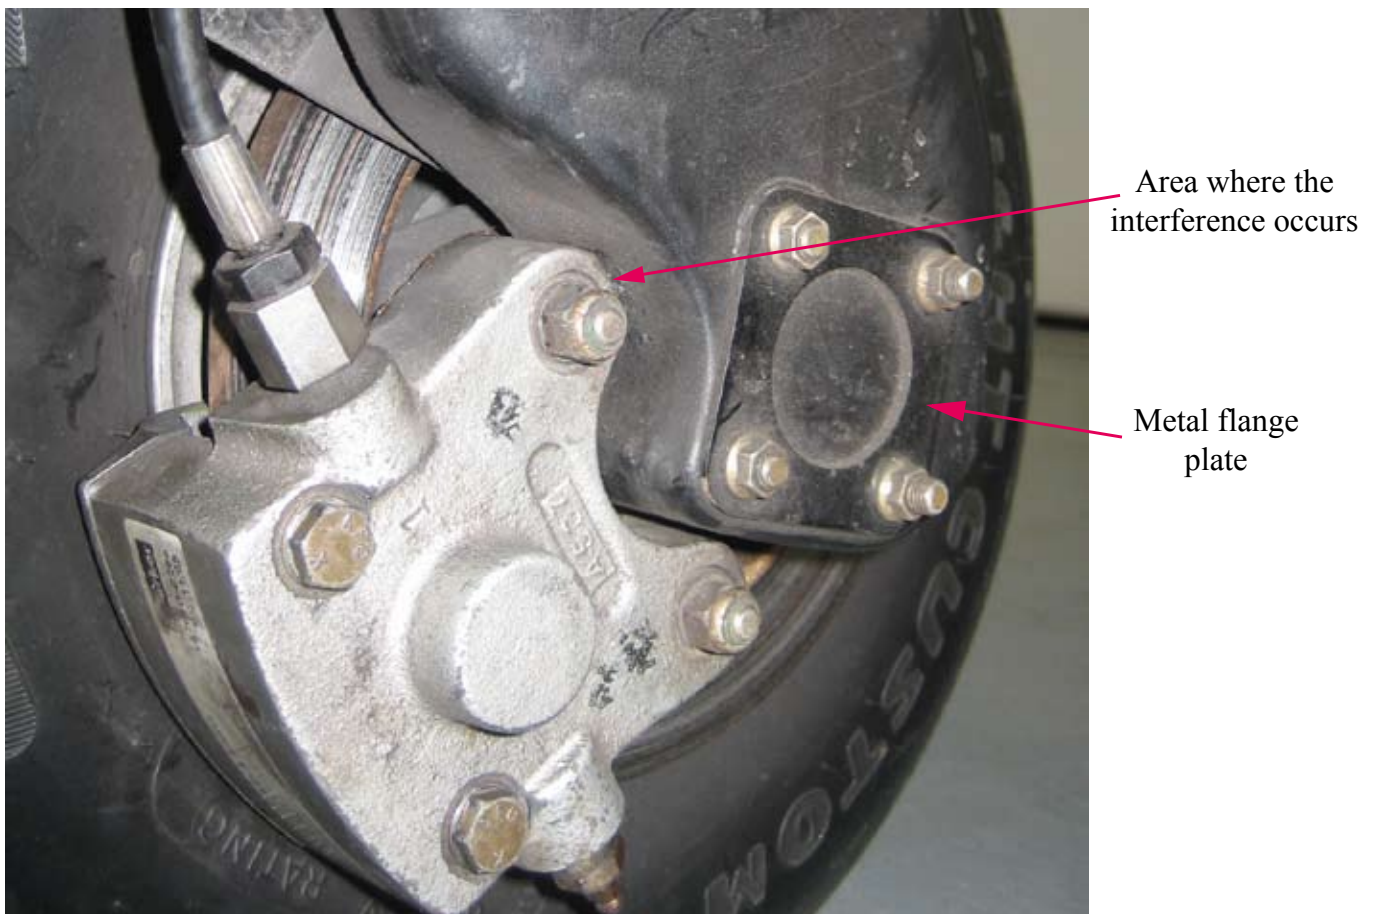
**Figure 2**

Interference between the brake calliper and the 'redesigned' landing gear leg

It is recommended that the Luftfahrt-Bundesamt (LBA) review the continued airworthiness of the main landing gear fitted to Extra EA 300 aircraft to ensure the integrity of the outer layer of the cotton flock filled composite material.

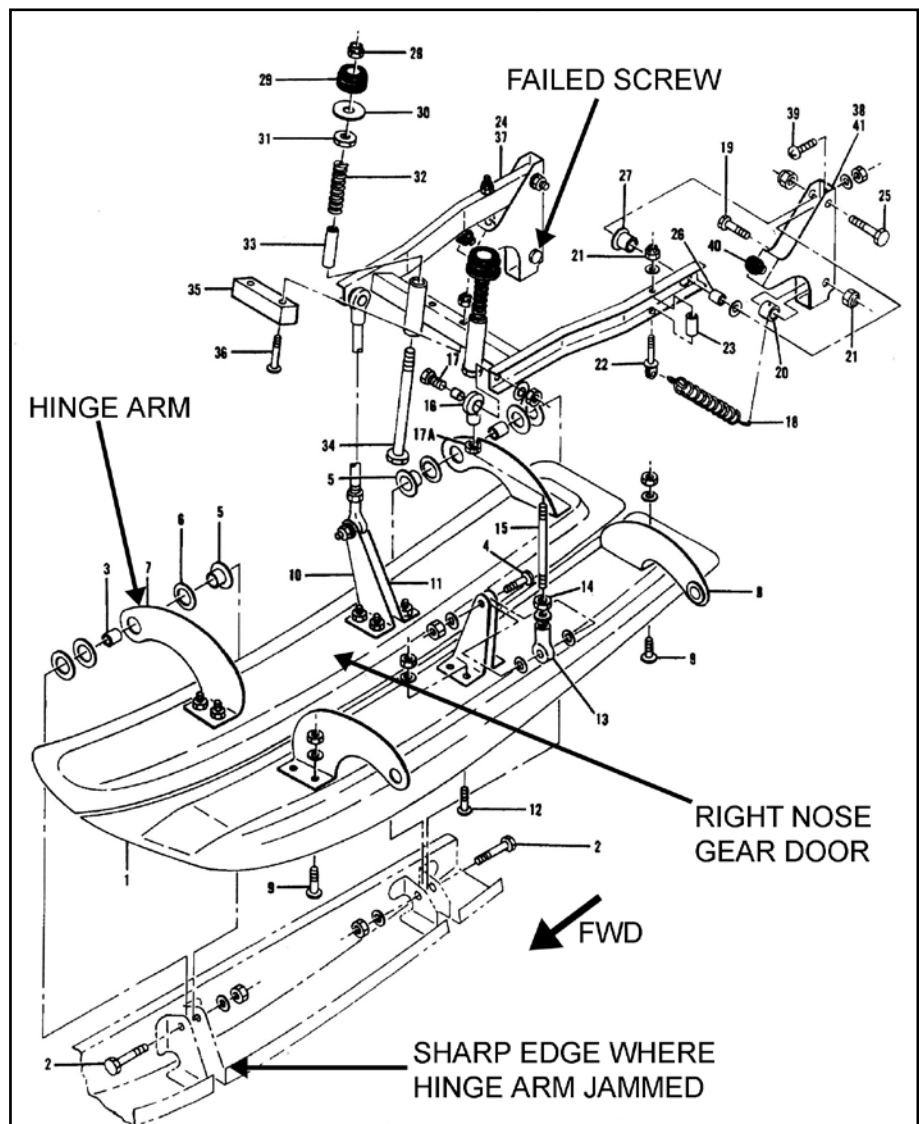
**Figure 1**

(see Figure 1). This would have caused the engine cowling to drop slightly and to move the right nose gear door. The door hinge operates in a narrow slot with sharp edges (see Figure 1) and a slight movement of the door could cause it to jam at the hinge. The engineer could not determine what had caused the screw to fail, but said that it was also possible that the screw had failed as a consequence of the door not opening, and the force of the nose gear actuator sheared the screw.

Nose gear door installation on G-BLTK

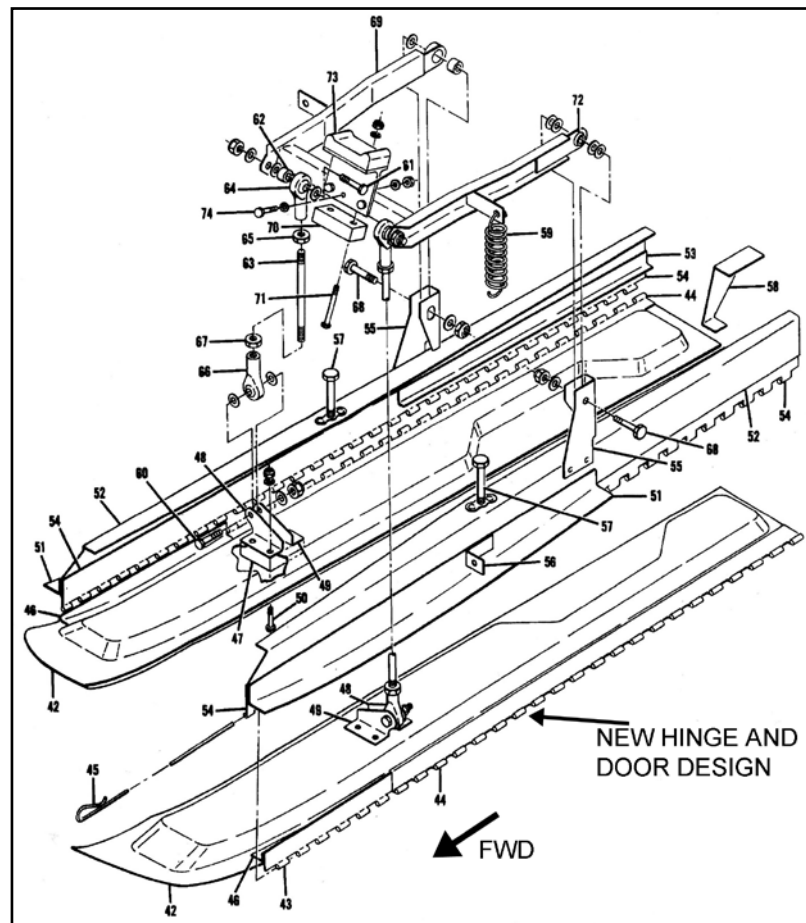
**Figure 2**

Later models of the Rockwell Commander 112 were fitted with nose gear doors that had a ‘piano-wire’ hinge (see Figure 2). This type of hinge would not have jammed in the same manner as the original design.

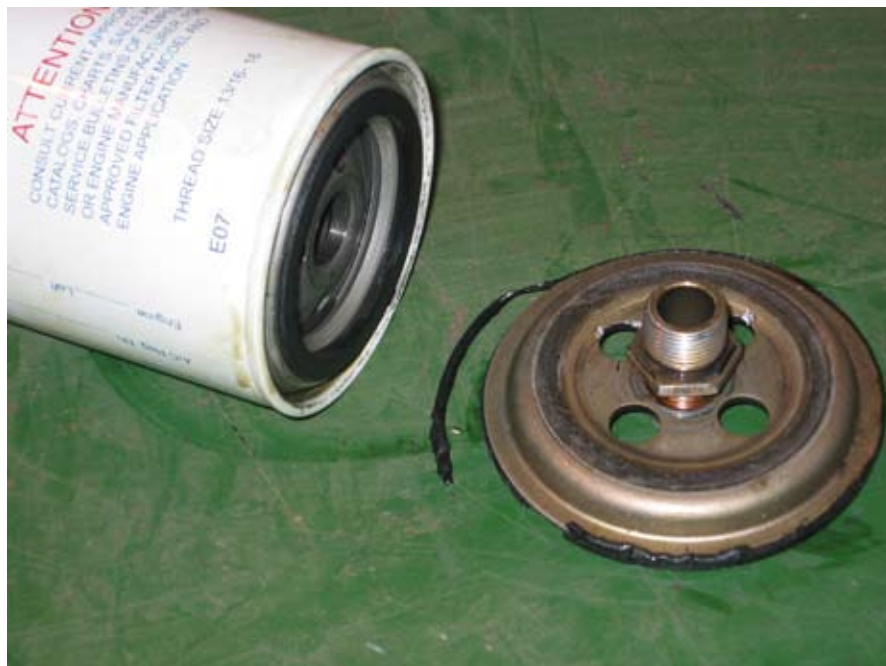
**Figure 2**

View of filter and converter plate, showing damaged gasket

The available evidence strongly indicated that the engine failed as a result of a complete loss of oil following the failure of the gasket on the oil filter converter plate. Loss of oil was consistent with the reported symptom
