AAIB
Air Accidents Investigation Branch

AAIB Bulletin

12/2014

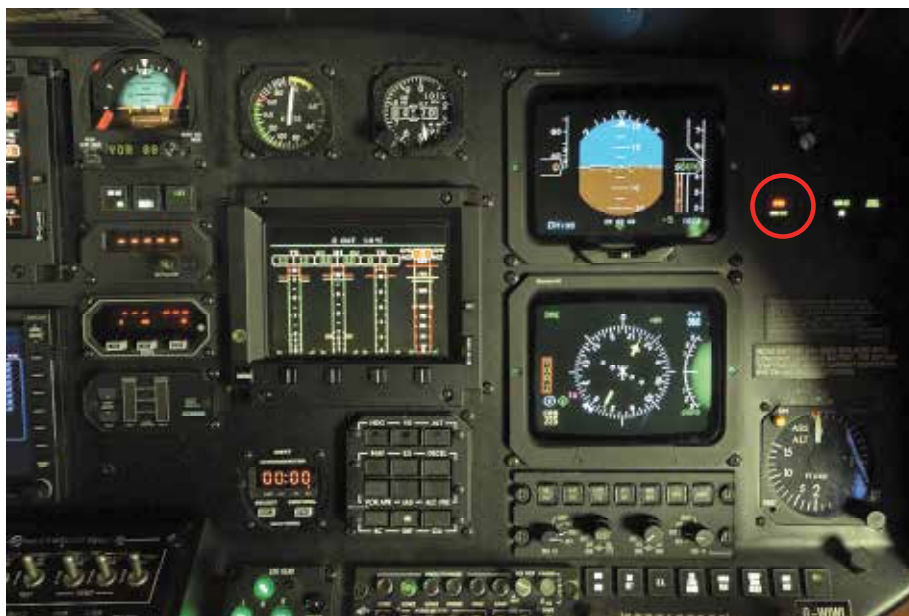
Figure 4

The right hand instrument panel in G-WIWI showing the 'GPWS visual alert' (amber, right of the EADI - circled red)

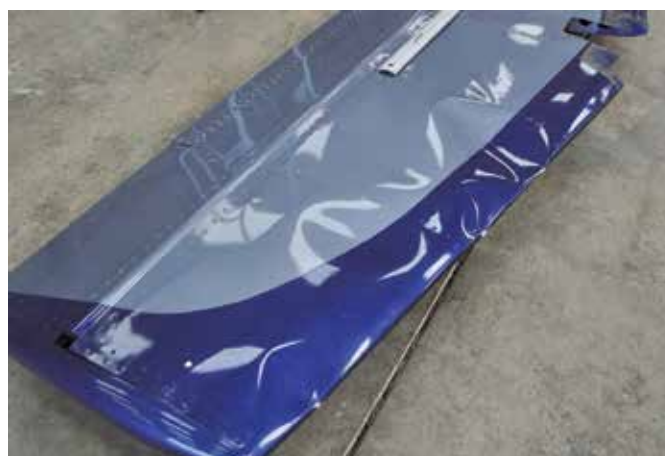
Figure 1

He was given directions to join directly downwind for Runway 26; the wind was less than 5 kt and virtually straight down the runway. A normal approach and landing followed and the pilot was able to taxi to his normal parking spot, disembark and inspect the damage to the aircraft. He found, in addition to the broken canopy, that the tailplane was severely buckled with ruptures on both sides and with consequent damage to the elevator. It was evident that the tailplane had been very close to complete failure (Figure 1).

Right side tailplane from G-MELL, showing severe buckling damage. Left side similar.
(Photo courtesy LAA)

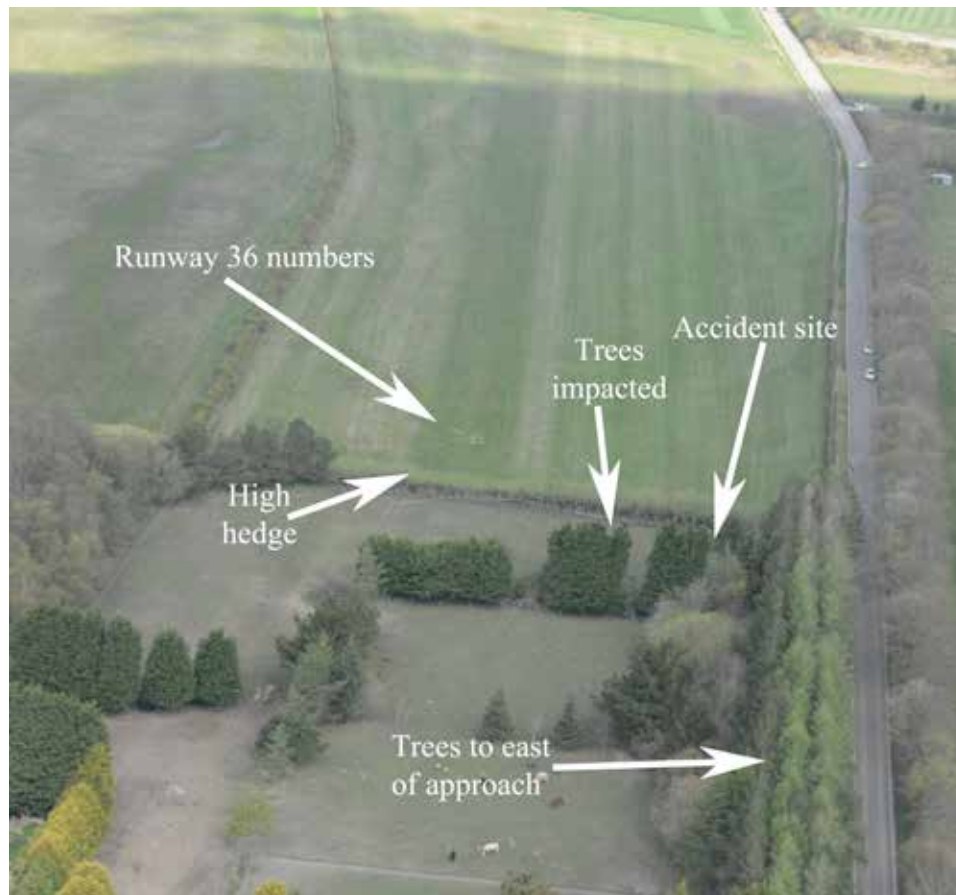
Figure 1

as indicated on Figure 1. Parallel to the approach track there were lines of taller trees along both sides of a road which ran south from the eastern airfield perimeter.

View of the approach to Runway 36
(photograph courtesy of the National Police Air Service, taken on 18 April 2014)

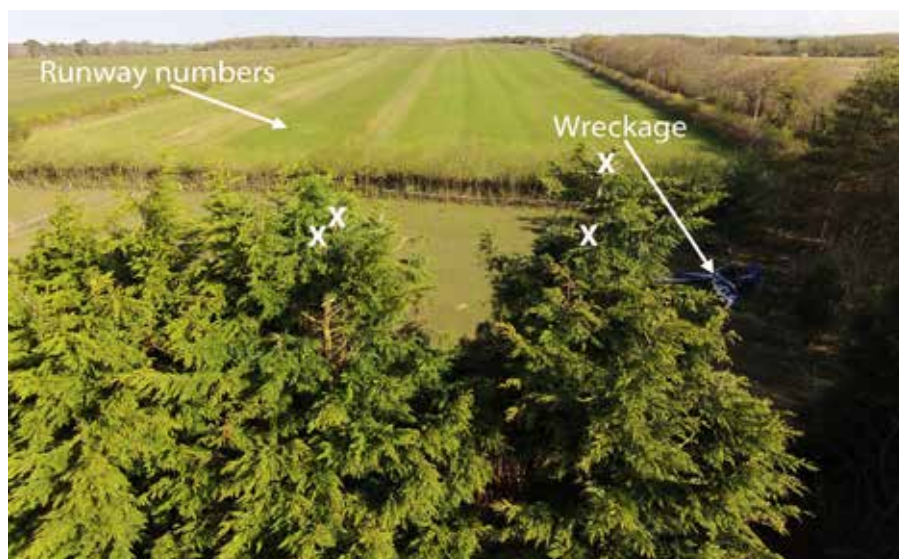
Figure 6

Examination of the accident site revealed that the aircraft had struck the tops of two trees 15 m high (Figure 6), and then descended steeply. It hit the ground in a steep left bank and then bounced about 7 m before coming to rest. Figure 7 shows the trike on its left side and the wing upside down. The left main landing gear leg had failed in compression and the left wing structure had crumpled in the impact. Two of the propeller blades had separated at the root and the remaining attached blade had suffered tip damage. One of the detached blades was found next to the main wreckage; the other blade was not found. Two pieces of propeller blade tip, identified as being from the two detached blades, were recovered from the opposite (southern) side of the trees. A piece of plastic cable end shroud was found midway between the trees and the main wreckage.

Accident site – the white Xs highlight some of the tree strike marks

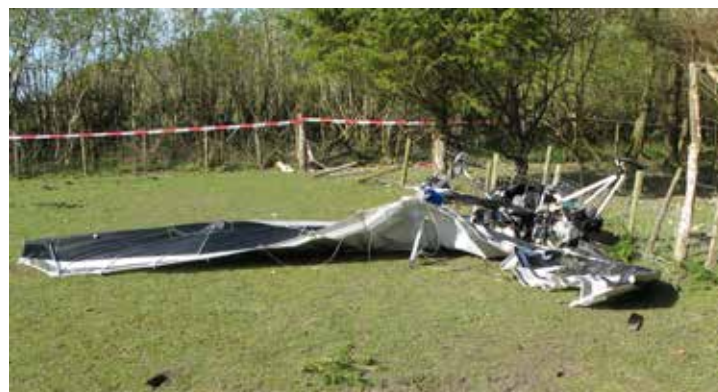
Figure 7

Main wreckage (wing upside down)

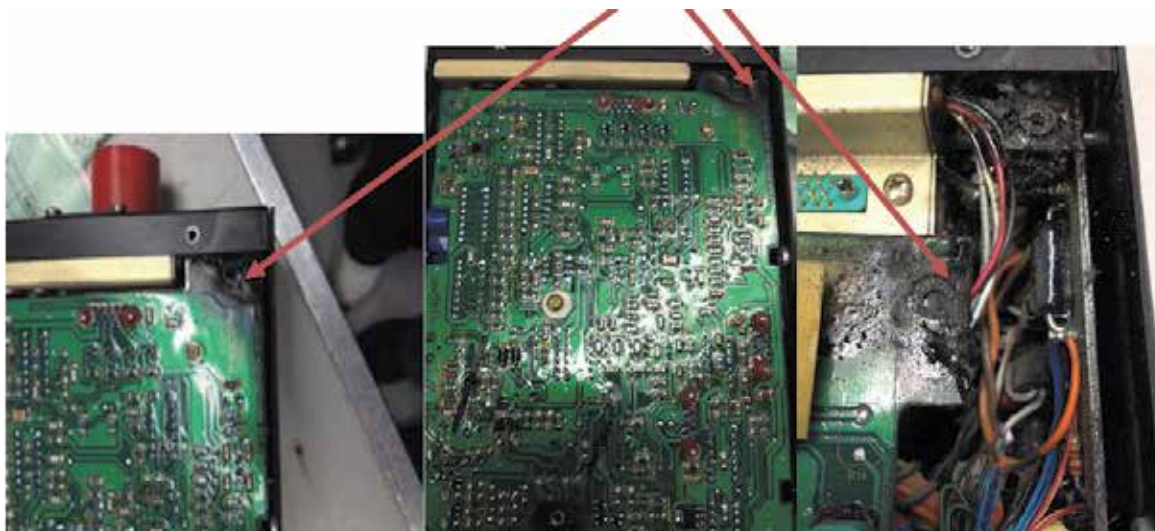
Figure 1

Further investigation by technicians found that a static inverter, part number 1-002-0102-1830/2A350-1AS-1830, located in the avionics bay, had signs of severe overheating (Figure 1). It was replaced and, after further testing, the aircraft returned to service. The function of the inverter is to supply 115VAC and 60 Hz power to a utility socket in the cockpit so that domestic equipment, such as computer laptops and tablets, can be plugged in. It does not form part of the racked avionics but is a stand-alone unit mounted below the co-pilot's footwell floor to the right of the centre console. The floor is not sealed to prevent fumes from the avionics bay entering the cockpit. The inverter was standard equipment on aircraft manufactured after serial number 2700.

Burn marks on the PCB of the static inverter

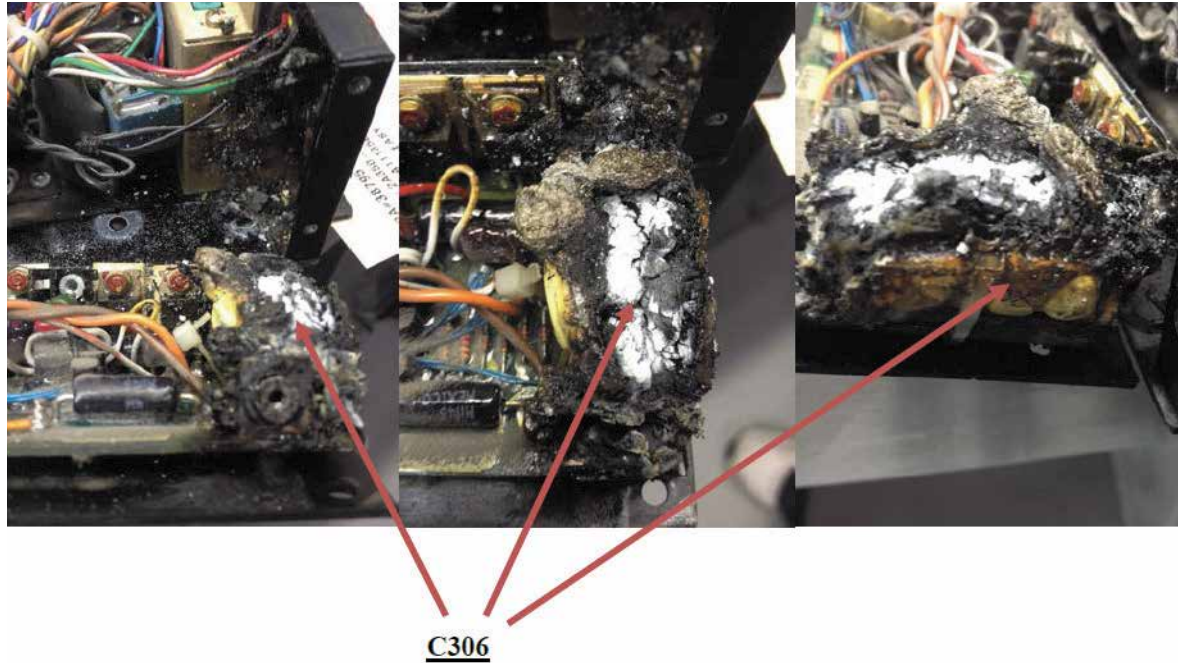
The inverter was returned to its manufacturer for examination. They reported that the damage centred on a capacitor, C306, which had been destroyed by overheating (Figure 2). The damage precluded establishing the precise reason for its failure, although tests on

Figure 2
Overheated capacitor C306

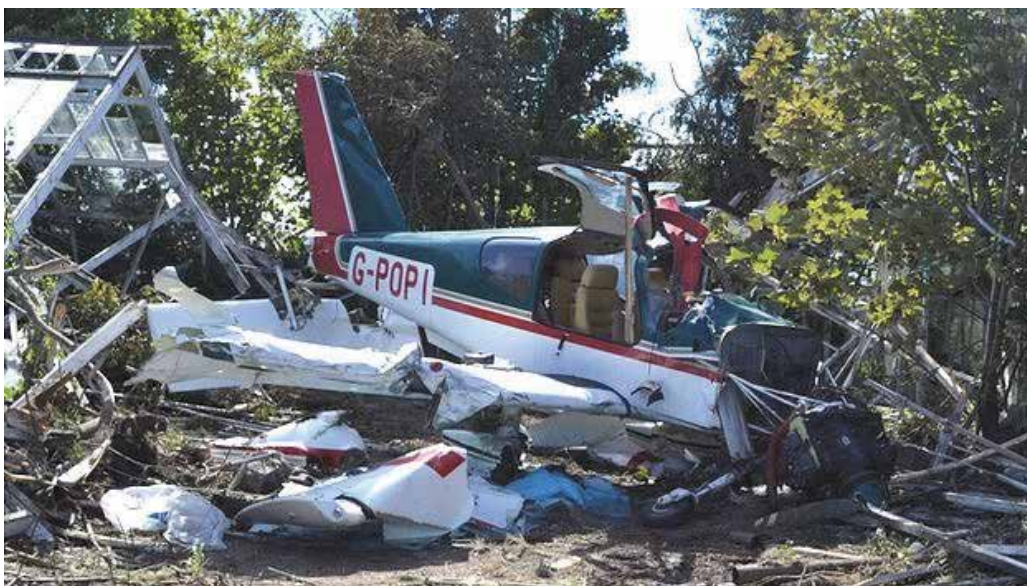
Figure 1

G-POPI after being laid on the ground and foliage cleared to assist recovery.
Note remains of the disused greenhouse to the left

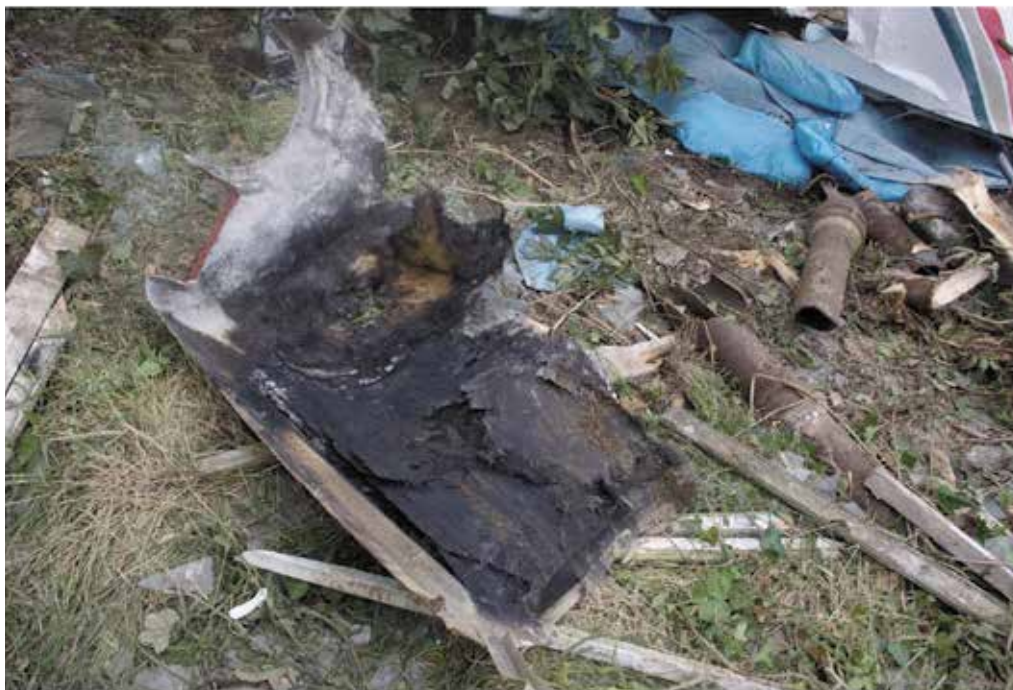
Figure 2

A local maintenance organisation examined the aircraft and prepared a report, which was made available to the AAIB. It identified an area of severe burning on the lower left side of the glass-fibre engine cowl (Figure 2) and scorching of the metal forward fuselage structure. The left side of the engine firewall was also scorched and, whilst the firewall itself had remained intact, a seal around the nosewheel steering linkage where it passed through it had been badly heat-affected and had probably allowed the smoke to enter the cabin.

Lower left side of engine cowl showing burning of glass-fibre construction

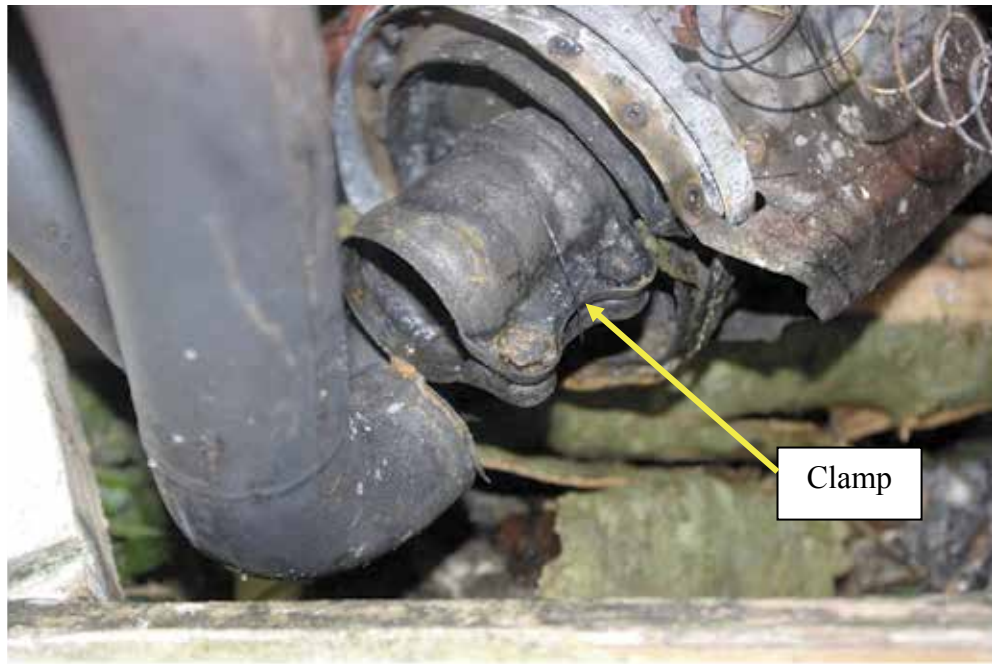
Figure 3

The No 4 engine cylinder exhaust downpipe had fractured at the clamp where it joins the exhaust muffler (Figure 3). Since the other end of the pipe allows movement should this occur, the end of the pipe was free to move away from its normal position and allowed hot exhaust gasses to flow unrestricted into the cowl.

The exhaust system and muffler are visually inspected every 50 flying hours or 6 months according to the Light Aircraft Maintenance Programme (LAMP). The condition of the fracture suggests that it had started as a crack which developed over a considerable period of time, but its location, effectively inside the clamp, would render it very difficult to see without dismantling the joint.

Fracture of No 4 cylinder exhaust downpipe where it attaches to exhaust muffler
