## FLYER TO TUG OPERATORS AND PORTS INDUSTRY

### Fatal Accident - the risks associated with the combined push/pull towage configuration

**Marine Accident Investigation Branch**  
**23 May 2012**

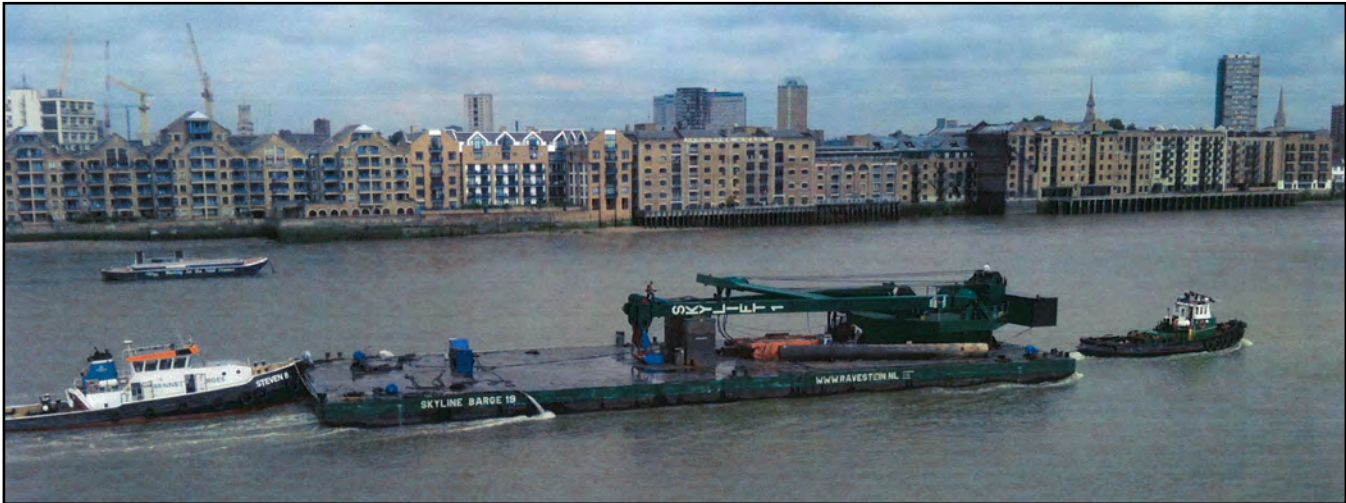
On 12 August 2011, the tugs *Steven B* and *Chiefton* were connected to a 60m crane barge in a combined push/pull configuration. *Steven B* was secured aft with a combination of wires and ropes, making the tug and barge a composite unit. The distance between *Chiefton*, which was pulling, and the barge was 8.4 metres. There were two pilots positioned on the crane as the tow was navigated from St George Wharf towards Gravesend on the River Thames.

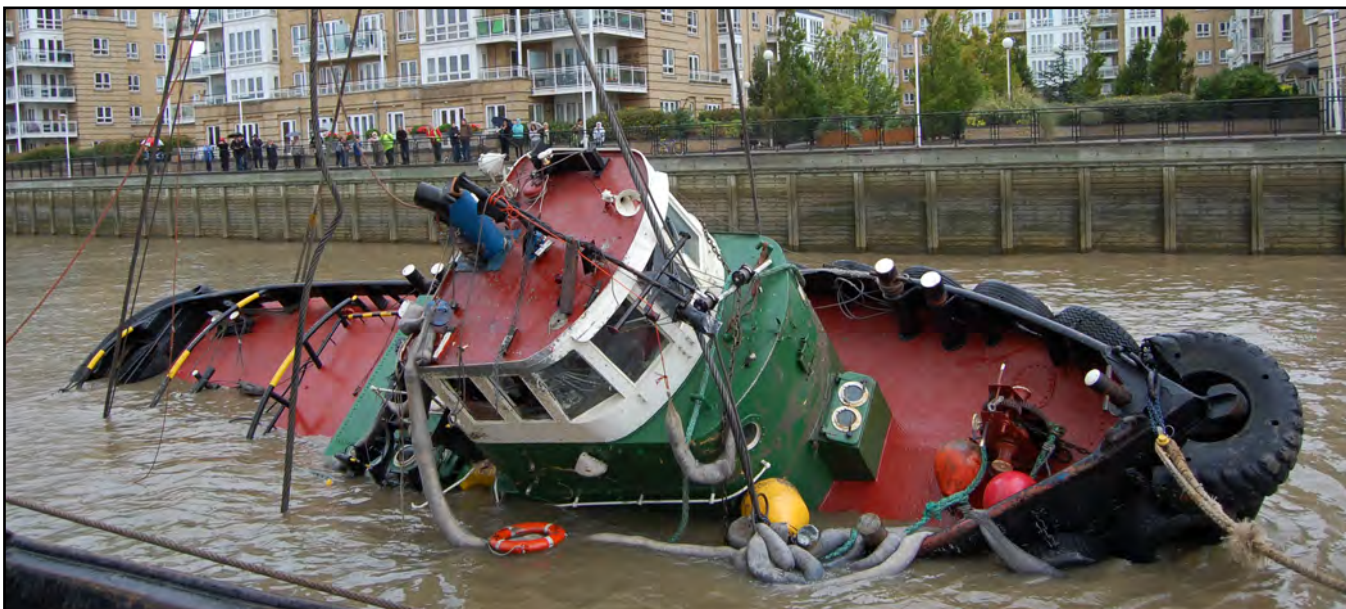
*Chiefton's* and *Steven B's* engine powers were set at 95% and 70-75% respectively as the tow approached the eastern buoys of Greenwich Ship Tier, where it was set to the south by the flooding tidal stream. Port helm was applied by *Chiefton's* skipper in an attempt to prevent the barge making contact with the northernmost buoy. The pilot then instructed him to pull to port and ordered starboard helm on *Steven B* in an unsuccessful attempt to "lift" the barge to port. The barge turned to starboard, hit the buoy and then collided with *Chiefton*, overrunning her and causing her to capsize and founder. The skipper and mate were rescued from the river but the engineer/deckhand, who was a non-swimmer and was not wearing a lifejacket, sadly drowned.

Late and inappropriate action, coupled with *Chiefton's* insufficient reserve of power and short tow ropes, made collision with the barge inevitable. This was largely due to inexperience of the tug configuration used. The following safety lessons should be carefully considered by harbour authorities and tug owners/operators for non-standard towage operations:

3. The risk of the leading tug being overrun, in the push/pull configuration, in the event of propulsion or steering failures needs to be fully assessed. Where appropriate, consideration should be given to lengthening the tow to reduce the risk.

4. The tugs selected need to be fit for the task intended. Bollard pull should be appropriate for the **whole** operation and sufficient to provide a suitable reserve of power for emergency purposes.
