Aircraft Type and Registration:	Airbus A320-231, G-JOEM	
No & Type of Engines:	2 IAE V2500-A1 turbofan engines	
Year of Manufacture:	1993	
Date & Time (UTC):	17 March 2004 at 1540 hrs	
Location:	Birmingham Airport, West Midlands	
Type of Flight:	Public Transport (Passenger)	
Persons on Board:	Crew - 6	Passengers - 168
Injuries:	Crew - None	Passengers - None
Nature of Damage:	Damage to forward left cabin door	
Commander's Licence:	Airline Transport Pilot's Licence	
Commander's Age:	36 years	
Commander's Flying Experience:	7,000 hours (of which 4,400 were on type) Last 90 days - 155 hours Last 28 days - 50 hours	
Information Source:	Aircraft Accident Report Form submitted by the pilot and further enquiries by the AAIB

Aircraft Type and Registration:	Falcon 50, CS-DFI
No & Type of Engines:	3 TFE-731 turbofan engines
Year of Manufacture:	1982
Date & Time (UTC):	16 September 2004 at 1035 hrs
Location:	London City Airport, London
Type of Flight:	Commercial
Persons on Board:	Crew - 2 Passengers - 4
Injuries:	Crew - None Passengers - None
Nature of Damage:	Nil
Commander's Licence:	Airline Transport Pilot's Licence
Commander's Age:	40 years
Commander's Flying Experience:	6,465 hours (of wh

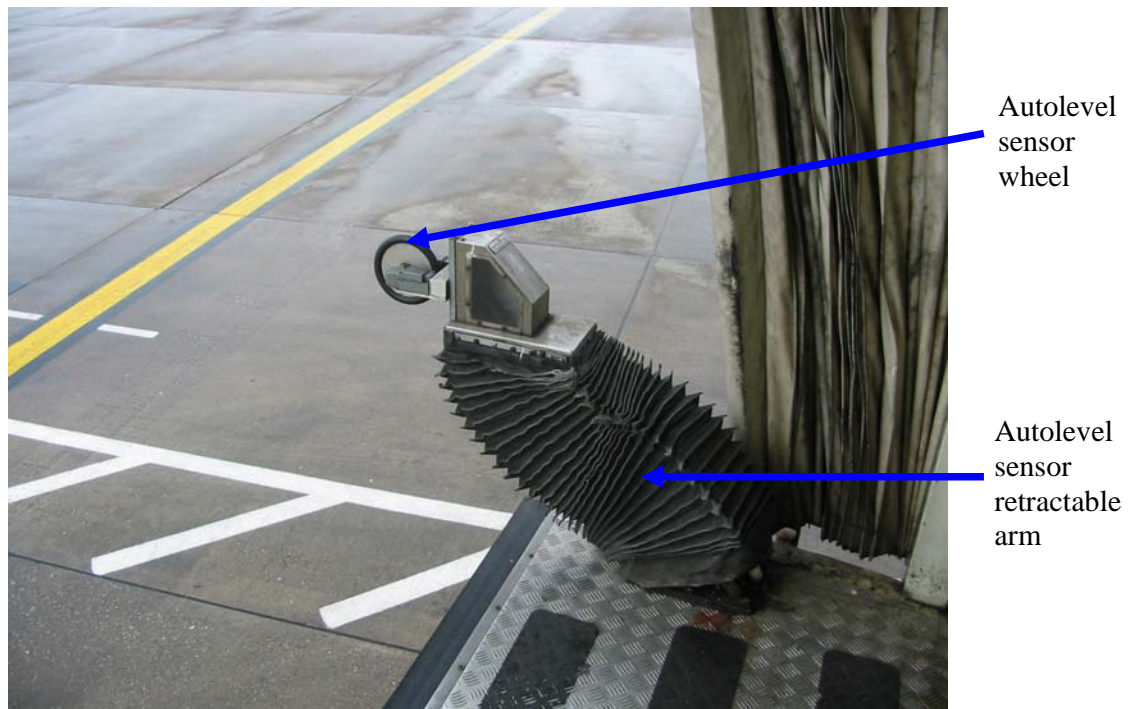
Figure 3

Examination of the autolevel sensor on the airbridge (see Figure 3) showed that the wheel had rotated to its full extent and jammed, indicating that the aircraft had descended relative to the floor of the airbridge. Once the wheel had been freed, the autolevel system was tested and found to operate correctly.

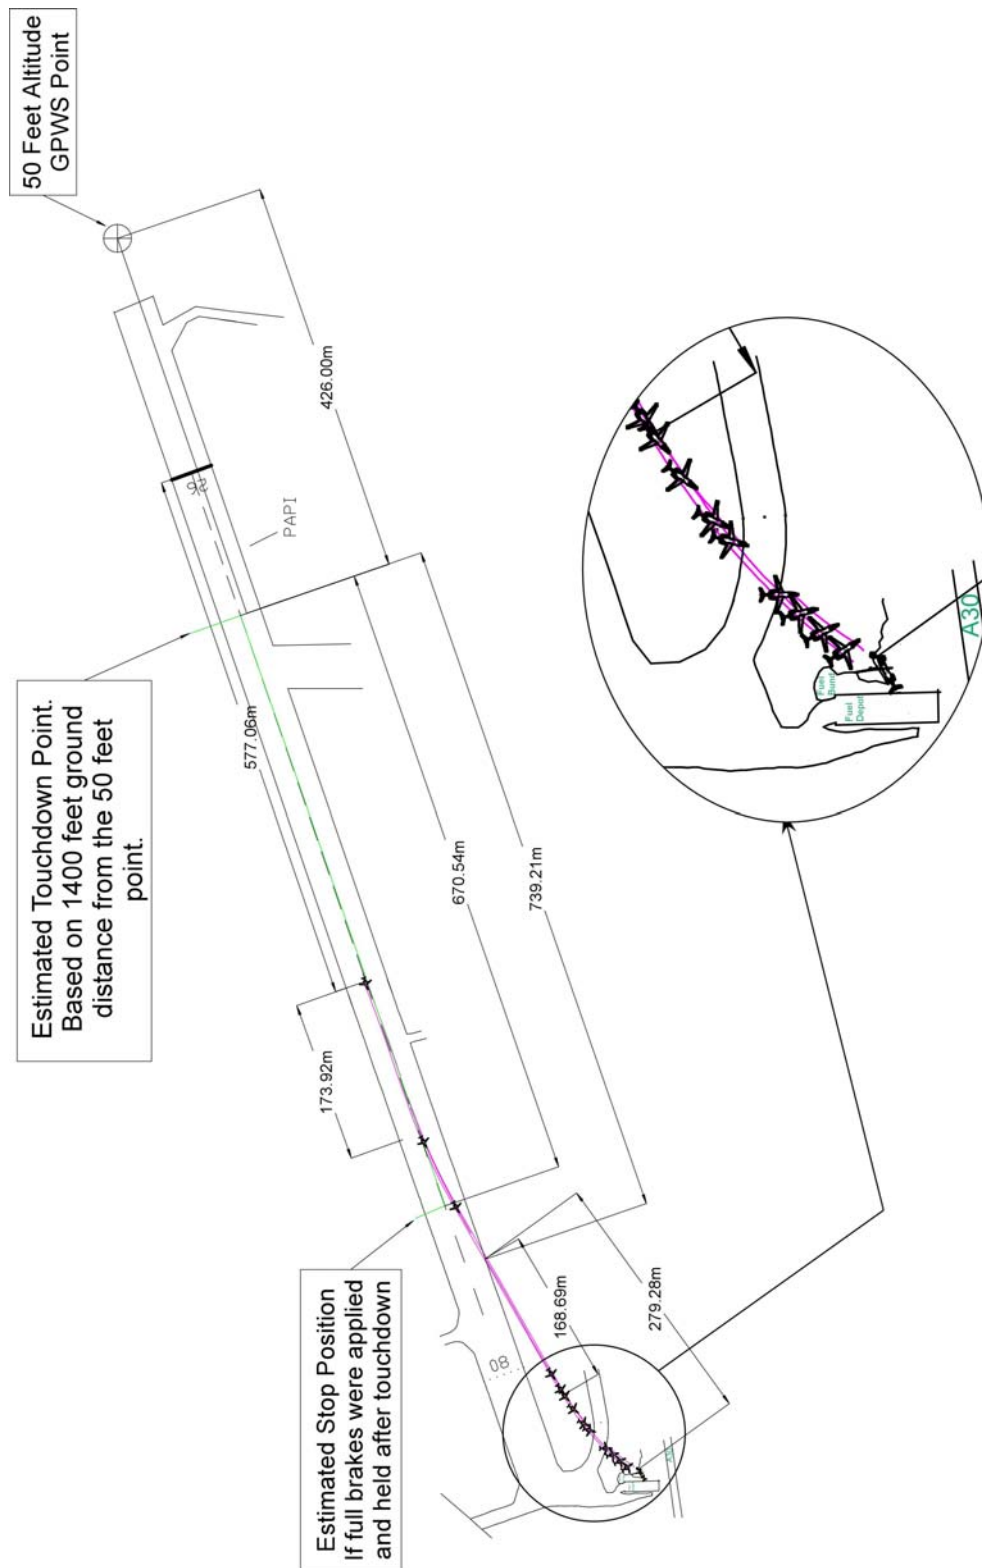
Figure 1 - Accident Sequence

When the wing was abruptly stopped by the fuel bund, the aircraft rolled and pivoted about the tree to the right, in the process detaching the entire wing due to the fracture of the wing to fuselage attaching tie rods. When the aircraft finally came to rest the wing had become airborne and landed on top of the fuselage, just aft of the cockpit area. In the final accident sequence the right main gear had also collapsed and the right engine had detached from its pylon, but was retained to the aircraft by fuel and control lines.

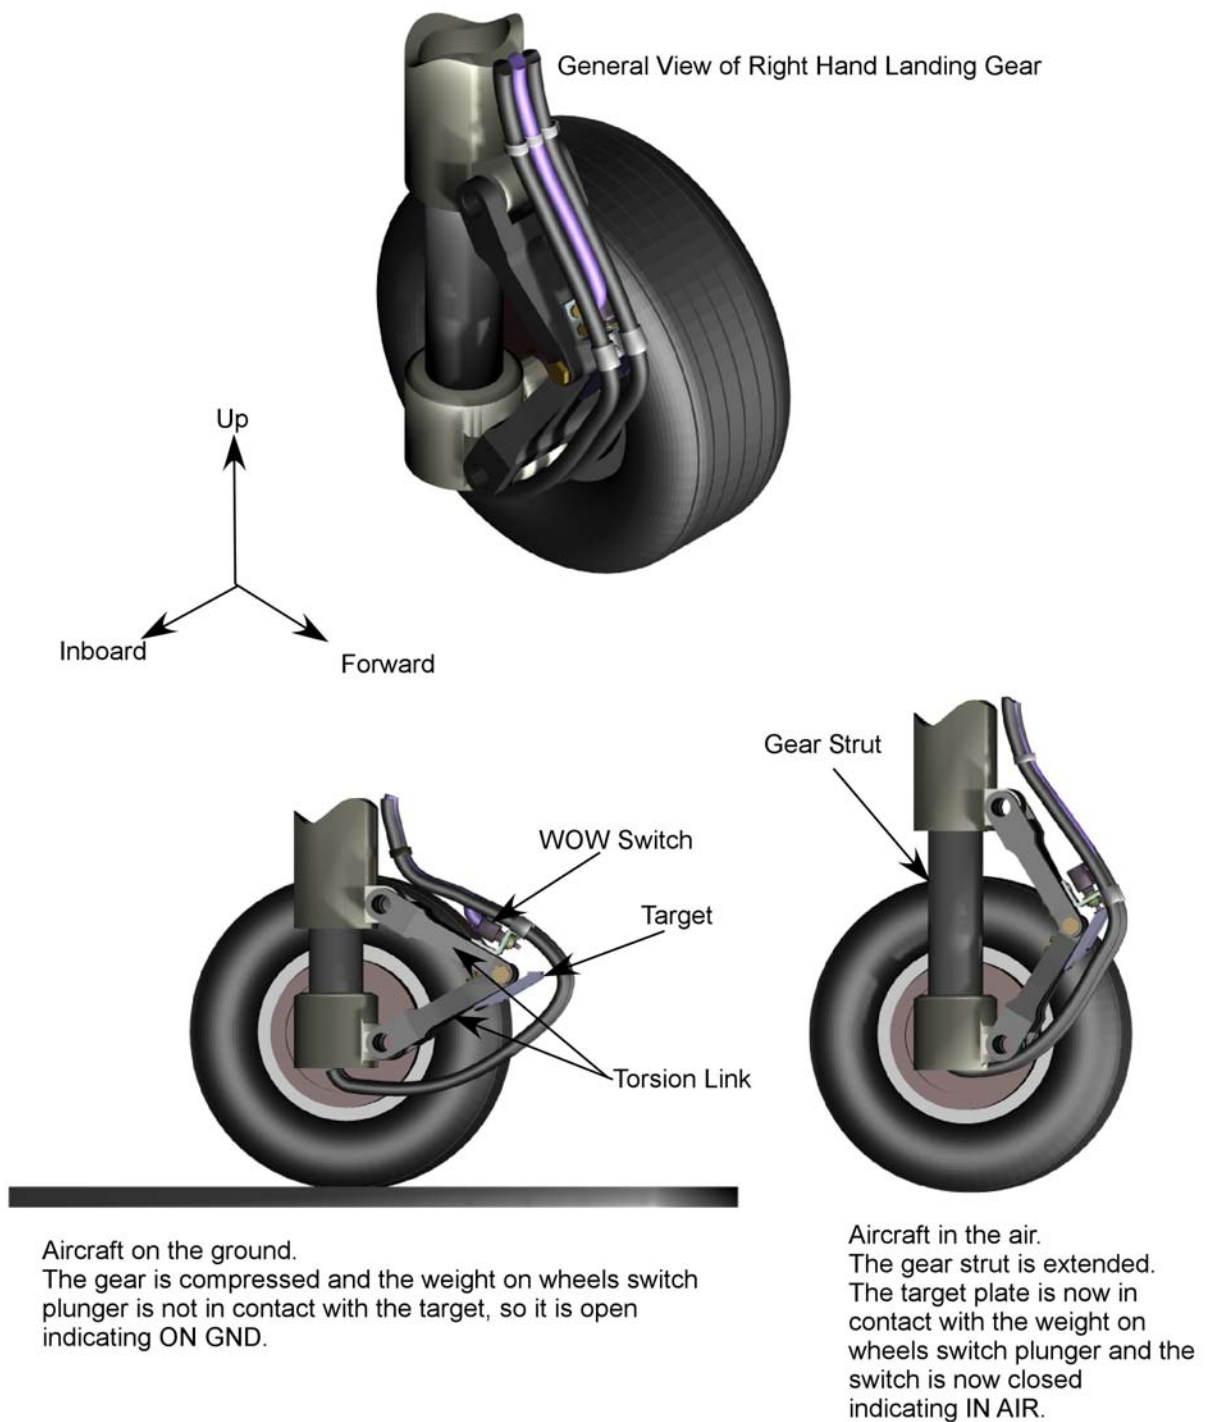
Figure 2 – WOW Switch installation.

Because the pilot had reported that he had been unable to retract the main landing gear the WOW switches were examined in detail. Checks of the electrical operation and the rigging of the switches found them to be correct. However, the right main landing gear WOW support bracket was found fractured and the fracture surface was not as expected for an overload failure associated with impact forces. The fracture was perpendicular to the landing gear torsion link it was fitted to, and ran across the bracket from a hole used to retain the tang of a washer (see Figure 4). The bracket was sent for metallurgic examination, along with the intact support bracket for the left gear WOW switch.

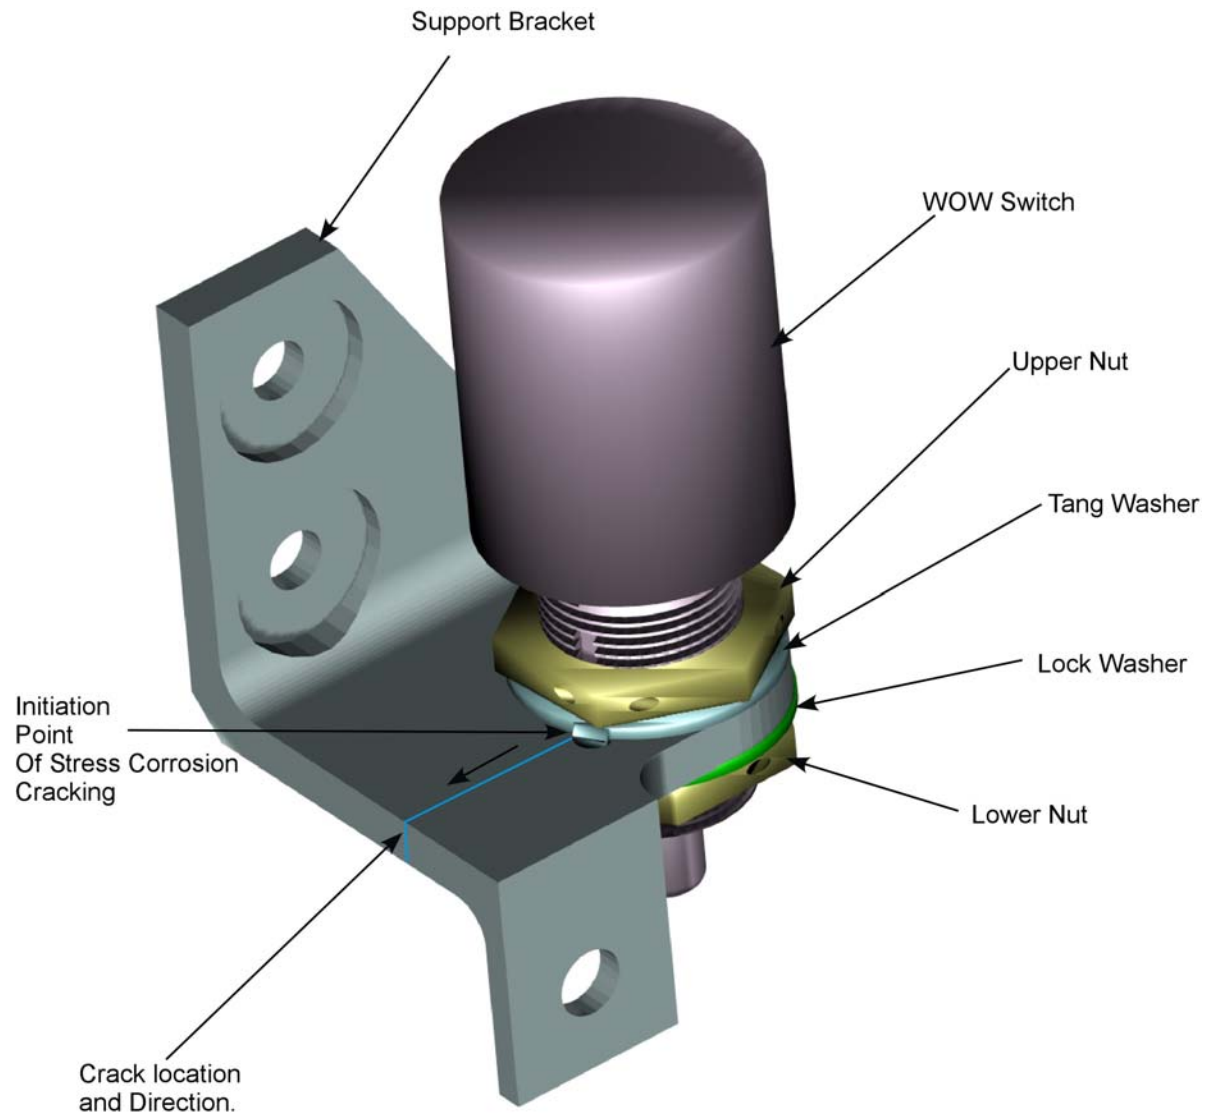
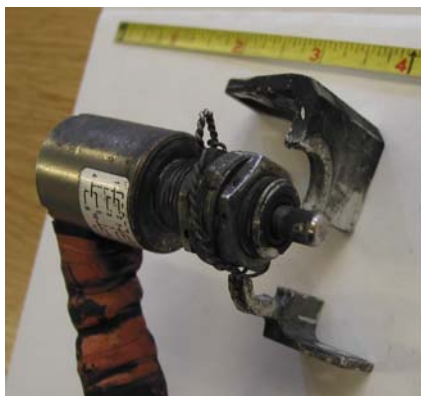
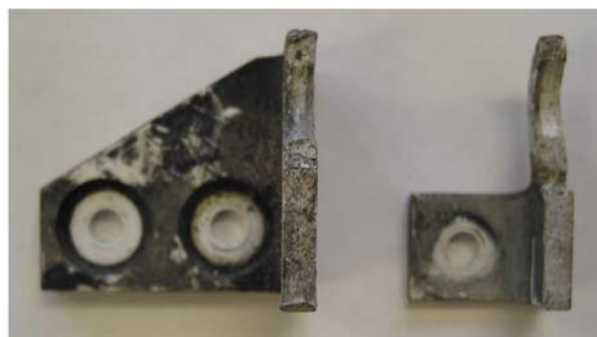
Figure 4 – WOW switch bracket.

The metallurgic examination revealed that the right WOW support bracket had cracked due to stress corrosion which had initiated at the tang washer outer tang support hole (see Figure 4). Localised galvanic corrosion had been set up at the outer tang support hole due to the presence of the dissimilar metals of the aluminium support bracket and the steel tang washer, and brought about by contact with an electrically conductive liquid such as rain water. The stress part of the mechanism was due to the tang washer having been rotated in relation to the WOW switch, causing the inner tang of the washer to become jammed in the threads of the WOW switch. This caused the outer tang of the washer to be forced against the edge of the outer tang support hole, causing the edge of the outer tang to penetrate the paint protection and apply a tensile stress on the bracket. In addition, corrosion was also discovered on the underside of the bracket where the teeth of the steel lock washer had 'bitten' through the paint and into the aluminium of the bracket; this had also set up galvanic corrosion.

The installation of the SB was carried out based on kit drawings. These detailed the installation of the WOW switches and the LIFT DUMP handle. The WOW switch installation however omitted to provide details on the build up of the switch mounting hardware and as such omitted to show the location of the lock washer or tab washer. The WOW switches on N200PR had been installed with the tab washer between the upper nut and the bracket, and the lock washer between the lower nut and the bracket, which had led to damage of the support bracket. (See Figure 4.)

Tests later revealed the right WOW switch was electrically functioning correctly, placing suspicion on its fitting to the right main landing gear leg. Inspection of the switch installation had revealed that the support bracket for the WOW switch had fractured due to stress corrosion cracking. For the switch to indicate IN AIR, the target must compress the switch plunger. The progressive fracture of the bracket would have allowed flexure of the bracket. When the target, at takeoff, contacted the switch plunger the load imparted by the target transferred through the switch and to the bracket. But, instead of the bracket reacting these loads and operating the plunger the flexure allowed the switch to move upward, thus preventing operation of the microswitches. This would have led to a constant ON GND indication to the systems served by the right WOW switch.

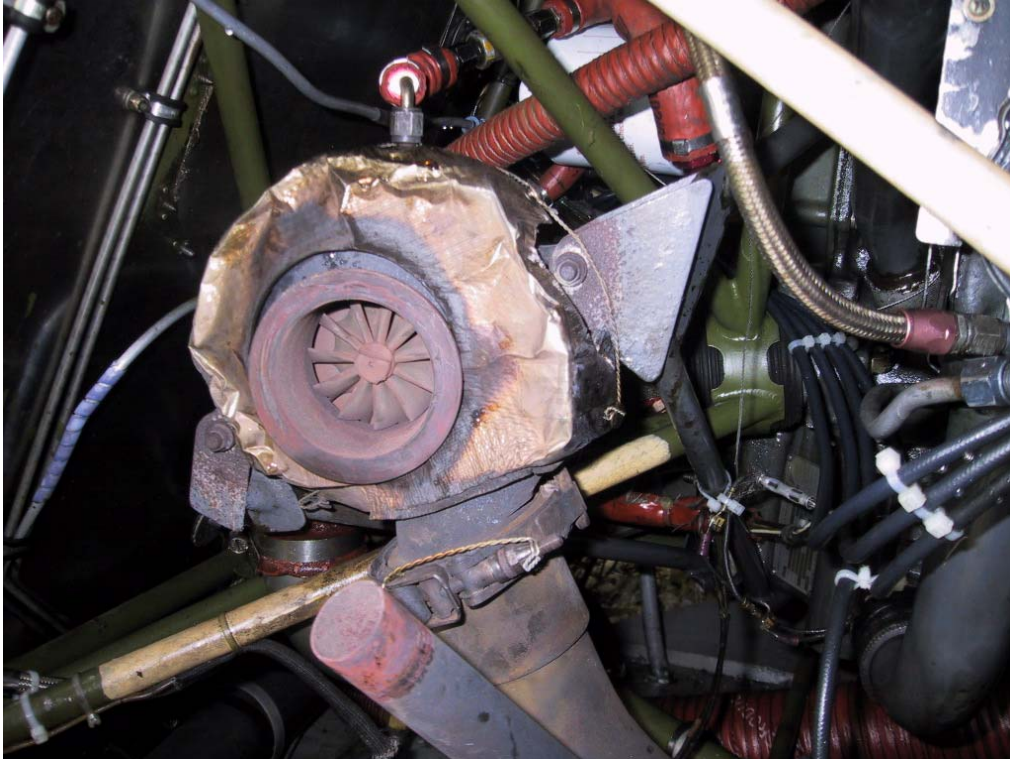
Figure 1

Turbocharger outlet and disconnected bypass pipe
(To the left is the bulkhead behind the left seat)

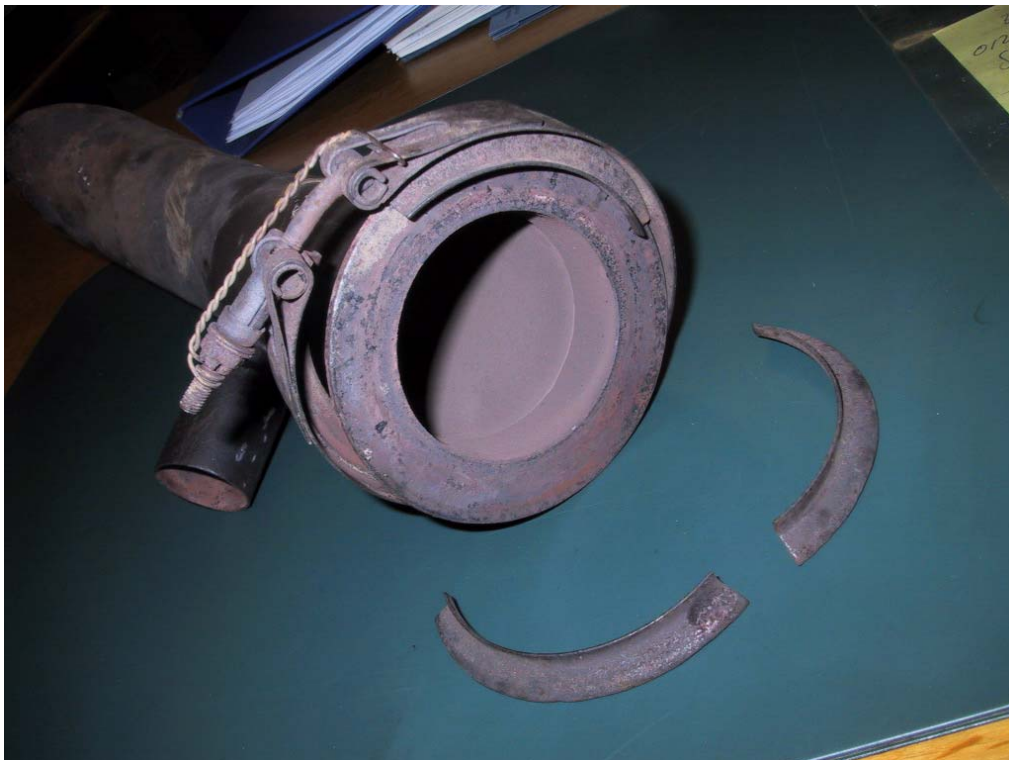
Figure 2

The manufacturer's agent advised that fractures of this type of clamp are rare, and that in this particular case the clamp appeared to be quite old. There is, however, no requirement to change it if it appears serviceable.

Fractured clamp and detached exhaust outlet pipe

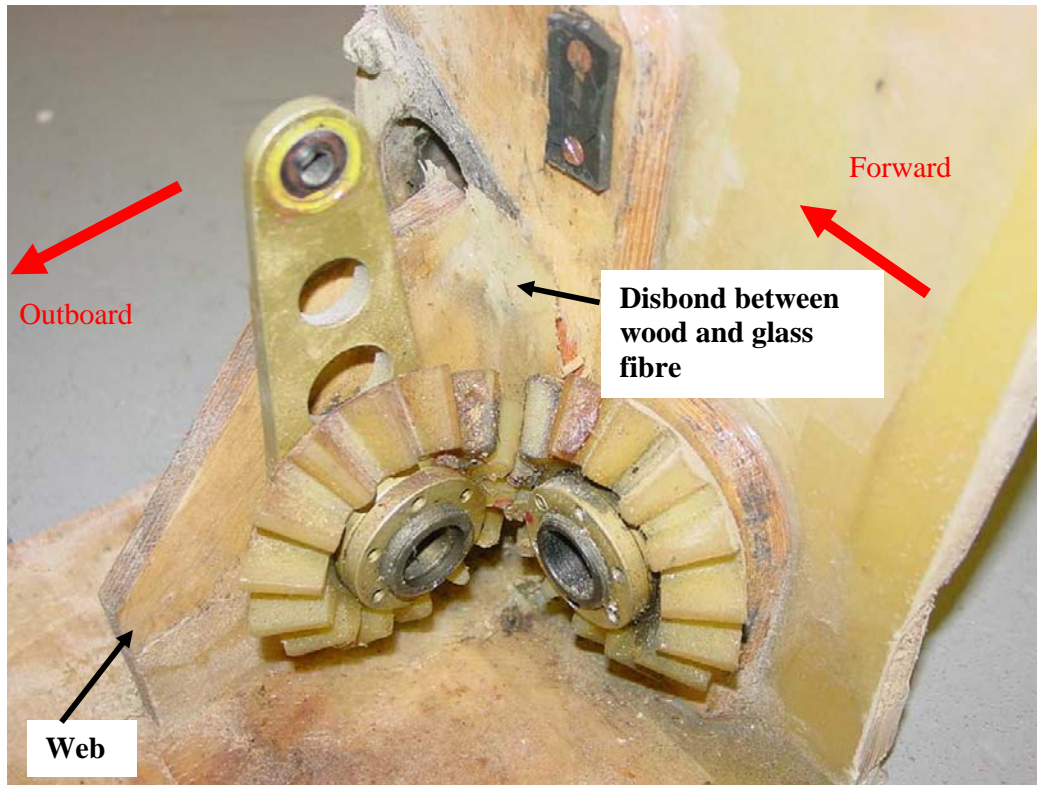
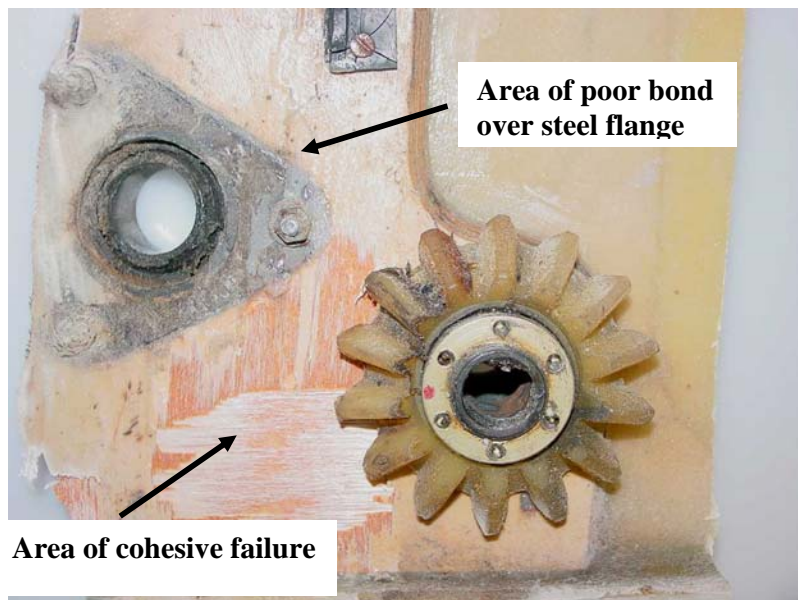
Figure 1. Details of the left hand airbrake bevel gear assembly, after being cut out of the aircraft

It is recommended that the British Gliding Association require regular inspections to be conducted on the left wing bevel gear support structure associated with the airbrake actuation system of the SZD Puchacz glider, paying particular attention to the bond between the gear support web and the inner face of the wing root rib.
