<b>Summary of:</b>	<b>Aircraft Accident Report No: 3/2007</b>	140
	Report on the accident to Piper PA-23-250 Aztec, N444DA 1 nm north of South Caicos Airport, Turks and Caicos Islands, Caribbean on 26 December 2005

<b>Aircraft Type and Registration:</b>	Airbus A320-232, G-MIDW	
<b>No &amp; Type of Engines:</b>	2 International Aero Engines V2527-A5 turbofan engines	
<b>Year of Manufacture:</b>	2000	
<b>Date &amp; Time (UTC):</b>	8 October 2006 at 0340 hrs	
<b>Location:</b>	En-route Kos to Glasgow International Airport	
<b>Type of Flight:</b>	Commercial Air Transport	
<b>Persons on Board:</b>	Crew - 6	Passengers - 156
<b>Injuries:</b>	Crew - None	Passengers - None
<b>Nature of Damage:</b>	None	
<b>Commander's Licence:</b>	Airline Transport Pilot's Licence	
<b>Commander's Age:</b>	47 years	
<b>Commander's Flying Experience:</b>	10, 600 hours (hours on type - unknown) Last 90 days - 260 hours Last 28 days - 70 hours	
<b>Information Source:</b>	Aircraft Accident Report Form submitted by the airline's flight safety department and additional inquiries by the AAIB

<b>Aircraft Type and Registration:</b>	Airbus A340-642, G-VSHY
<b>No &amp; Type of Engines:</b>	4 Rolls-Royce Trent 556-61 tu

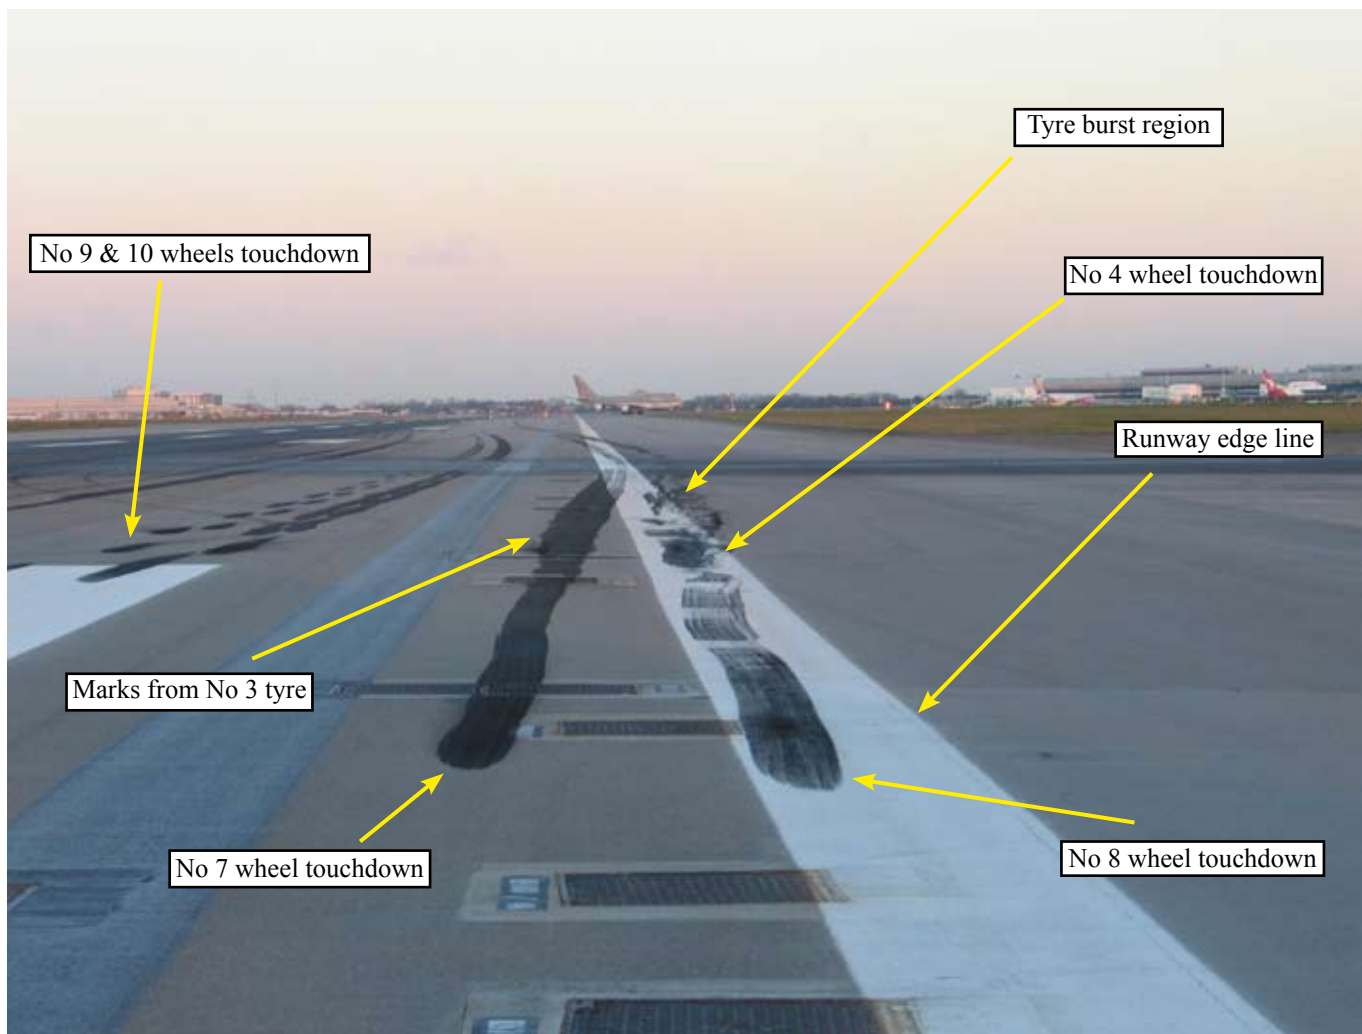
**Figure 3**

A gouge was present in the runway surface in the area where the two tyres had burst, most likely caused by the No 4 outer wheel rim contacting the ground. Whilst the fore and aft wheels on each bogey are in-line with the longitudinal axis of the aircraft, the marks on the runway made by the No 3 and 7 main gear tyres were consistent with the aircraft's heading being to the left of its track, ie, skidding to the right. Approximately 40 m after the start of the right main gear wheel tracks, wheel Nos 4 and 8 crossed over the runway right edge on to the hard shoulder for a short distance, after which the tyre tracks from all the main gear wheels indicated that the aircraft had tracked towards the runway centreline.

Marks made by the tyres from the right and centre main landing gear

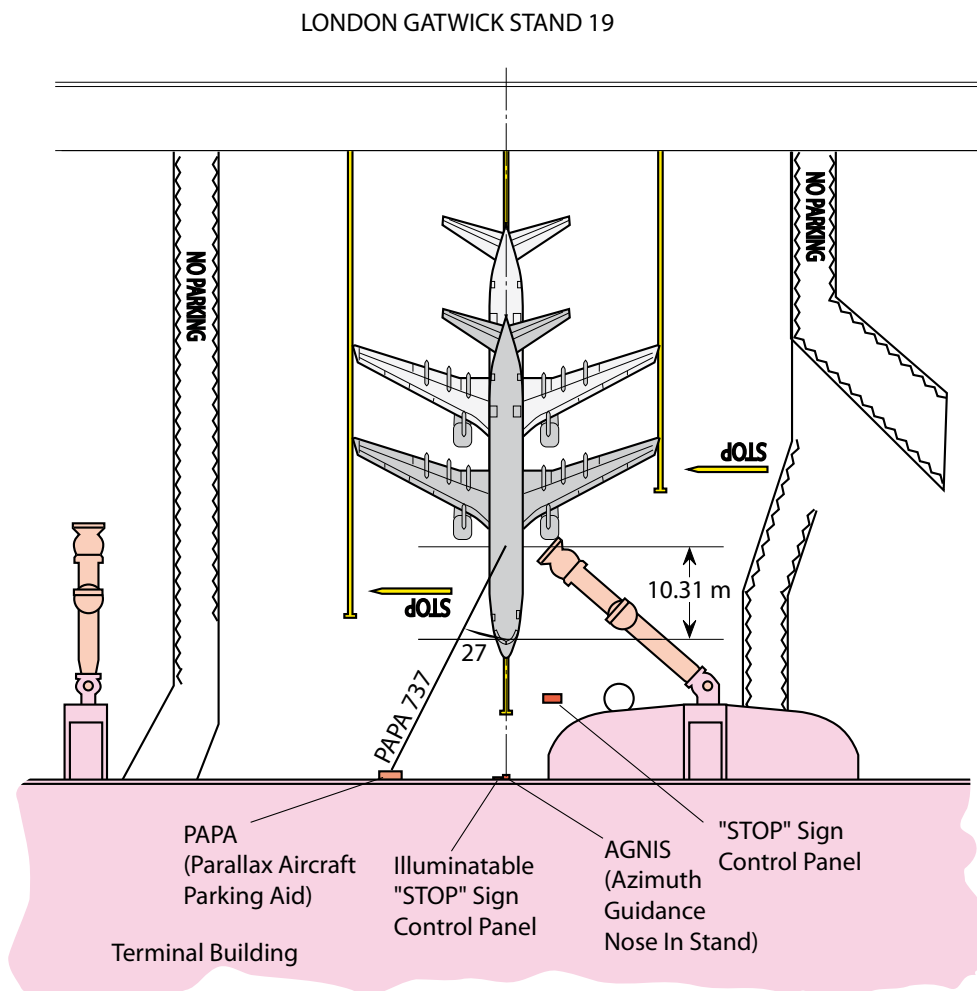
Layout of Stand 19, illustrating normal stopping position and stopped position of 7T-VJT

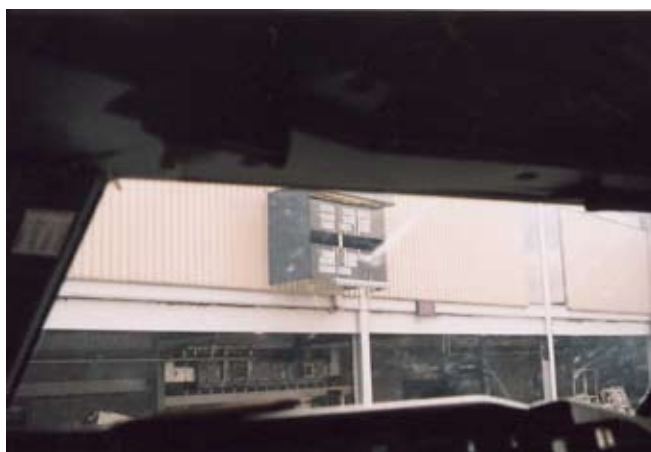
**Figure 3**

On Stand 19, the PAPA, Figure 2, was installed approximately 13 m to the right of the stand centreline but designed for use from the left pilot position. Consequently, it was necessary for the commander to look across the cockpit in order to view it as shown in Figure 3.

Stand 19 PAPA viewed from commander's seat<sup>4</sup>

The PAPA for Stand 19 was serviceable and would have provided correct stopping guidance to the commander of the aircraft whilst tracking the stand centreline. The commander reported after the incident that, because of its location, it was not apparent that this PAPA referred to Stand 19.

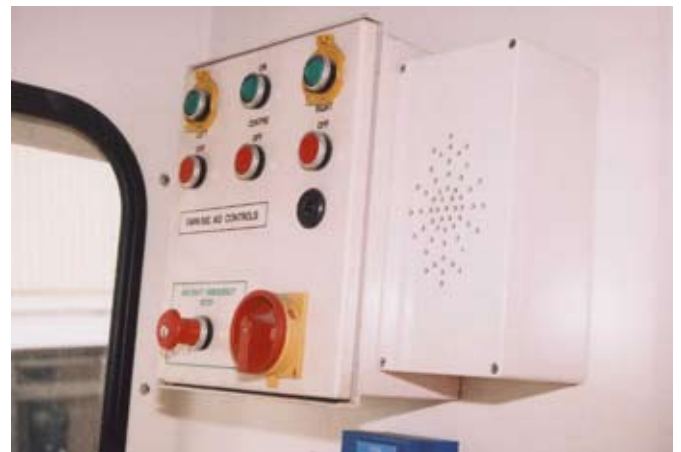
**Figure 5**

The emergency STOP sign could be activated by pressing a button on the stand guidance control box, located at the head of the stand (nearest the terminal building) to the left of the stand centreline, Figure 4. It could also be operated by a button on an identical control box mounted above the steering controls in the cab of the airbridge, on the left side of the airbridge head (nearest the aircraft), Figure 5. The Traffic Officer was not aware of this, believing that it was located beside the door to the airbridge steps, on the other side of the airbridge head and, consequently, out of reach.

Stand guidance control box (airbridge)

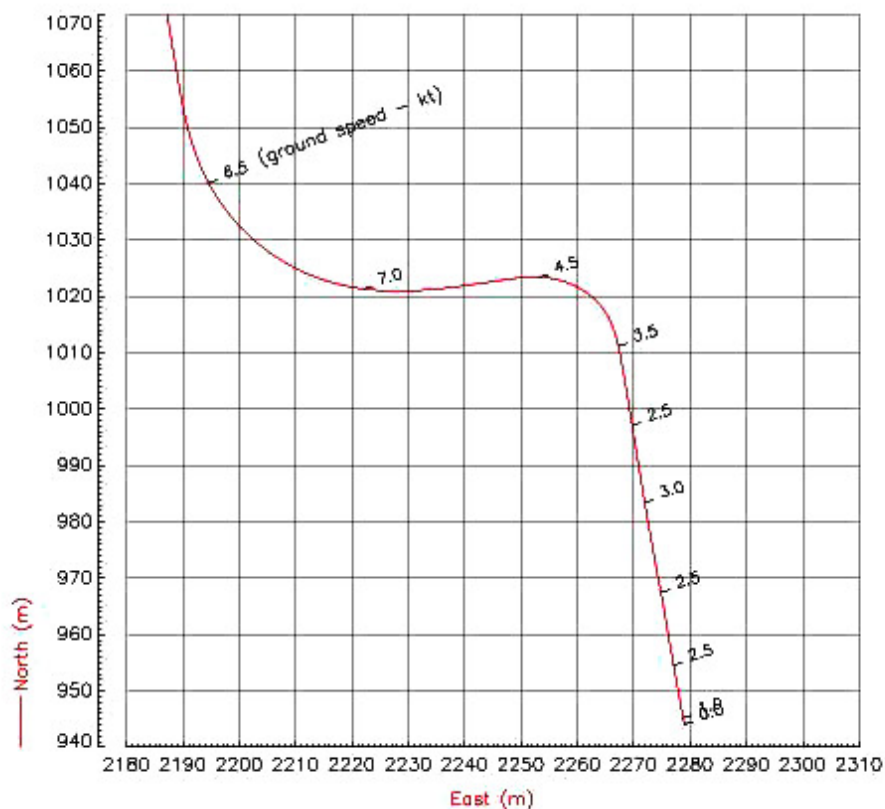
**Figure 6**

Ground track of 7T-VJT onto stand

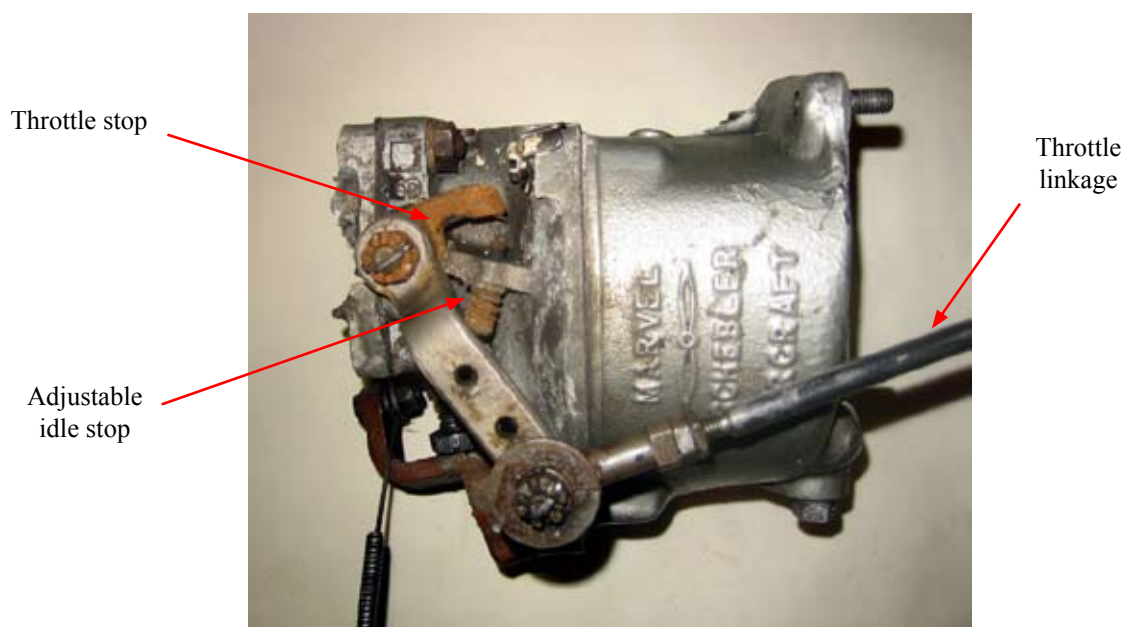
**Figure 3**

Carburettor removed from G-BABB  
(Oxidation of the throttle stop and idle screw occurred after the accident)

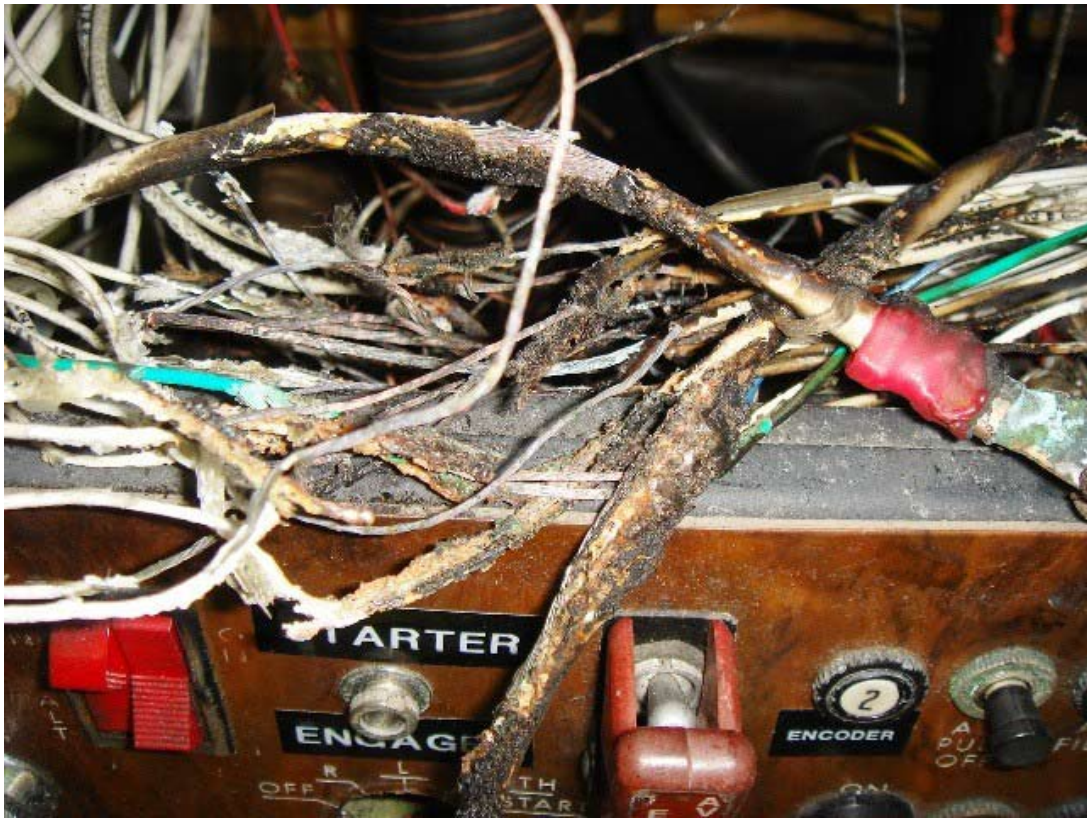
View of wiring damage

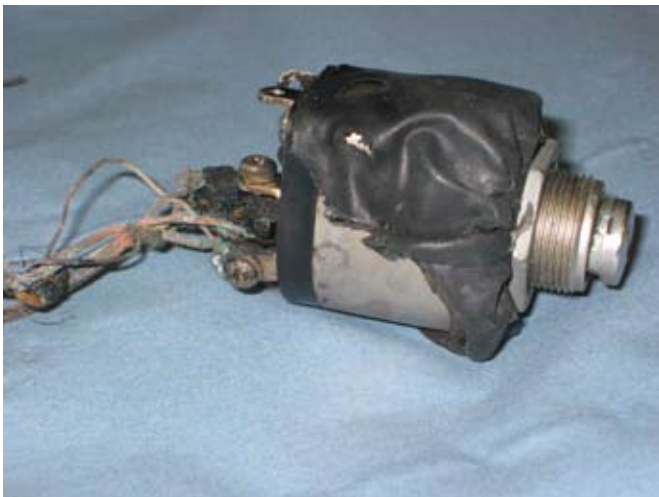
Ignition switch

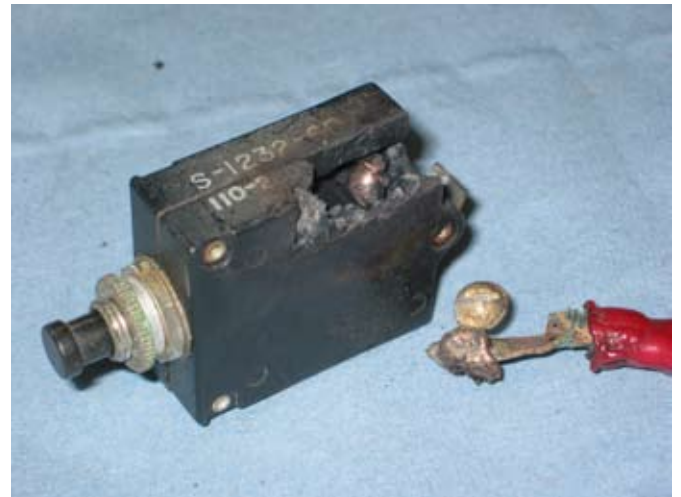
Alternator circuit breaker and feed wire
