# Rail Accident Investigation: Interim Report

**Fatal accident involving the derailment of a tram  
at Sandilands Junction, Croydon  
9 November 2016**

Report IR1/2016  
November 2016

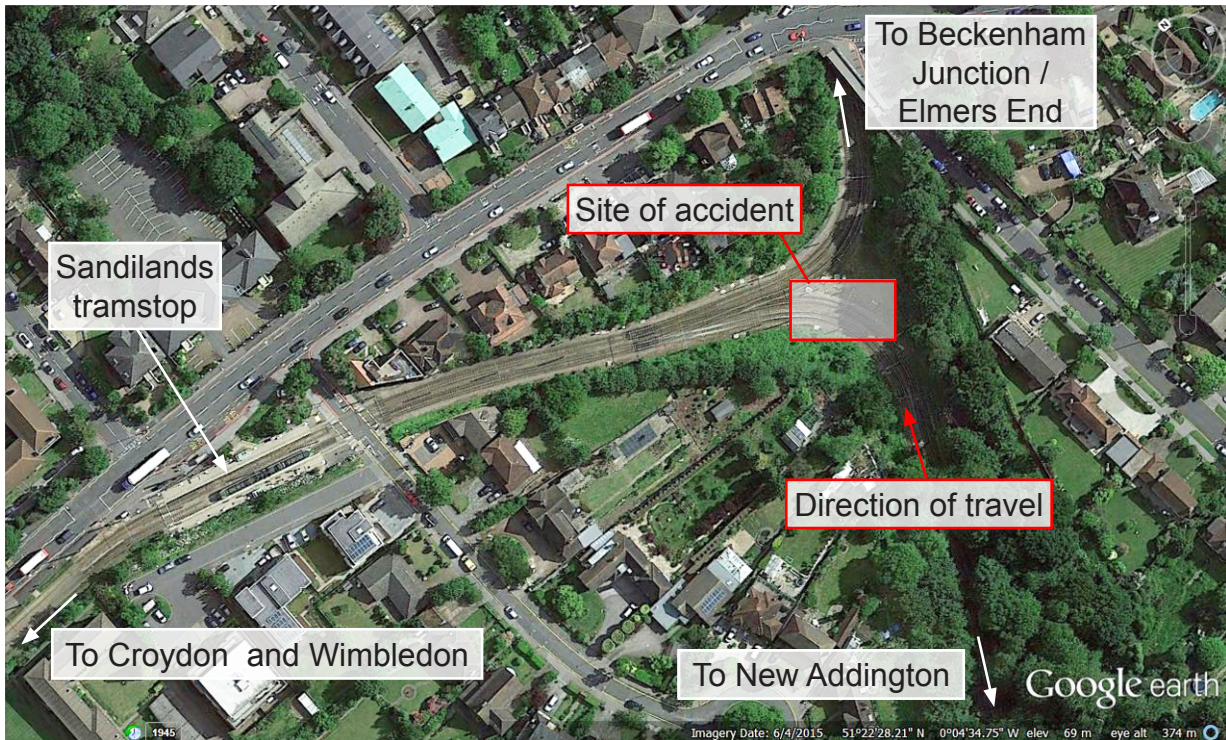
- 1 At about 06:07 hrs on Wednesday 9 November 2016, a tram running between New Addington and Wimbledon derailed and overturned on a curve as it approached Sandilands Junction, in Croydon (figure 1). The tram travelled for a short distance on its side before stopping in the vicinity of the junction.
- 2 Seven people suffered fatal injuries in the accident. A further 51 people were taken to hospital, with eight of them suffering injuries described by the London Ambulance Service as “serious or life-threatening”.
- 3 The Rail Accident Investigation Branch’s (RAIB) initial review of the on-tram data recorder (OTDR) shows that the tram was travelling at a speed of approximately 70 km/h (43.5 mph) as it entered the curve, which had a maximum permitted speed of 20 km/h (12.5 mph).

Figure 1: Google image showing area where accident occurred

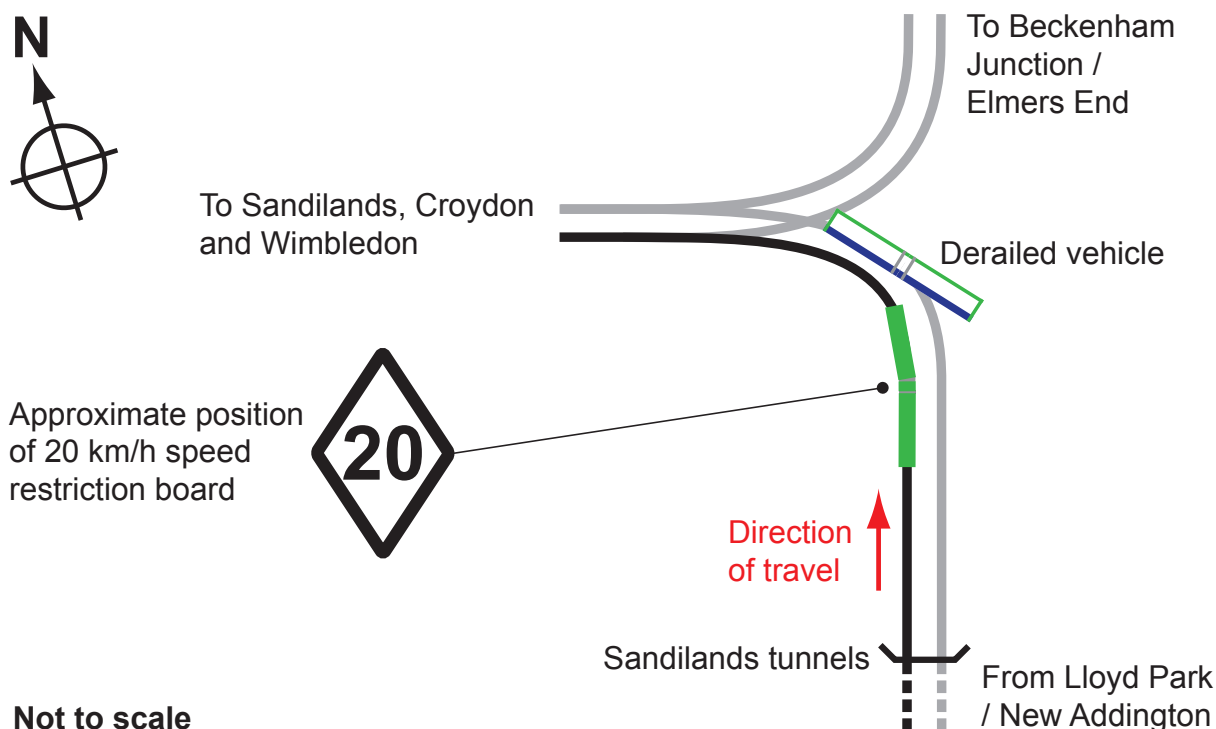
- 12 The accident occurred at Sandilands Junction on the London Tramlink network in Croydon; the point at which the two easterly legs of the network from Beckenham Junction/Elmers End and New Addington converge (see figure 2).

- 13 The tram involved in the accident was running between Lloyd Park and Sandilands tram stops on the route from New Addington. After the Lloyd Park tram stop, the route runs in the open for about 900 metres, and then passes through Sandilands tunnels (comprised of three closely spaced tunnels with a total length of 512 metres), before emerging into a cutting approximately 100 metres before the left-hand curve on which the accident occurred. The curve has a radius of approximately 30 metres.

Figure 2: Diagram of accident location
