Rail Accident Investigation Branch

Rail Accident Report

Report on the runaway manually propelled trolley between Larkhall and Barncluith Tunnel 2 November 2005

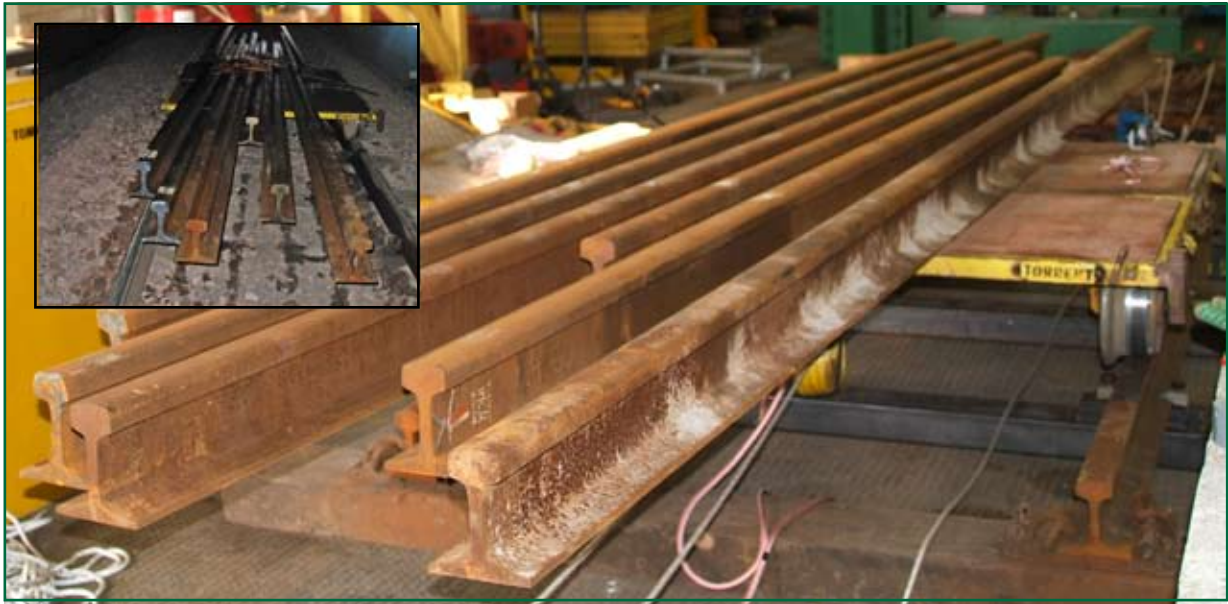
Figure 6: The incident trolley showing rails and relationship to 'as found' condition in Barncluith Tunnel

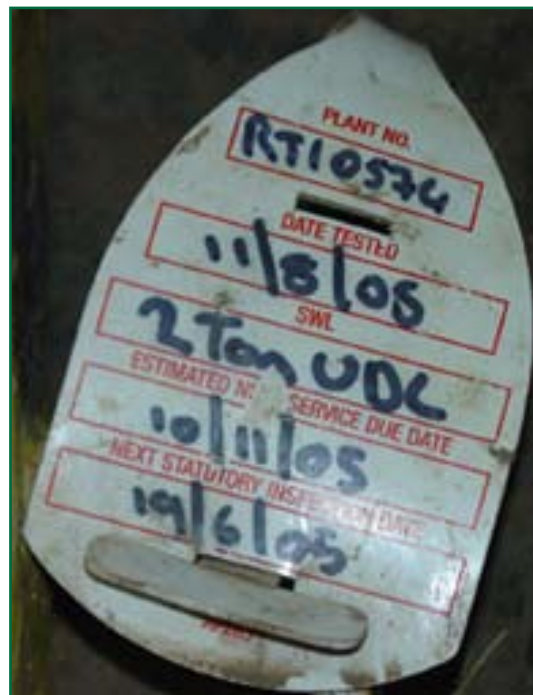
Figure 7: Bull tag on the incident trolley. This correctly indentifies the 3 month service date and incorrectly shows the annual inspection date as 2005

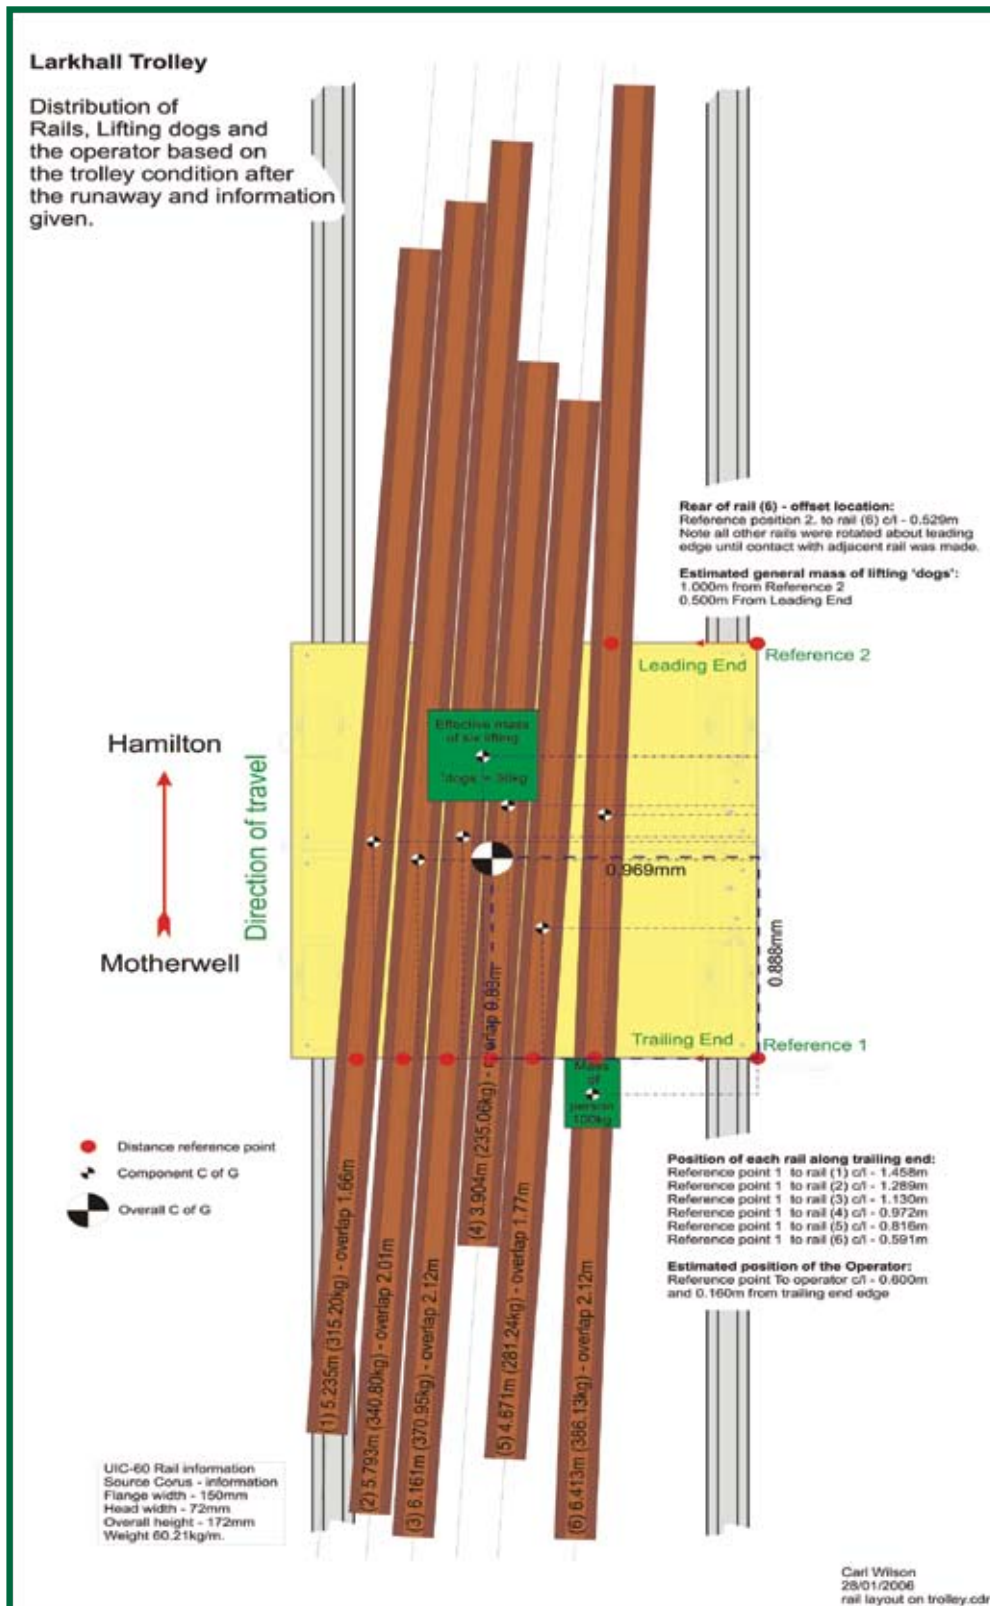
66 At the Merryton site (see Figure 9) old rails were removed from the track, and new rails installed and welded into longer lengths. The scrap rails were cut into smaller sections in order that they could be lifted onto the trolley for onward transportation. Two sections of rails loaded onto the incident trolley were 0.413 m and 0.161 m above the 6 m requirement for movement by a single trolley; the remaining four were within the specified limit. Appendix C contains full details of the rail lengths, weights and overhangs.

Figure 9: Load distribution diagram derived from photographic evidence

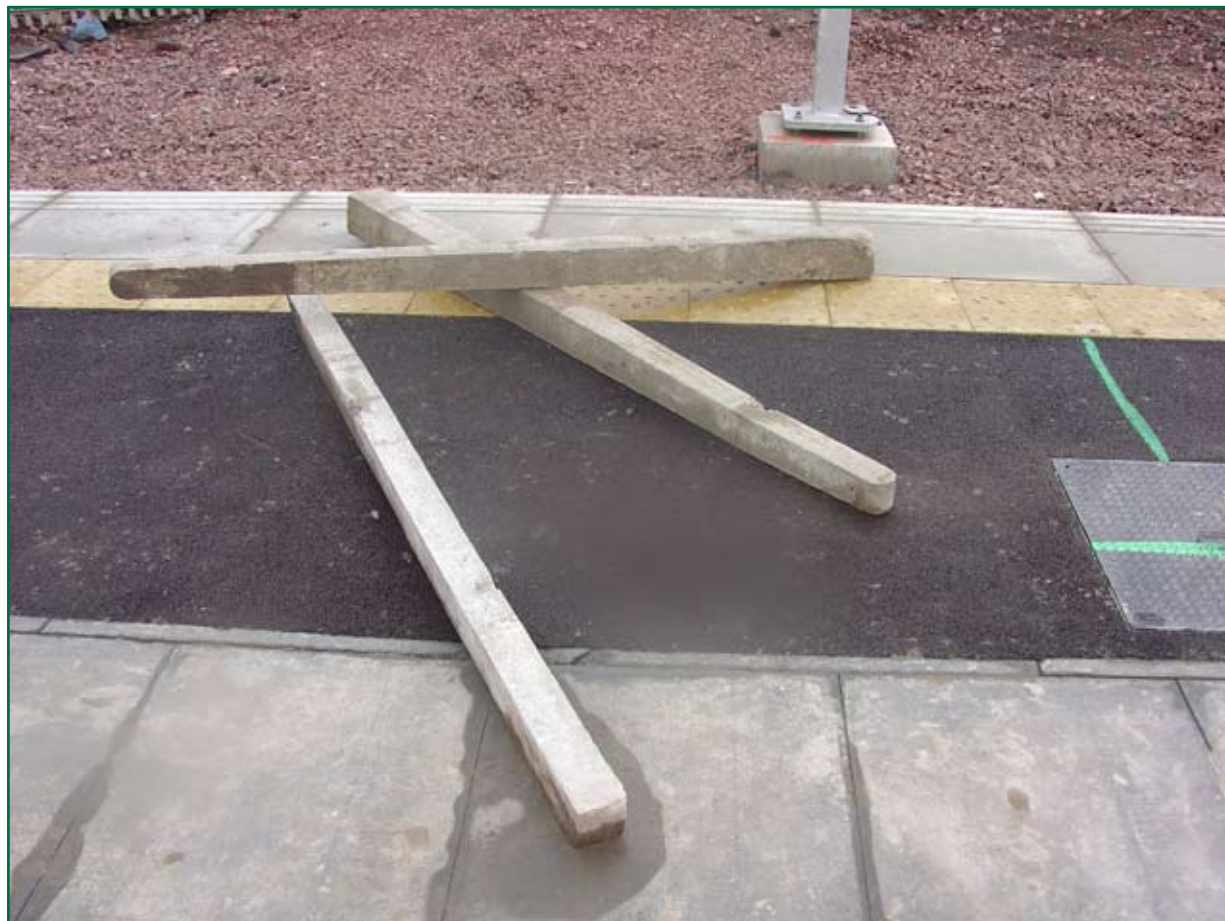
87 Skyblue and Carillion staff had by this time made their way to Chatelherault station. Three fence posts were thrown onto the track onto in an attempt to derail the trolley and prevent it from proceeding down the line. Unknown to these members of staff, the trolley had already passed this location. The fence posts were later removed and placed on the station platform.

Figure 11: Image of fence posts thrown onto the running line in an attempt to prevent the trolley passing through Chatelherault station

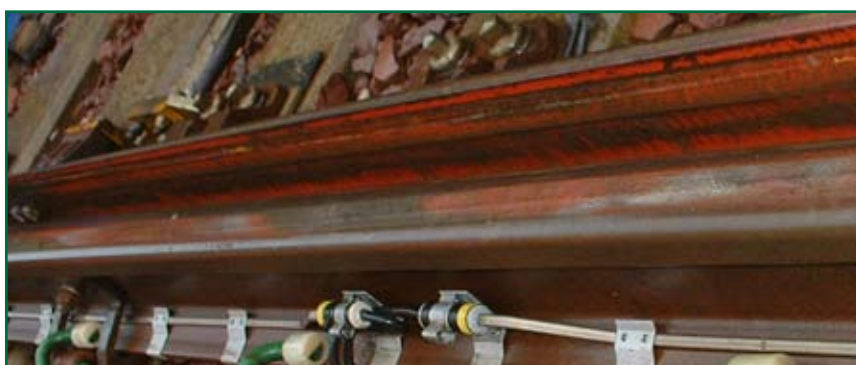
Figure 13: Image of flange climb marks from RT10574 wheel and number 50 points blade at Haughhead Junction

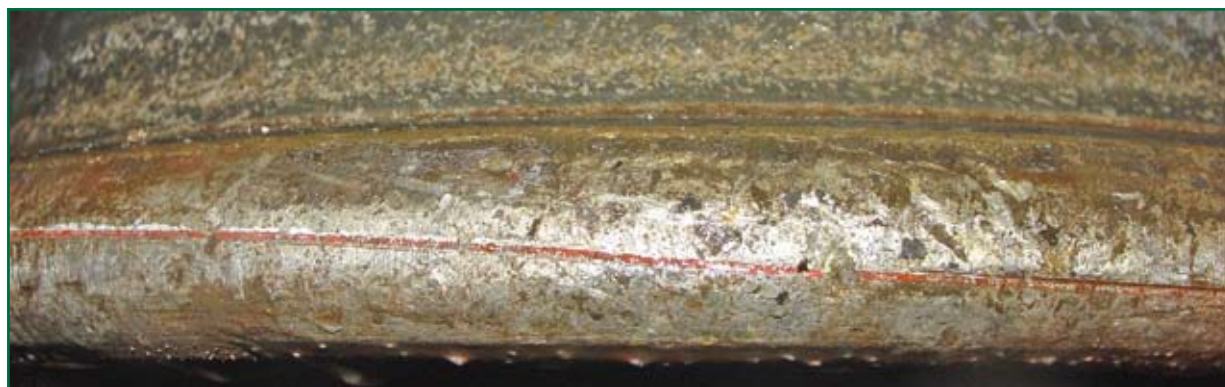
Figure 14: Cross contamination samples and flange climb marks (shown in red) on trolley wheel and Haughhead Junction number 58 points blade

104 Although there was evidence of 'swarf' from the aluminium wheels of trolley on the switch blades of number 58 points, no damage was sustained by the rails, stretcher bars or point mechanisms. The points were examined and authorised for immediate use by Network Rail engineers. No remedial work was required.

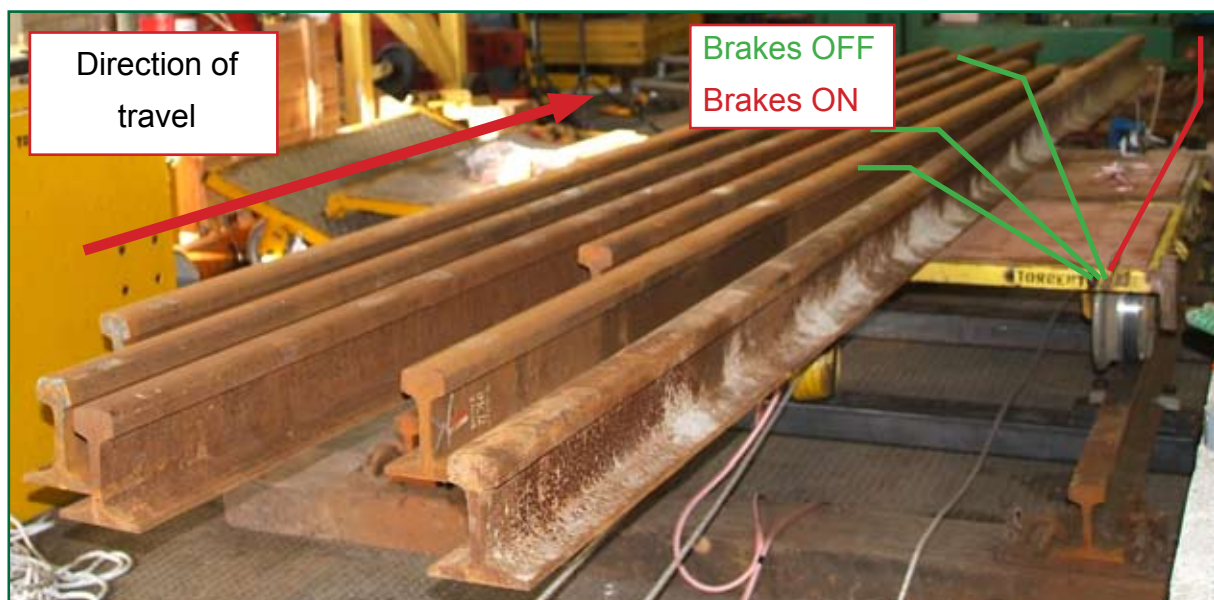
Figure 15: Image of incident trolley RT10574 showing incident rails in position and handle positions

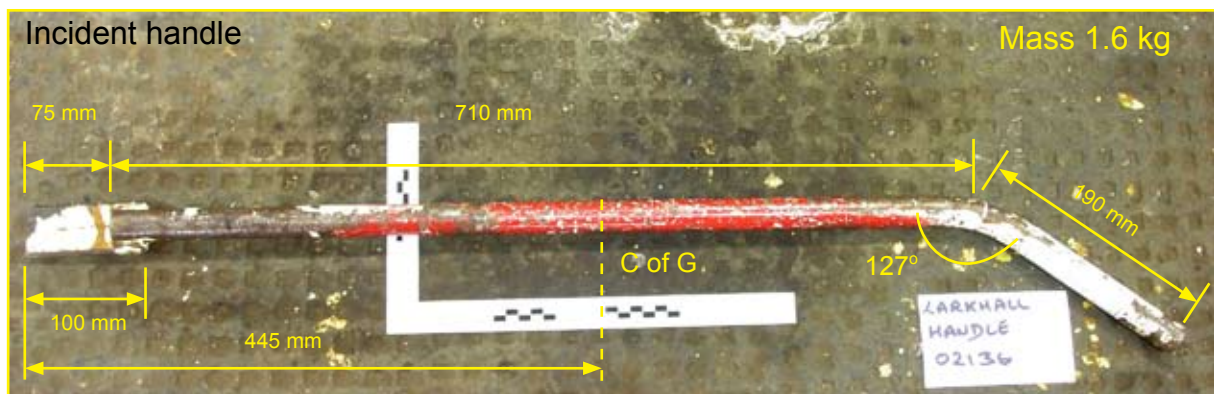
175 The handle found at Haughhead Junction (see paragraph 111) was identified as that used on the incident trolley. However it was not supplied for use with a Type B Permaquip trolley (Figure 10), but for use with a *Link* trolley also known as a Type A (Figure 12).

176 Torrent's records of their AP38 tests show that they had supplied the correct handle when the trolley was initially hired to Carillion. The investigation could not establish why an incorrect handle had been used with the incident trolley.

Figure 18: Link handle found in vicinity of Haughhead Junction number 58 points in rear of the runaway trolley. Identified by witnesses as the incident handle.

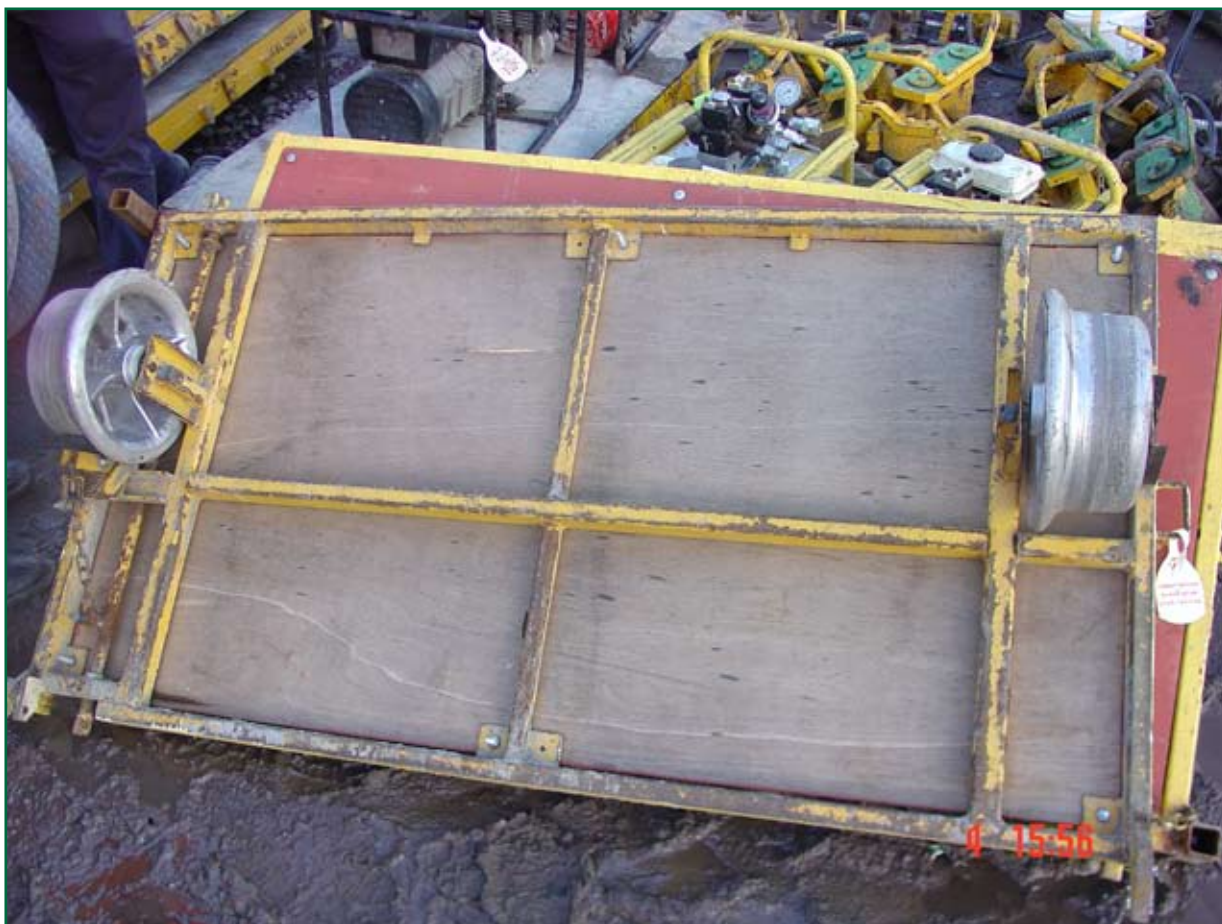
- 219 Examples of both Link type and Type B of trolleys were stored at the depot in an area where contamination was evident. The incident trolley was based at the depot, on lease, over the previous four weeks. Evidence gathered indicates that the trolleys were regularly stored in areas where geological contamination had been in contact with the brake mechanisms. It is thus likely that the contamination of the brake block lining material on the incident trolley occurred here.

- 220 Contamination of the brake lining reduces braking performance, as demonstrated by the RAIB’s tests (see paragraphs 125 and 126). The contamination of the brake lining of the trolley due to its use and storage was causal to the runaway.

Figure 21: Area at Lanark Road where manual trolleys were stored
