# Rail Accident Report

## **Derailment of a freight train at Marks Tey, Essex 12 June 2008**

This report is published by the Rail Accident Investigation Branch, Department for Transport.

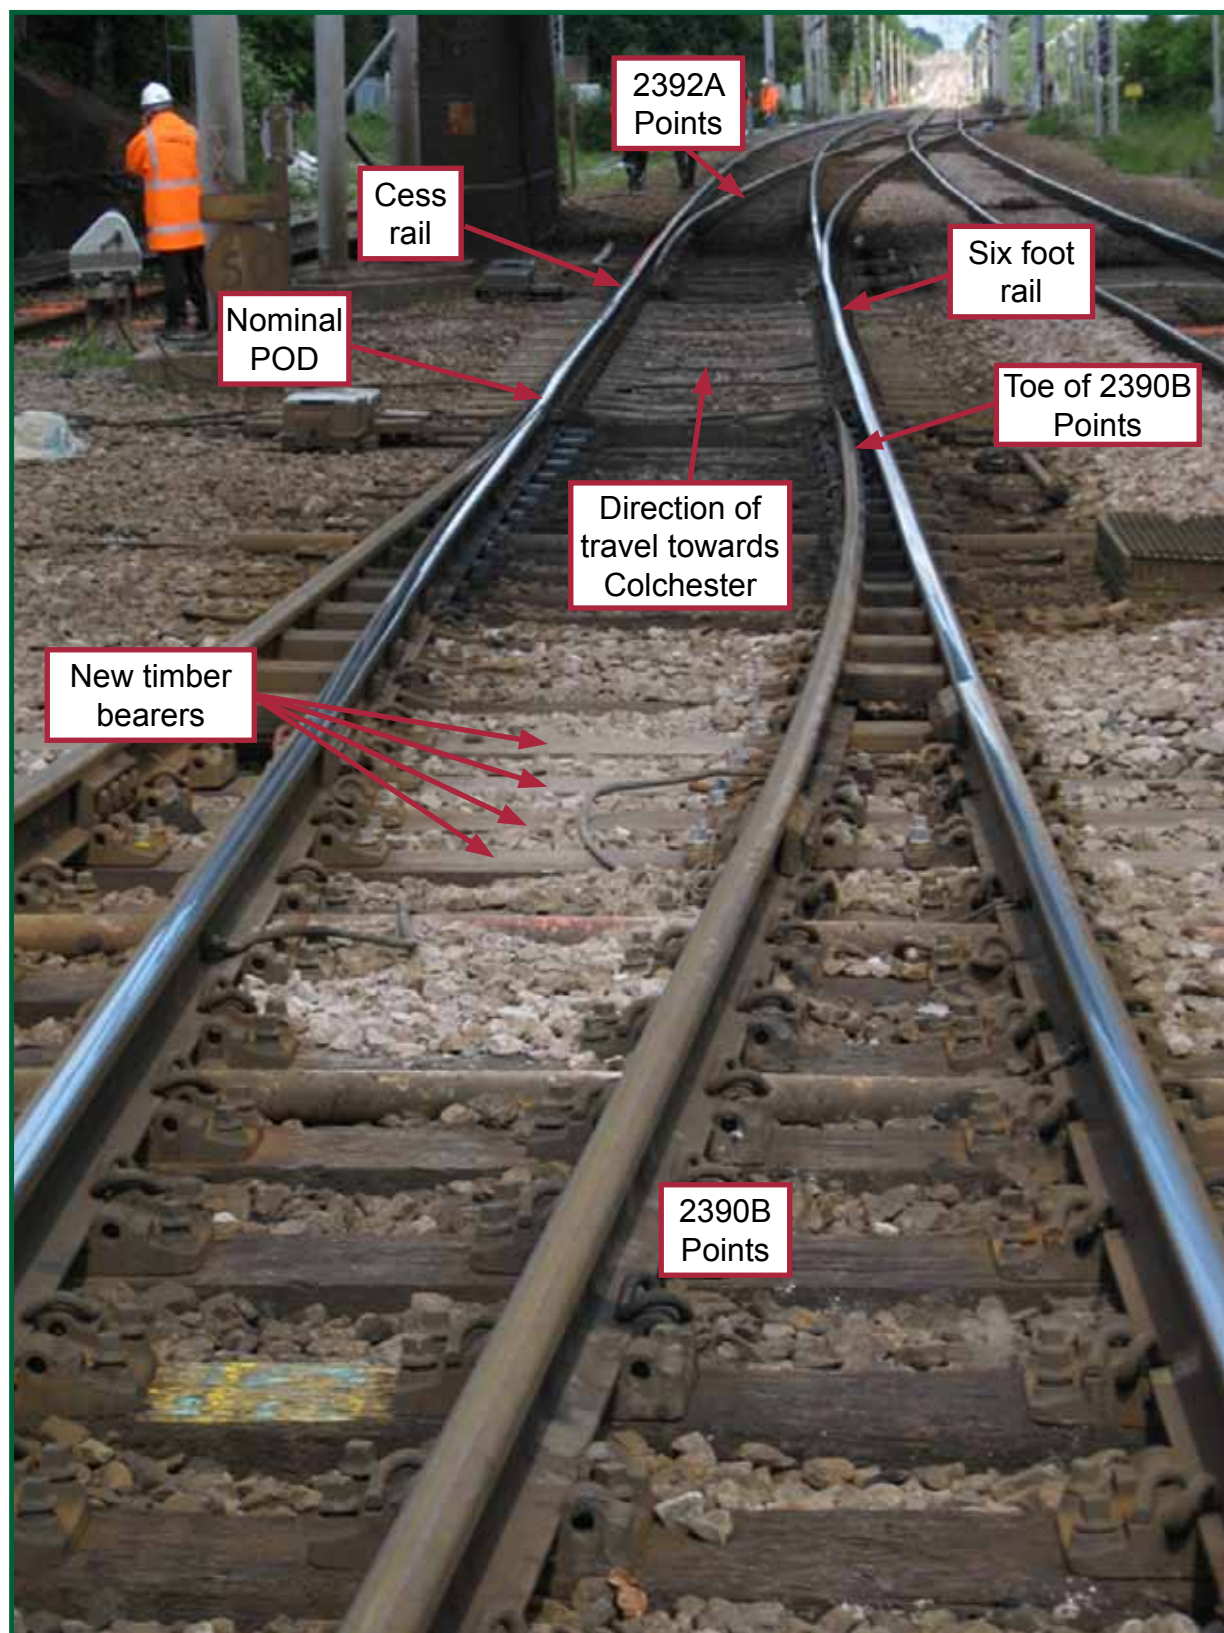
- 63 On the six-foot rail head there was a 'drop-in' mark between sleepers -14 and -15 (around 9.1 to 9.7 metres beyond the nominal point of derailment). This mark was caused by the tread corner of a wheel as it left the rail head and entered the *four-foot*. Contact marks on track components confirm that a wheelset was running derailed beyond this point.

*Figure 7: Nominal point of derailment, facing the direction of travel*

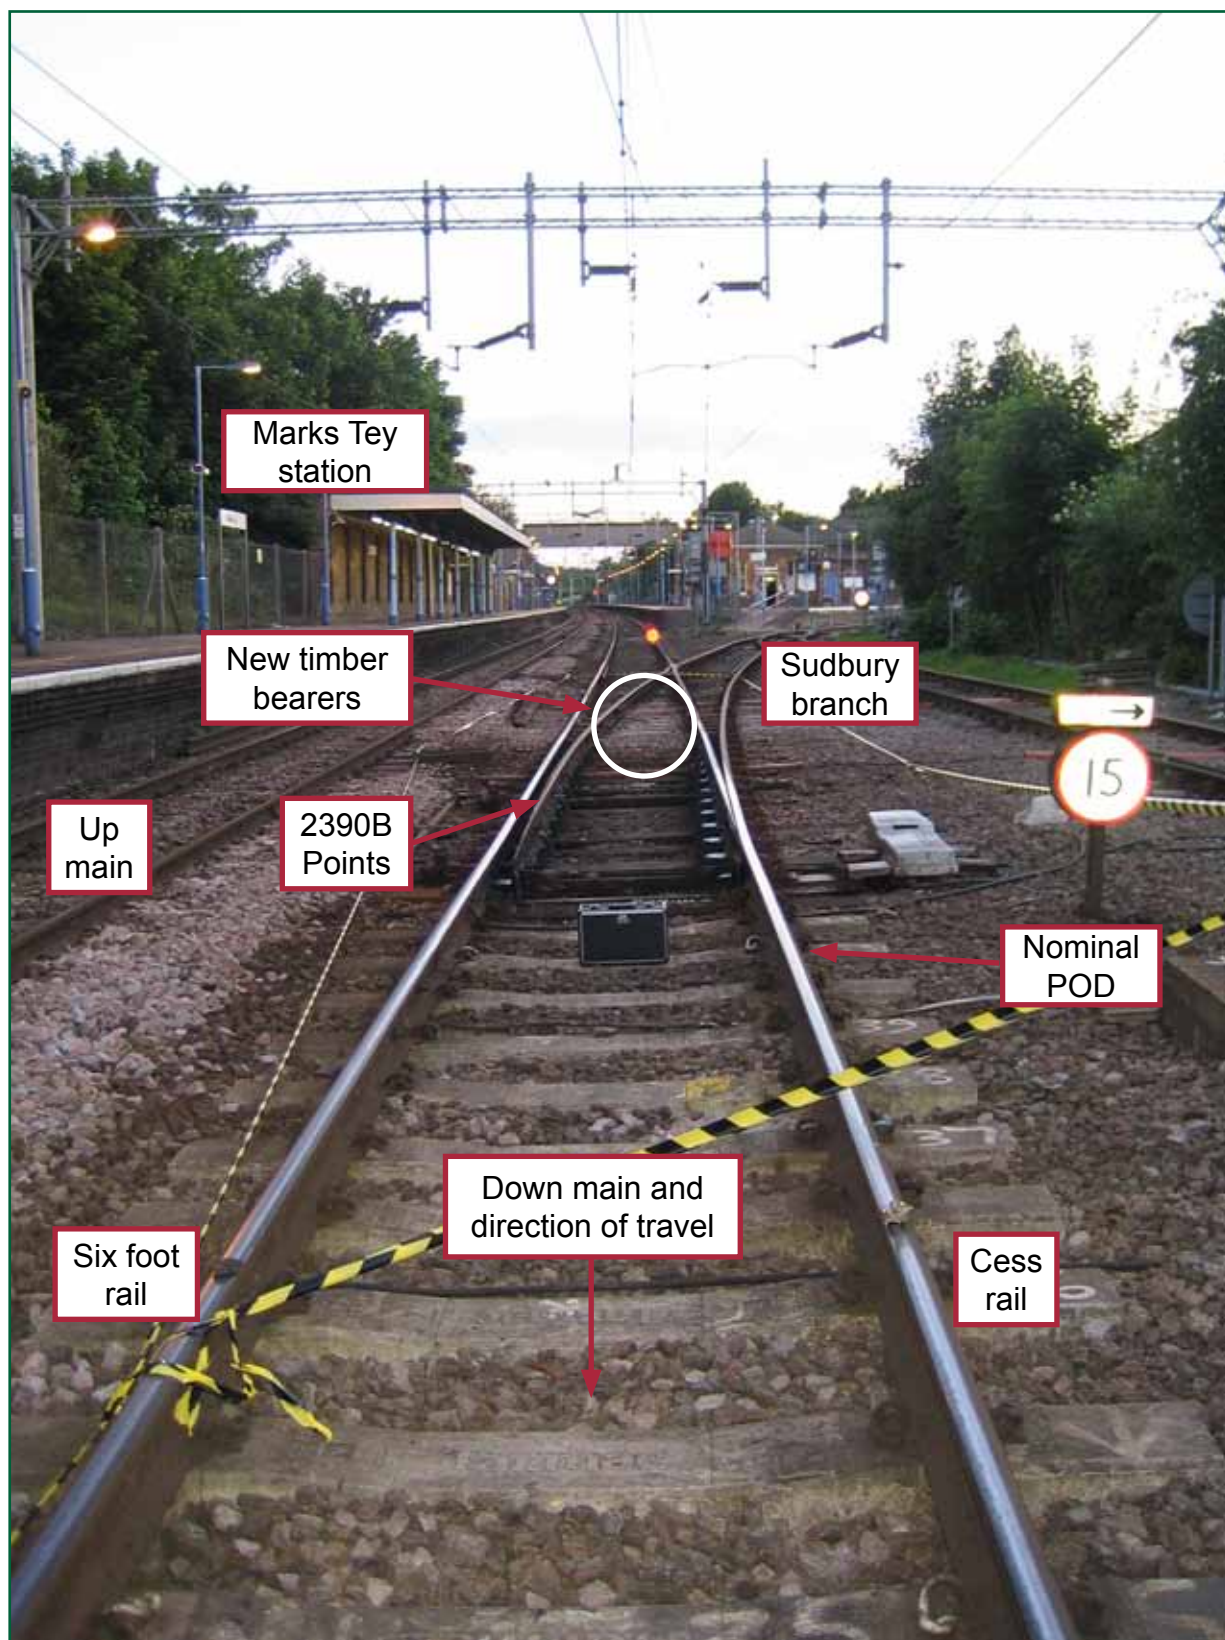
Figure 8: Nominal point of derailment, facing against the direction of travel (photograph courtesy of Delta Rail)

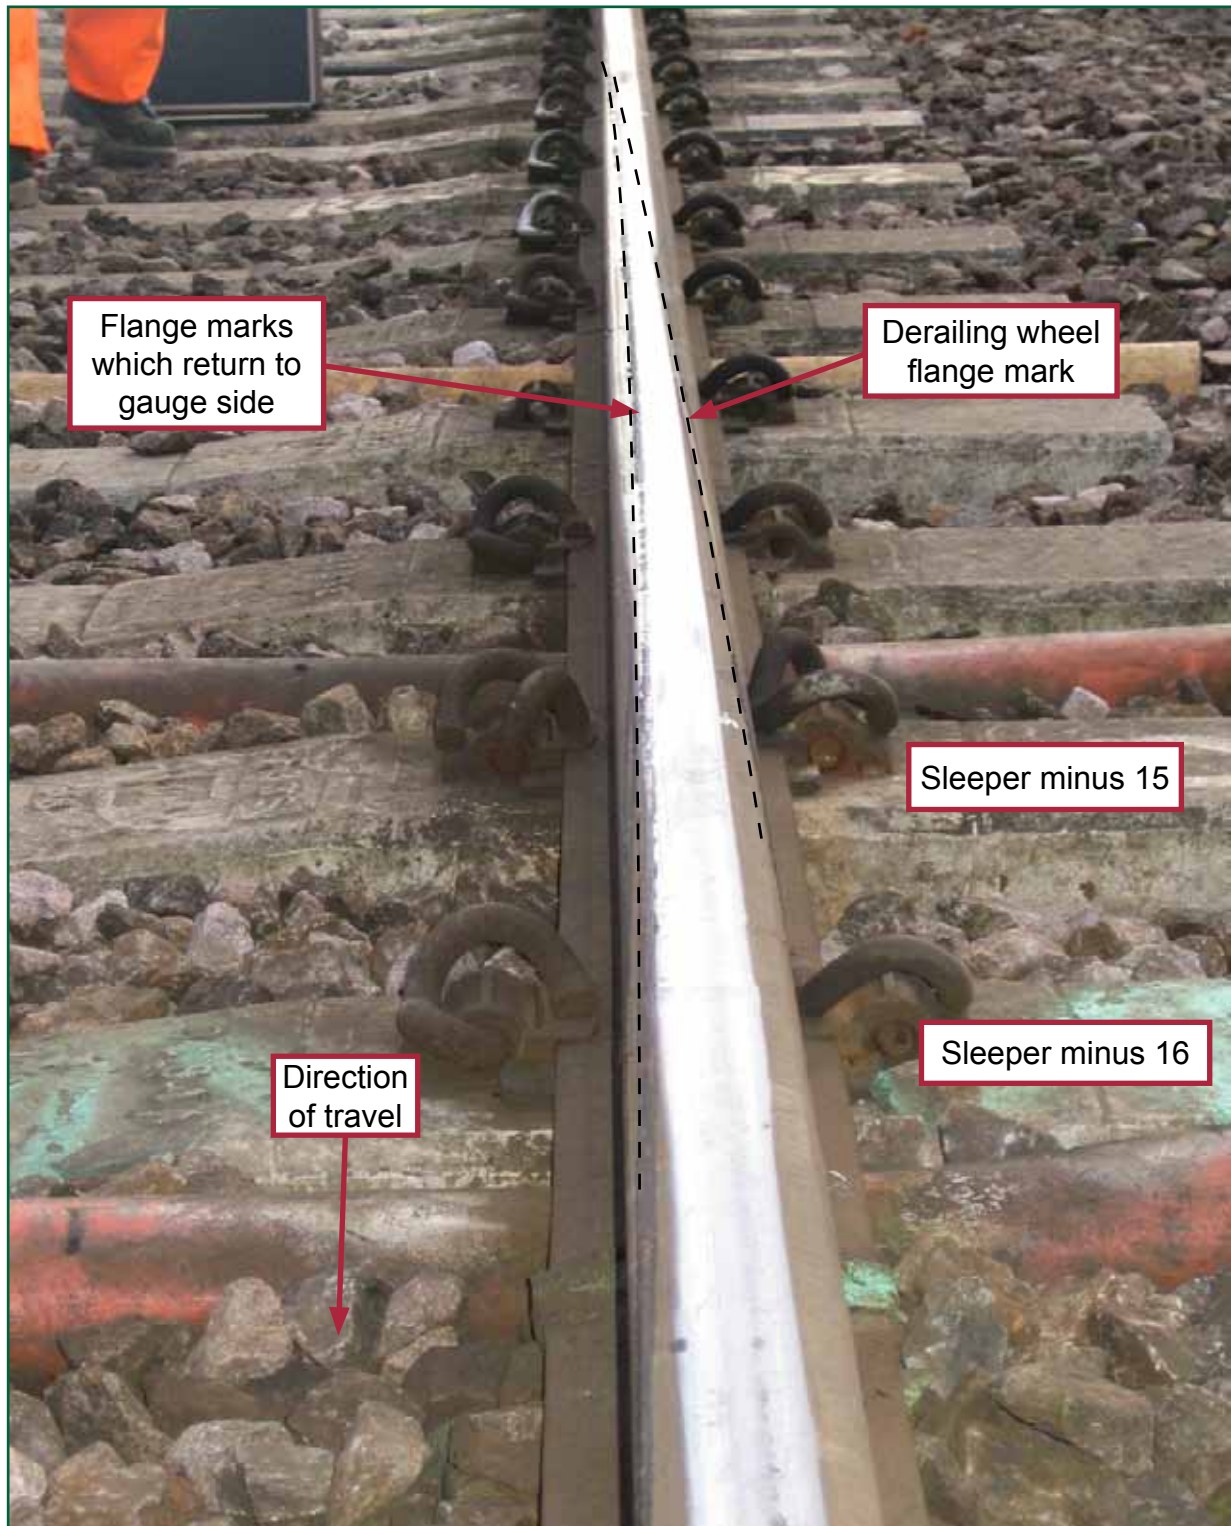
- 64 There were additional flange marks on the cess rail head around sleeper -7 (approximately 4.5 metres beyond the nominal point of derailment), indicating that a number of other wheels had climbed onto the rail head. These flange marks stayed on the rail head before returning to the gauge side of the rail head in the vicinity of sleepers -15, -16 and -17 (around 9.7 to 11 metres beyond the nominal point of derailment, see figure 9).

Figure 9: Flange mark on cess rail, facing against direction of travel (photograph courtesy of Delta Rail)

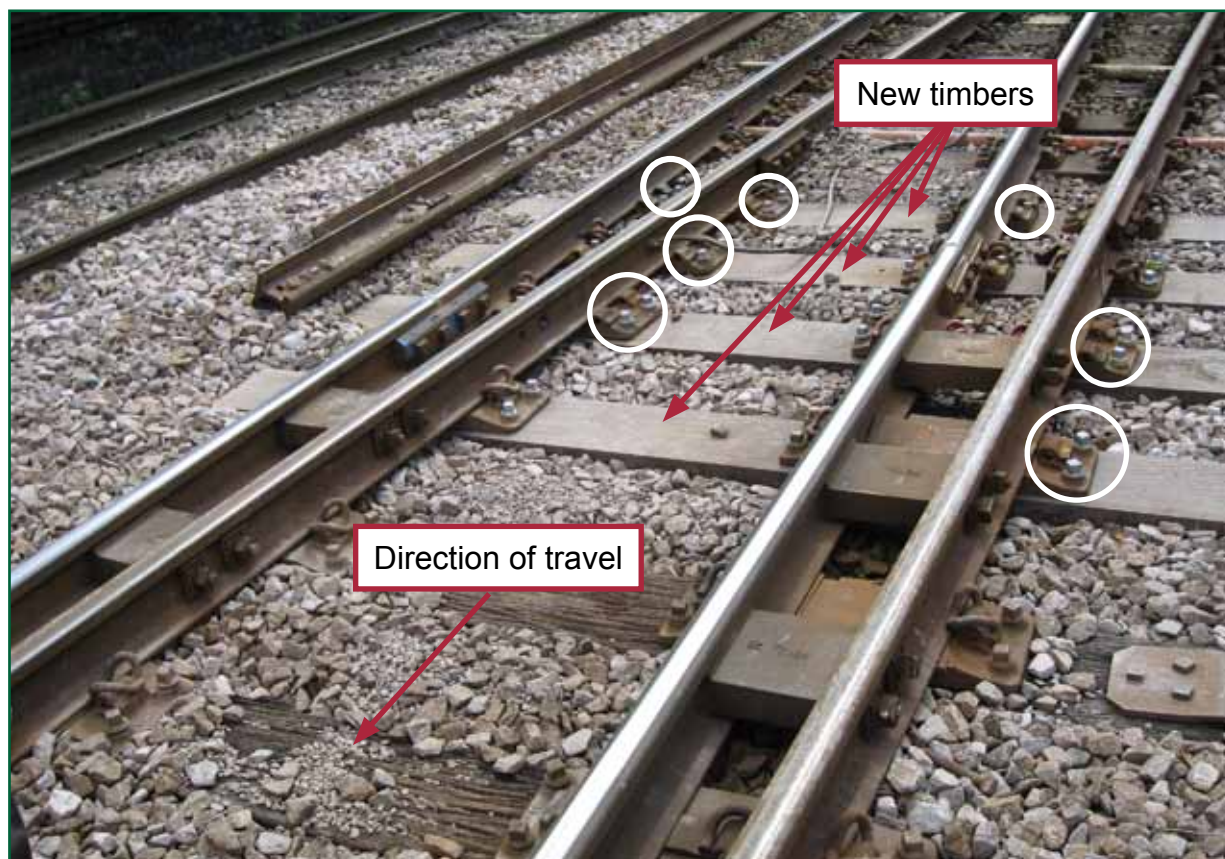
- Pandrol rail fastenings were missing from some of these replacement timber bearers - rust markings on the rails indicated that the fastenings had probably been in place until a few days prior to the derailment (figures 10 and 11); and

- contrary to normal practice, new insulating rail pads had not been fitted to the replacement timbers - in some cases old pads had been reused (however, there is no requirements in standards for such replacement).

Figure 10: New timbers fitted to heel of 2390B points; missing fasteners highlighted

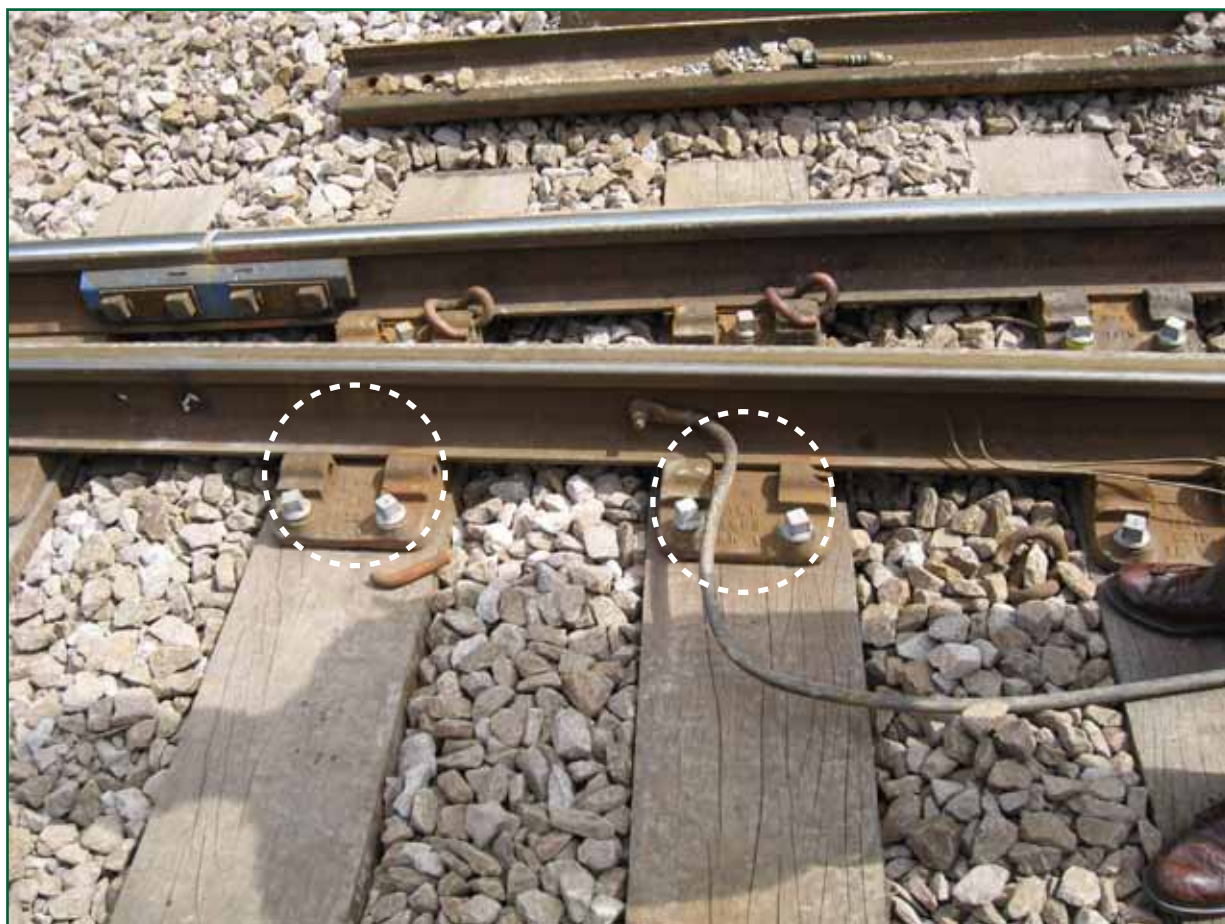
Figure 11: Close up of baseplates with missing fasteners

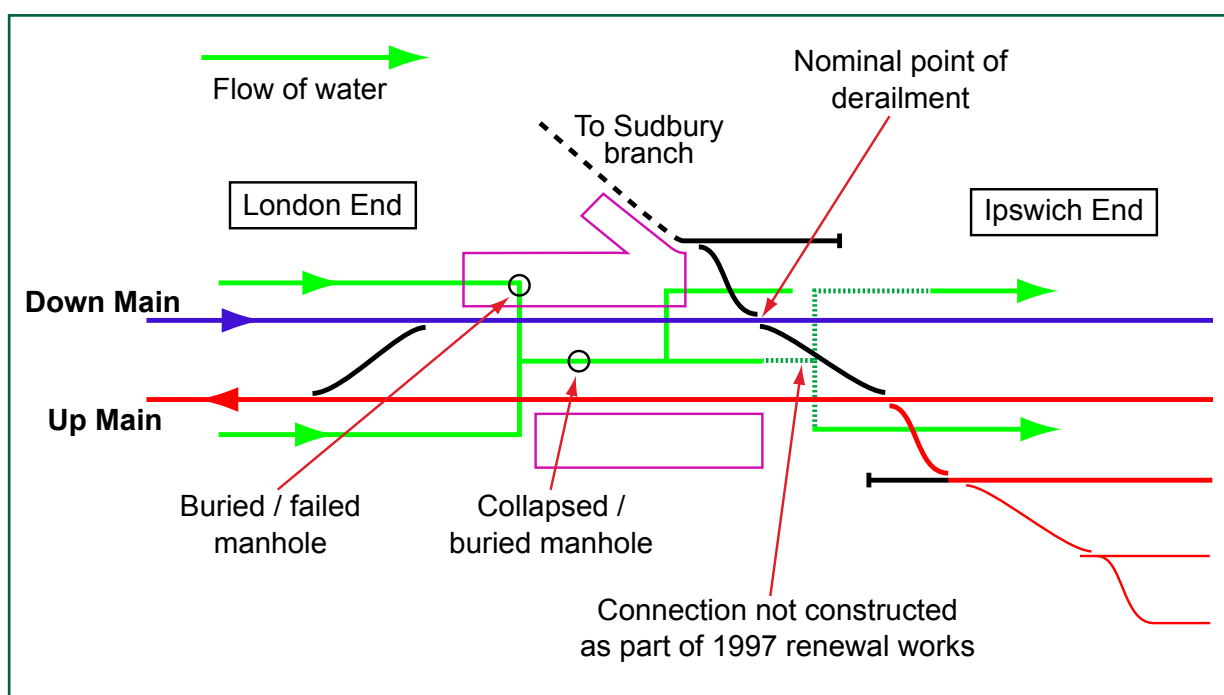
Figure 12: Drainage layout (not to scale)

- 72 Because of the presence of dips in the track as it passed through the station (see paragraph 68) Network Rail undertook a full inspection of the drainage catch pits located around Marks Tey station and junction following the derailment (figure 12).

- 73 This inspection found that the catch pits either contained still water and debris, or that they could not be accessed for inspection because they were covered in ballast or had been built over. At the London end a catch pit in the down cess drain had been buried under a platform extension and had failed, thus blocking the drainage system at this point. At around the mid-point of the platform a catch pit in the centre track drain had either collapsed or was buried, again possibly blocking the drainage system.

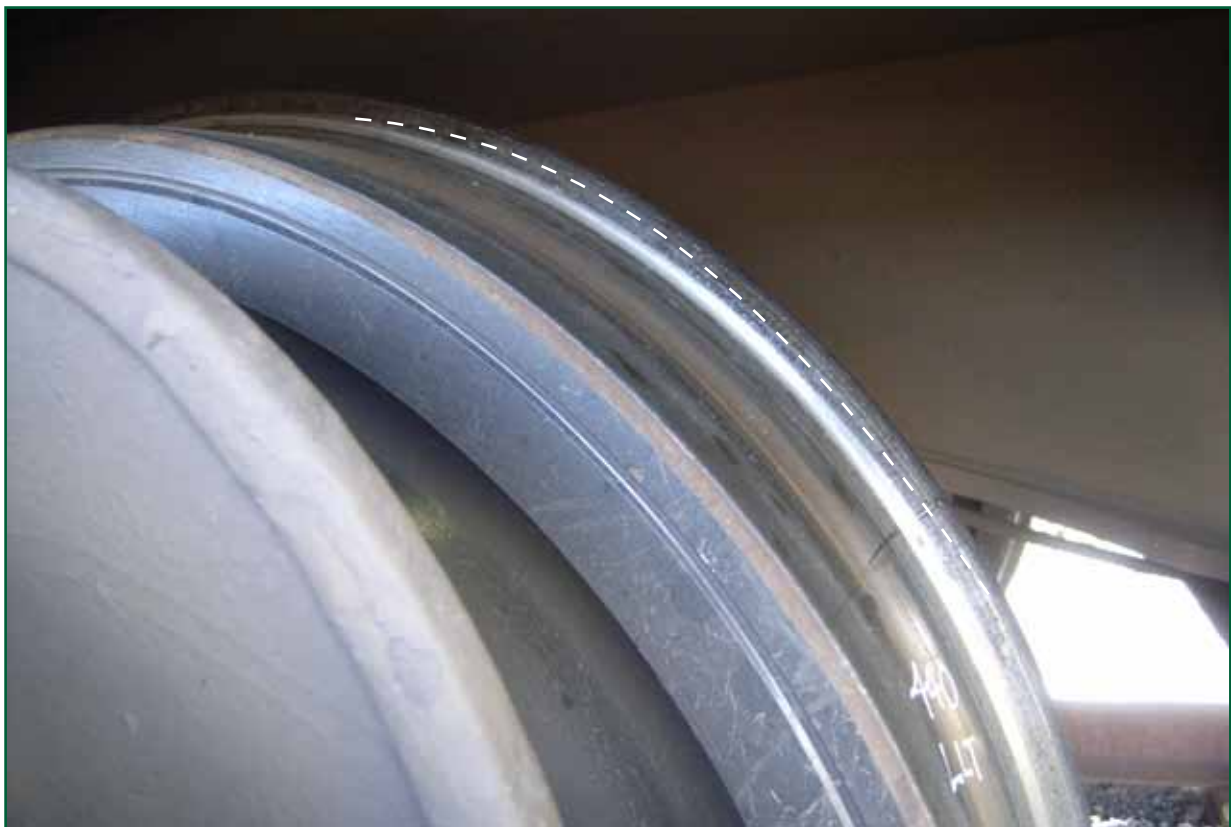
- 79 Examination of the front bogie of wagon 608440 revealed contact marks high on the flange of the left-hand wheel of the leading wheelset and a possible climb mark on the left-hand wheel of the trailing wheelset (figure 13).

Figure 13: Possible climb marks on the left-hand wheel of the trailing wheelset of the rear bogie of wagon 608440

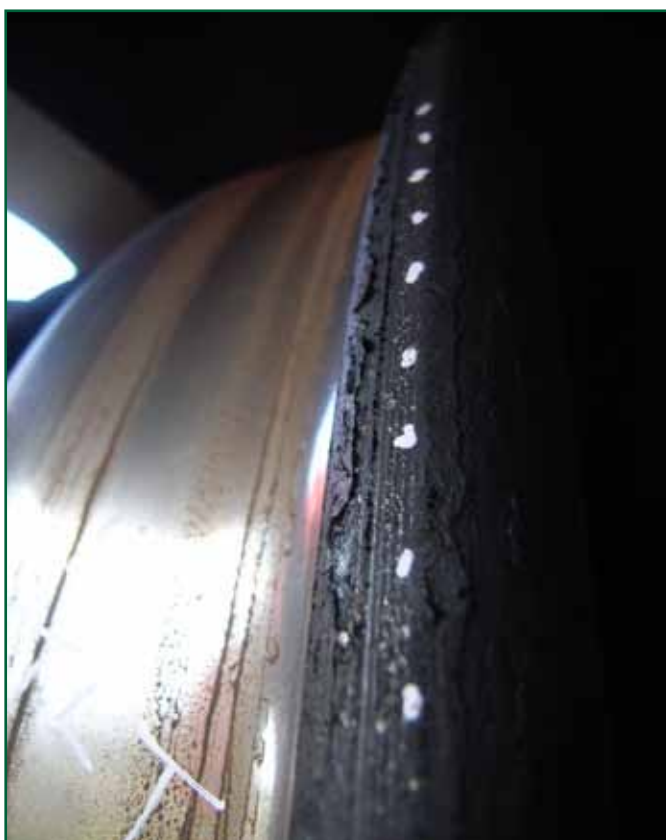
- 83 The rear bogie leading wheelset showed contact marks indicating that the left-hand wheel had also ridden high on the wheel flange. The trailing wheelset of the rear bogie had contact marks on the tip of its left-hand wheel flange; this wheel also had a fresh mark on its tread that was indicative of it having dropped onto a rail head (figure 14). There was a possible contact mark on the right-hand wheel of this wheelset, and evidence of contact on the underside of the lift stop on the right-hand wheel of the trailing wheelset (figure 6), indicating that the bogie frame may have applied a lifting force to this wheel.

*Figure 14: Contact marks on the left-hand wheel of the trailing wheelset of the rear bogie of wagon 607129*

- 84 These marks demonstrate that this wagon had run partially derailed prior to returning to normal running. Paragraphs 204 to 217 explore how this might have happened.
- 85 The wagon was found to have an overall body twist of 10 mm, which was not considered to be significant.
- 86 No issues of relevance were recorded with respect to the wheel profiles and diameters of the wheels which displayed contact marks.

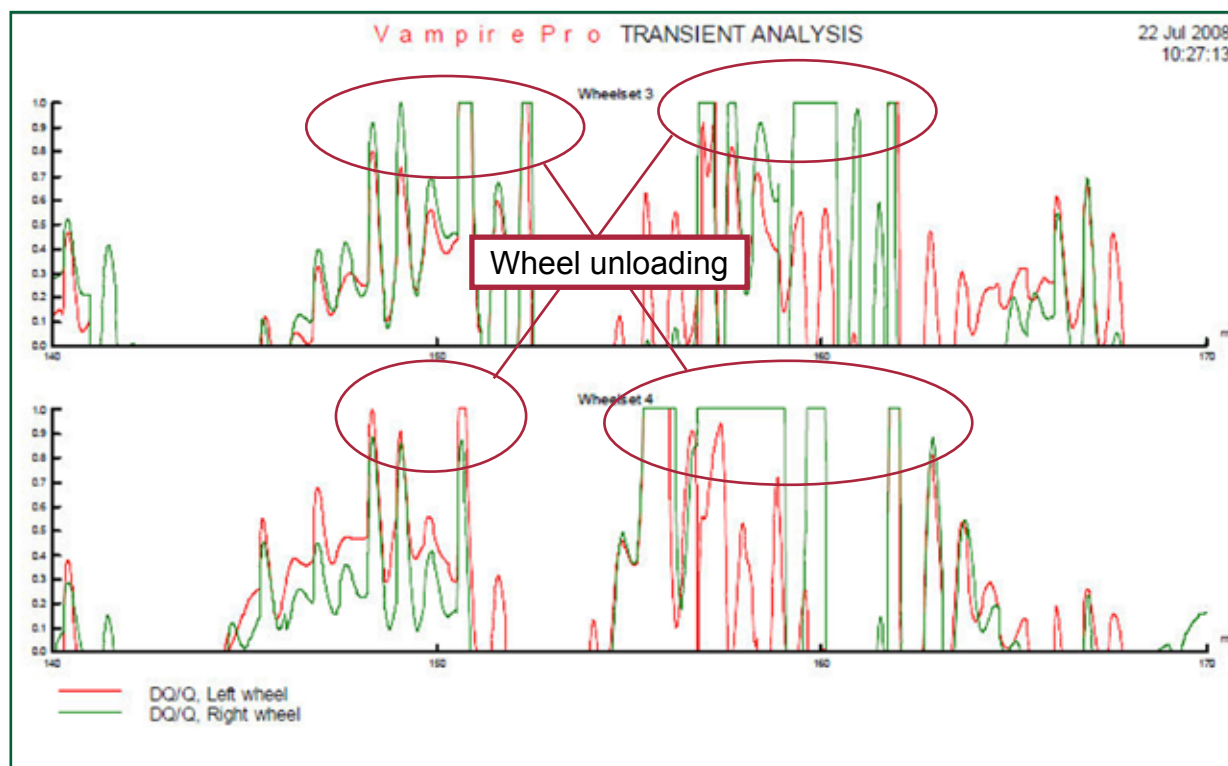
Figure 18: Cycle of wheel unloading on trailing bogie on approach to nominal POD (image courtesy of Delta Rail)

- 199 The modelling was able to confirm that the measured cant, curvature, horizontal alignment and gauge of the track contributed little to creating the wheel unloading events, and that the dominant mechanism was the vehicle's response to changes in vertical track alignment.

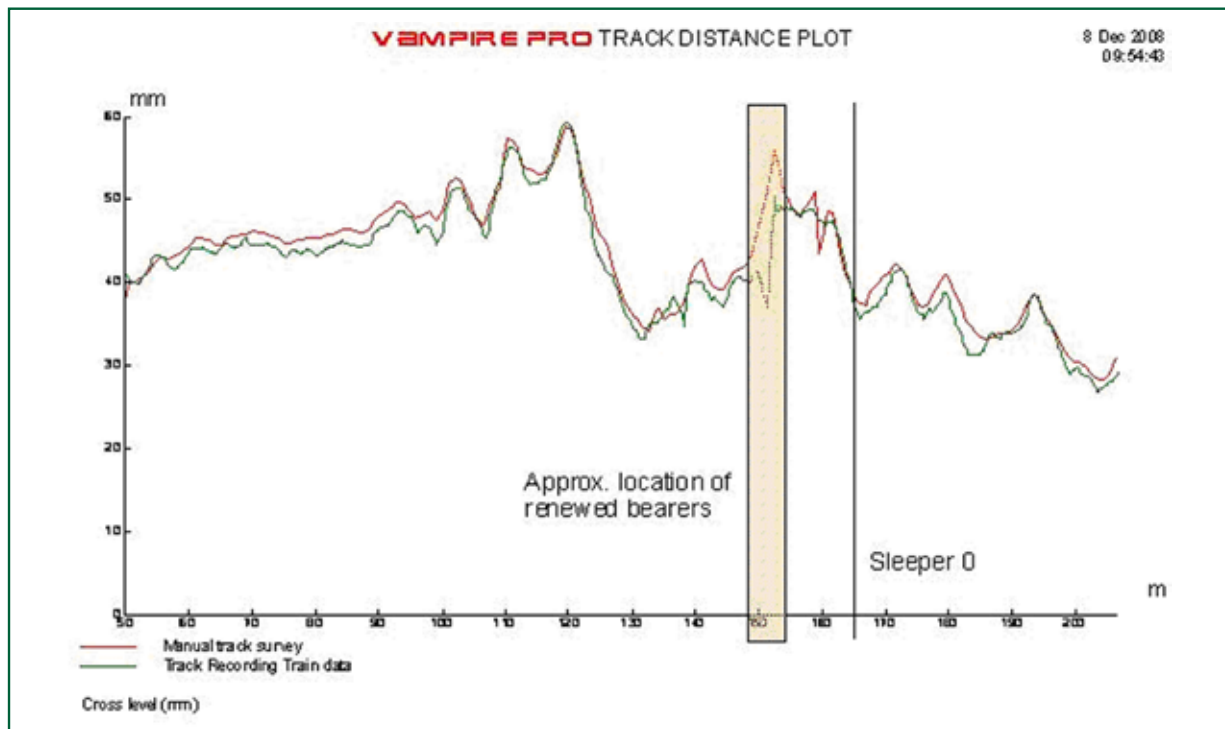
Figure 19: Comparison between the post-accident survey and the data recorded on 27 May 2008 (image courtesy of Delta Rail)

202 This meant that the geometry of the track on the approach to the defect (i.e. the down main through Marks Tey station platform) was not causal to the derailment. It also meant that, although the dip at the heel of 2390B points found following the accident was necessary for the derailment to take place, it was not on its own sufficient for the wagons to pose a derailment risk. For such a derailment risk to exist, it was also necessary for the track beyond this dip to have the presence of the cyclic top that was measured post-accident and which matched well with that recorded on 27 May 2008 (paragraph 167).

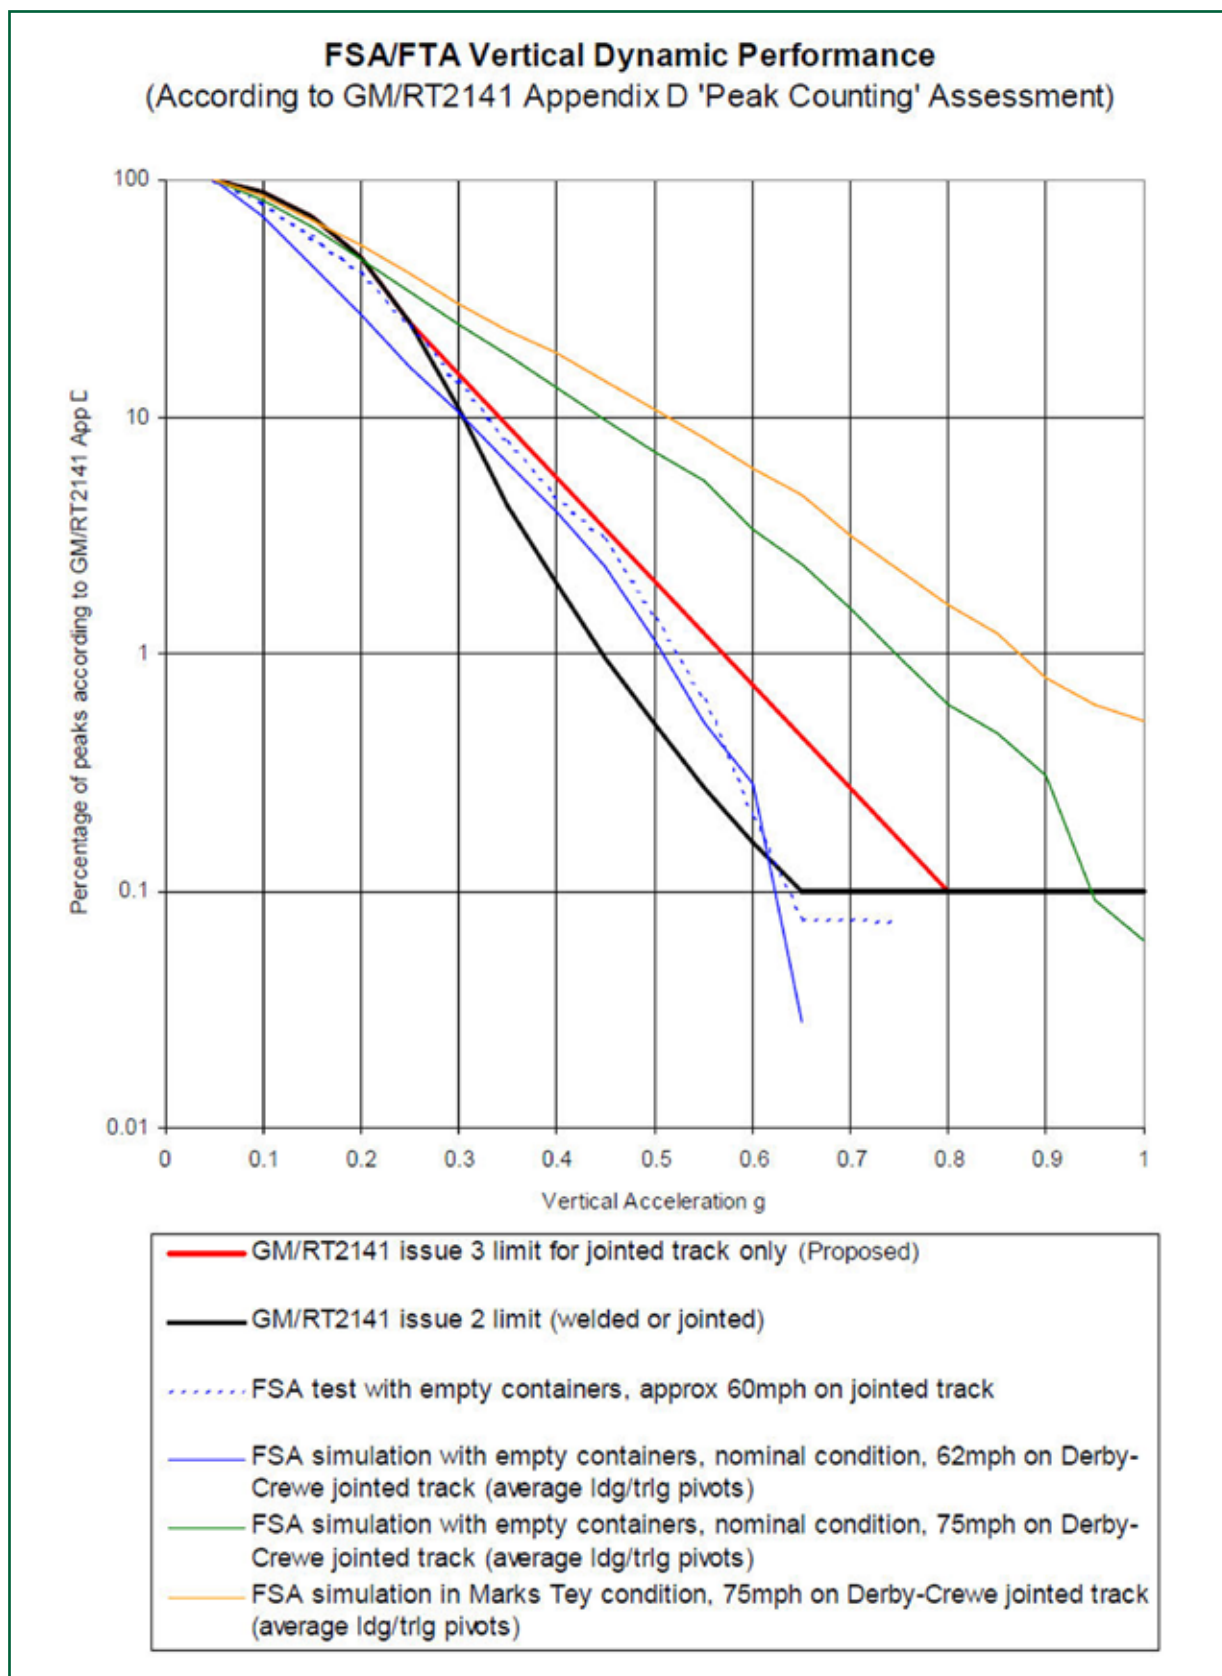
205 The model showed that, over jointed track, a part-laden FSA/FTA wagon did not satisfy the requirements of GM/RT 2141 Issue 2. In the nominal condition at 60 mph, it exceeded these requirements only slightly; however, in both the nominal and Marks Tey conditions at 75 mph, its performance fell significantly outside that required. The Marks Tey condition was the worst performing of all, which reflected the effect of reduced friction damping (caused as a result of the worn Lenoir links) on vertical dynamic behaviour (figure 20).

Figure 20: FSA/FTA Vertical Dynamic Performance comparison (image courtesy of Delta Rail)

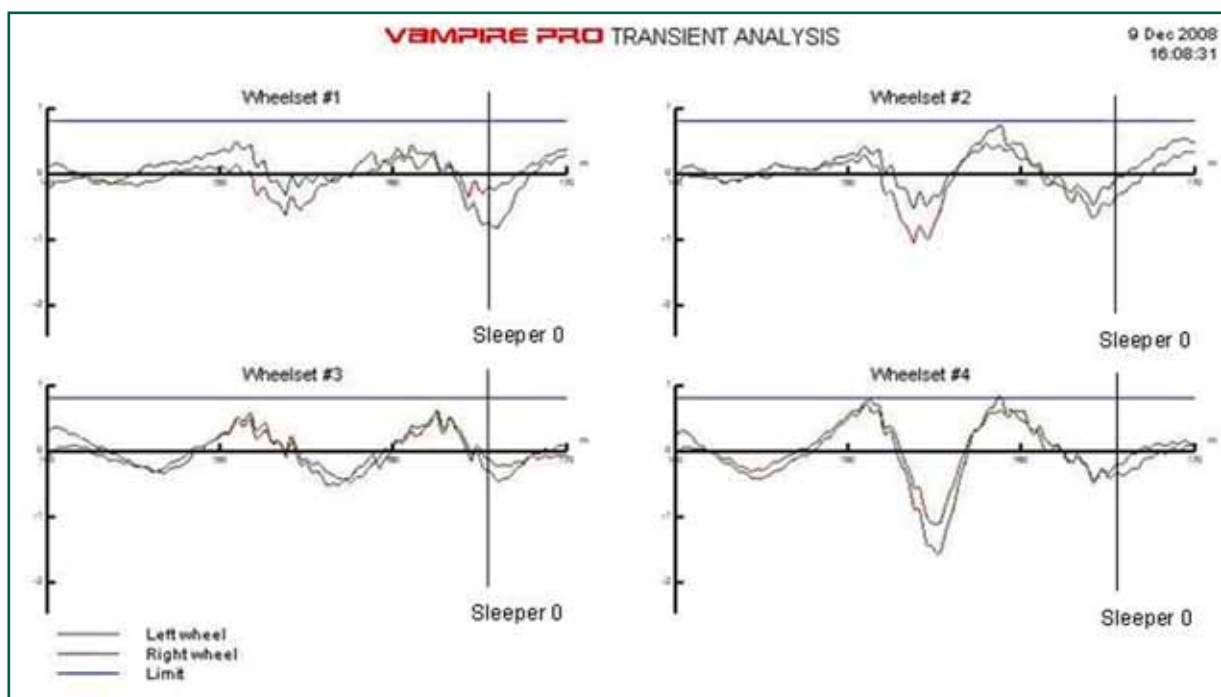
Figure 21: Filtered cycle of wheel unloading on compliant wagon on approach to nominal POD (image courtesy of Delta Rail)

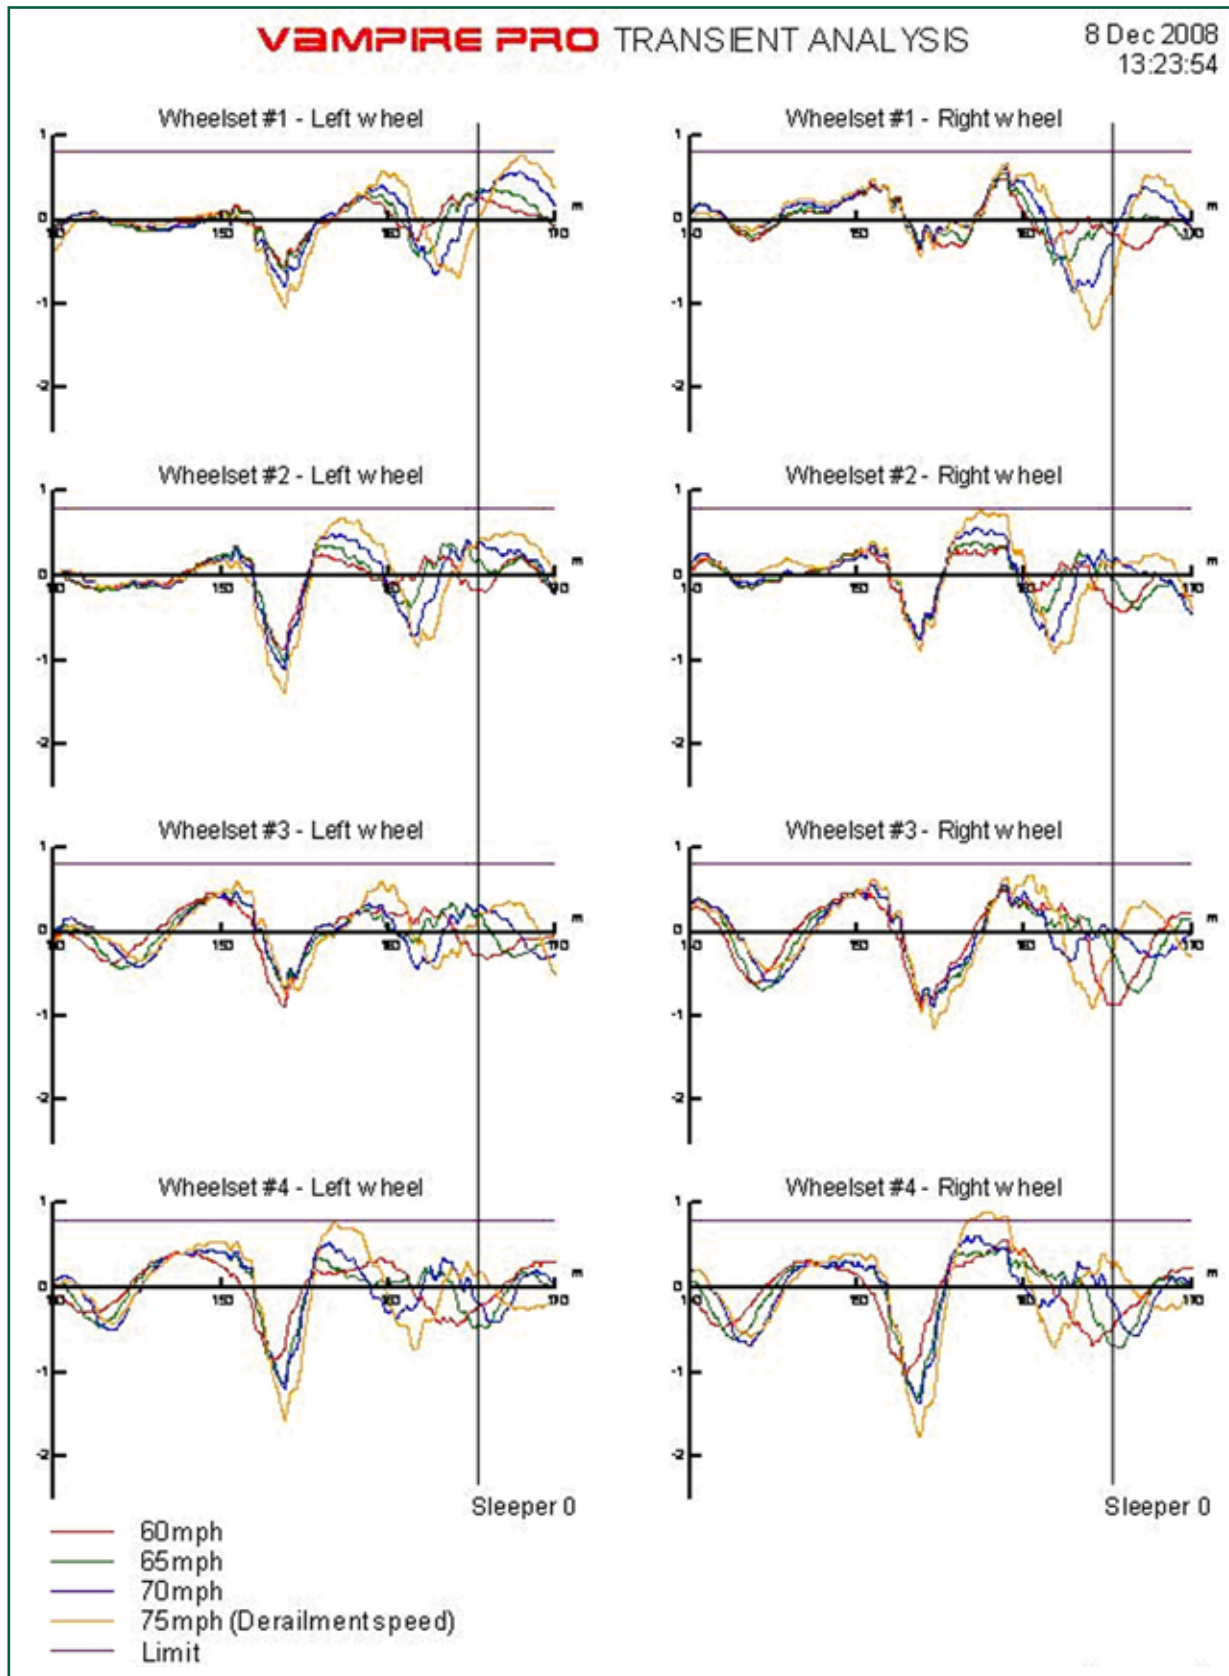
- 210 The effect of speed on the behaviour of a wagon in the Marks Tey condition over the accident track geometry was also modelled. Speeds ranging from 60 mph to 75 mph were examined in 5 mph increments and the results showed that cyclic wheel unloading was still present at all speeds (figure 22); however the dynamic wheel unloading was not sustained for a large enough distance to present a significant risk of derailment at speeds of 70 mph or below. The permitted speed of the train was 75 mph; this was a causal factor in the derailment.

Figure 22: Filtered cycle of wheel unloading on Marks Tey condition wagon at various speeds (image courtesy of Delta Rail)
