Rail Accident Report

**Runaway and subsequent collision near to
Loughborough Central station, Great Central
Railway
12 May 2014**

Report 04/2015
May 2015

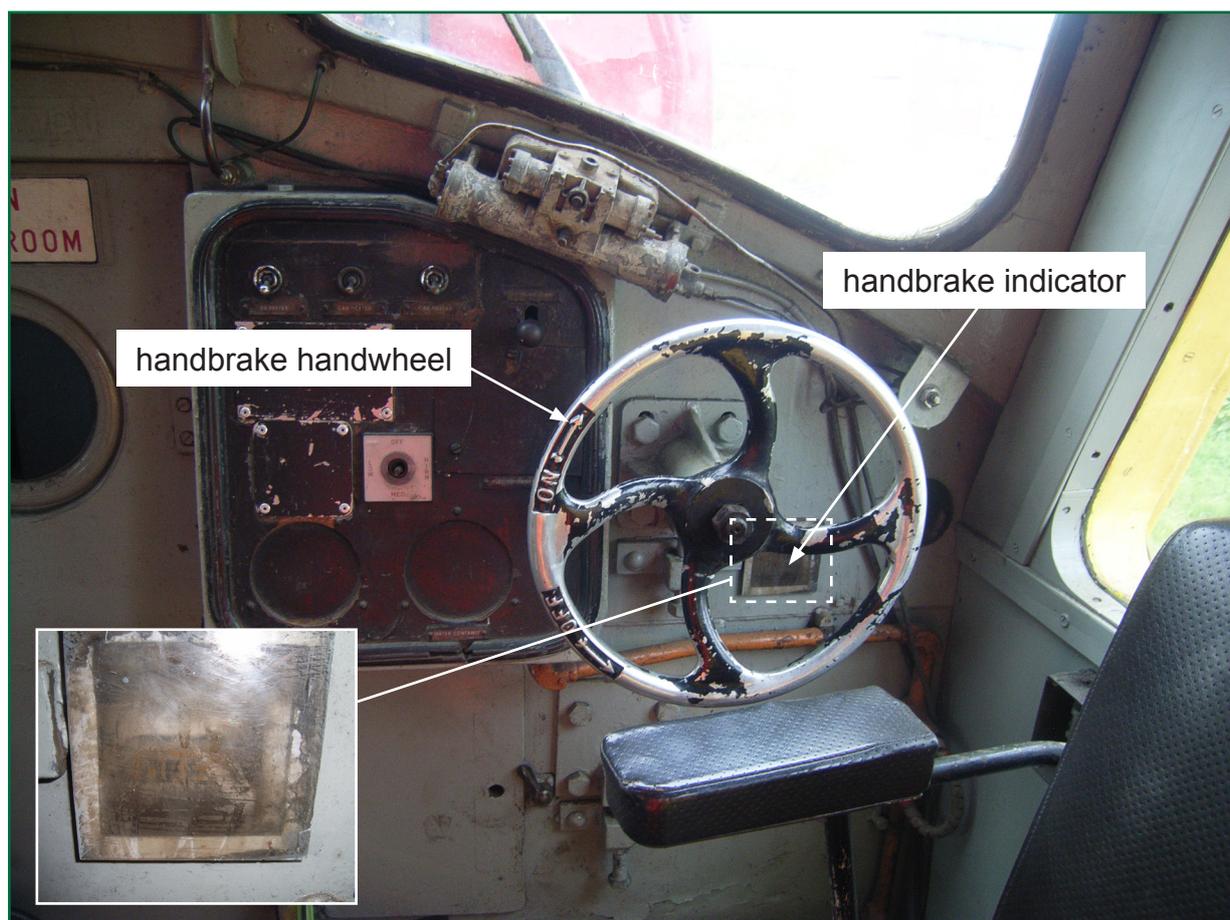
Figure 4: Class 37 handbrake hand wheel and indicator

- 35 Damage to locomotive 37198 meant that only the No. 2 end handbrake (which would have been the trailing cab on the incident train) could be tested by the RAIB following the accident. During this test, the brake blocks were observed to have become fully applied to the middle wheel on the secondman's side after 60 turns of the hand wheel and on the driver's side after 80 turns. This indicated that the No.2 end handbrake was not correctly adjusted. The maintenance of the locomotive is discussed further in paragraphs 123 to 134.

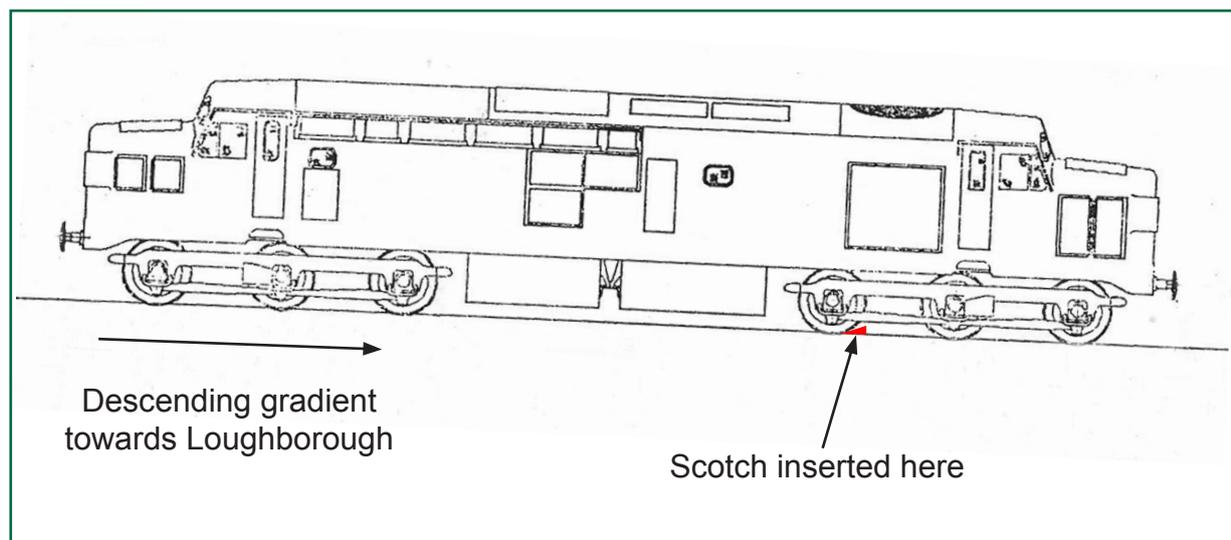
- GCR staff training and competency records;
 - a reconstruction of how the incident train was stabled at Quorn and Woodhouse on 12 May 2014;
 - technical data and schematics relating to the Class 37 locomotive;

Figure 6: The position on the locomotive where Trackworker A placed the scotch

- 60 The available evidence suggests that the scotch was placed in this position by Trackworker A for a number of reasons, including:
- the team exited the cabs from this side of the locomotive (which was closest to the mess room);

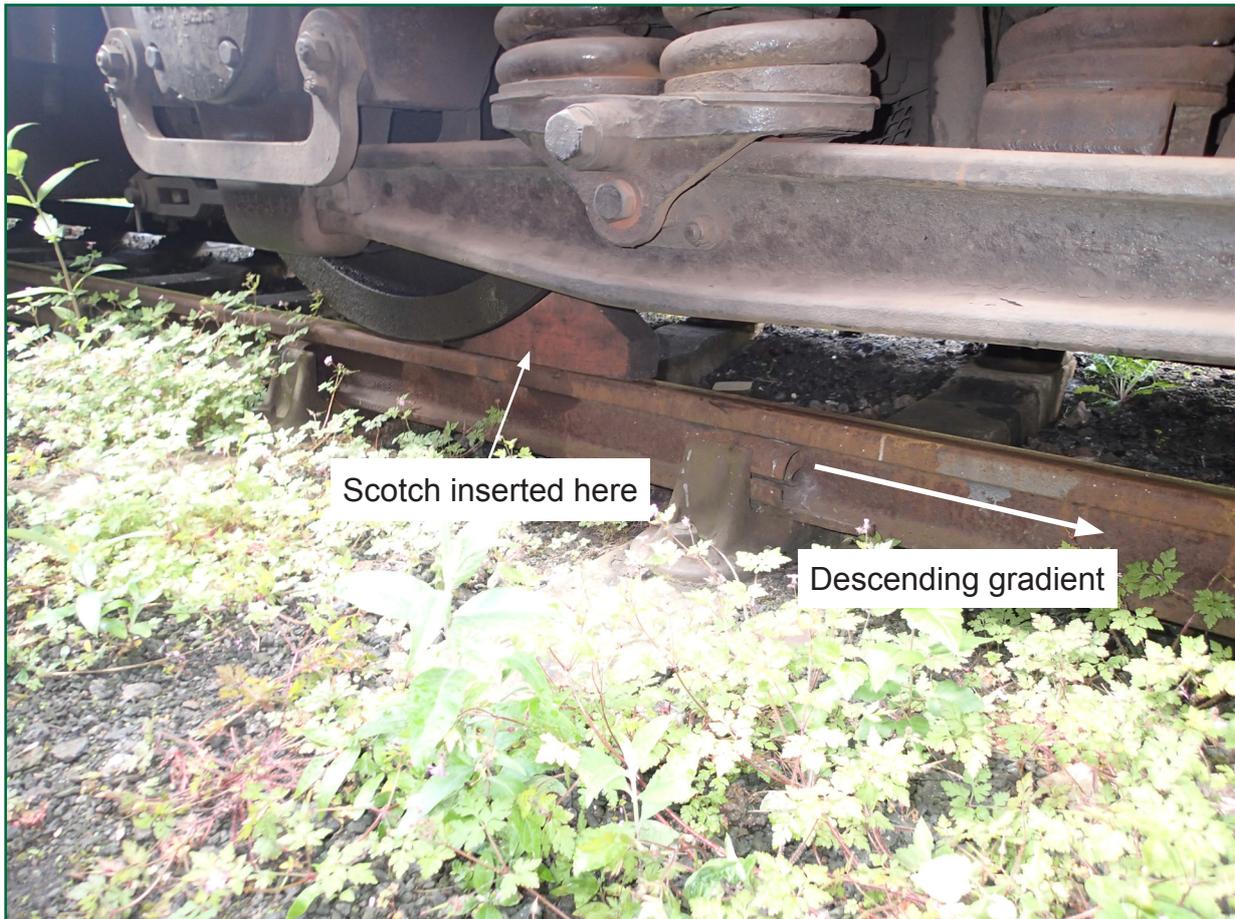
Figure 7: The position of the scotch as it was placed during a post-incident reconstruction

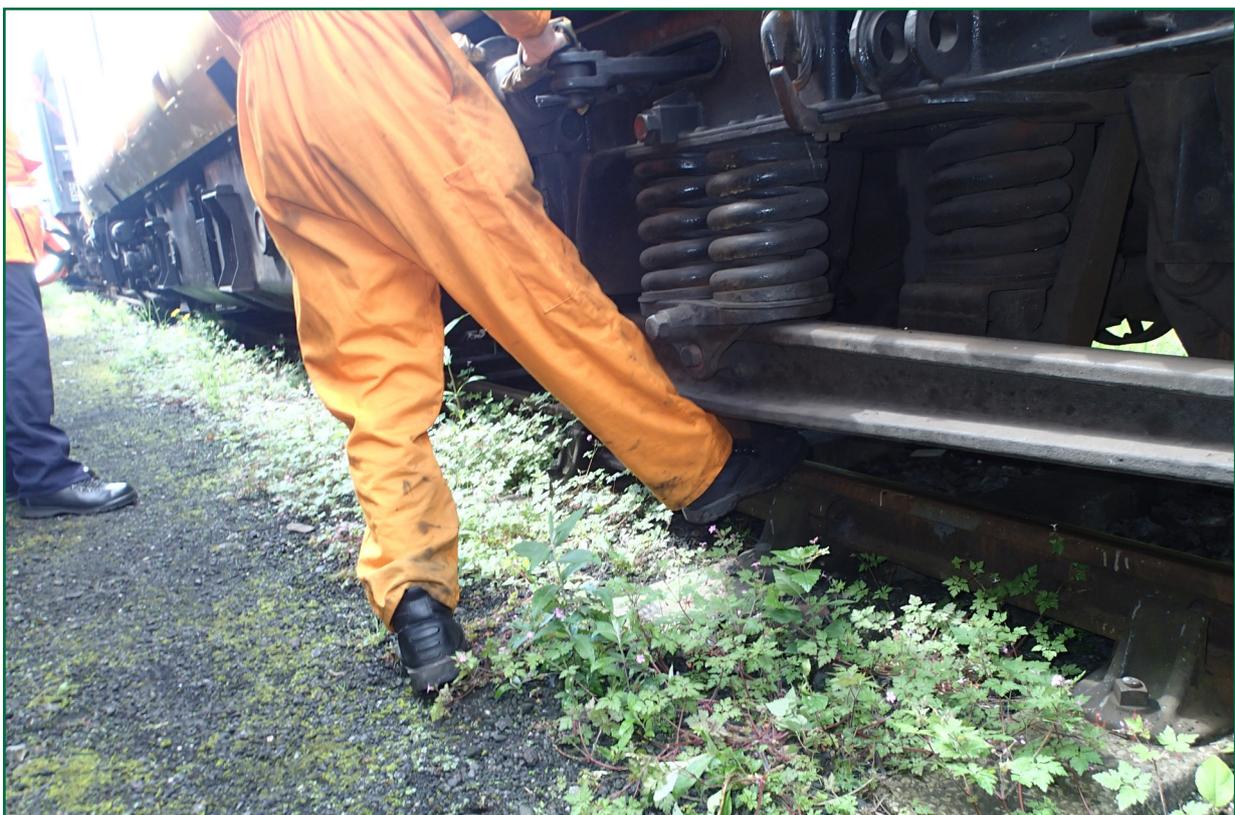
Figure 8: A post-incident reconstruction of how the scotch was driven against the wheel tread

- 75 To be effective, a scotch has to be positioned squarely on the rail head and snugly against the face of the wheel tread. Failure to do this may allow the scotch to fall out or reduce its available holding force. Trackworker A stated that, when he placed the scotch, he was certain that it was 'well in place' and that he was 'very conscious' of the need not to leave a gap between the wheel and the scotch.

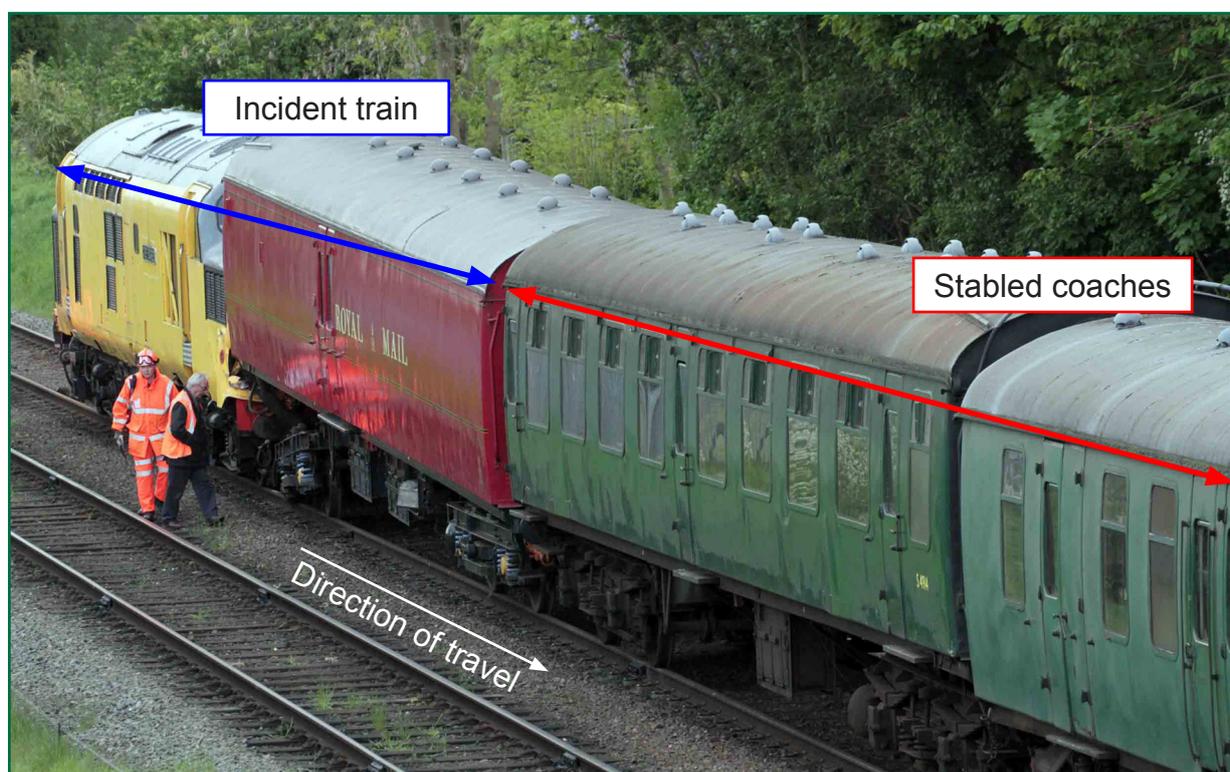
- 62 The PICOP telephoned the operations manager, who was at Loughborough, in order to warn him about the runaway. The operations manager asked a signaller to go to Loughborough North signal box in order to check the status of the track circuits. The signaller concluded from the indications within the signal box that the stabled set of coaches had moved and that a collision had occurred (figures 9 and 10).

Figure 9: The positions of the incident train and stabled set of coaches following the collision (image courtesy of Chris Milner, *The Railway Magazine*)

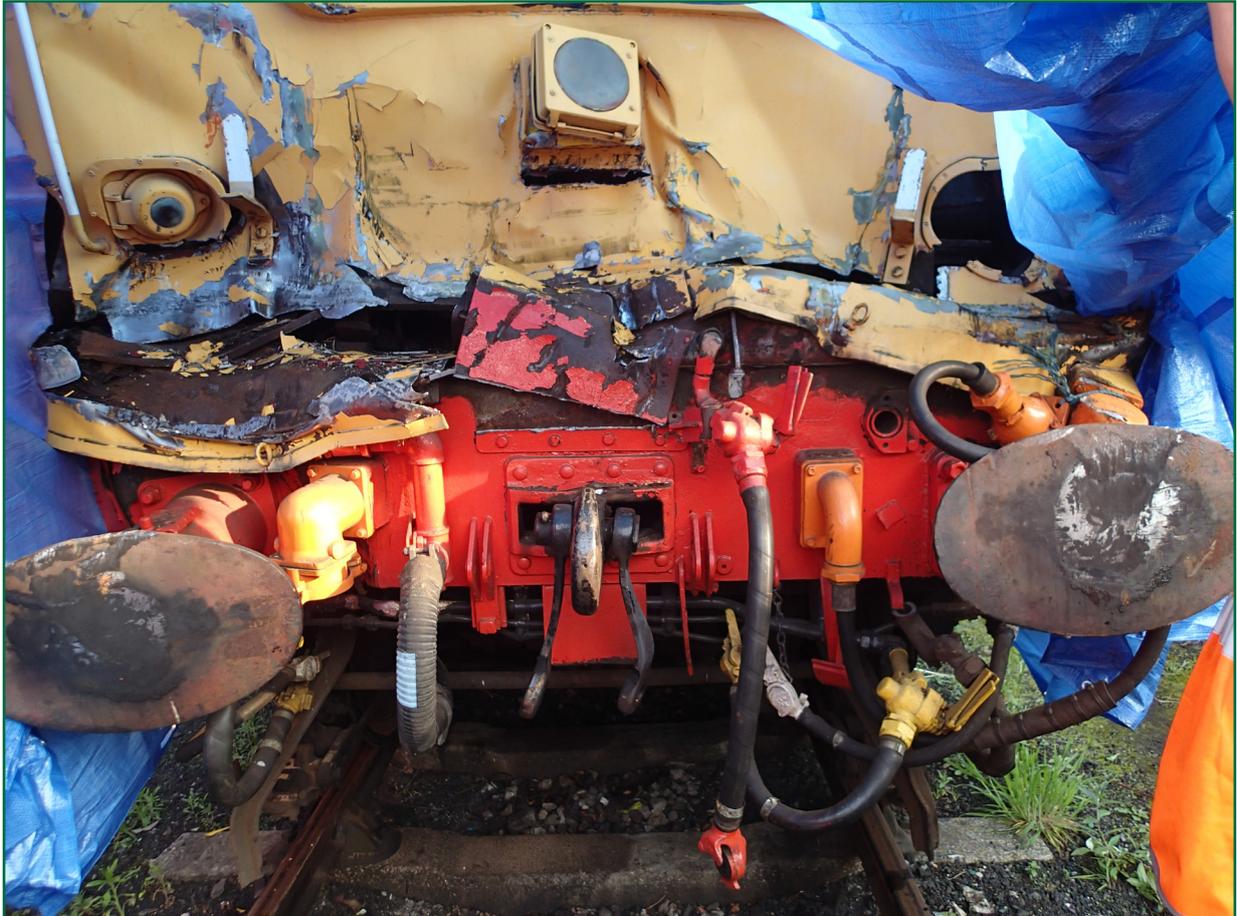
- 7 Nobody was injured as a result of the collision. Significant damage was sustained by some of the rail vehicles involved.

Figure 10: Damage sustained by locomotive 37198 following the collision

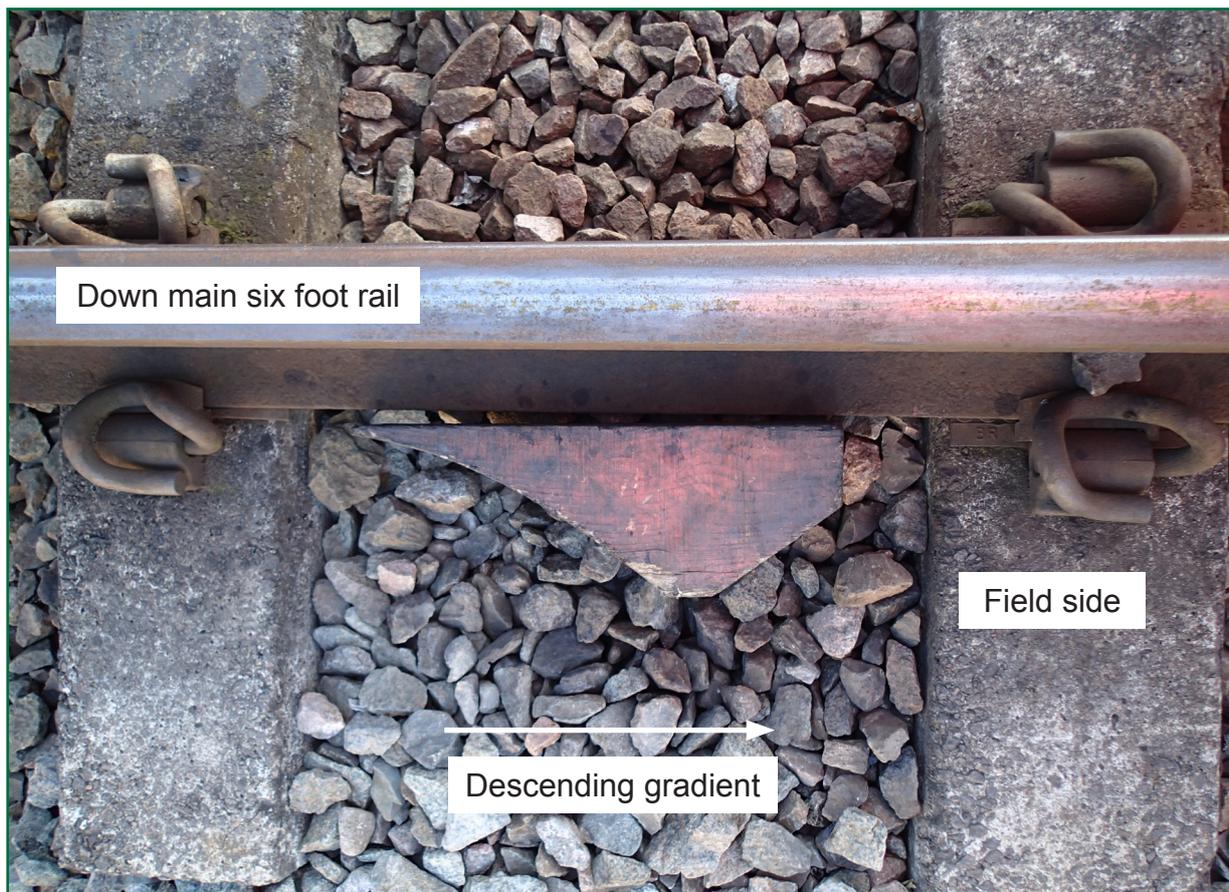
- 64 There is witness evidence that, following the runaway, members of the permanent way team found a scotch on the *field side* of the six foot rail of the down main, a short distance north of where the incident train had been stabled. The RAIB subsequently recovered this scotch during its post-incident examination of the railway at Quorn and Woodhouse (figures 11 and 12).

Figure 11: Position of the scotch as found post-incident by the RAIB at Quorn and Woodhouse

- 82 The RAIB examined the scotch which was recovered post-incident (paragraph 64). This showed that the scotch was in a reasonable state of repair and that it had not been crushed or over-ridden by rail wheels. It was also evident that the base of the scotch was not heavily contaminated with either oil or grease.

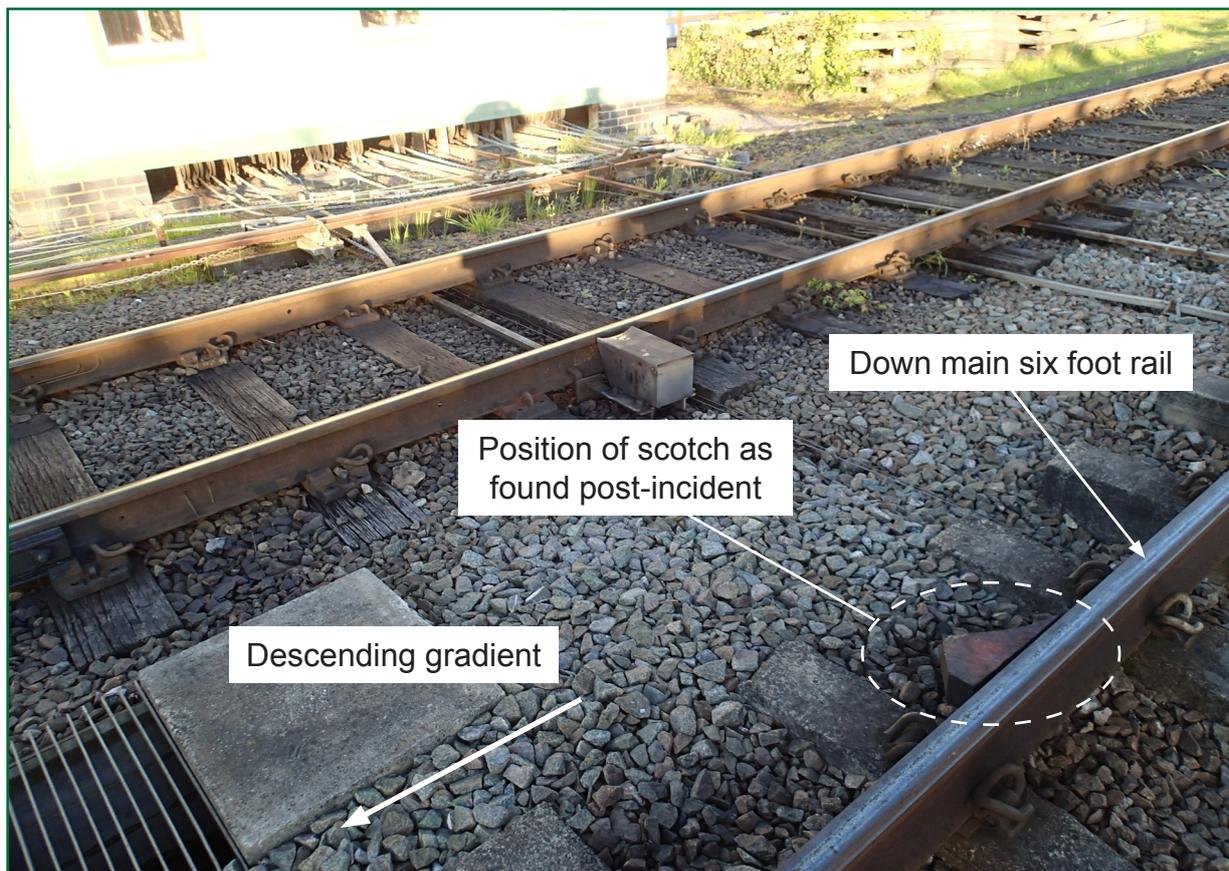
Figure 12: Position of the scotch as found post-incident by the RAIB at Quorn and Woodhouse
