Rail Accident Investigation Branch

# Rail Accident Report

## Trackworker struck by train, Stevenage 7 December 2008

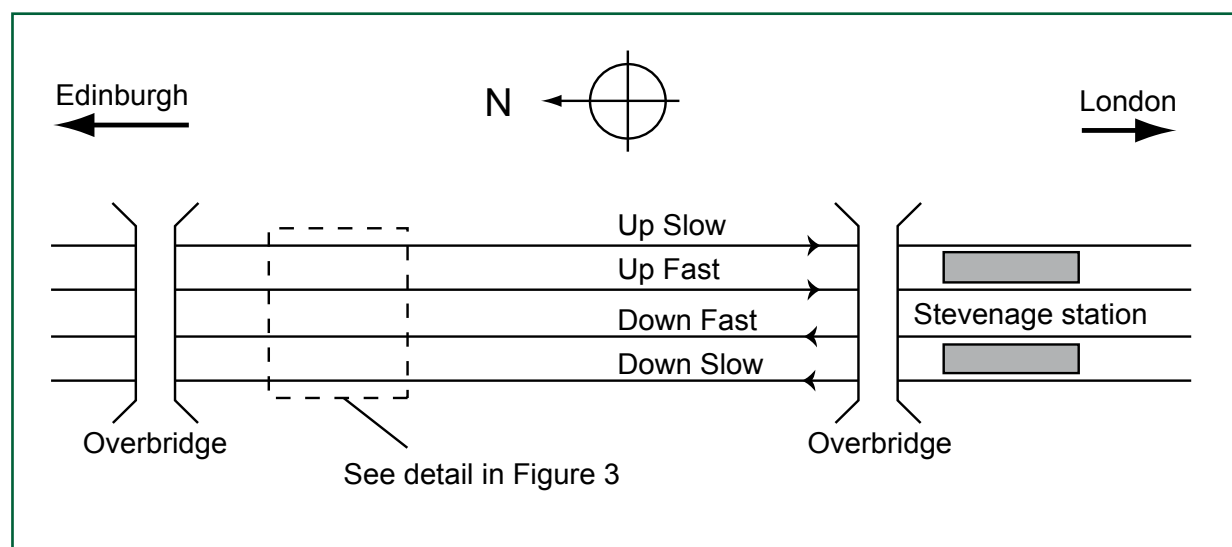
Figure 2: Diagram of the lines at the location of the accident

- 7 At about 17:35 hrs on 7 December 2008 a trackworker came into contact with a train passing a site at which track relaying was taking place at Stevenage in Hertfordshire.
- 8 The trackworker was taken to hospital for treatment of his injuries which were not life threatening.
- 9 The relaying was temporarily suspended for the *Safe Systems of Work* in place to be reviewed, leading to a delay in the re-opening to rail traffic of the line being repaired.

- 63 Where the accident occurred the railway is straight. During normal running of the railway there is clear visibility of the approach of trains.
- 64 The distance between the adjacent rails of the up lines at this location is 3.1 metres.

- 100 In this case the distance between the adjacent rails of the up fast and up slow lines was 3.1 metres. Therefore any work under Separated Green Zone conditions on the up fast line could not take place more than 10 cm from the outer edge of the rail adjacent to the up slow line, unless a Site Warden or fence were to be provided.

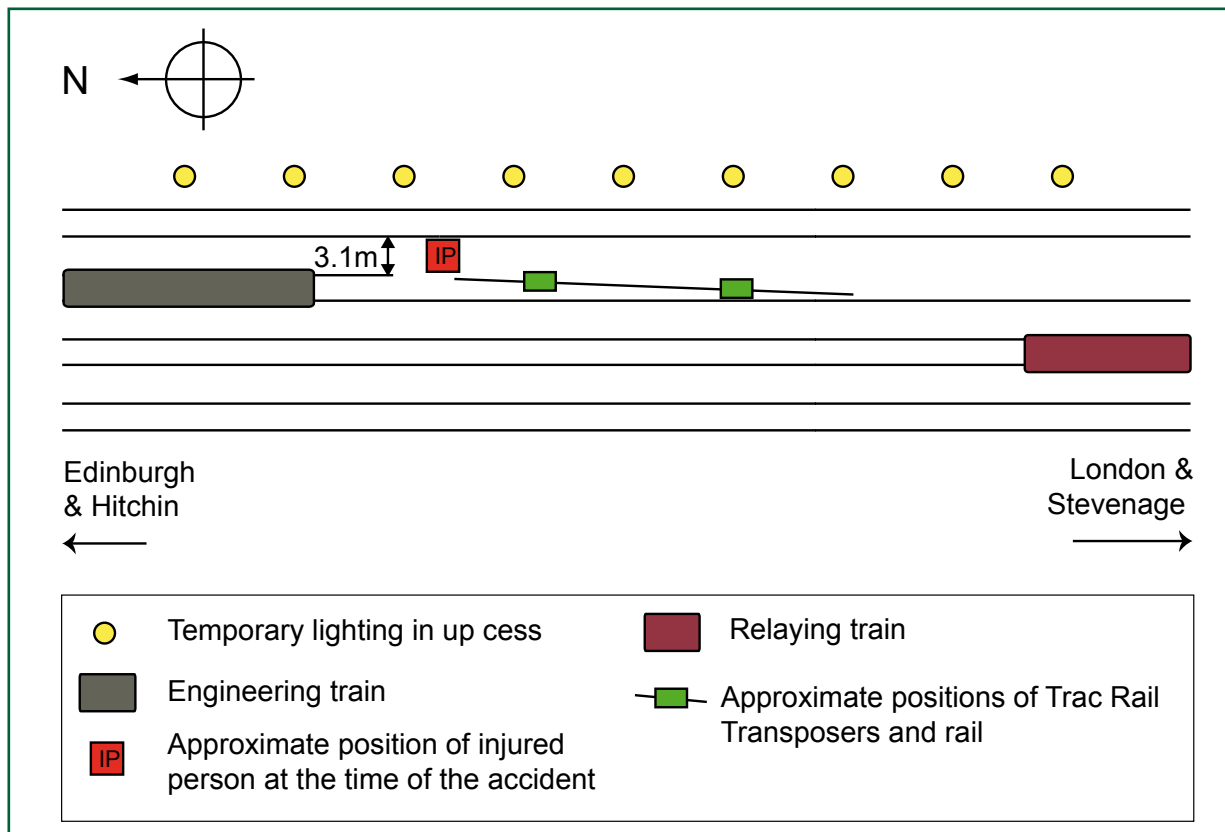
Figure 3: Diagrammatic representation of the site at the time of the accident

- 49 At this time the team members had become separated by their work activities. Some were at the engineering train shown in Figure 3, some by the relaying train and one member of the team, trackworker A, was standing close to the rail end to which the new rail was to be attached. Consequently he had to stand aside from the length of rail being positioned by the Trac Rail Transposers. This resulted in him standing, with a small group of other track workers, in the space between the up fast and up slow lines.

- 52 As the train passed, it obscured the temporary lighting placed in the up cess. The site adjacent to the train was now only lit by the limited light shining through the train windows.

- 53 Trackworker A could not move into his designated position of safety (see paragraph 47) as the Trac Rail Transposers were now working there, so he remained in the area between the up lines facing away from the passing train.

- 54 Trackworker A, who was not aware that the Trac Rail Transposers had temporarily stopped working, now became concerned that the rail being moved might swing unexpectedly and strike him. He felt that the position he was in was no longer safe as he was unable to see the exact location or movement of the rail being positioned. He has since stated that as soon as the train had passed he had intended to alert the COSS that the designated position of safety was no longer safe. As an immediate measure, he decided to establish how far back he could move towards the up slow line to get away from the Trac Rail Transposers.

- 55 He began to turn to his left to see how much space remained between him and the passing train when he came into contact with it and fell to the ground towards the up fast line. The other trackworkers standing near him were far enough from the train not to come into contact with it.

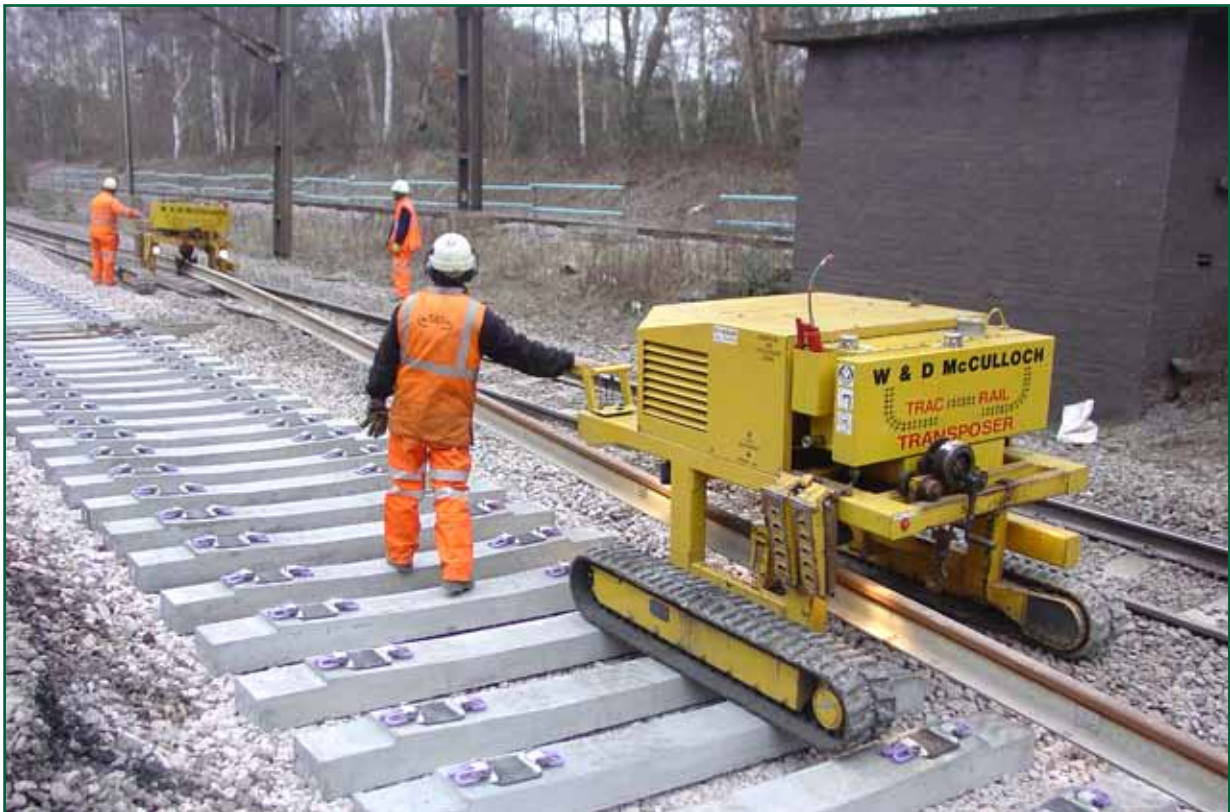
Figure 4: A Trac Rail Transposer in use

- 89 The rail being positioned can suddenly move laterally when it is lifted, particularly if it has been obstructed in its initial movement. Consequently, W&D McCulloch have imposed an 'exclusion zone' around each Trac Rail Transposer whenever it is moving rail, which can only be entered by the operator. This zone extends 5 metres in all horizontal directions and the Trac Rail Transposers carry a notice stating 'MAINTAIN 5M EXCLUSION ZONE'. The RAIB has found no evidence that staff other than those employed by W&D McCulloch are aware of the extent of the exclusion zone or that they have been briefed on its implications.

- 90 Although they are powered equipment, Trac Rail Transposers do not classify as rail vehicles because they run on their own caterpillar tracks rather than rails. They are not required by the Rule Book to stop working while a train passes a work site.

- 91 The Engineering Supervisor in charge of the work site instructed the Trac Rail Transposer operators directly to move the rail without reference to any of the other staff already working on the site.

- 92 There is evidence that, apart from the Trac Rail Transposer operators, none of the staff involved in the accident had received instruction on working in proximity to Trac Rail Transposers.

- 120 When Trac Rail Transposers are in use an exclusion zone of five metres should be set up around them, as indicated by a notice carried on each Trac Rail Transposer (see paragraph 89). It is usual for the Trac Rail Transposer operators to ensure that staff do not move into an unsafe position in relation to the rail being moved.

- 2 Jarvis Rail should enhance its risk assessments to include Trac Rail Transposers and the inclusion of any risk mitigation measures in documented working arrangements (this should include an assessment of the exclusion zone around the machines and its enforcement). Jarvis Rail should subsequently brief all relevant staff (and in particular Engineering Supervisors and Controllers of Site Safety) on the hazards identified and the nature of the exclusion zone (paragraphs 124b, 124c, 124d and 124f).

- 6 Network Rail, in consultation with the users of Trac Rail Transposers, should review the conditions of their operation, when they work in close proximity to lines that are open to traffic, with particular reference to the effect of the exclusion zone on the safe passage of trains (paragraph 121).
