Defence  
Infrastructure  
Organisation

# SAFETY ALERT

**Subject: CATASTROPHIC FAILURE OF A PIPEWORK CLAMP CONNECTOR**

**Number: SA 2015/12**

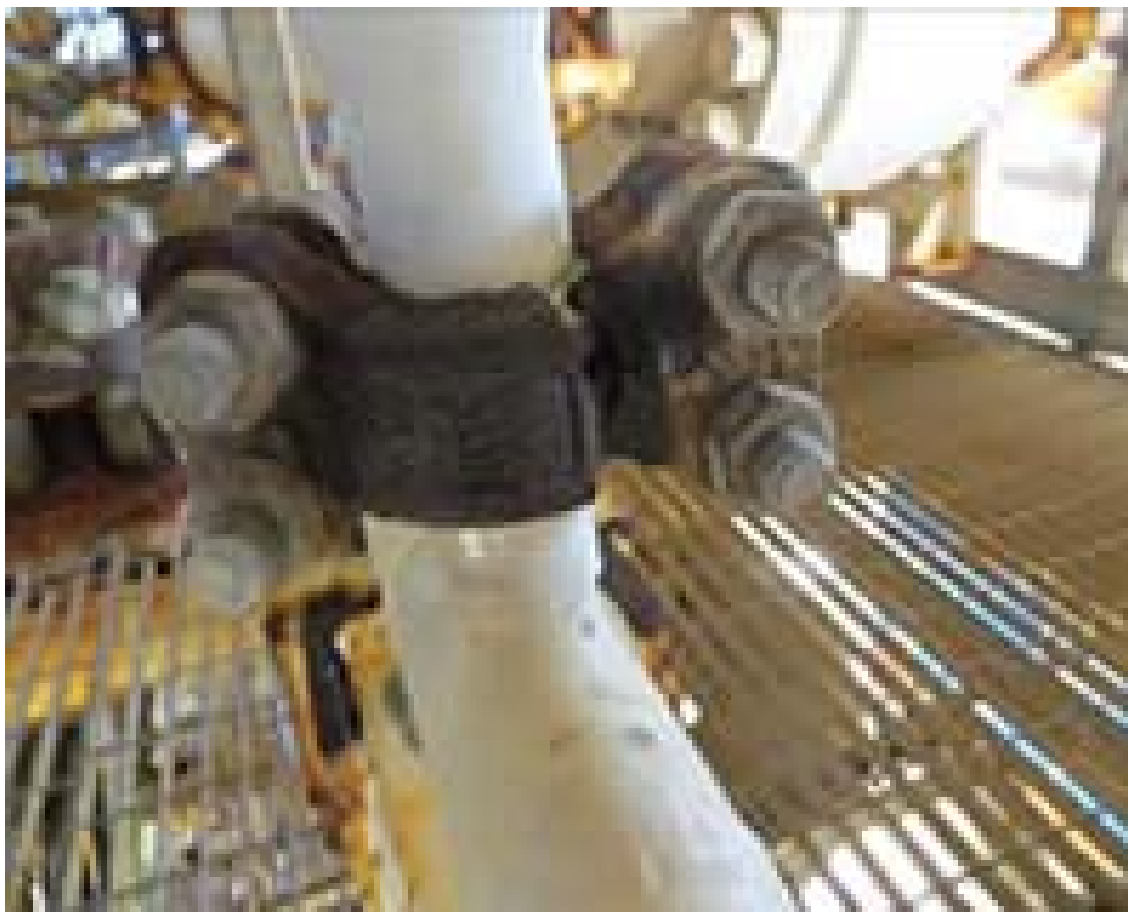
4. An incident occurred on an offshore production platform in December 2014 where a 1" diameter Vector 'Techlok' pipework clamp connector catastrophically failed causing a gas release. The failure was caused by poor heat treatment during the manufacturing process, which led to failure by cracking. Similar failures have occurred on other small-sized (1", 1 1/2" and 2" diameter) clamp connector segments. Further information can be found at HSE Safety Alert Bulletin No. ED 2-2015: <http://www.hse.gov.uk/safetybulletins/catastrophic-failure-of-a-techlok-clamp.htm?eban=govdel-safety-bulletins&cr=21-Sep-2015>

12. HSE investigation of the December incident on an offshore production platform following the uncontrolled release of gas concluded that the primary cause of the catastrophic pipework clamp failure was due to hydrogen cracking. Evidence from this clamp and others checked later indicates that high hardness, with values in excess of 48-50HRC (Rockwell hardness value), being the underlying cause. High hardness increases the material's susceptibility to cracking in general from reduced ductility.

13. Clamp connector segments are produced by a forging process in a number of foundries in the UK and are manufactured from AISI 4140 alloy steel with a recommended Rockwell hardness value of 22HRC. Investigations revealed that prior to 2010 the clamps, which require quench and temper heat treatment, were not subject to 100% hardness testing. Hence the quality controls were not sufficient to detect components that had received improper heat treatment and lacked ductility.

Figure 1 Showing Cracking caused by poor heat treatment during manufacturing process

6. Responsible persons are to identify if they have in use any 2" or below Techlok or Destec 'G' clamp connectors supplied before 2010, or have the potential to be used (for example spares kept in stores) on any of their installations and to verify their fitness for continued service. Verification could be established from supplier records, whereby the material properties of the clamps are fully certified, or by appropriate NDT inspection and hardness tests.

7 Any found to exceed acceptable hardness values must be taken out of service and either destroyed, exchanged or otherwise prevented from reuse. Note that clamp segments may also have been supplied by other vendors along with their main products (e.g. valve assemblies) and duty holders should ensure that these are subject to the same checks.
