AAIB
Air Accidents Investigation Branch

AAIB Bulletin

7/2016

Published 14 July 2016

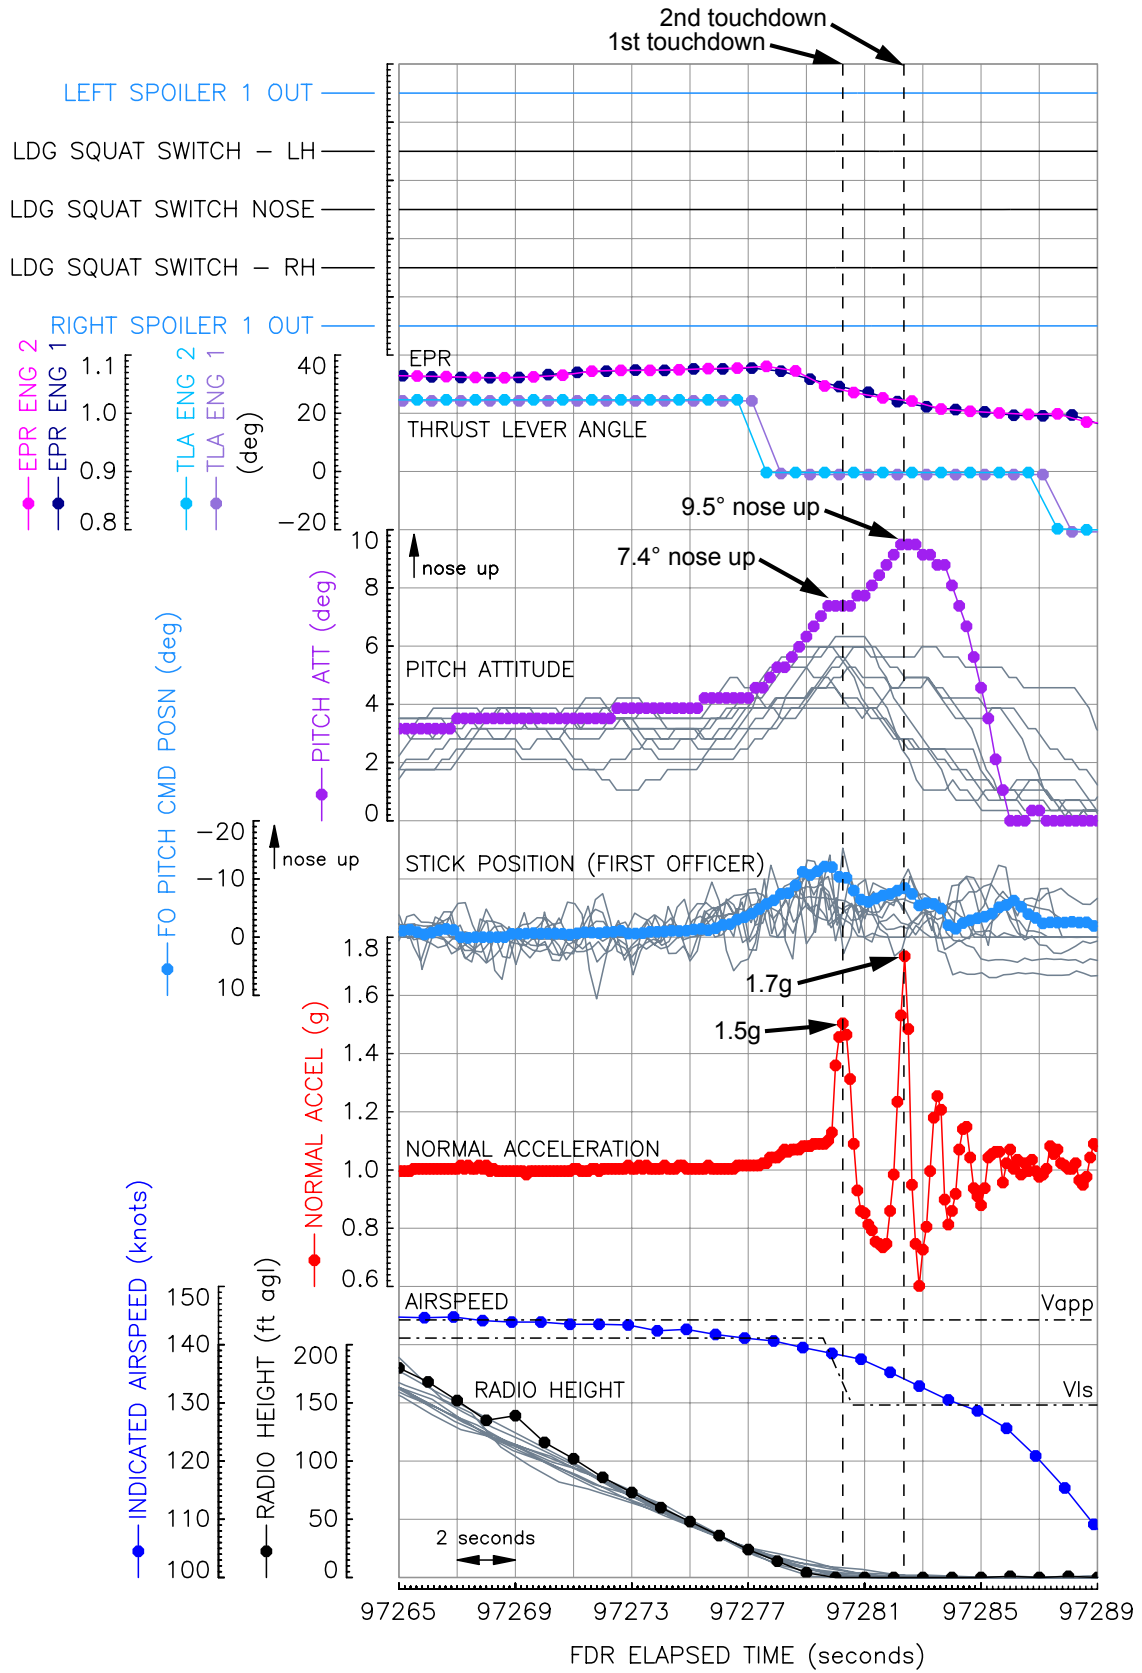
Figure 1

FDR data for the tailstrike event and elements of ten previous landings (grey traces)

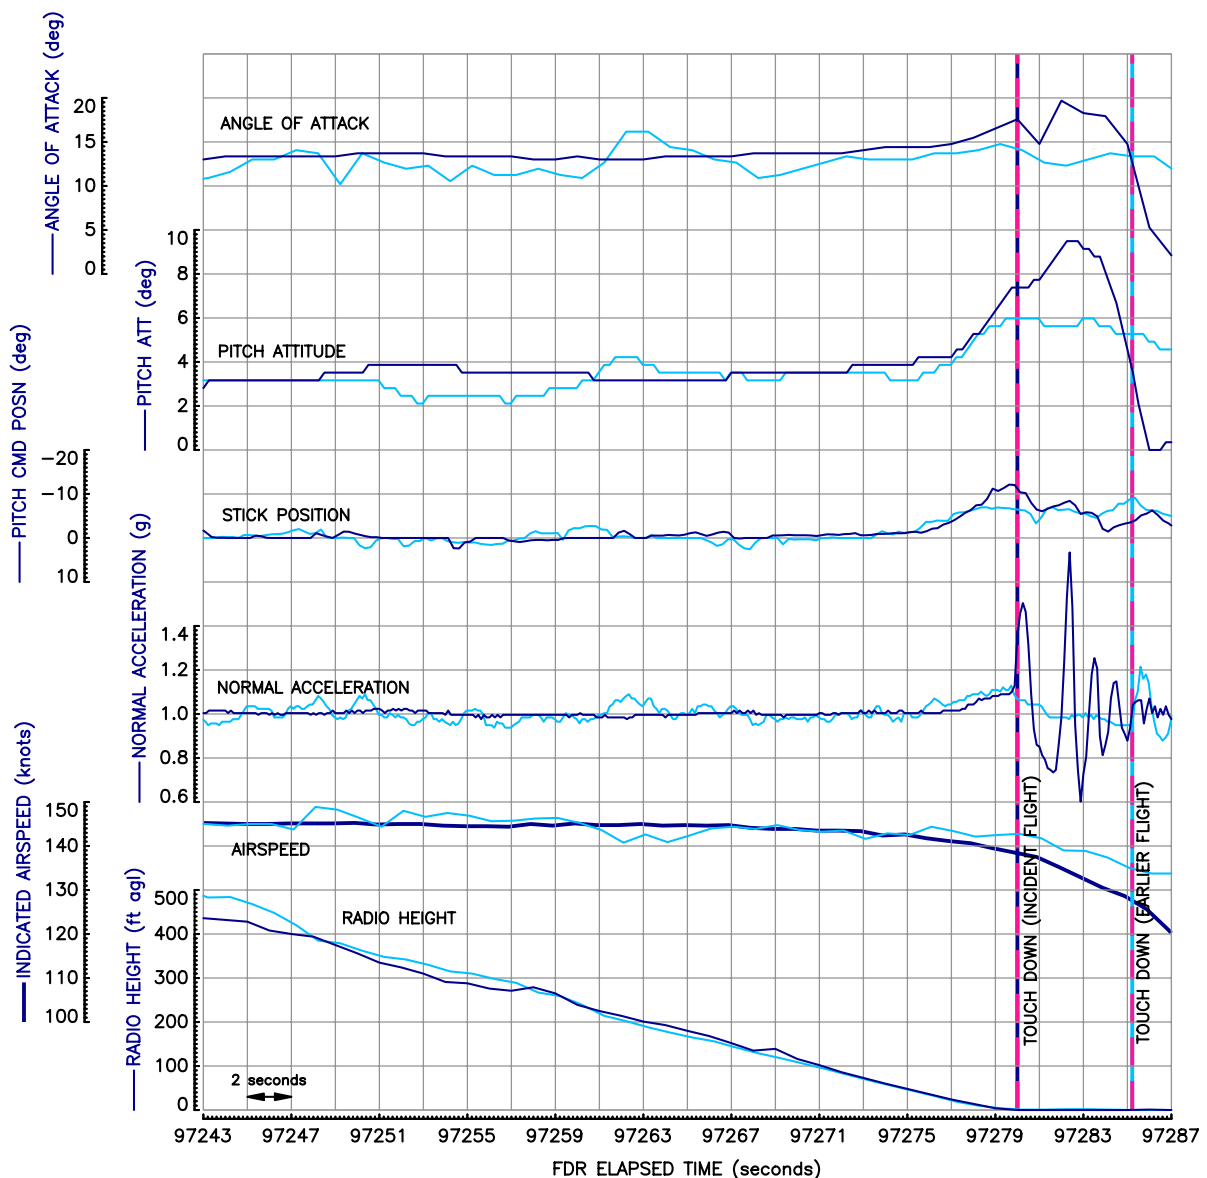
Figure 2 compares the tailstrike event with one of the previous landings (light blue traces), also aligned in time at 30 ft agl. The flight profile and aircraft attitudes are similar until about 50 ft agl when the flare is initiated. The earlier flight shows a positive aft sidestick input to a maximum of 7° over 3 seconds, without any loss in airspeed. However, for the tailstrike event, the aft stick input is initially slower but reaches a maximum of 12° aft over a period of 4 seconds, just prior to touchdown, during which the airspeed decays by about 4 kt. For both landings, the thrust levers are reduced to idle at 25 ft RA. However, the airspeed decays more gradually on the earlier flight and touchdown occurs 5 seconds later than on the tailstrike event.

Comparison of data on the tailstrike event (dark blue)
with an earlier landing on G-EUXF (light blue)

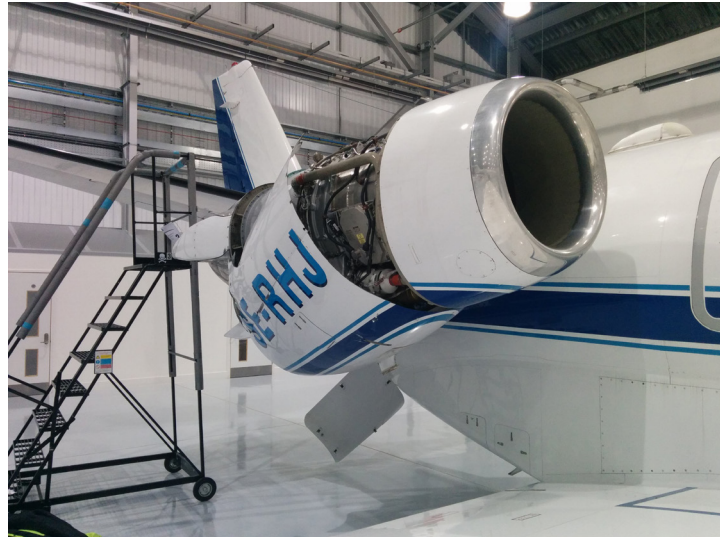
Figure 1

The aircraft was recovered to a local maintenance organisation where the majority of the right engine upper cowling was observed to be missing, Figure 1. Damage on the leading edges of the vertical and horizontal stabilisers was consistent with them being struck by debris.

Right engine cowlings following recovery of the aircraft to the hangar

It is unlikely that the fasteners were the wrong size or had failed in flight and investigation concluded that the cowling probably detached because a number of fasteners had not been securely fastened during maintenance.

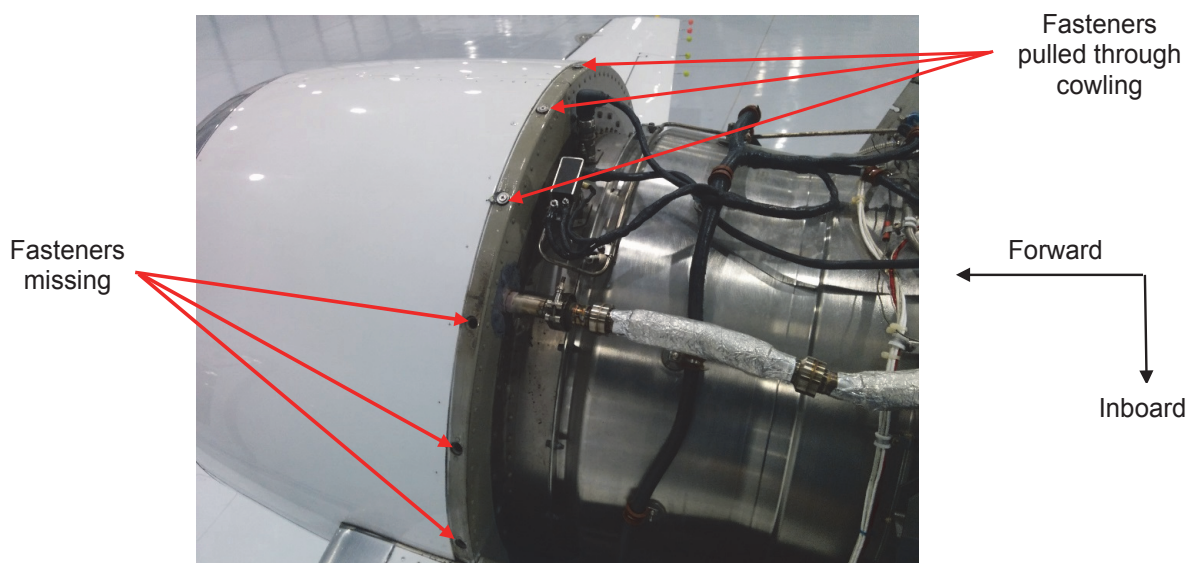
Figure 2

The remnants of the upper cowling that remained with the aircraft had been pulled from the fasteners, which, with the exception of four, remained securely locked, Figure 2. Three fasteners were missing from the inboard leading edge and one was missing from the inboard trailing edge. The empty locking receptacles were confirmed to be serviceable using a representative fastener and the surrounding structure showed no evidence of damage.

Upper cowling inboard leading edge attachment fasteners

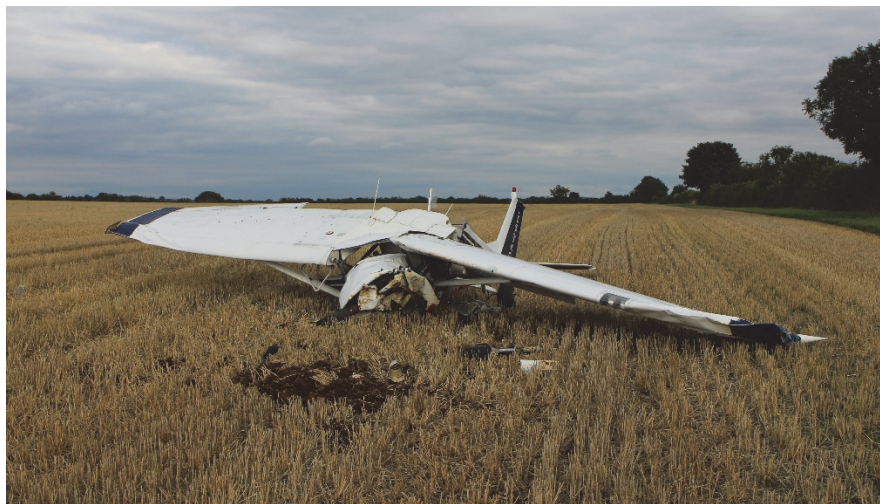
Figure 2

The aircraft came down 230 m from the end of the concrete surface in a stubble field with a dry densely packed stony soil surface (Figure 2). It had impacted the ground nose-down at an estimated angle between 10 and 15° from the vertical, leaving a 150 mm deep impression in the soil. The nose landing gear had detached and the aircraft had fallen back to rest upright on its main landing gear which was displaced, twisted and folded underneath the aircraft. One of the propeller blades was curved to the extent that the tip was pointing forwards. The other blade was less damaged, with slight distortion to its tip and deep nicks in the leading edge. The propeller spinner was crushed against the propeller boss leaving impressions of the propeller attachment bolts.

Accident site and impact mark

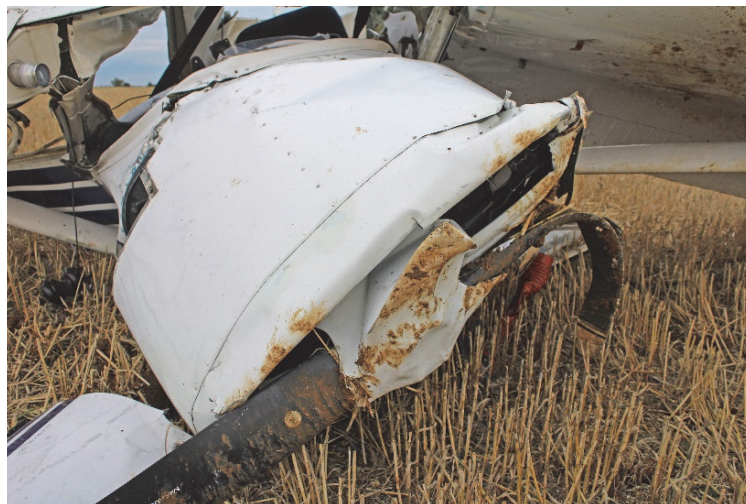
The damage to the propeller indicates that one of the blades cut into and drew itself deeply into the soil at the point of impact (Figure 3). The extent of the bend of this blade indicates that it was under high power at this point and the relatively little damage to the other blade shows that the propeller was brought to a stop in one revolution or less. The very steep aircraft angle at impact meant the propeller was presented to the soil almost fully face-on and did not exhibit the multiple progressively increasing tip impacts characteristic of a more shallow impact angle. The propeller effectively tried to 'screw' itself into the ground, causing extreme bending and leading to the conclusion that the engine was at a high power setting.

Figure 3
Propeller damage

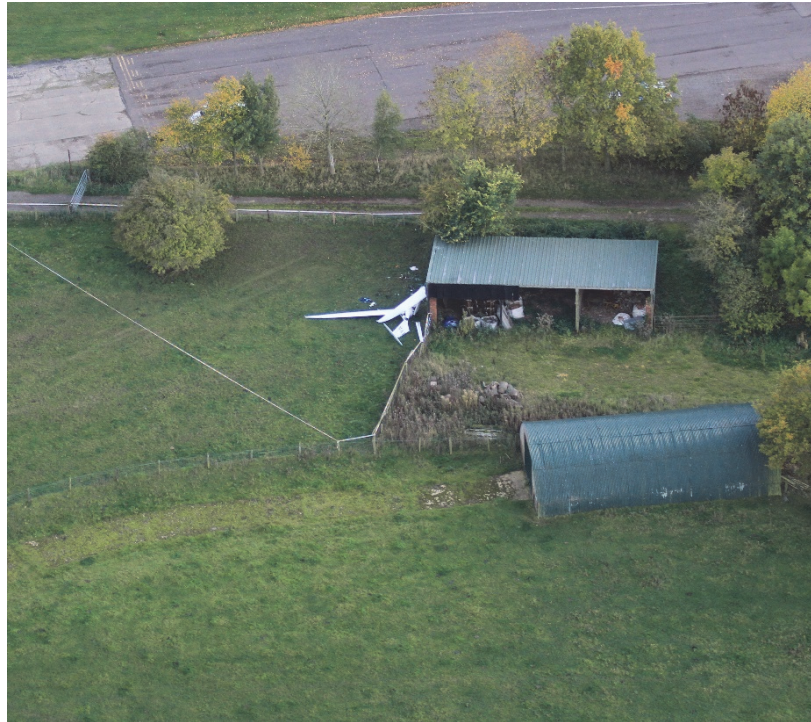
The aircraft impacted the roof of a farm building located 20 m north of the northern taxiway at Husbands Bosworth Airfield, (see Figure 2). Ground marks and damage to the building indicate that the aircraft was in a steep nose-down attitude when the outer 4 m section of the right wing hit the roof of the building before the left wing and fuselage impacted the ground.

Figure 2
Accident site

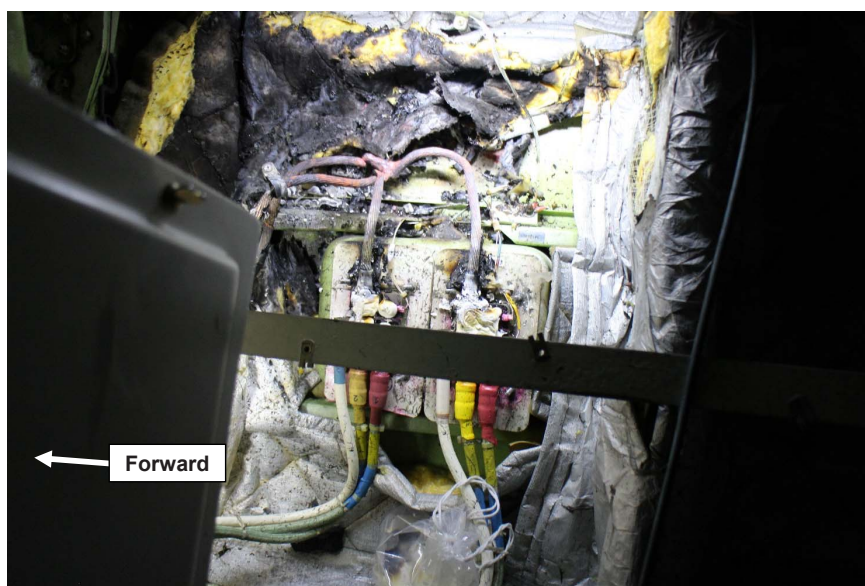
Figure 1

A more detailed inspection of the aircraft was carried out after arrival at Heathrow. Examination of the E/E bay revealed significant sooting and heat damage to the power cables, and the insulation in the underfloor compartment appeared to have briefly caught fire (Figure 1). The limited volume of air around the wiring might have been a factor in preventing further damage. The aircraft structure was assessed, including eddy current testing, but despite the sooting there was no degradation in the aircraft's structural integrity.

An inspection of both receptacles revealed that the neutral phases were severely overheated, with some evidence of electrical arcing.

Image of GPU receptacles with the E/E bay floor panel removed showing fire damage

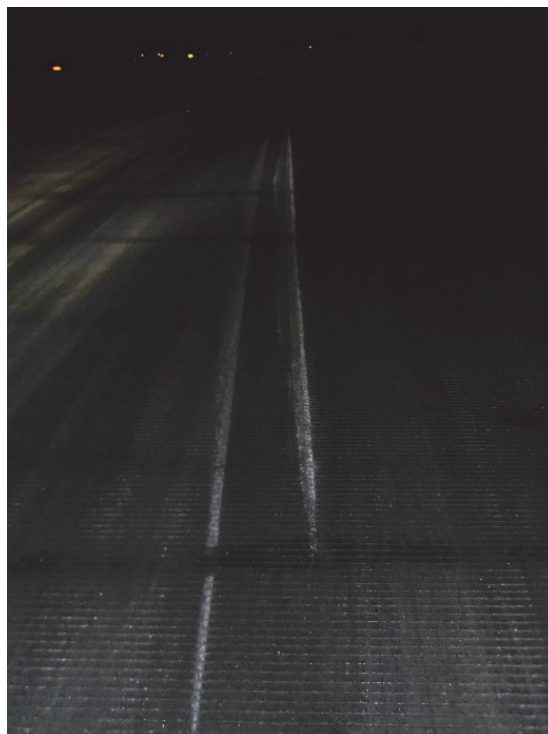
Figure 1

An ATC controller thought he saw a spark from the vicinity of the aircraft when it landed and asked an airfield operations officer to investigate. A technician, working abeam the touchdown zone, told the operations officer that the aircraft had seemed to roll to one side while landing. The operations officer inspected the runway and found witness marks, which started approximately 270 m from the displaced threshold and 1 m to the left of the runway centreline (Figure 1). The operations officer passed this information to ATC and visited the parked aircraft, where the crew had discovered scuff marks and abrasions to paintwork on the left wingtip.

Witness marks on Runway 25, viewed looking east towards the landing threshold

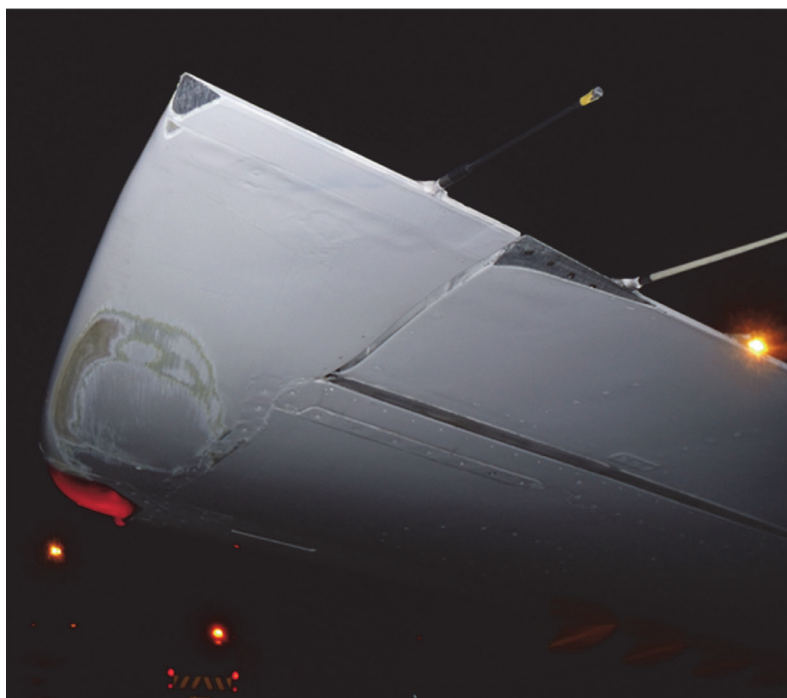
Figure 2

Following the accident, surface abrasions were noted to the left wingtip fairing and the left aileron (Figure 2). Subsequent examination proved that the wingtip fairing could be repaired but the aileron was damaged beyond acceptable limits and was replaced.

Damage to the left wingtip and aileron of G-CGWW
(photographs courtesy of Newcastle Airport)

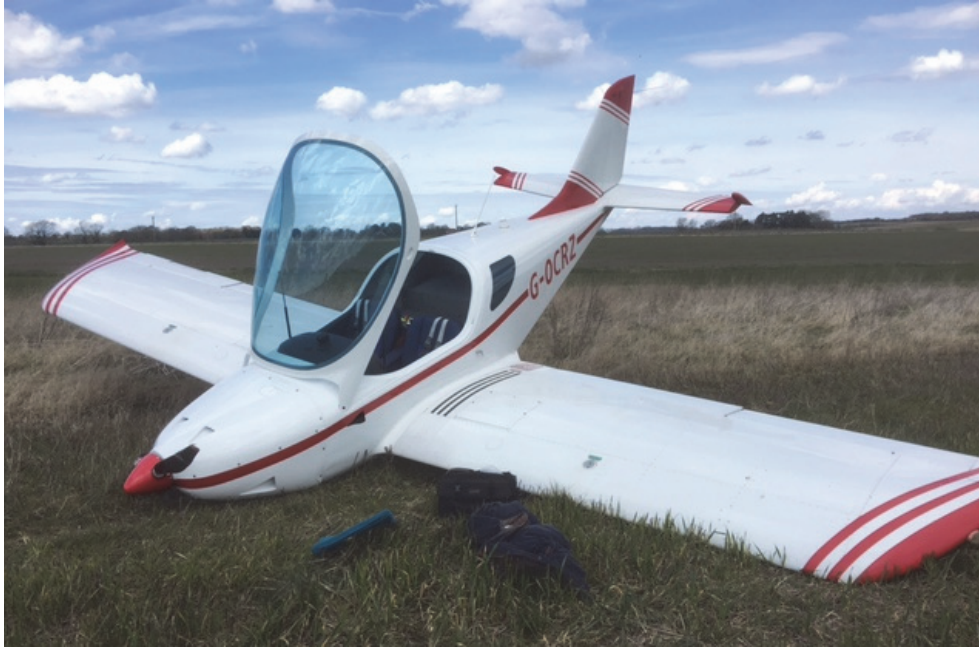
Figure 1

The nose leg immediately collapsed and detached, and the propeller struck the ground. As the aircraft slowed, the left main landing gear collapsed and the aircraft came to a halt with its nose and left wing resting on the ground (Figure 1). The pilot turned the master switch OFF and vacated the aircraft without difficulty.

G-OCRZ after the landing accident

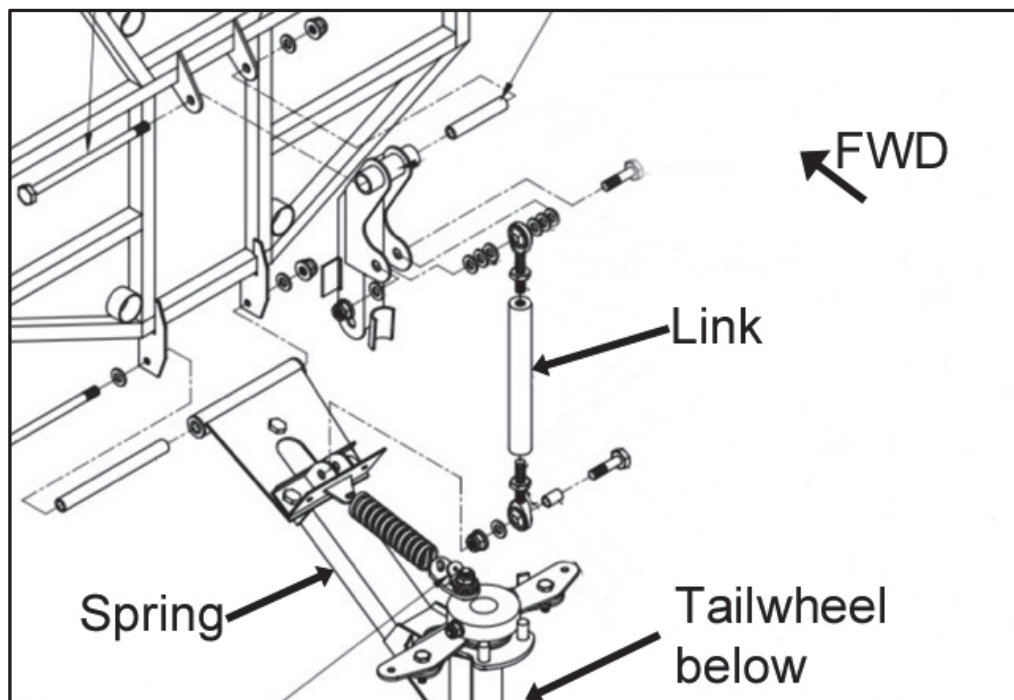
Figure 2

Earlier in the year the owner discovered that the aluminium tailwheel spring had bent. He discussed this problem with the kit manufacturer and thought the kit manufacturer had advised re-installing the spring upside down. The owner installed the spring upside down and after landing on 8 April 2016 the spring failed. The owner obtained a new spring and installed it in the aircraft. He carried out an uneventful flight on 16 April 2016. The subsequent flight was the incident flight on 14 May 2016 when the link failed at a rose joint.

Tailwheel installation showing spring and link location
