# Rail Accident Report

**Dispatch of a train with an unsecured load,  
Basford Hall Yard, Crewe  
21 February 2006**

# Dispatch of a train with an unsecured load, Basford Hall Yard, Crewe 21 February 2006

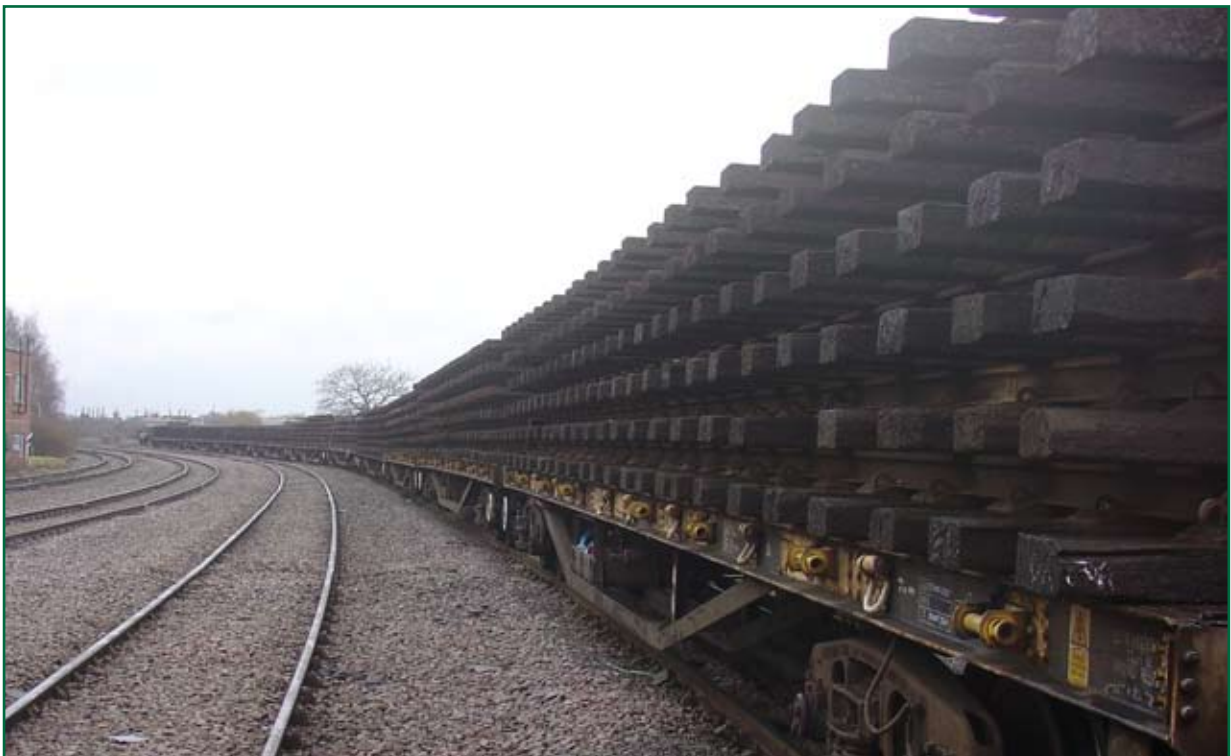
- 87 Train 6D51 was viewed and photographed at Toton on 22 February 2006 in the condition it arrived from Basford Hall. Only one strap was in place over the track panels on one of the wagons. A number of other straps were found loose on the load. It was not possible to determine how many straps had been removed by TMA at Basford Hall, and how many fell from the wagons during the journey.

*Figure 10: Part of the train after arrival at Toton*

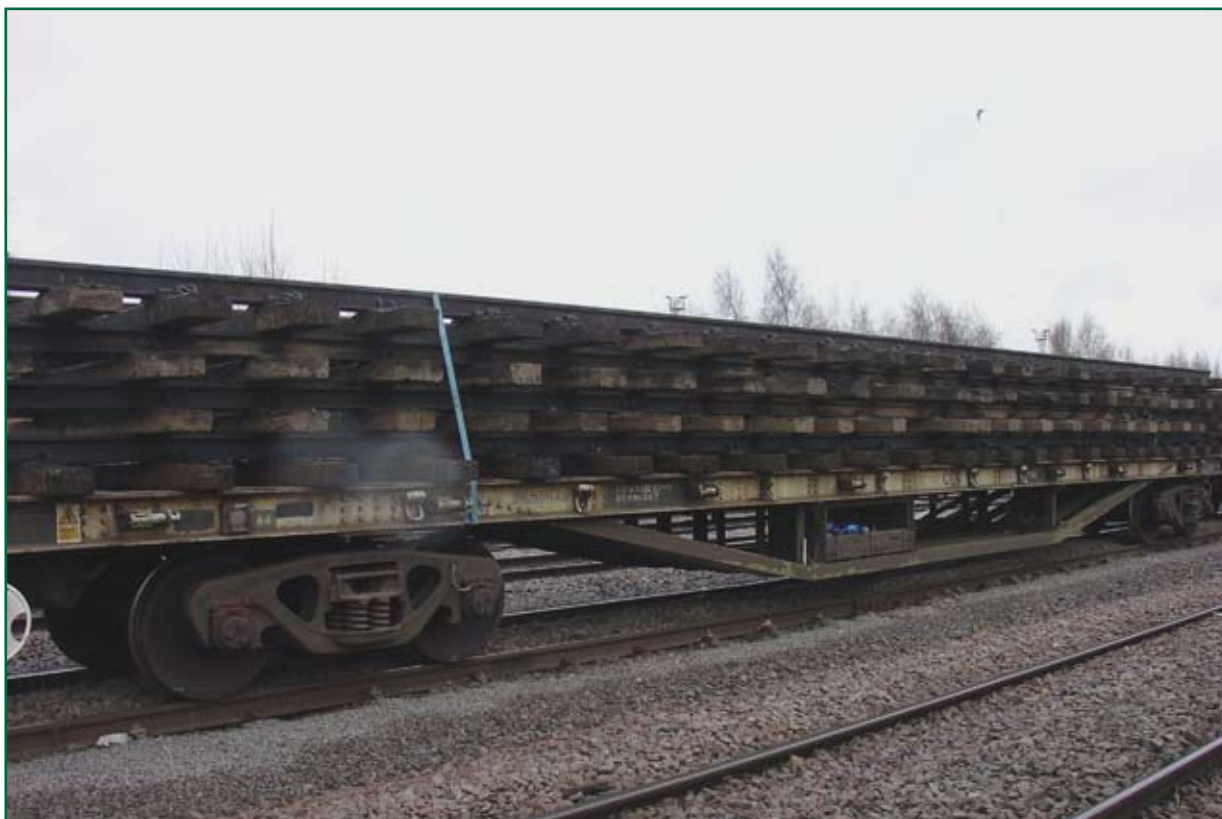
Figure 11: Wagon with one strap attached.

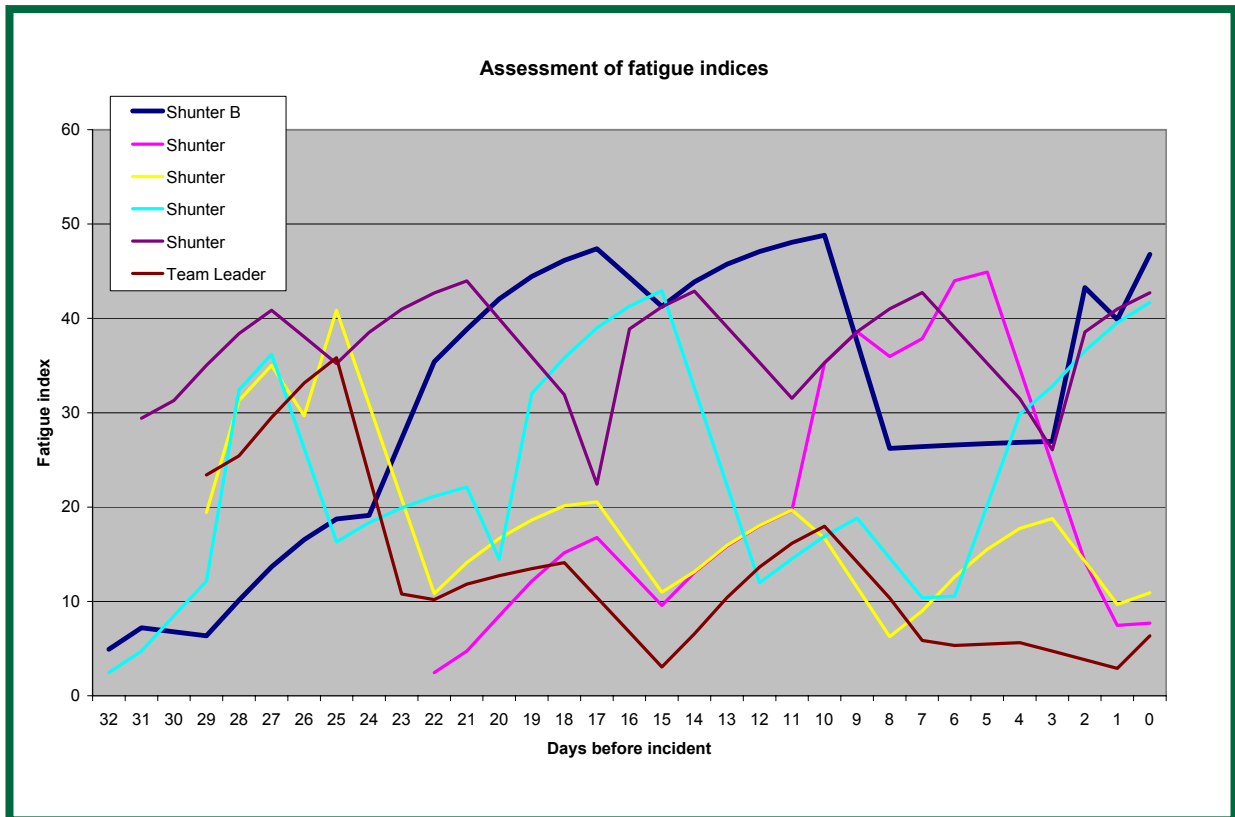
125 The RAIB assessed the hours that five shunting staff, including shunter B, and a team leader worked over the preceding weeks using the newly developed HSE Fatigue and Risk Index (FRI) (This is made up of two separate Risk and Fatigue indices, as detailed in Appendix C).

Figure 12. Chart showing the fatigue indices of a sample of the Freightliner staff

- 4 Freightliner to put in place a company process to assess and take account of fatigue arising from the shifts that members of staff work together with any disclosed off-duty factors so as to reduce the likelihood of staff making errors due to fatigue. Action should include consideration of amending staffing levels and roster patterns where appropriate (Paragraph 142).

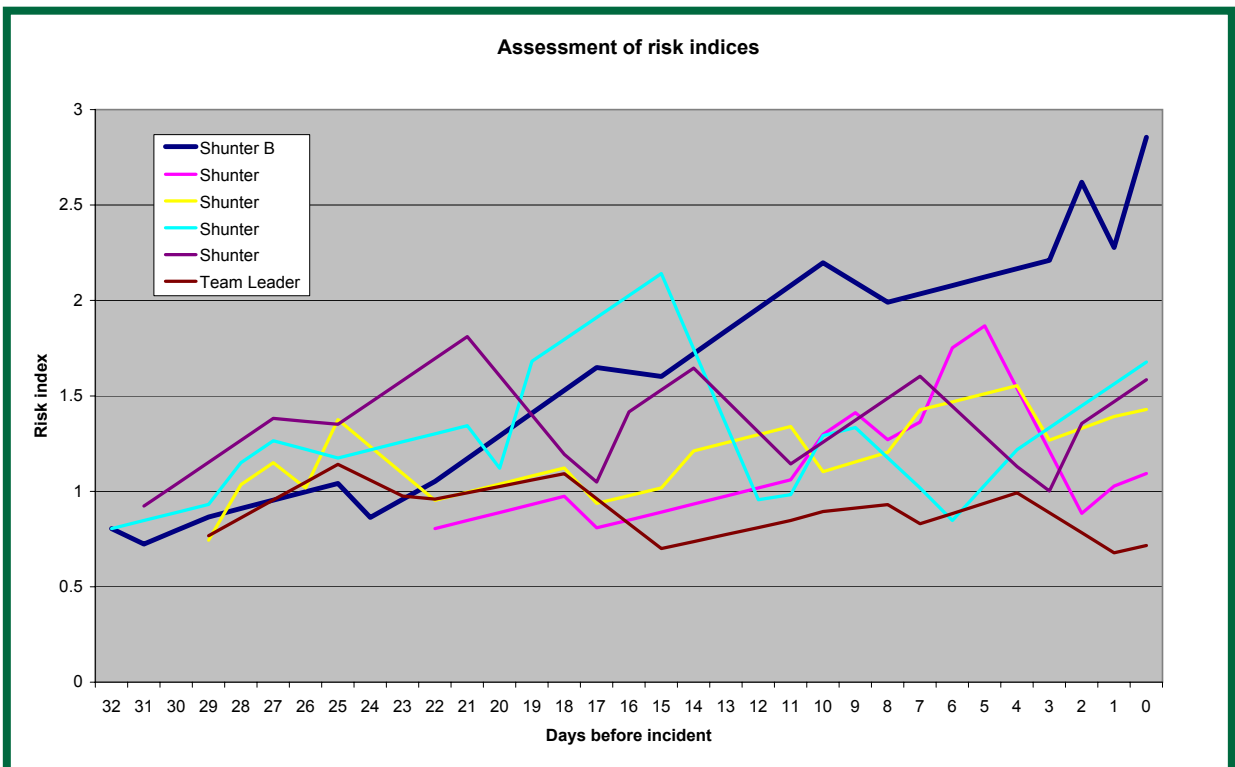
Figure 13. Chart showing the risk indices of a sample of the Freightliner staff
