RAIB investigations involving freight trains – current areas of concern

Presentation to DB Schenker Rail (UK) 4th Risk Management Seminar on 5 November 2015

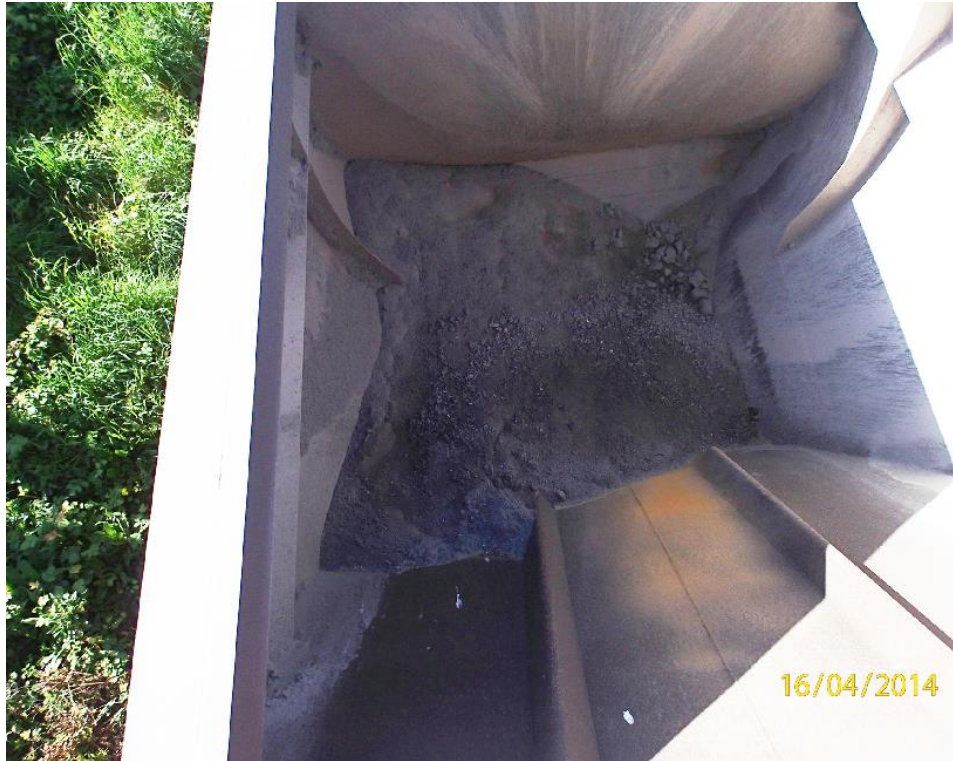
Angerstein Junction:
Unevenly distributed load of
crushed stone left in hopper
affected wheel loads.

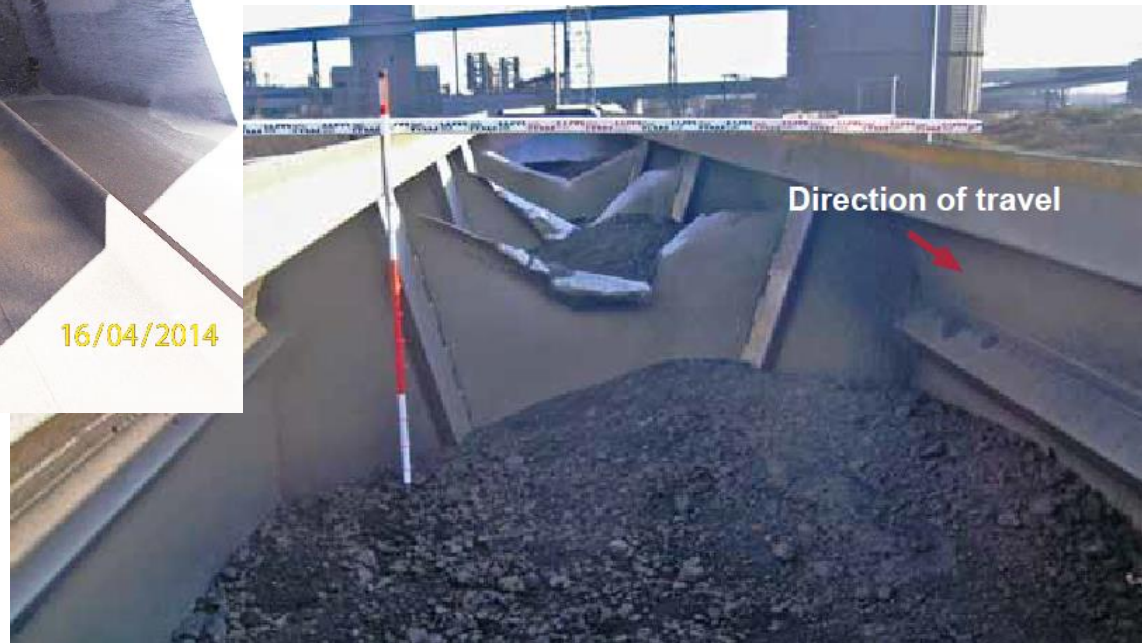
Santon: Coal laterally offset
after wagon was loaded from
a pad which affected load on
leading right hand wheel.

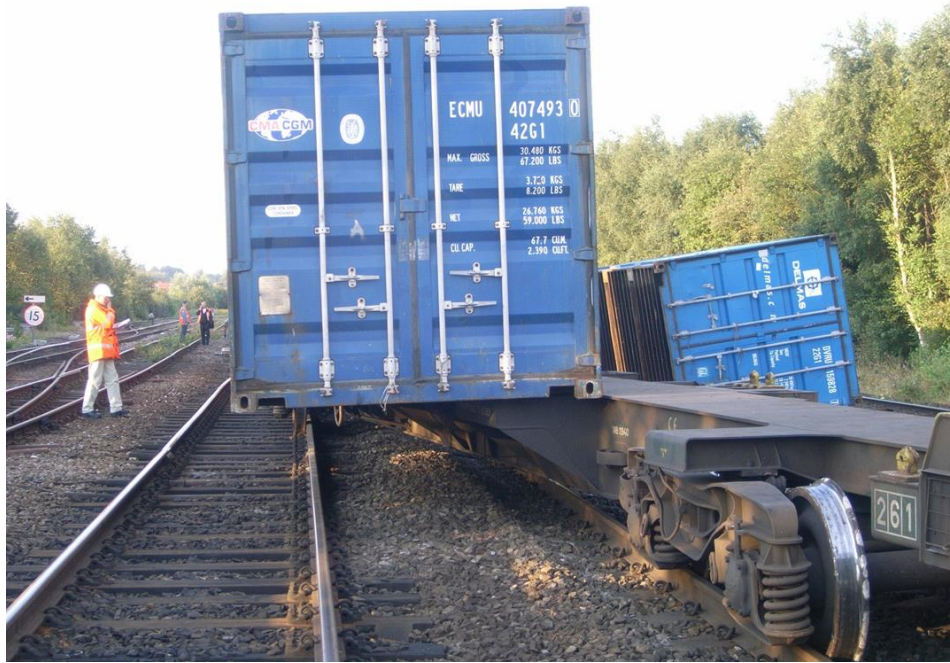
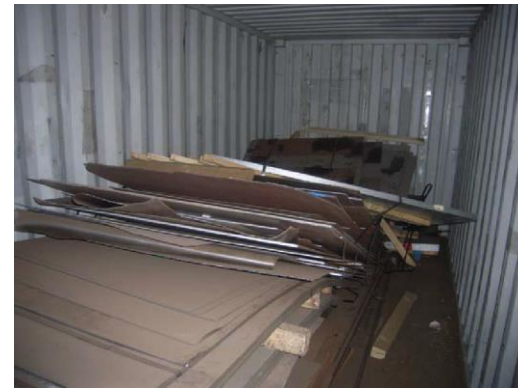
Duddeston: Leading wheelset derailed due wheel unloading. Load on wagon resulted in combination of lateral and longitudinal asymmetry

Sheet steel inside container was offset to left-hand side

Loaded 20' container
(30.4t)

Empty 40' container
(tare 4t)

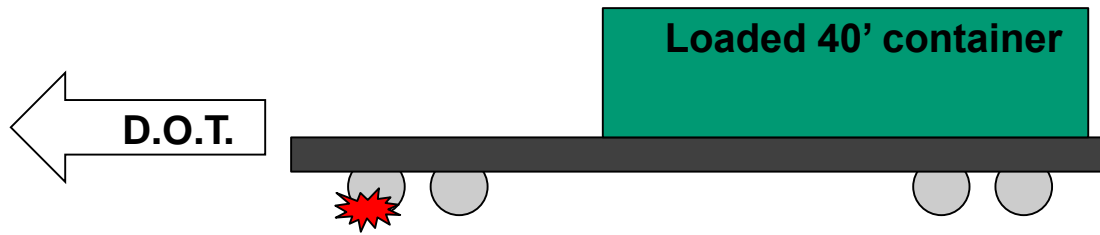
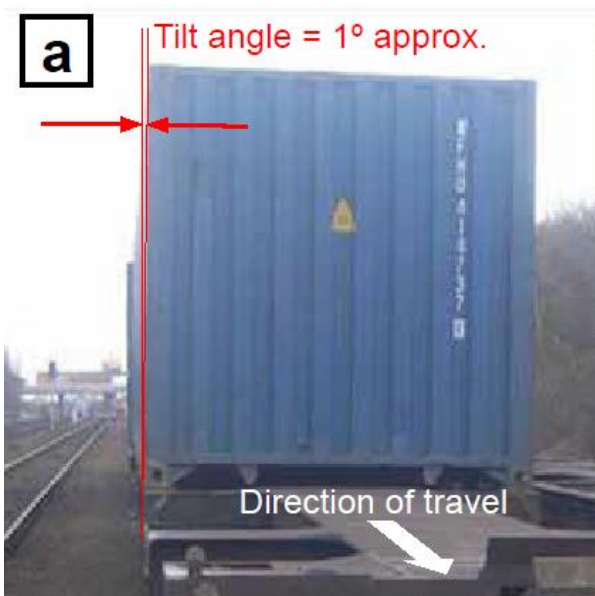
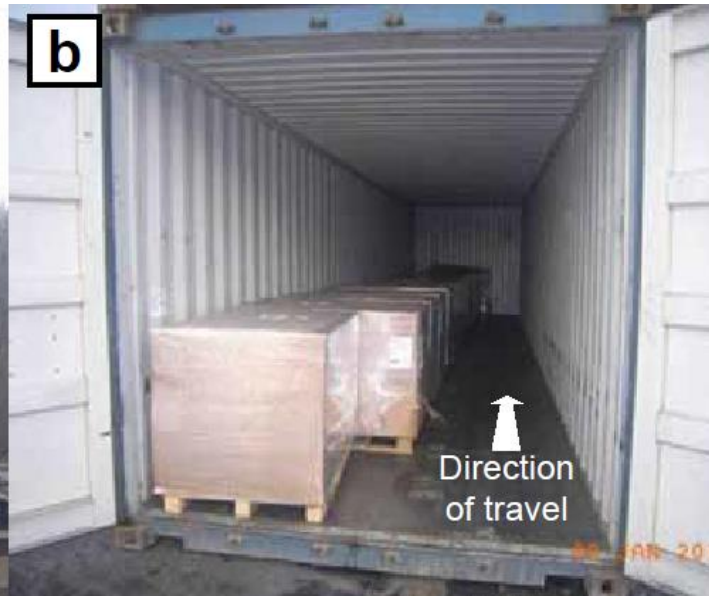
Reading West: Leading wheelset derailed due wheel unloading.
 Load on wagon resulted in combination of lateral and longitudinal asymmetry.

Load of unsecured pallets had at some point shifted inside container

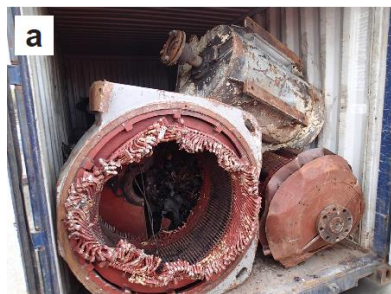
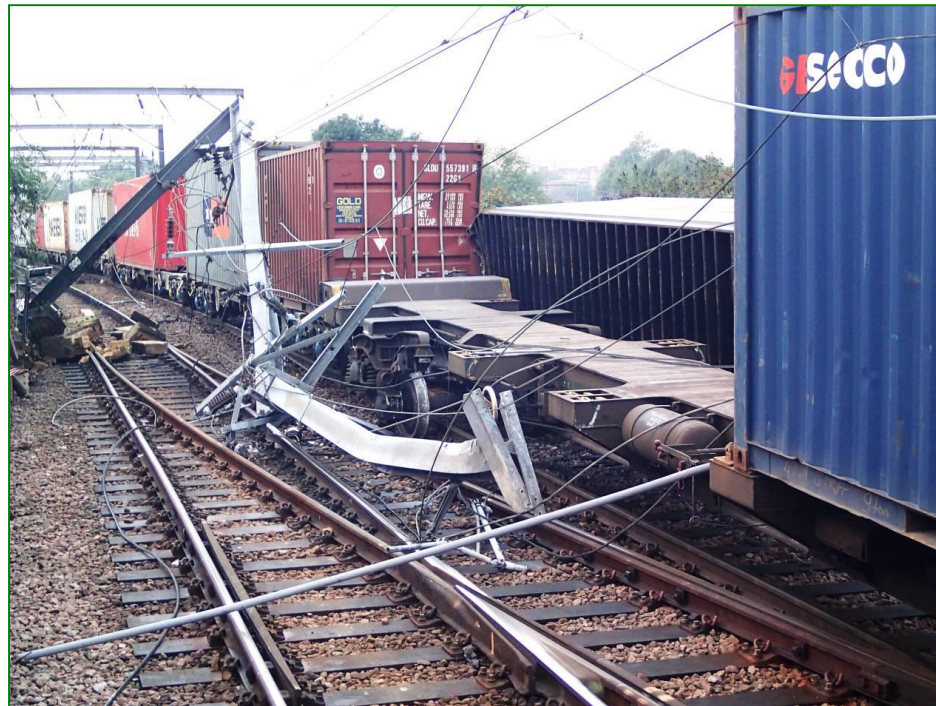
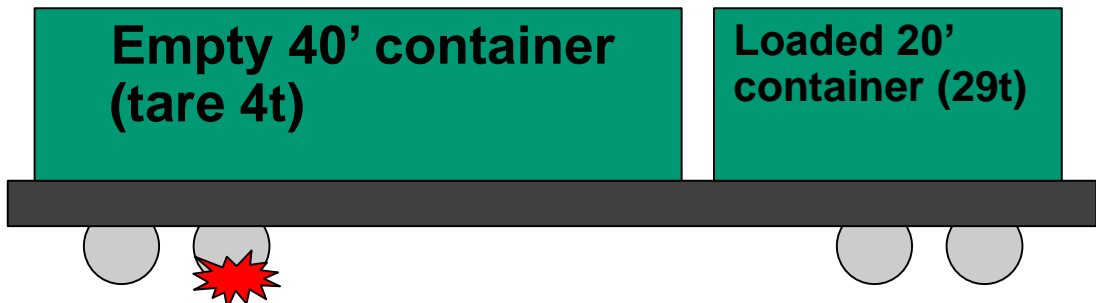
Primrose Hill / Camden Road:
 Leading wheelset on trailing bogie derailed due wheel unloading.
 Again containers loaded on wagon resulted in combination of lateral and longitudinal asymmetry.

Loaded container was carrying scrap electrical machines

Freightliner and Network Rail should jointly research the factors that may increase the probability of derailment when container wagons are asymmetrically loaded, including:

- *sensitivity to combinations of longitudinal and lateral offsets in loads that can reasonably be encountered in service;*
- *the effect of multiple track twist faults over various distances*

and work with other industry stakeholders to identify, evaluate and promote adoption of any additional reasonably practicable mitigations capable of reducing the risk from asymmetric loading of wagons.

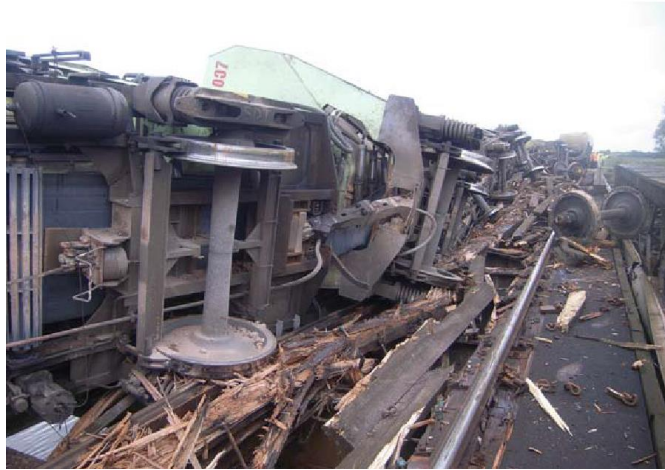
Ely Dock Junction:
Leading right hand suspension
locked-up causing
this wheel to
unload and flange
climb.

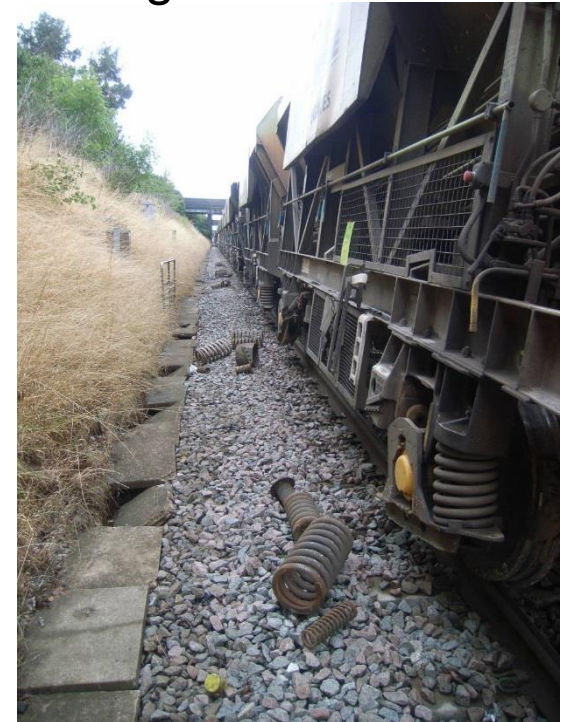
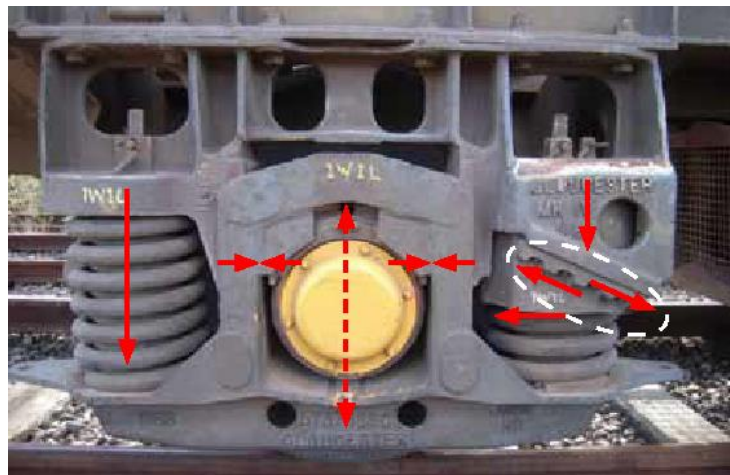
Bordesley Junction: Trailing
left hand suspension
locked-up causing leading
right hand wheel to unload
and flange climb.

Gloucester pedestal
suspension prone to
locking-up when
components are
worn – modifications
recommended.

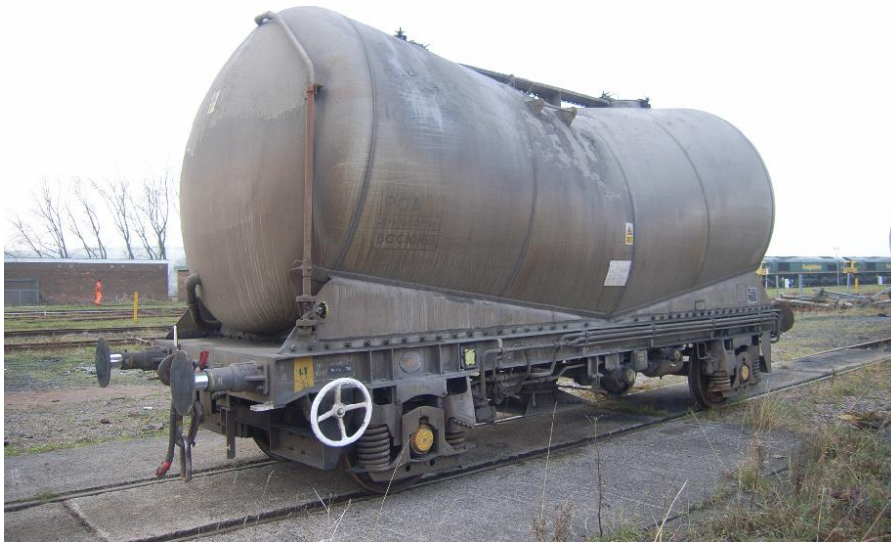
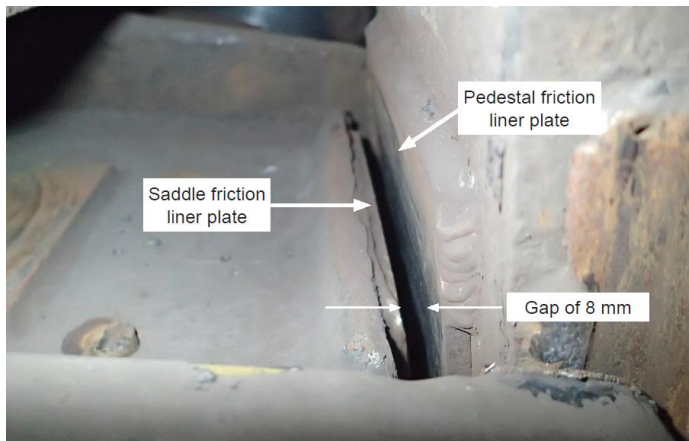
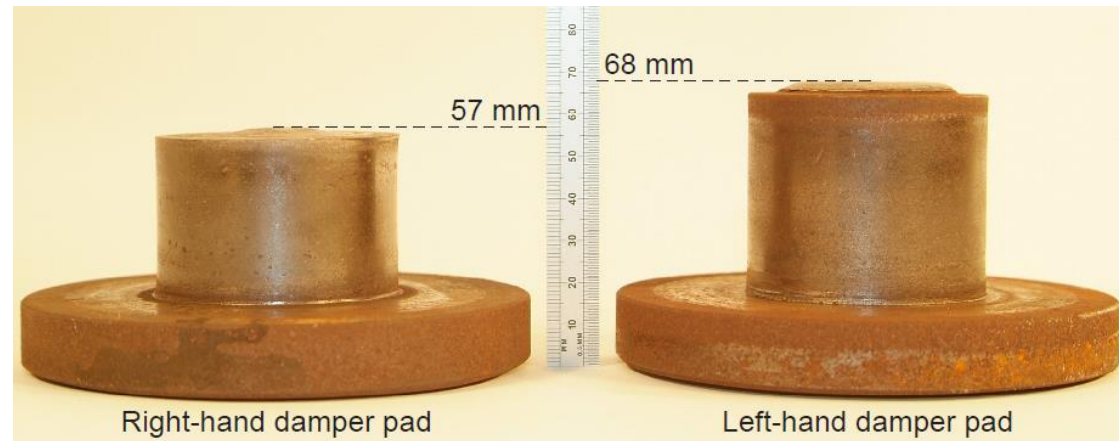
Heworth: Leading left hand wheel derailed due to an un-damped Gloucester pedestal suspension on leading right hand wheel. Worn components were found within this suspension. Recommendation to mitigate risk of degraded ride performance due to worn suspension components.

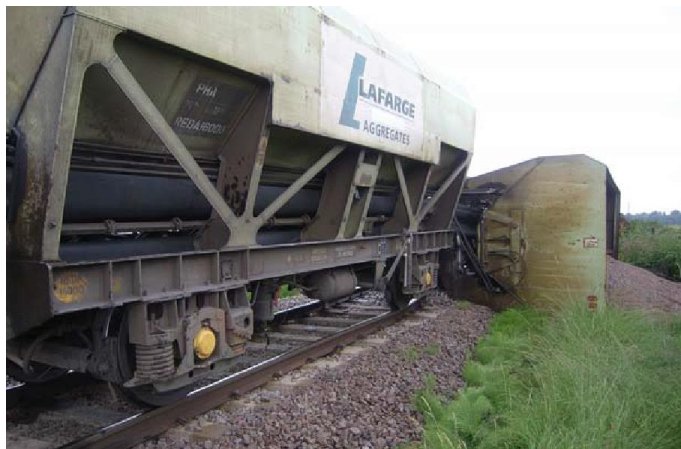
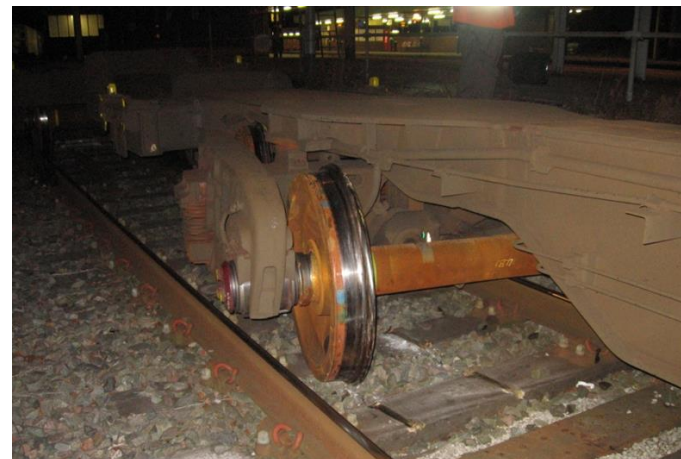
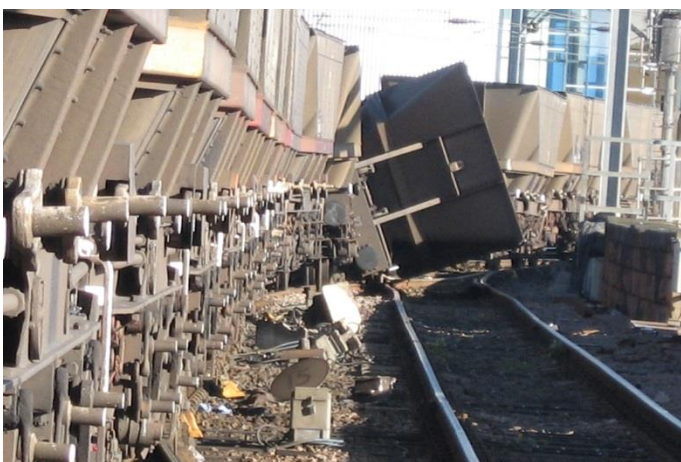
Ely Dock Junction and Wigan: Wagons had frame twist with incorrect packing that worsened the amount of twist.

King Edward Bridge Junction: Wagon had a twisted frame.

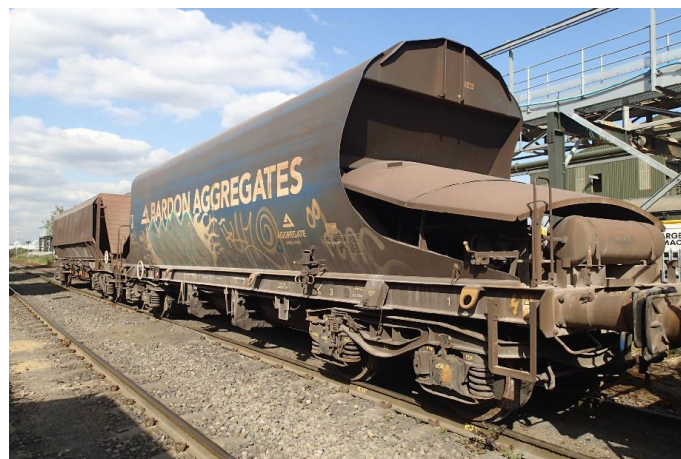
Angerstein Junction: Wagon had a twisted bogie

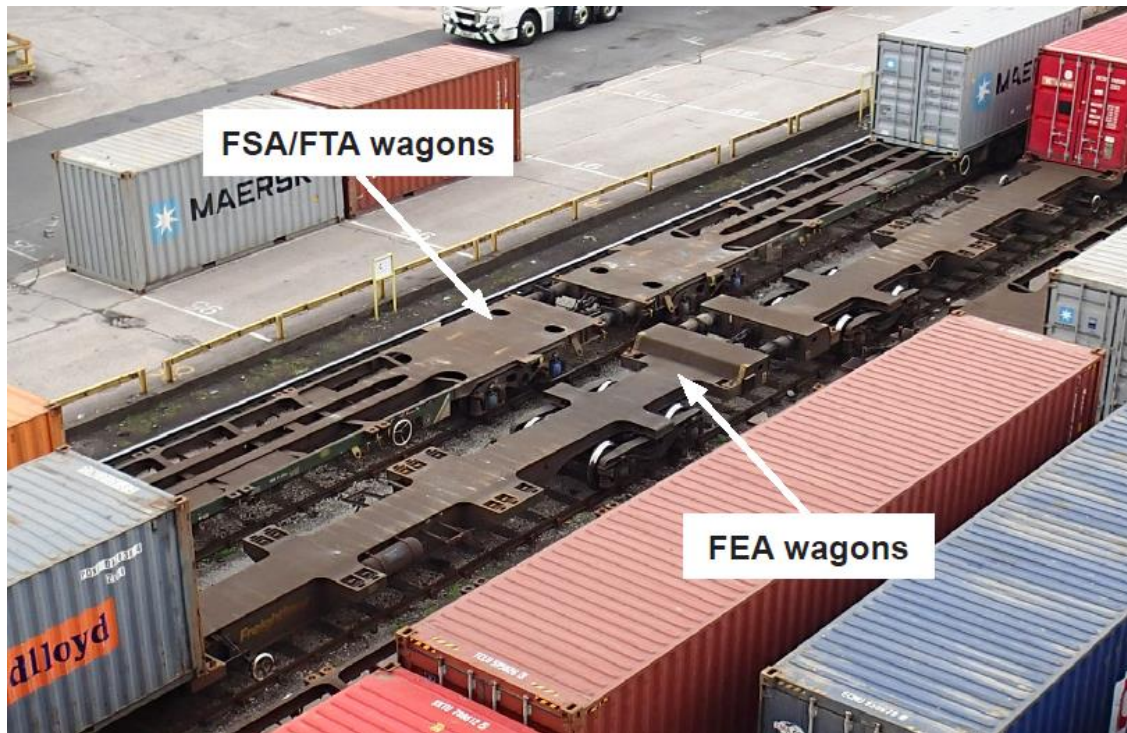
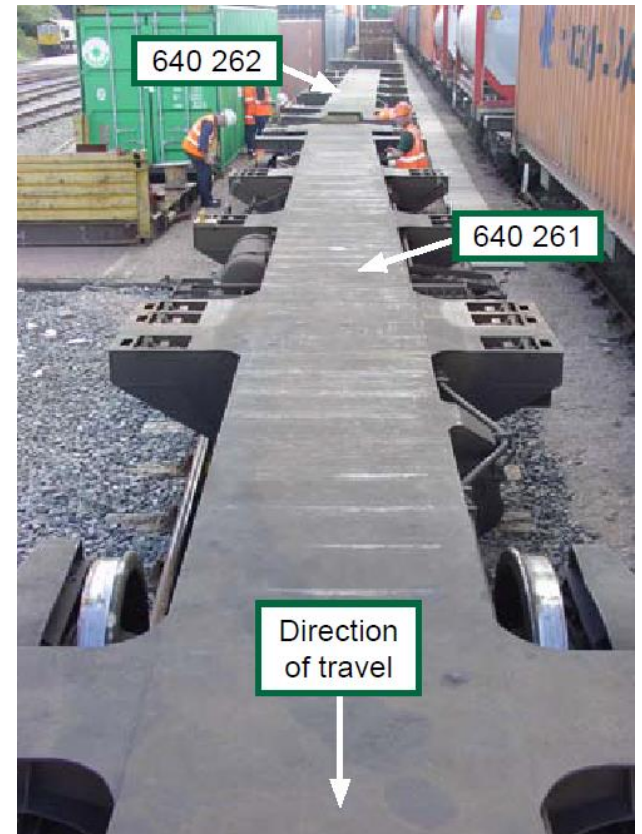
Primrose Hill / Camden Road:

Possible factor related to high torsional stiffness of the FEA wagon underframe, particularly when partially loaded. This wagon type has a central spine. It is also the same type that derailed at Duddeston.

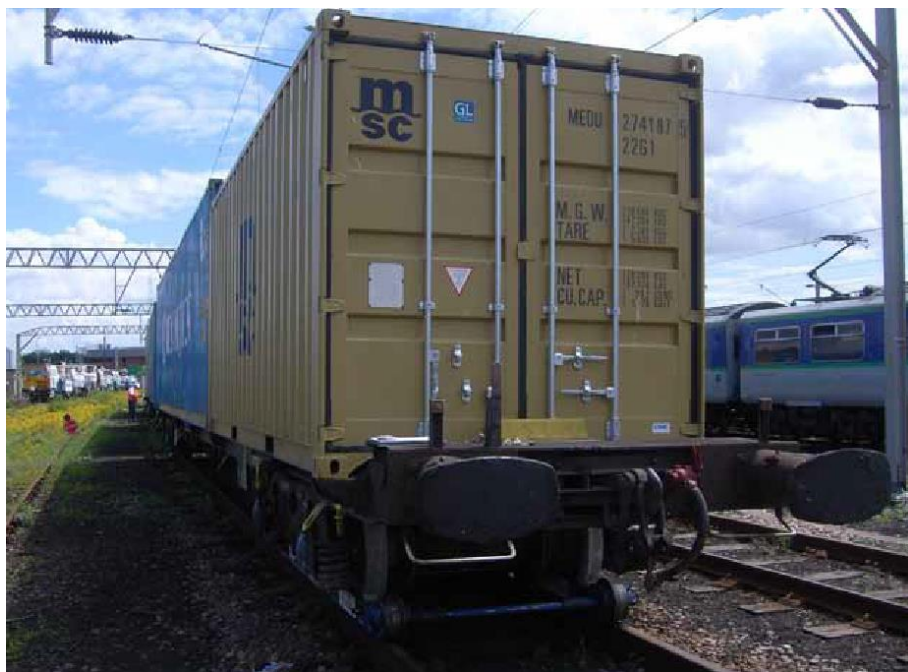
Marks Tey: Container flat wagon (type FSA/FTA) derailed on a series of dips in the track. Wagon type did not meet vertical ride performance requirements in standards when partially loaded.

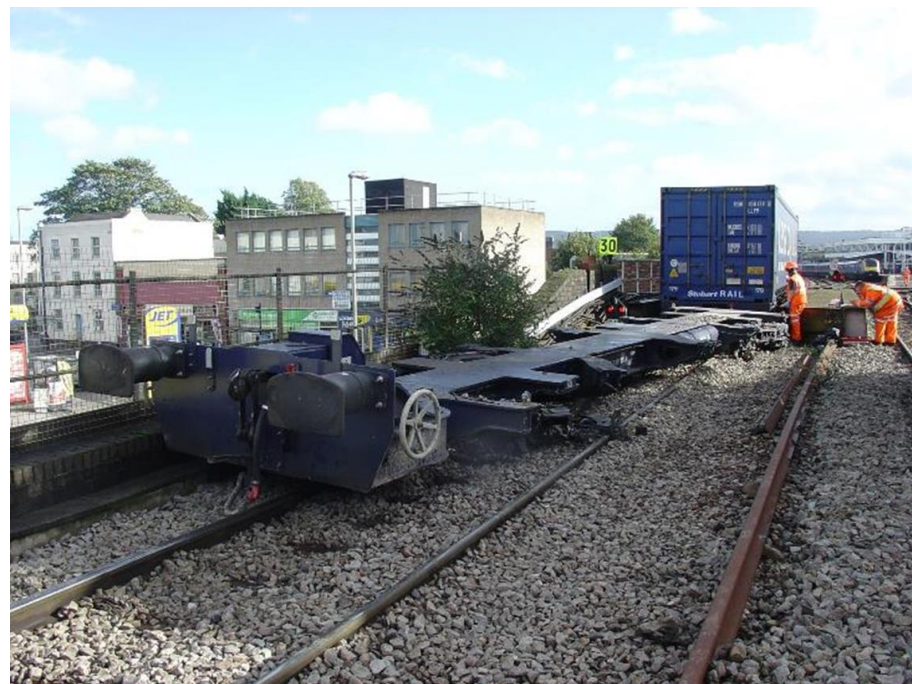
Gloucester: New design of container flat wagon (type IDA) derailed on a series of dips in the track. Wagon did not meet vertical ride performance requirements in standards when partially loaded.

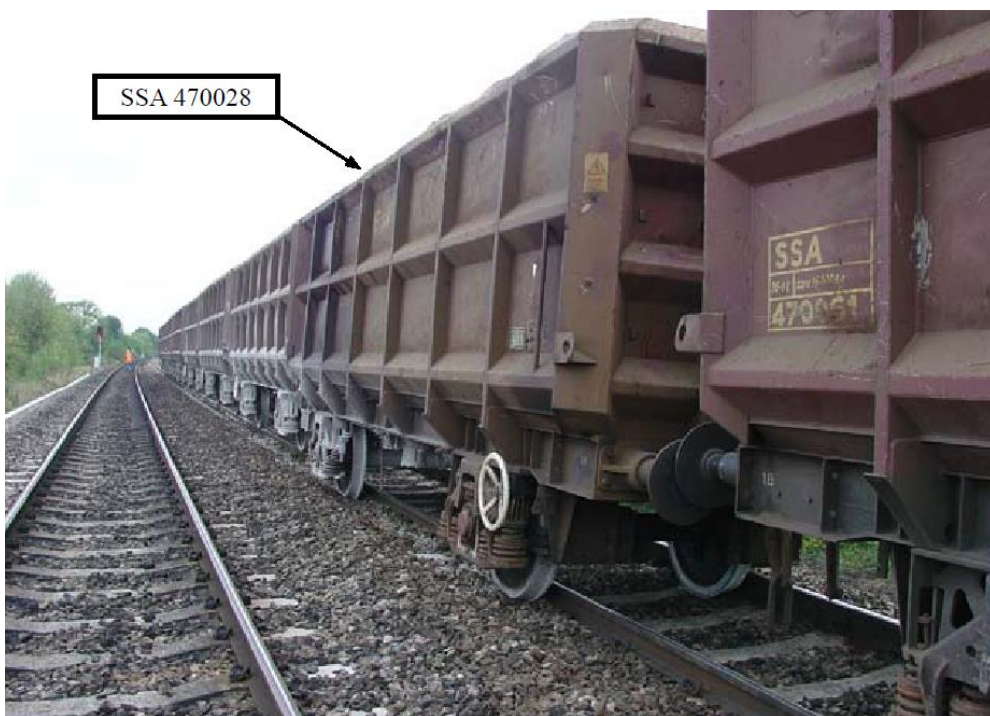
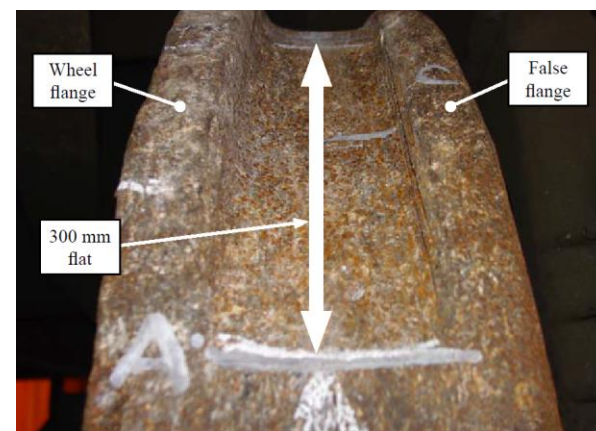
October 2005, Hatherley. Handbrake left on and wheels developed false flanges. Wheelset then derailed on trailing points.

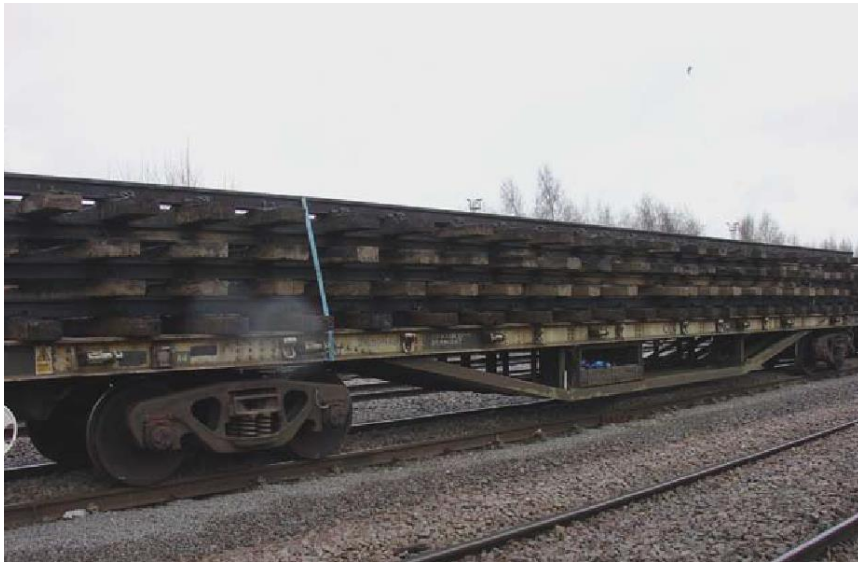
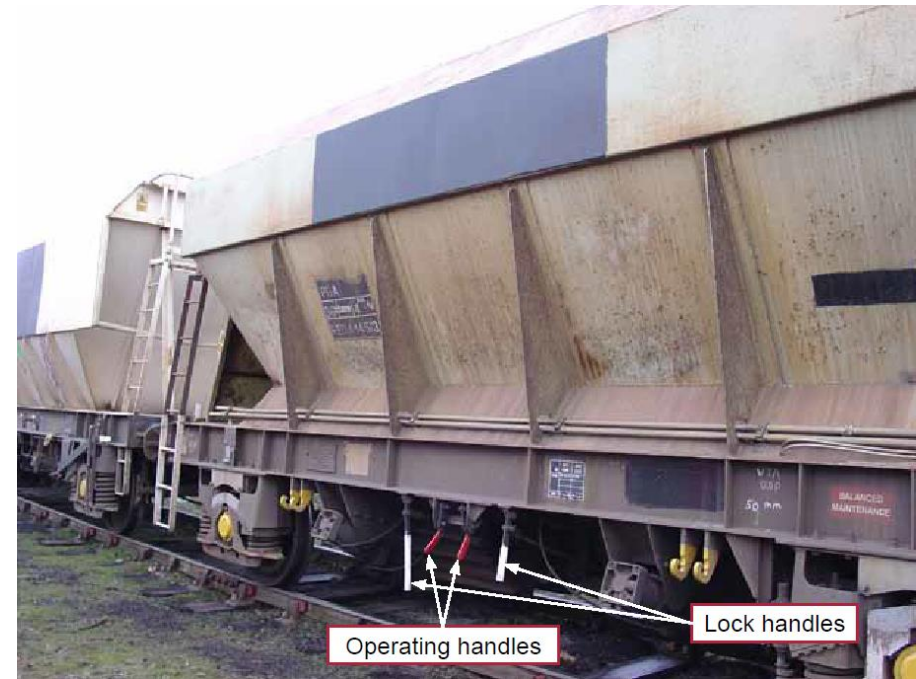
February 2006, Basford Hall.
Freight train was dispatched from yard with the wrong wagons in the consist. These wagons were carrying loads that were unsecured.

February 2010, Romford.
Freight train was dispatched from yard with bottom doors on wagon not fully closed. Ballast then fell from the wagon and struck passengers waiting on a platform.

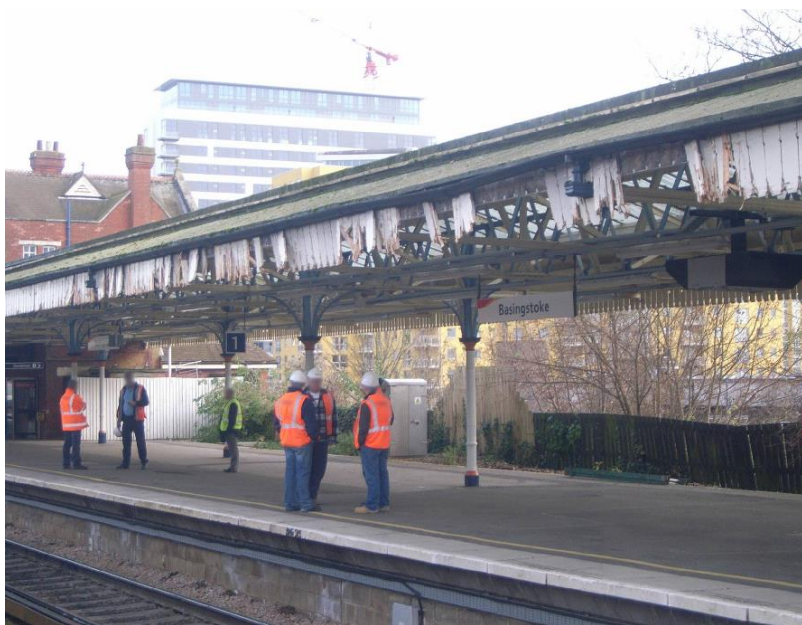
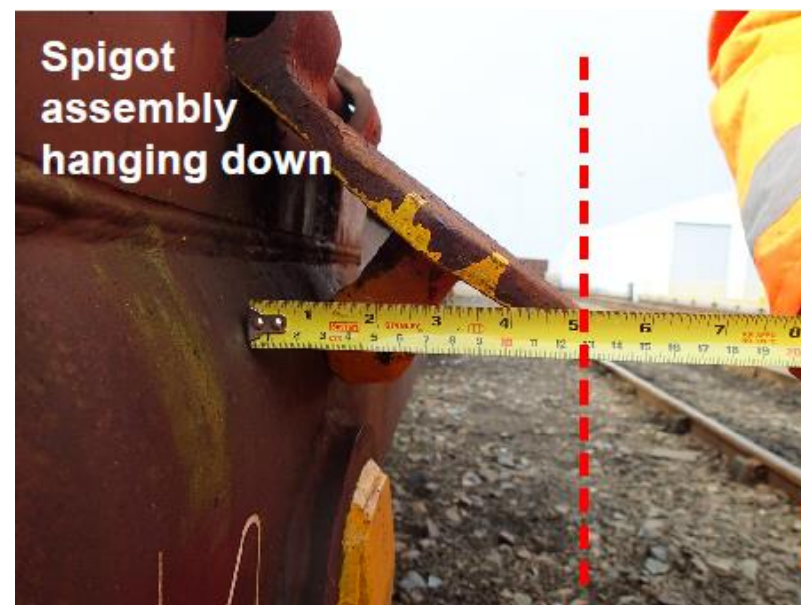
December 2008, Basingstoke.
Train dispatched with 9' 6" container out of gauge for the route the train was due to take. During its journey the container struck the canopy at Basingstoke station.

January 2015, Moston.
Wagon was out of gauge due to a spigot that was not stowed. This was not noticed when the train was prepared. Spigot collided with platform and dislodged coping stones which following train struck.

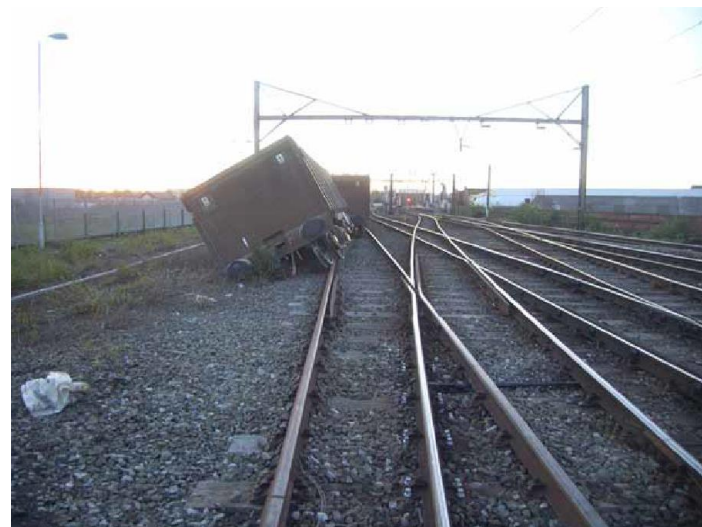
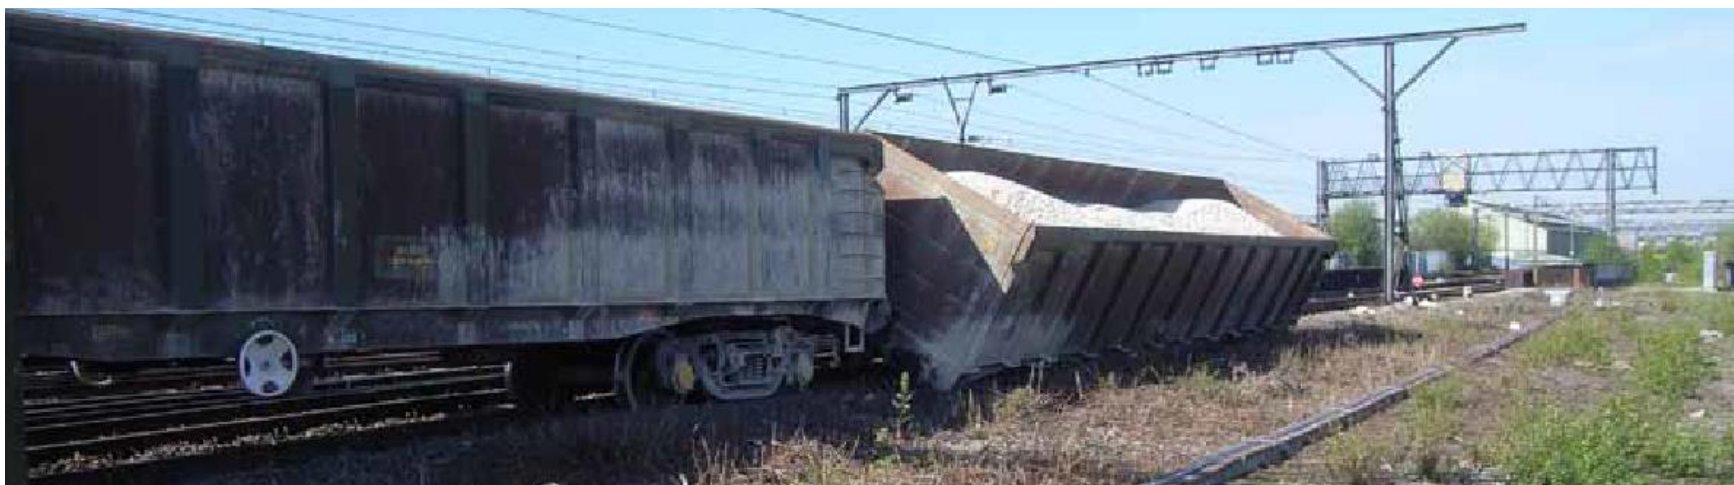
May 2010, Ashburys.

Handbrakes were applied when train was stabled but these were ineffective. Five wagons ran away and only stopped when two derailed on trap points.

Recommended that pull test is carried out when stabling to check effectiveness of applied handbrakes.

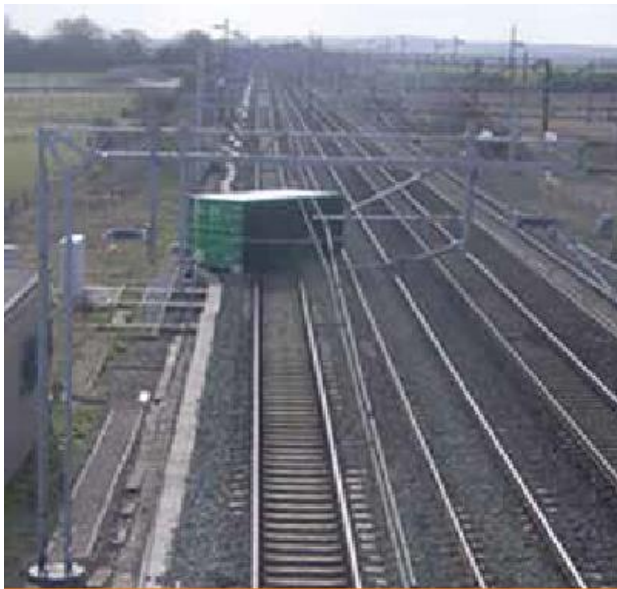
March 2008, Cheddington.
Two empty containers were
blown off a freight train.

In both cases, the containers blocked running lines and damaged infrastructure.

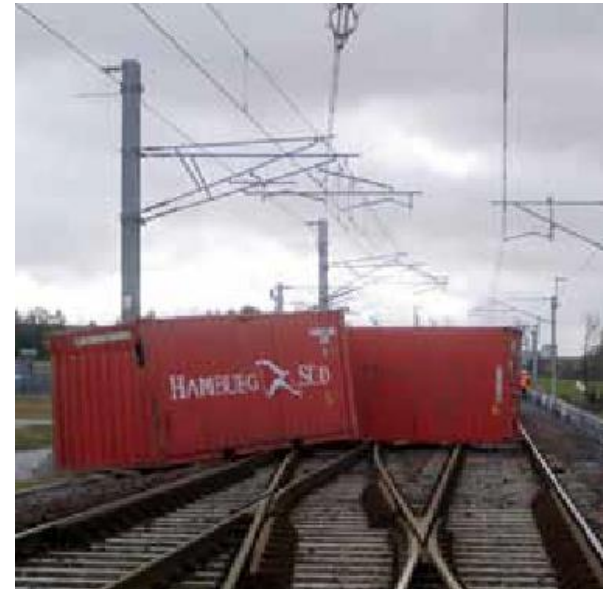
March 2008, Hardendale.
Five empty containers were
blown off a freight train.

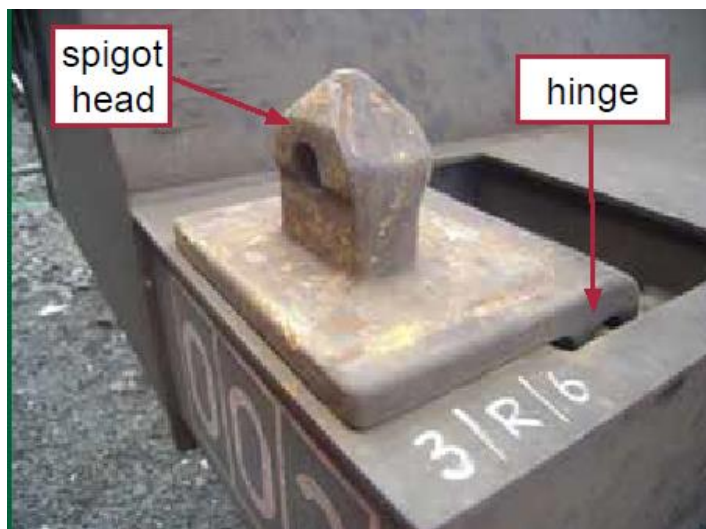
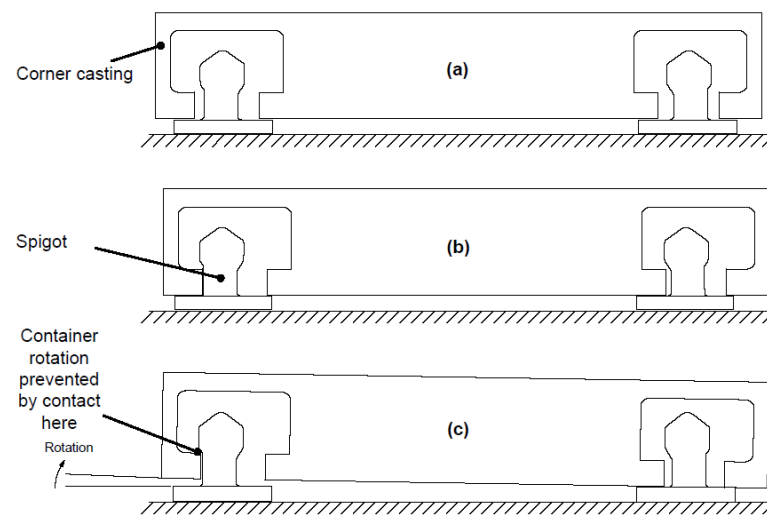
- In both cases, the empty containers were sat, unsecured, on top of fold-down spigots on FEA wagons
- The overturning and detachment of the empty containers was due to:
 - aerodynamic forces from a combination of high cross winds and train speeds
 - the FEA wagon's fold-down spigots not providing overturning retention because they had not been designed in accordance with UIC standards

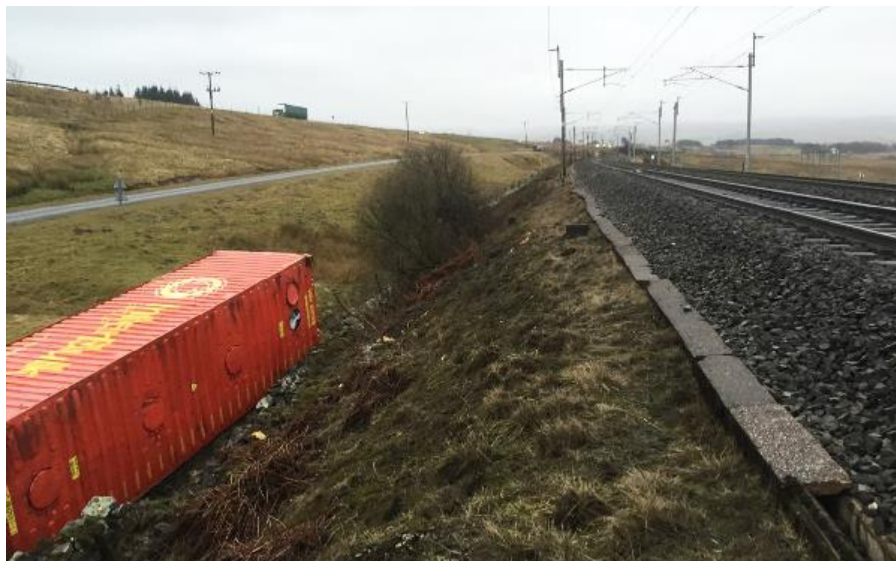
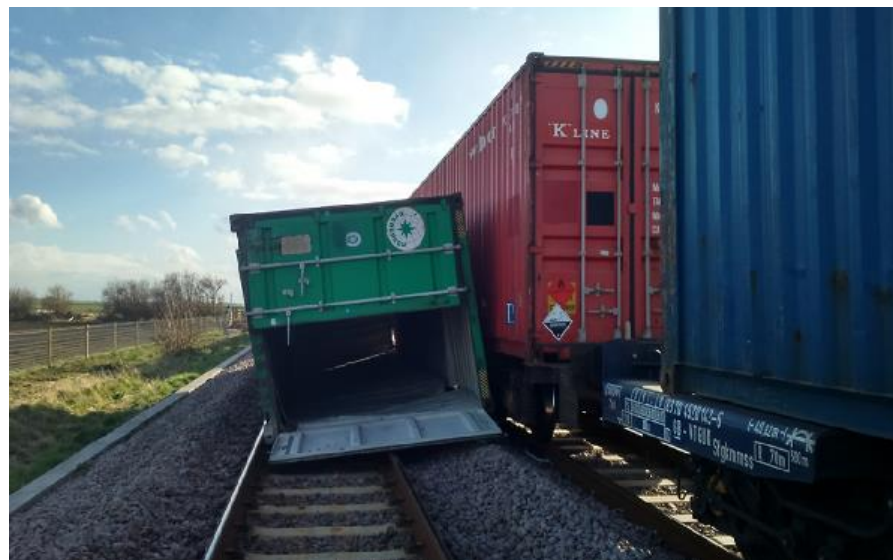
- RAIB made 10 recommendations to address the issues found
- However, in March 2015, there were two further occasions when an unsecured, empty container was blown from an FEA wagon

March 2015, Scout Green, Cumbria.

March 2015, Deeping St Nicholas, Lincolnshire.

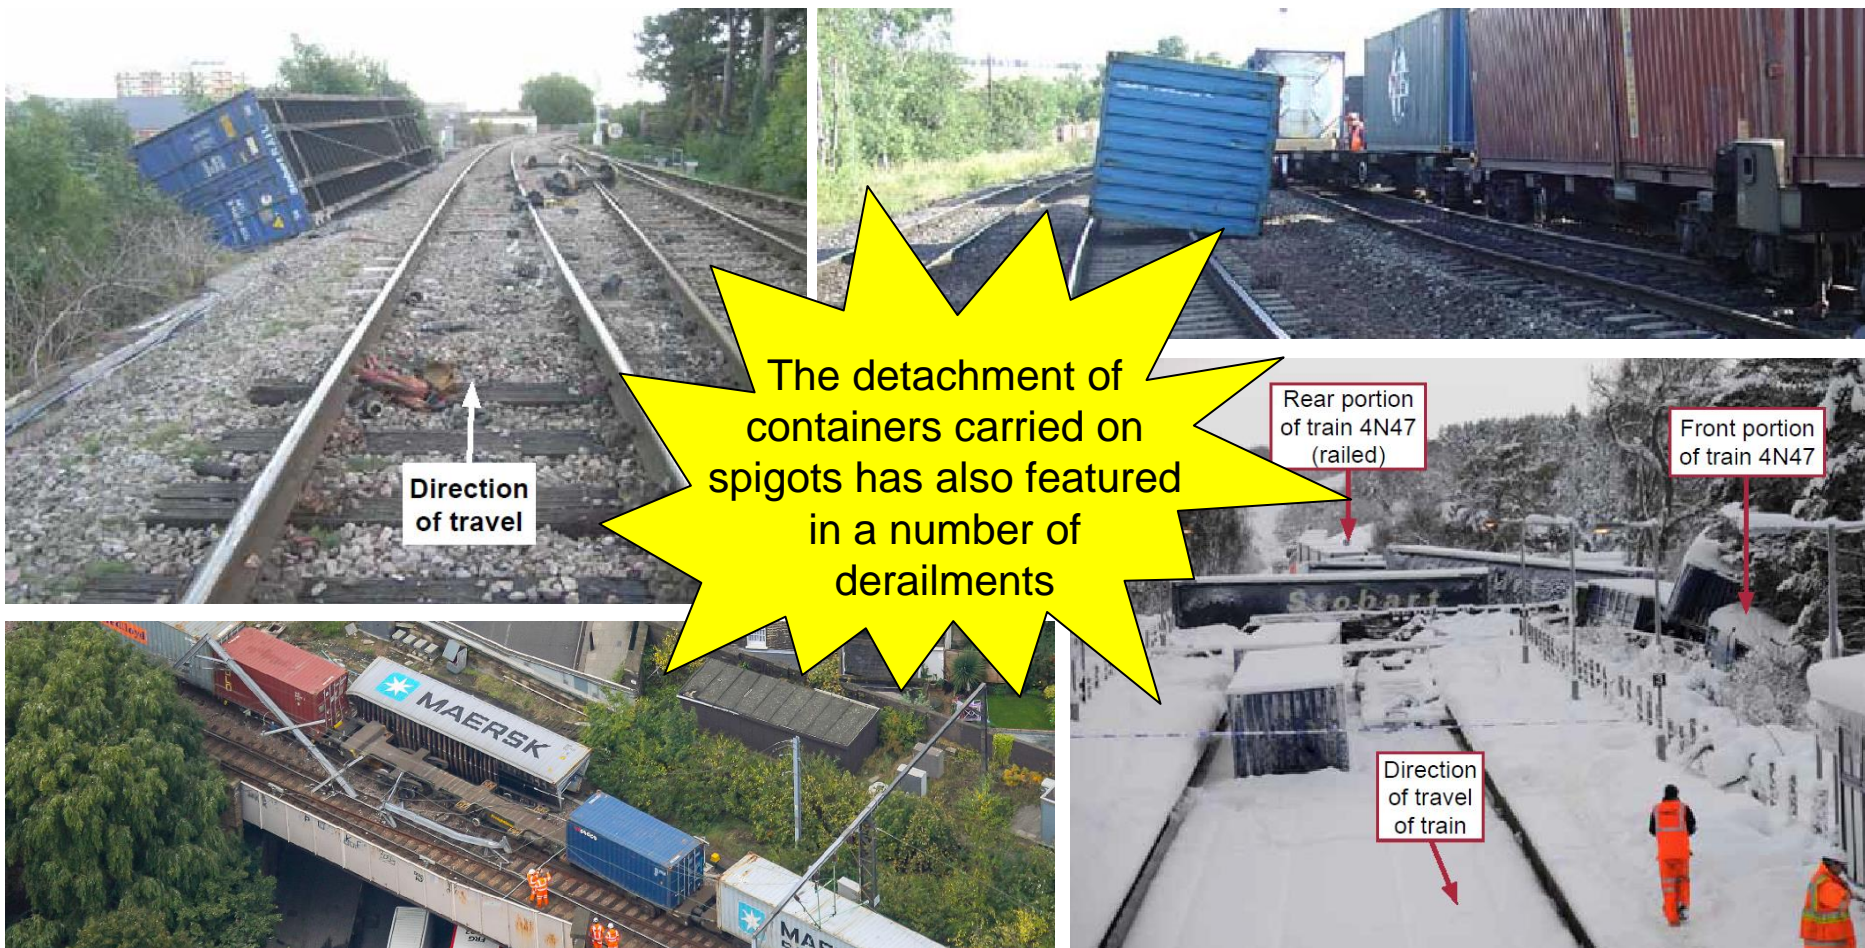
The detachment of containers carried on spigots has also featured in a number of derailments

Rear portion of train 4N47 (railed)

Front portion of train 4N47

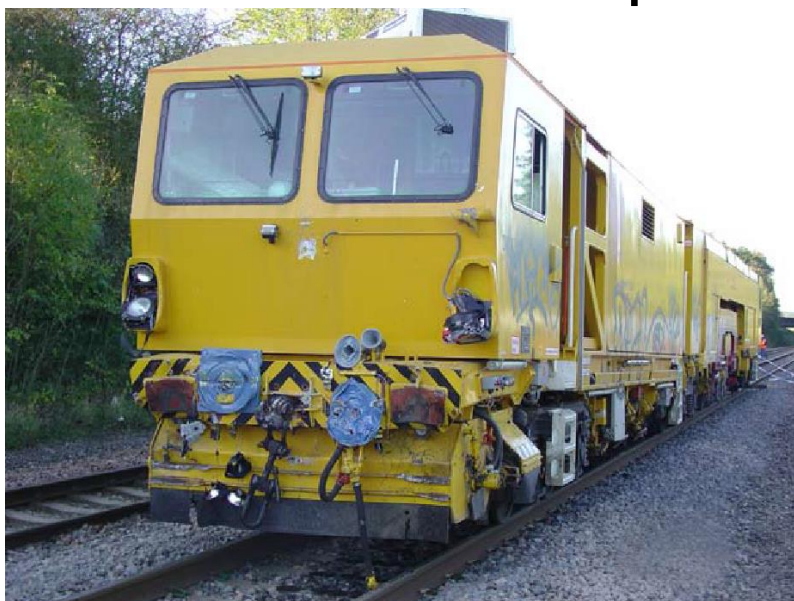
October 2006, Badminton.
Tamper collided with a ballast regulator while travelling in a work site. Tamper driver did not control speed to be able to stop in time.

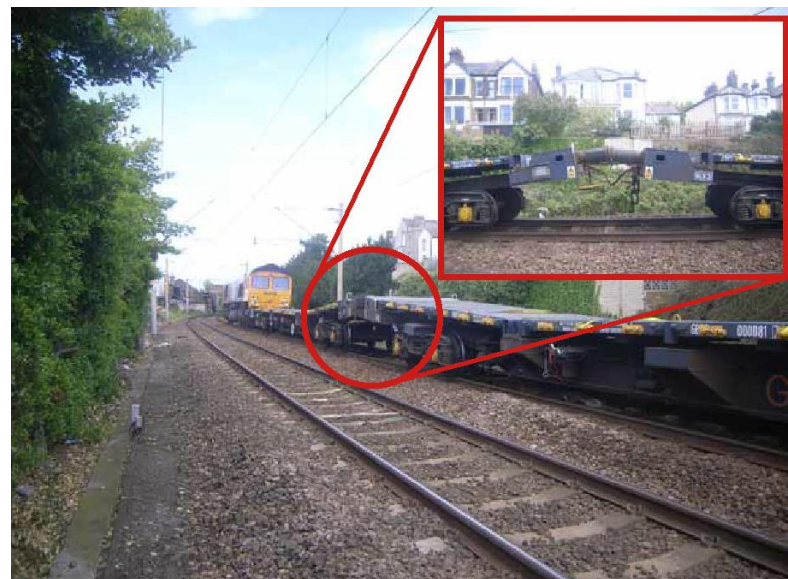
April 2008, Leigh-on-Sea.
Train collided with rear of a train ahead of it while travelling in a work site. Driver unsure of stopping location and going too fast to stop.

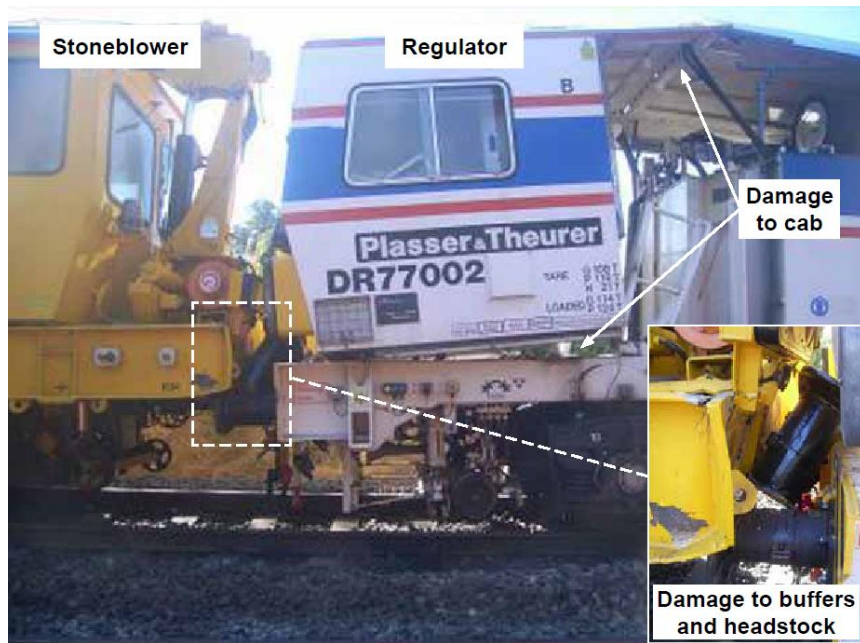
September 2012, Arley.
 Stone blower collided with a ballast regulator while travelling in a work site. Stone blower driver unaware regulator had stopped and was going too fast to stop.

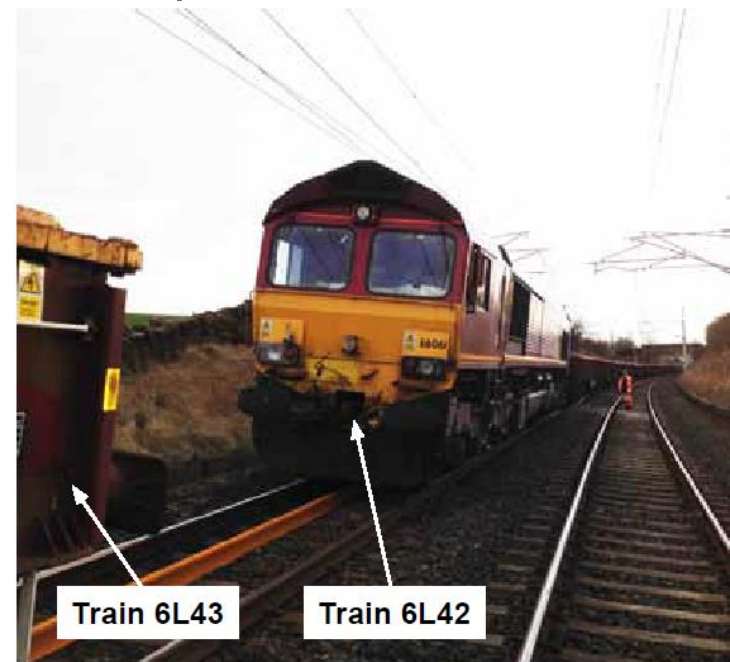
January 2014, Kitchen Hill.
 Train collided with rear of a train ahead of it while travelling in a work site. Driver thought train ahead was in different place and was going too fast to stop.
