RAIB investigations involving freight trains – current areas of concern

Presentation to DB Schenker Rail (UK) 4th Risk Management Seminar on 5 November 2015

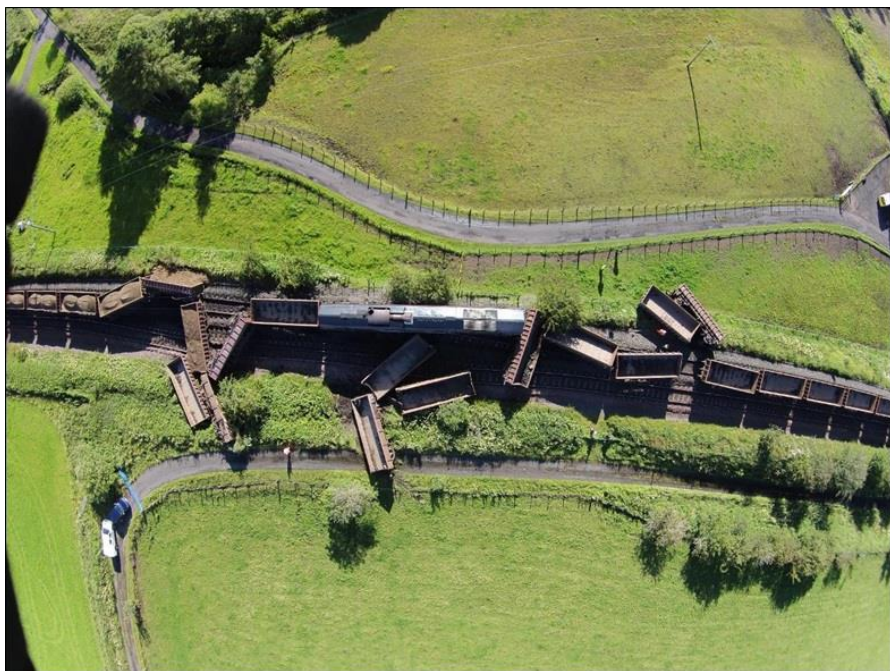
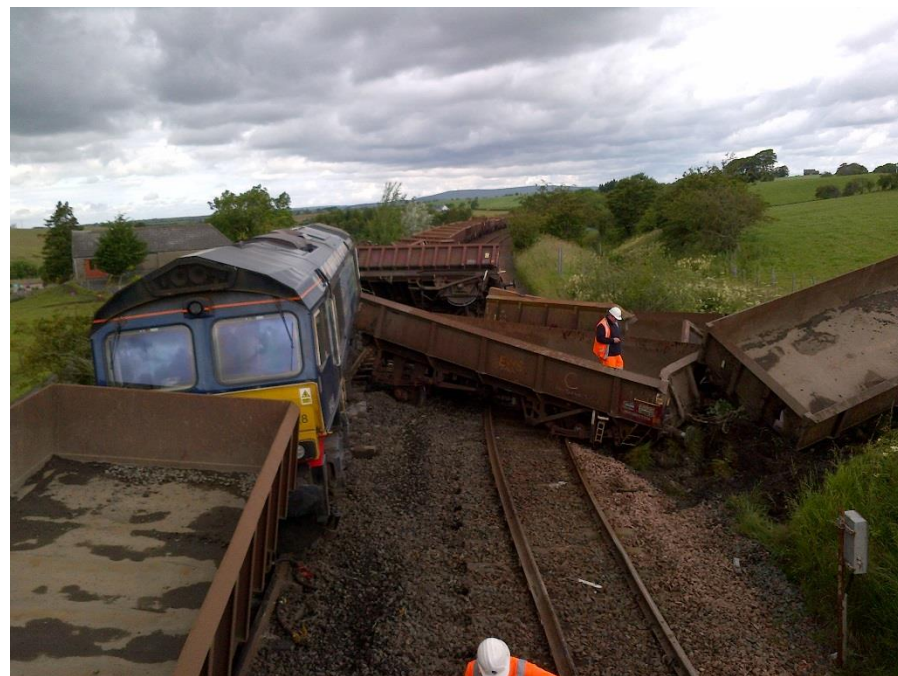
August 2015, Logan.

Train collided with rear of a train ahead of it while travelling in a work site. Investigation is ongoing but emerging findings are driver's understanding of location of train ahead and speed travelling at are likely to be issues.
