Maritime &
Coastguard
Agency

SS RICHARD MONTGOMERY Survey & Sub-Bottom Profiling Report 2014

Maritime and Coastguard Agency
September 2015

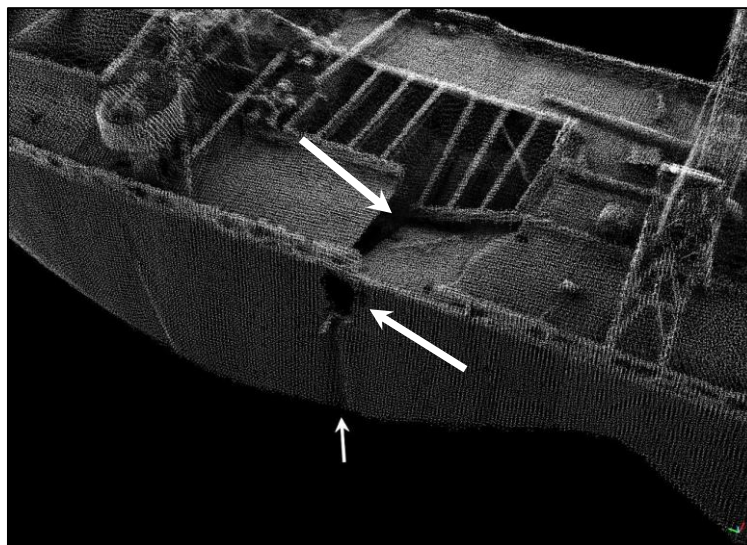
4.5.3 Area 1 is a crack in the hull on the port side of the forward section at Hold 2. Visual assessment of the crack suggested that there had been little change in its dimensions since the 2013 survey was completed. Also visible in the 2014 dataset was the vertically orientated bend in the hull plate below the crack which was identified in the last survey. Measurements of the maximum height and width confirmed that there had been no significant change.

Figure 4. Crack in the hull at Hold 2 and collapsed deck plating at Hold 2

Dimensions of Crack in Hull		
Year	Height (m)	Width (m)
2013	3.31	2.16
2014	3.40	2.10

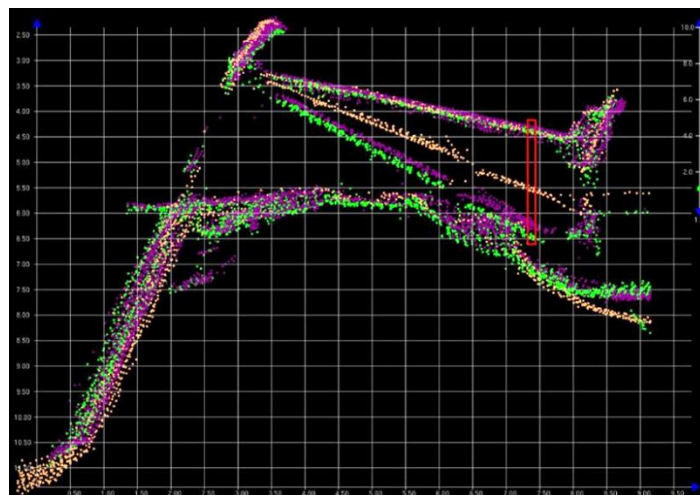
4.5.4 Area 2 is an area of collapsed deck plating on the port side at Hold 2. This area was well defined in the dataset of the 2014 survey. Measurements taken indicated that subsidence of the deck plate was continuing. The distance between the in-situ deck plate and the subsiding section in the 2013 dataset was found to be 1.80m whereas in the 2014 data this had increased to 2.05 m. This subsidence is confined to the collapsed section of the deck. Adjacent to the collapsing deck plate the lower hatch cover of Hold 2 shows a large change in depth since the 2013 survey. A shoaling of the surface by up to 1.5m was observed and this is most likely the result of deposition of sand onto the cover. An increased sediment load may also be a contributing factor to the continued collapse of the deck plating.

Figure 5. Collapse of deck plating from 2010 (orange), 2013 (purple) and 2014 (green)

Dataset	Depth (m)	Magnitude of Collapse (m)	Collapse since Jan 2014 [Date of 2013 survey] (m)
Normal Deck Level (Forward of Collapsed Section)	All Datasets	4.35		
Collapsed Deck	2010	5.50	1.15	
	2013	6.15	1.80	
	2014	6.40	2.05	0.25

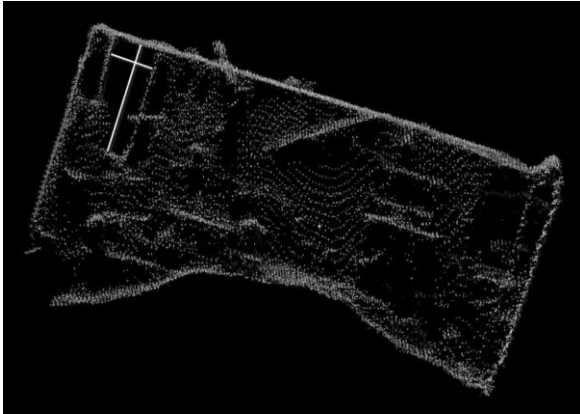
4.5.5 Area 3 is an aperture on the port side of the bulkhead at the aft end of Hold 3. This is of interest because it permits access to the interior of Hold 3 and it has been possible on some occasions to visualise what may be evidence of the cargo in Hold 3. Comparisons between the 2013 and 2014 datasets showed that no increase in the dimensions of the aperture had occurred. In fact, a small reduction of the width was recorded, although this is likely to correspond to a small difference in the positions from which the measurements were taken. As in 2013, the height of the aperture was measured at 4.10m. However, the width was measured as 1.70m in 2013 and 1.56 in 2014.

Figure 6. Hold 3 bulkhead Aperture. White lines show the locations of the measurements.

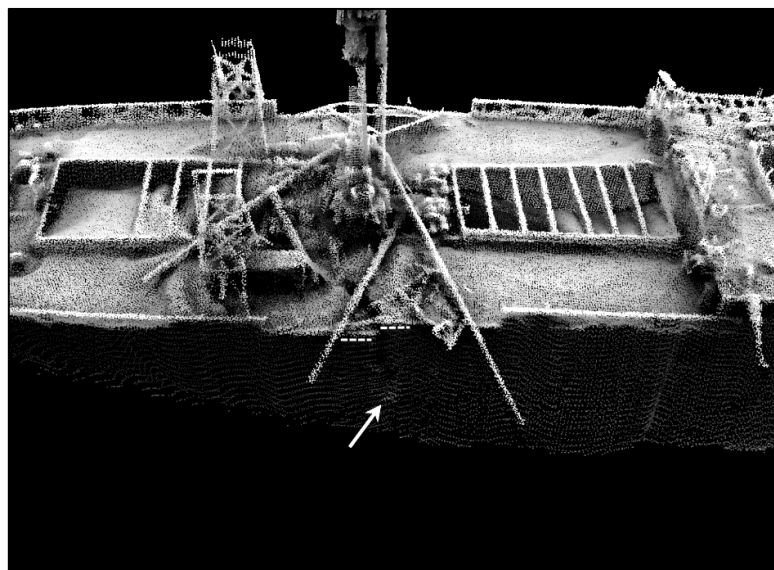
4.5.6 Area 4 is a split in the hull on the starboard side of the stern section. This feature has been once again clearly defined in the 2014 dataset. An effective comparison with the historical datasets in CARIS Subset Editor showed that there had been no increase in the width of the split in the hull plate between the 2013 and 2014 surveys. The slight misalignment of the two datasets is not considered to indicate movement of the hull as it is within the limits of accuracy of the positional equipment.

Figure 7. Misalignment of gunnel and associated split in hull – starboard side between Holds 5 & 4

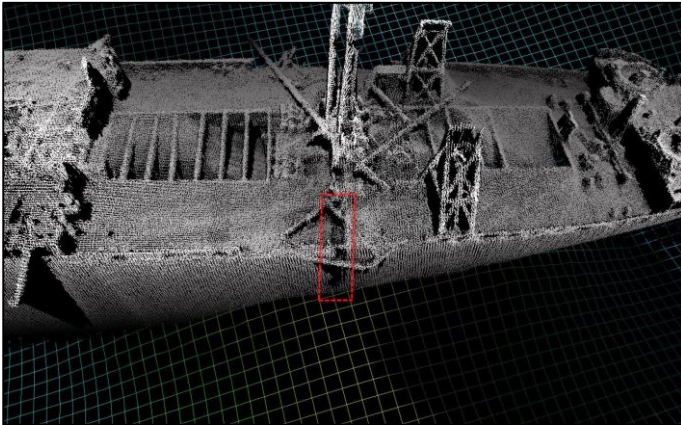
4.5.7 Area 5 is a large split in the deck and hull plating on the port side of the stern section adjacent to the aft mast house. This area of structural deterioration was added to the key areas following the 2013 survey and is adjacent to similar deterioration on the starboard side of the hull at this location. The area was again well defined by the 2014 survey and assessment of the data suggests that there has been no further subsidence of the different levels of deck plate since the 2013 survey. Examination of the split in the hull plate from the port side indicated that there had been no identifiable deterioration since 2013. However as this is the site of recent noted structural shifting it will remain a key area in future surveys.

Figure 8. View of the split in deck and hull plating on port side of the Aft section

7.4 Noteworthy for a lack of change is the split in the deck and hull on the port side of the aft section. Surface difference analysis conducted on products of the 2010 and 2014 datasets showed that the significant structural failures were still restricted to a small number of key areas around the wreck. Generally, the positions of the hull and deck, the masts and the bow and stern superstructure have remained quite stable over the last four years. This does not mean to say that the integrity of the hull is not in question as there are limitations to what the survey can detect. Additional work, such as the 2013 hull thickness assessment, is required to further determine weaknesses and corrosion. Surveys conducted with sonar and laser technology enable an overview of the gross state of the wreck to be achieved in areas where visual assessment is limited by the turbidity of the water and operations are restricted by the Thames Estuary tidal regime.

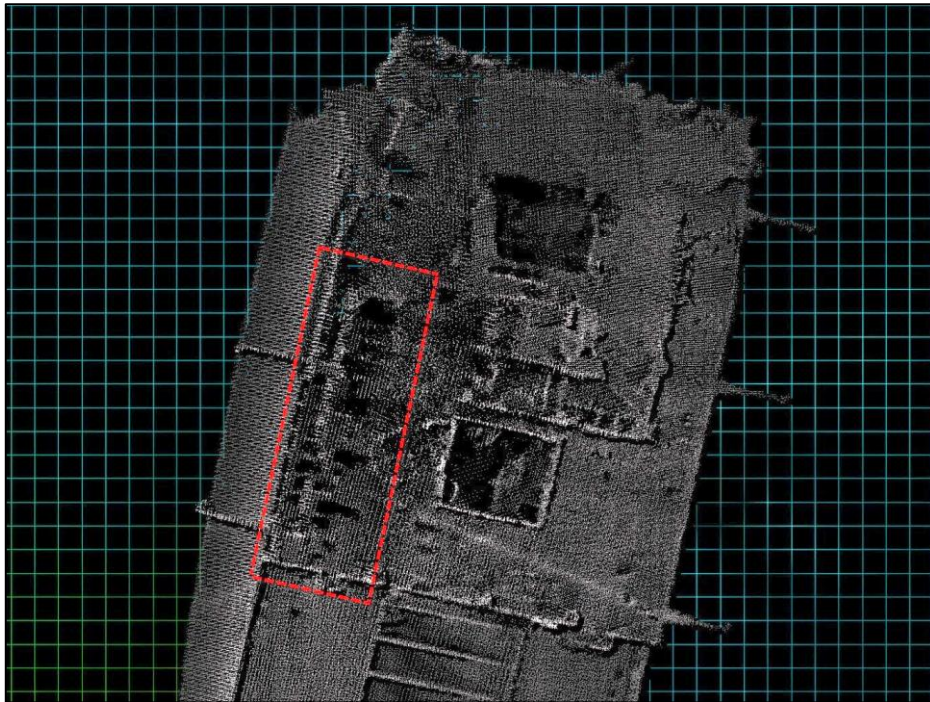
4.5.12 A number of the holes along the port side of the boat deck on the aft section are shown to have increased in size and some evidence of subsidence was identified in the collapsed section of the boat deck forward of the holes. Whilst some of the holes in this area appear to have remained consistent in size and shape between the two surveys, some holes slightly in-board show some evidence of change. This is due to the loss of deck plating around the edges of holes and in some cases this process has caused some smaller holes to merge into larger gaps in the deck.

Figure 9. Plan view of the bridge deck with the holes in the boat deck highlighted on the port side

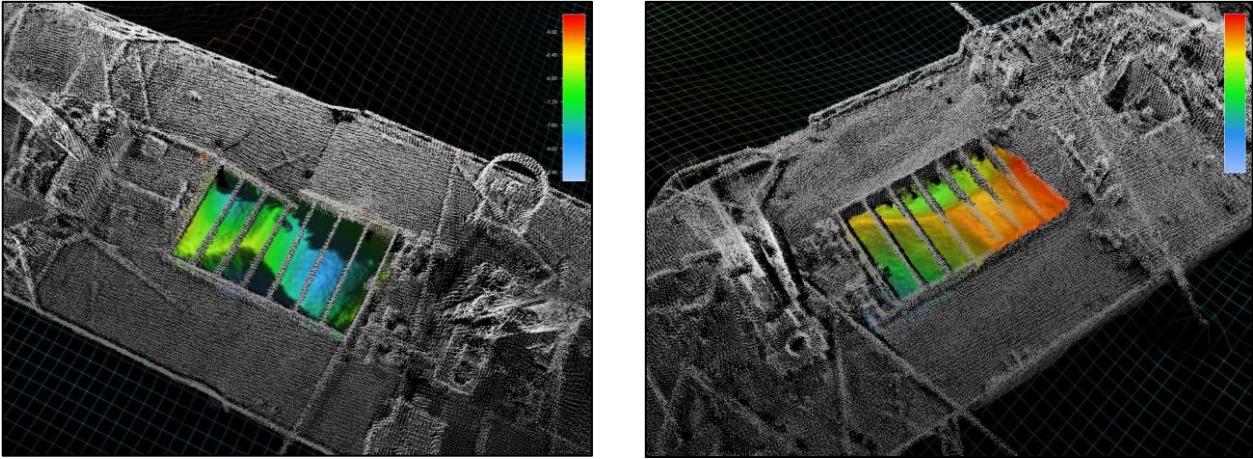
4.5.13 Over the lower hold covers of Holds 2, 3, 4 and 5 there has been some reworking or deposition of sediments. This is most evident at Hold 2 and may be associated with the ongoing subsidence of the deck plate along the port side. The survey vessel passed directly over the top of Hold 2 resulting in a high density of soundings over this area and showed the surface shoaling up to 1.5m near the aft end of the hatch. Hold 3 showed surface changes consistent with mobile sediment, but with less variability than is seen in Hold 2. This is probably due to Hold 3 being more exposed to the strong tidal current that passes between the sections of the wreck. Excellent coverage over Hold 4 was achieved during the 2014 survey, aided by the addition of survey lines aimed at covering the aft end of the boat deck area. The surface beneath the Hold 4 hatch cover supports showed evidence of some minor reworking of sediment infill, surface difference analysis determining that there had been a 30cm loss in height aft and a 30cm elevation forward. Similarly with Hold 5 surface difference analysis and examination of cross sections through combined datasets showed that the four remaining hatch cover supports have continued to remain static and some evidence of sediment reworking was evident on the lower hold cover.

Fig. 10 & 11 Sediment surface showing the form of the infill over the lower hold cover of Hold 2 & 4

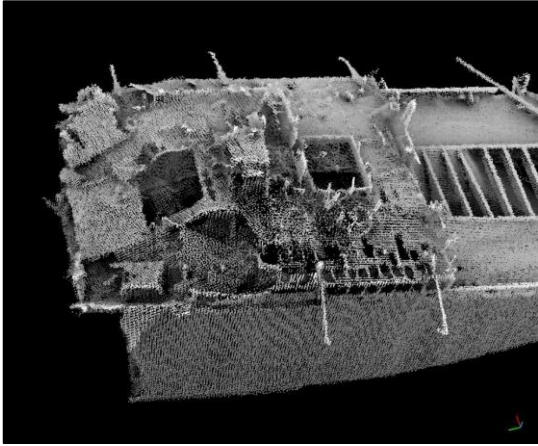
4.5.16 The boiler room casing showed evidence of minor subsidence on the forward side but the aft edge remained stable. It is possible that this change was related to the small misalignment between the 2013 tilted head dataset and the 2014 survey but given the unstable nature of this area of the wreck it seemed appropriate to include it as a detected change.

Figure 12. Forward end of the Aft Section; a region which has experienced structural changes over the last year

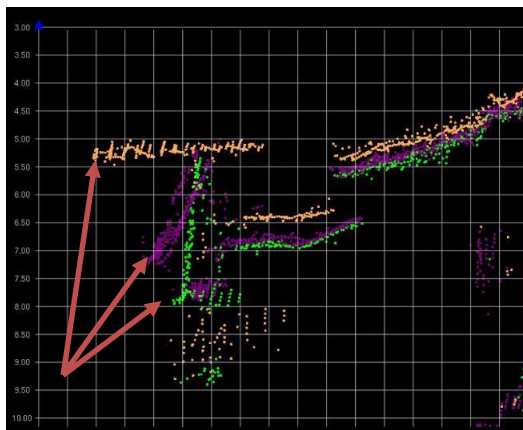
4.5.17 The collapsed boat deck on the port side of the forward end of the Aft Section has been the site of recent significant collapse in an overhanging structure which was observed in the 2013 report. On the left hand side of the image below, the 2010 data (orange) shows a near horizontal structure which in the 2013 dataset has tipped forwards to lie at an angle of approximately 65°. In the 2014 data this structure has continued to drop and now lies at approximately 83°. Across the collapsed boat deck region there is evidence of minor subsidence, typically around 0.1m.

Figure 13. Cross section through collapsed Boat Deck. Data from 2010 [orange], 2013 [purple] and 2014 [green]

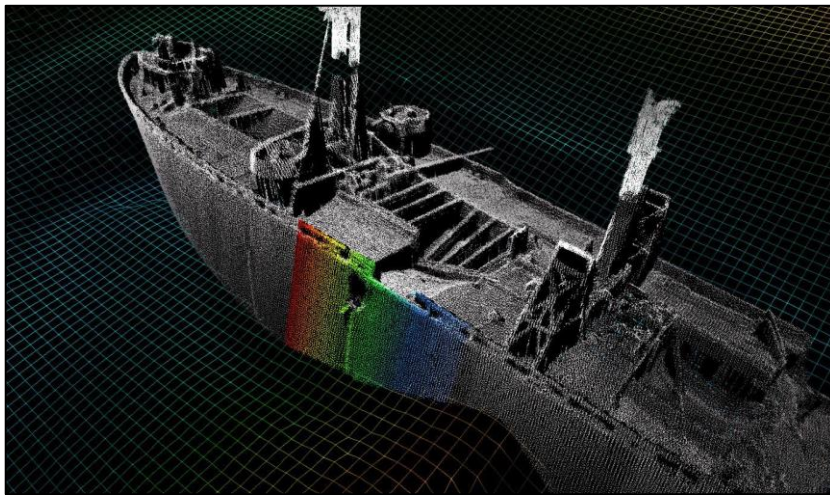
4.6.2 To determine whether any change had occurred in the deformity of the hull on the port side adjacent to Hold 2 a gridded surface was created. Surfaces from different years can then be easily compared. A visual comparison of the surfaces indicated that there had been no significant change during the period between the surveys.

Figure 14. Overview of the Forward Section with the area of the hull gridded into a surface highlighted in colour

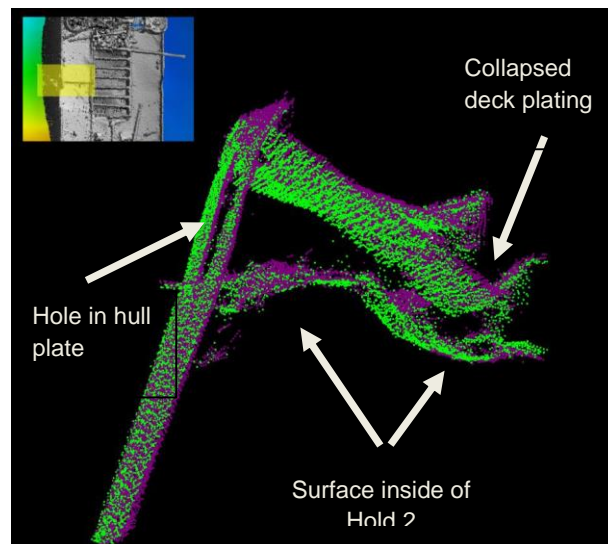
4.10.3 At the 'tween deck area of Hold 2 visualisation inside the hold is possible due to penetration through the crack in the port side of Hold 2 and the area of collapsed deck plating. Coverage of this area was very similar to that achieved in 2013 and no significant changes to the wreck interior were noted.

Figure 21. The interior of the hull at Hold 2 with 2014 (green) and 2013 (purple) datasets

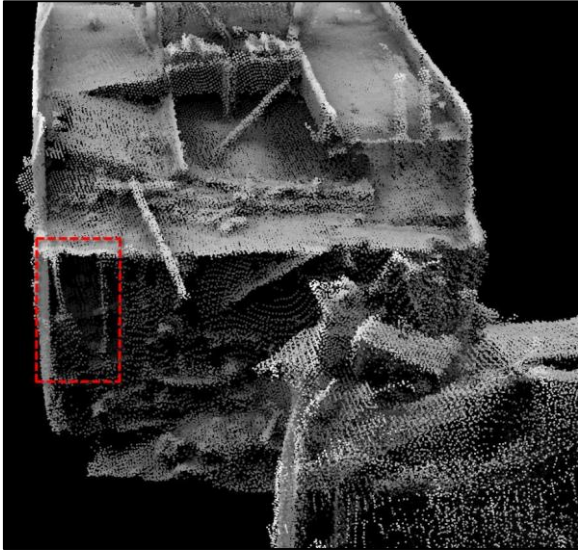
4.10.4 At the aft end of Hold 3 'tween deck is an area of debris caused by the breaking of the vessel into two sections. Examination of cross sections and combined datasets for this area indicated that there had been no changes in the structures strewn across the tween deck area. Through apertures in the bulkhead at the aft end of Hold 3 it has, on occasion, been possible to visualise material inside of Hold 3. In the 2014 survey some insonification of the contents of Hold 3 was achieved. This showed the presence of a stack of material approximately 3.0 m in height with a jagged profile. The same least depth, 7m, which was determined by the 2013 survey was observed in this year's survey however the density of soundings was higher in 2013. Due to the limitations of the system and the poor access to the hold interior it was not possible to identify the nature of the contents.

Fig 22. Hold 3 'tween deck and bulkhead with aperture

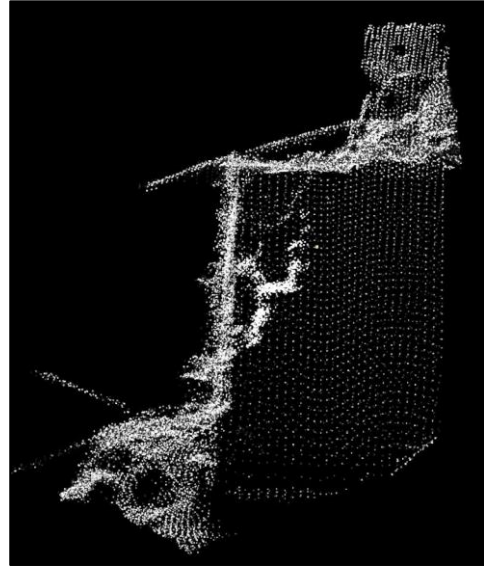
Fig. 23. Profile view showing zigzag shape of contents

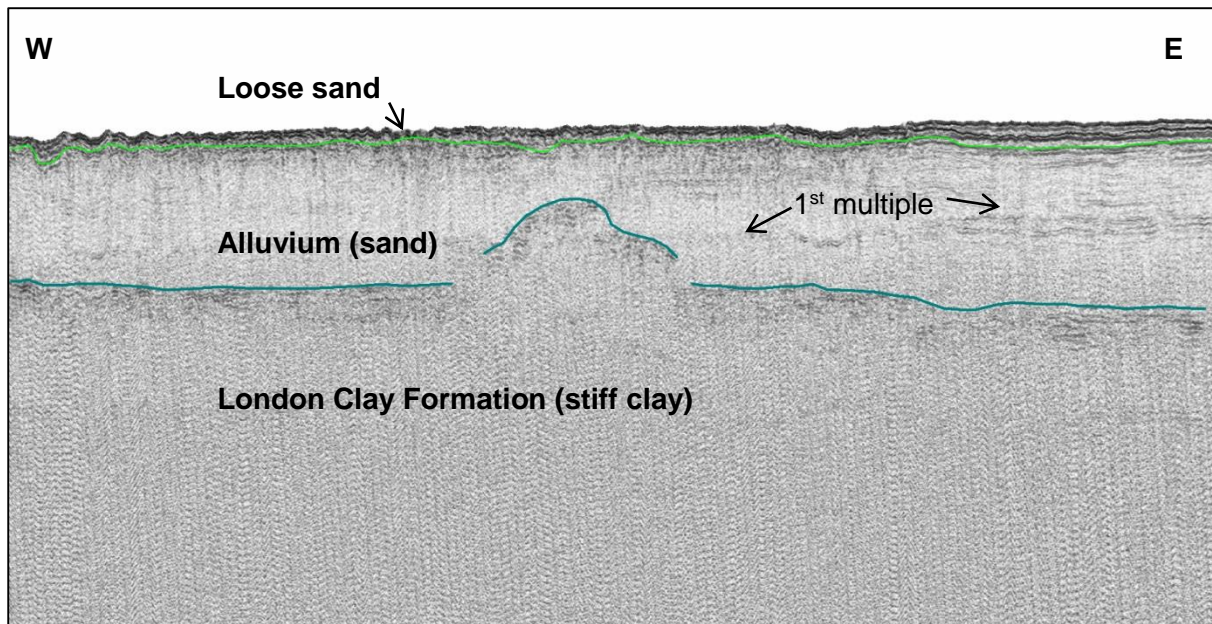
6.3.4 The second reflector, with variable geometry, 5m to 25m from the seabed (considering 1650 m/s sound speed in the sediment), probably corresponds to the interface between the alluvium and the stiff clay of the London Clay Formation.

Figure 27. W-E boomer seismic profile 100315.133144.sgy, north of the survey area. Two reflectors were digitized; one probably corresponds to the top of pre-Holocene stiff Clay (turquoise) and the other to the base of the top unit comprising mobile loose sands (light-green).
