Defence
Infrastructure
Organisation

SAFETY ALERT

Subject: Electric Shock Hazard: 250W SON Low Bay Lighting Fitting

Number: SA 04/15

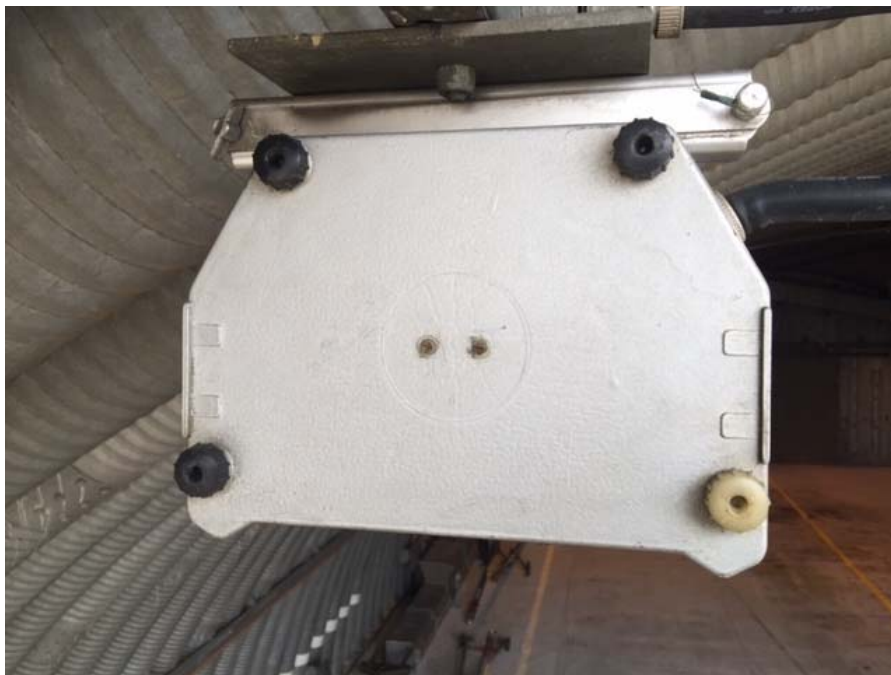
13. When carrying out a non-intrusive inspection, an operative touched the outer casing of the light fitting and received a shock. Initial Investigation revealed that the end cover was live at 230v to earth.
14. Further investigation revealed that 18 of the 24 fittings fitted in the building had a similar fault.

End view of fitting

9. A safe system of work is to be established the vicinity of these light fittings. No work should be undertaken on or near these light fittings unless appropriately isolated.

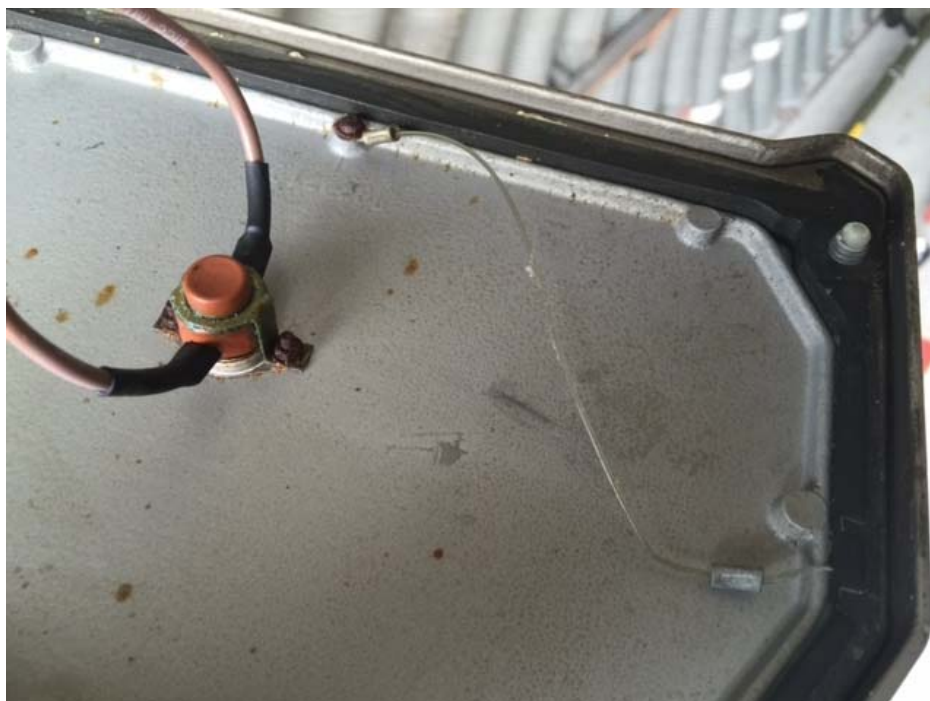
15. Following isolation of the circuit, a detailed examination was made of a fitting which revealed that the fault is likely to be the caused by the breakdown of insulation of the thermal cut-out fixed to the end cover.
16. It appears that the end cover is electrically isolated from the rest of the fitting by a gasket and non metallic mounting screws. Therefore this fault may not be detected by insulation resistance testing of the fitting and may only become apparent when the end cover is touched.

Internal detail of fitting

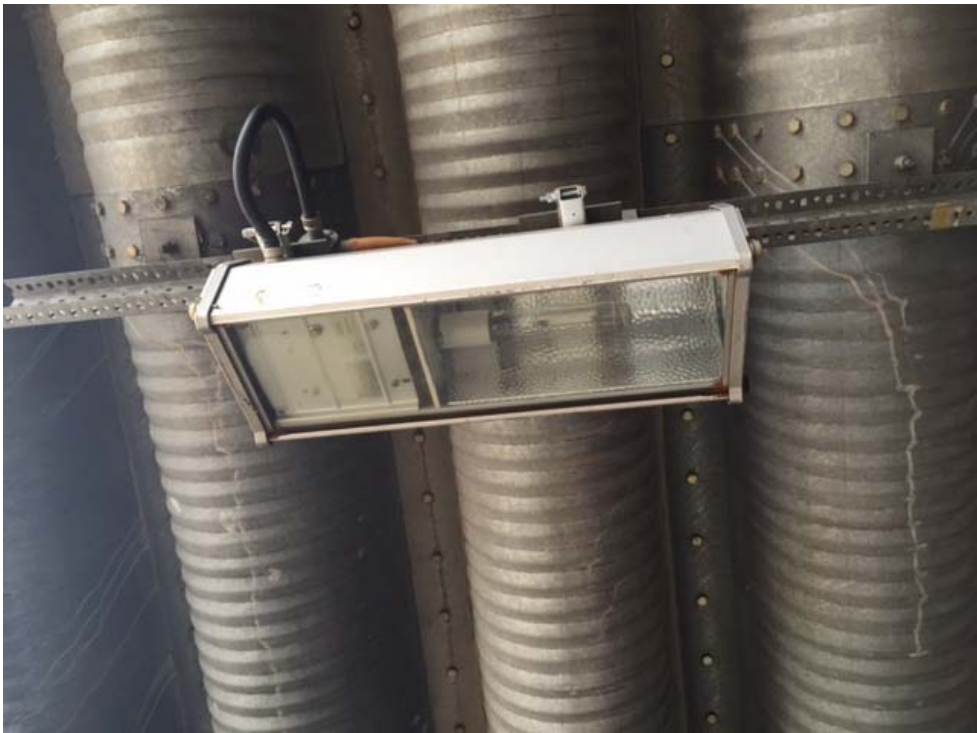
7. These light fittings are known to have been installed in NATO Hardened Aircraft Shelters (HAS) and similar structures circa 1980s, however, their installation in other areas cannot be precluded.

External View of Installed Fitting

8. Responsible persons are to establish if these light fittings are present on their sites. If found, their location, number, approximate age and condition should be recorded. Additionally, relevant persons at establishment and contract level informed and following suitable and sufficient risk assessment, appropriate notices posted to alert people to the hazard and 4Cs Register suitably annotated to identify the additional hazard.
