## **Appendix J: Metallographic Examination of Samples from GRW Tanker J2580**

This appendix specifically addresses the examination of the J2580 section.

### **4 Samples from J2580**

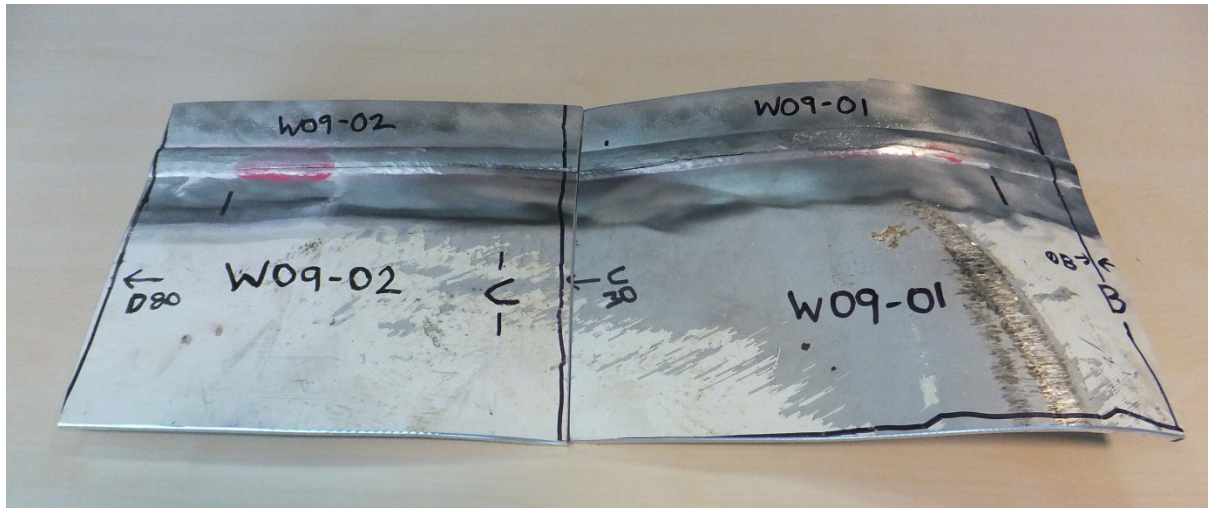
**Figure J4** J2580 samples W09-01 and W09-02 (incorporating longitudinal crack).

A small amount of dye penetrant was used to pinpoint the ends of the longitudinal crack before a sample was removed incorporating this crack. The total length of the through-thickness flaw was 320mm. This sample was cut into two pieces as shown in Figure J4.

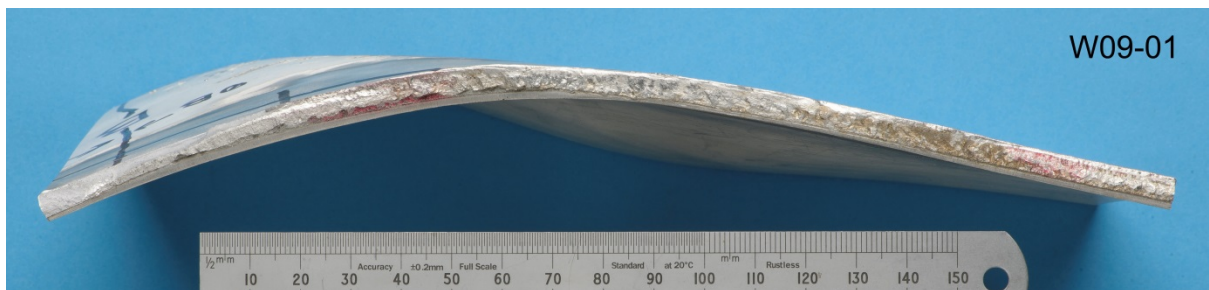
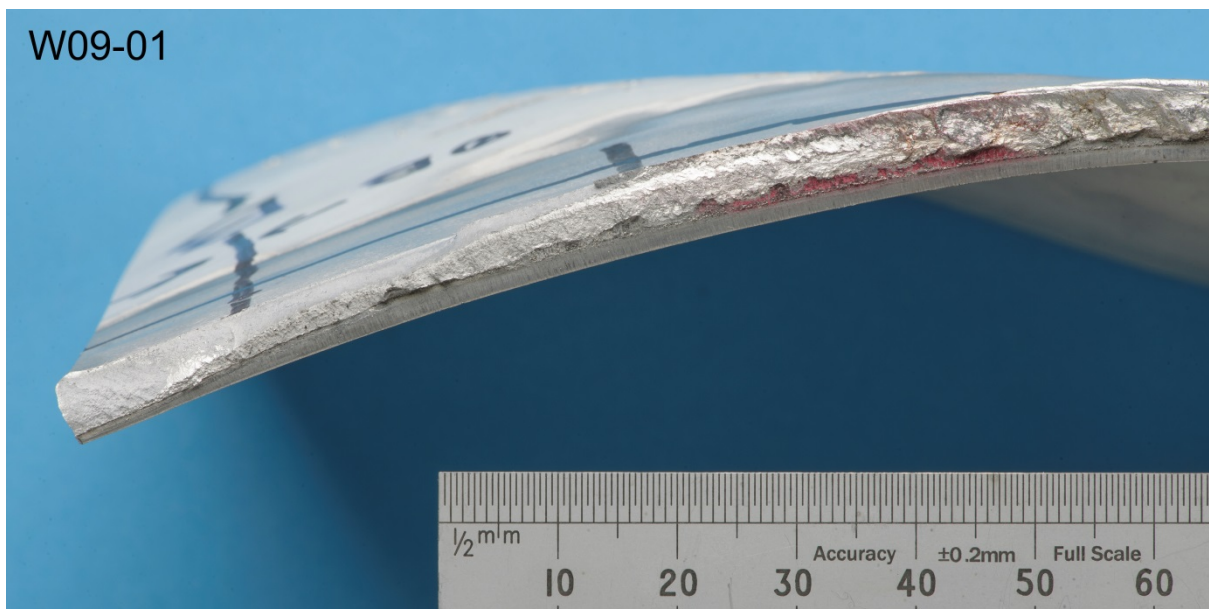
Sample W09-01 was then mechanically broken open to reveal the fracture faces (Figures J5 to J8). The lack of fusion defect was measured on the broken-open section and the total, continuous length was 230mm with very nearly a constant defect height of 1.0mm. It was not possible to measure the length of the initial lack of fusion defect from the section that was not broken open. However, the defect that led to the through-thickness rupture shows up on the radiographic inspection report and therefore the surface length of the initial flaw would have also been in excess of 100mm. However, without accurate measurement it is only possible to say conclusively that the initial lack of fusion defect that led to rupture was 1.0mm deep and at least 230mm long.

**Figure J5** J2580 sample W09-01 fracture surface.

**Figure J6** J2580 sample W09-01 fracture surface (left).

**Figure J7** J2580 sample W09-01 fracture surface (centre).

**Figure J8** J2580 sample W09-01 fracture surface (right).

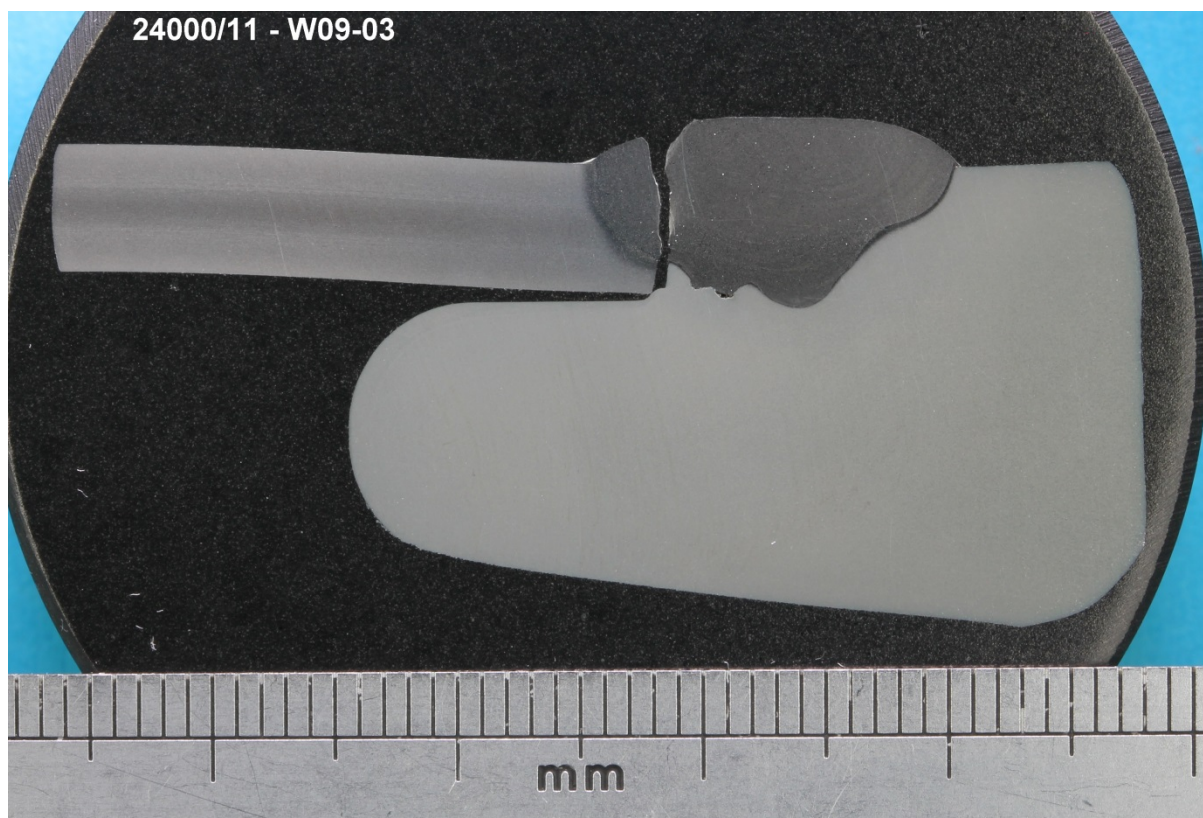
**Figure J9** J2580 sample W09-03 macro.

A 10mm section was removed from W09-02, near the centre of the crack and a macro section was produced (Figure J9).

- There is an initial lack of fusion defect located at the positioning lip (vertical up-stand located near the fusion line of the weld). The height of this lack of fusion is 1.0mm. The length of the lack of fusion defect is in excess of 100mm.
- The lack of fusion defect has the morphology of a surface-breaking flaw, because the material is unfused to the left of the defect (as oriented in Figure J9). See also Figure J10.
- As a result of the overload conditions (ie the topple test) the lack of fusion defect has ruptured through the circumferential seam weld.
- Measurements reveal that the misalignment in this macro section is approximately 0.5mm and the local weld cap height is approximately 1.0mm (see Figure J11).

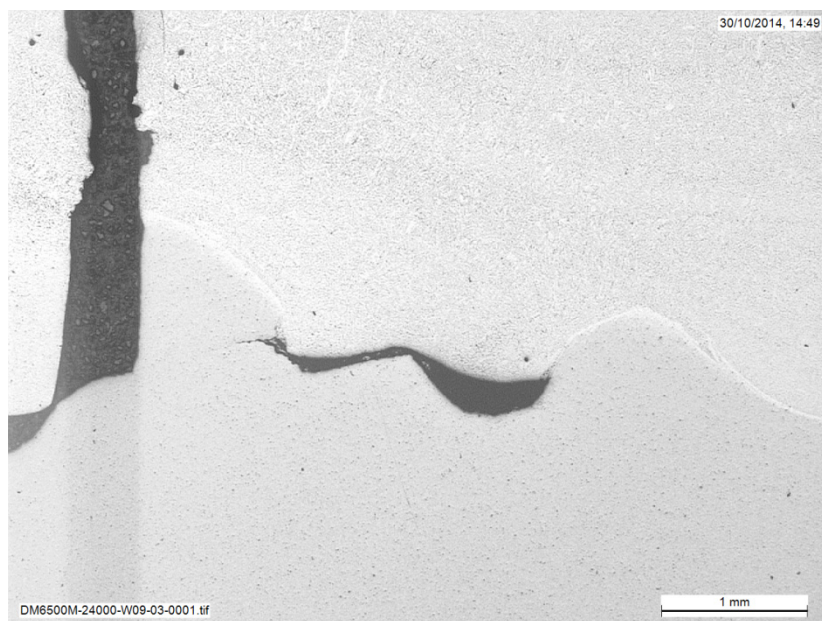
**Figure J10** J2580 sample W09-03 macro. Focus on the initial lack of fusion at the positioner lip.

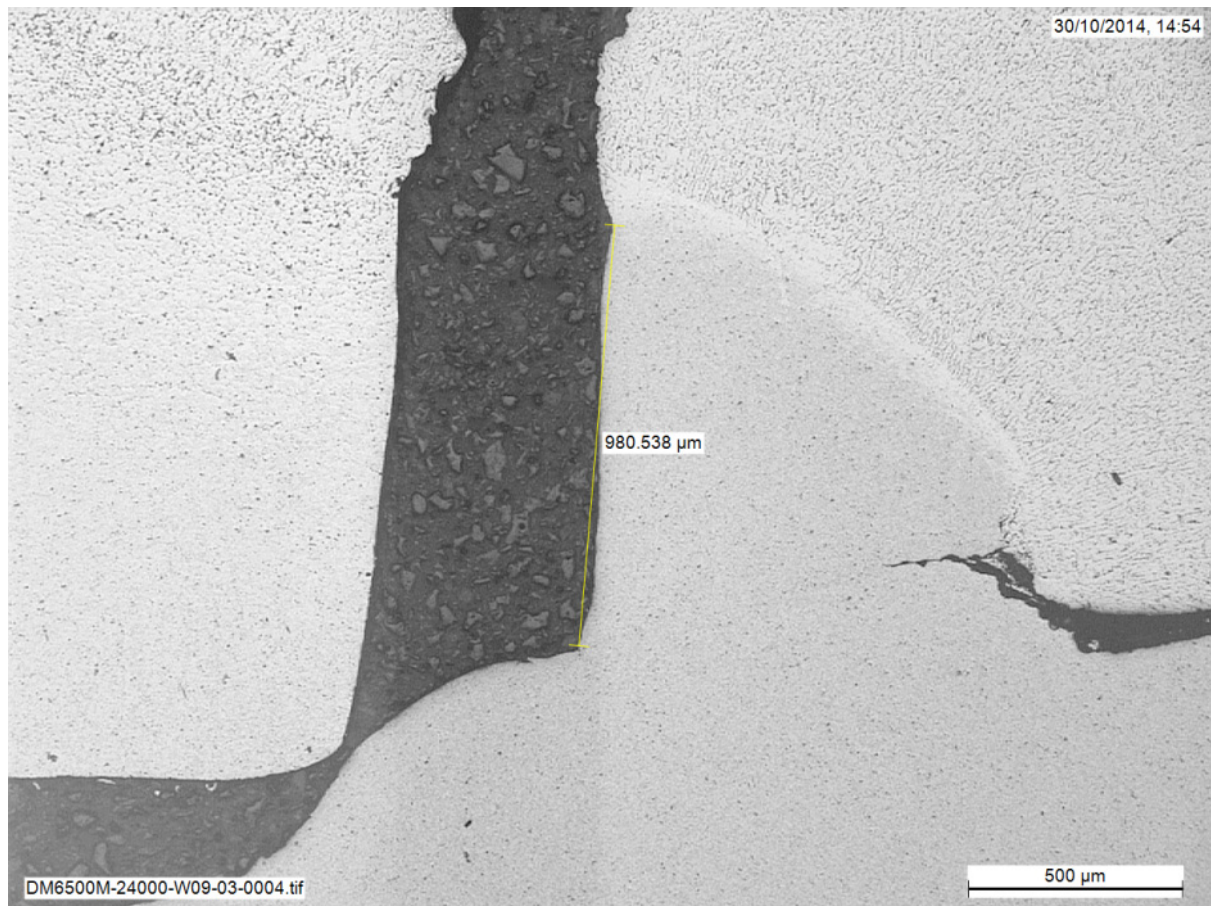
**Figure J11** J2580 sample W09-03 macro. Measurement of the lack of fusion defect at the positioner lip. Initial height of the surface flaw is approximately 1.0mm.
