Report No: 24000/13/15

Date: 04 September 2015

For: Department for Transport

Department for Transport Technical Assessment of Petroleum Tankers: Metallographic and Analytical Assessment of AT11-1475

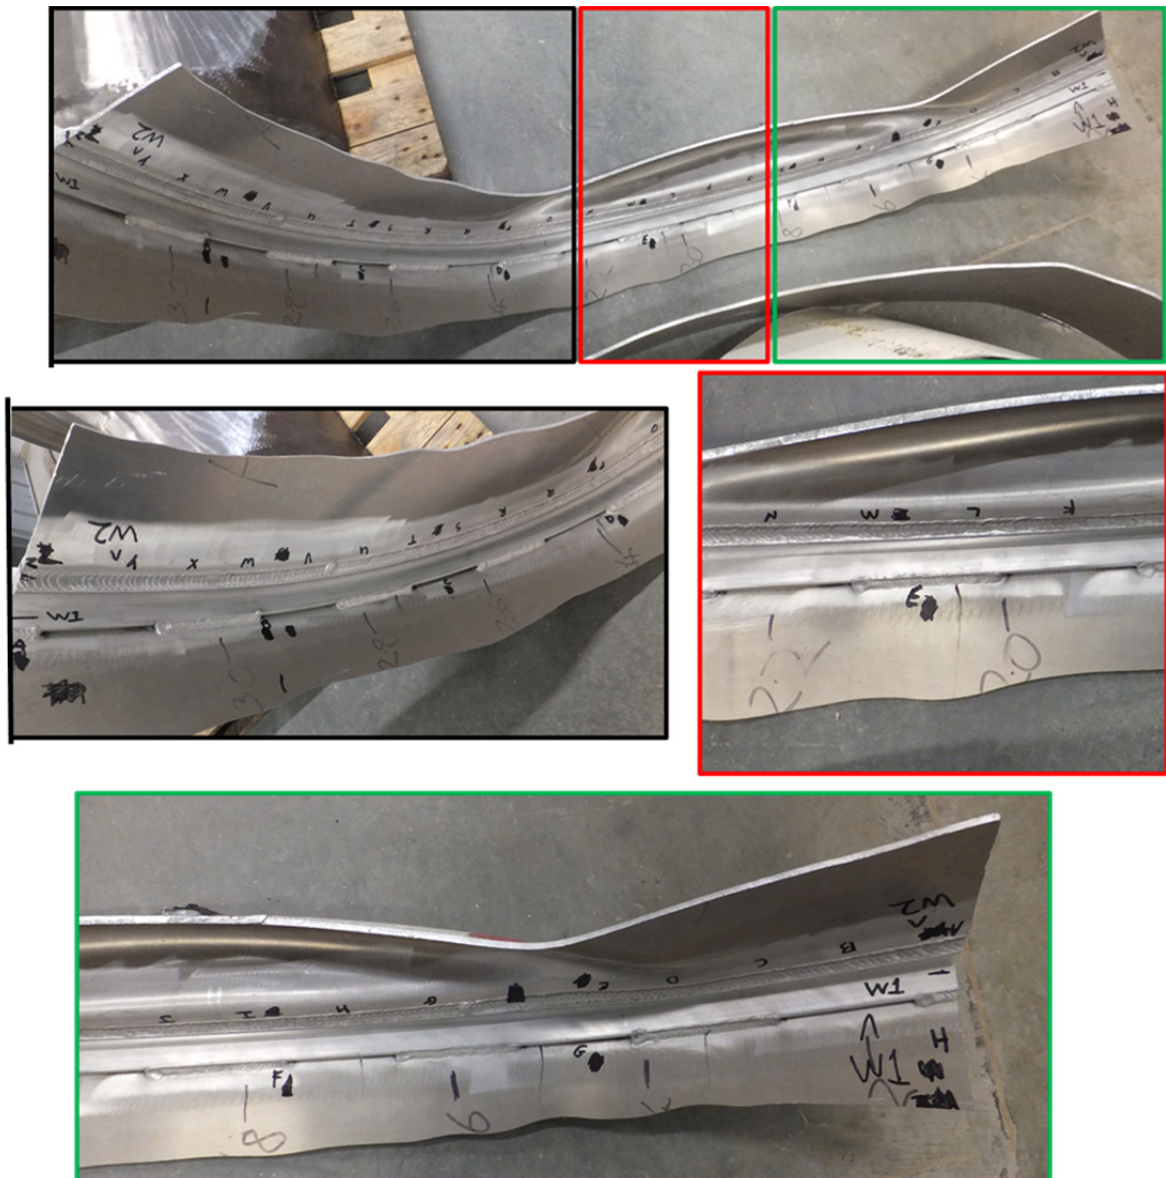
Radiograph Number	Weld Number	Datum Points	Comments
P0117	W1	A-B	Groove Noted, minor isolated pores throughout <0.8mm Ø.
P0118	W1	B-C	Groove Noted, linear aligned pores throughout <1.0mm Ø.
P0119	W1	C-D	Groove Noted, linear aligned pores throughout <1.0mm Ø.
P0120	W1	D-E	Groove Noted, linear aligned pores throughout <1.0mm Ø.
P0121	W1	E-F	Groove Noted, linear aligned pores throughout <1.0mm Ø.
P0122	W1	F-G	Groove Noted, linear aligned pores throughout <1.0mm Ø.
P0123	W1	G-H	Groove Noted, linear aligned pores throughout <1.0mm Ø.

Figure 4 Image of the section from the rear offside of AT11-1475 showing the datum markers (A-H for the primary circumferential weld) for the radiographic examination (see Table 1).

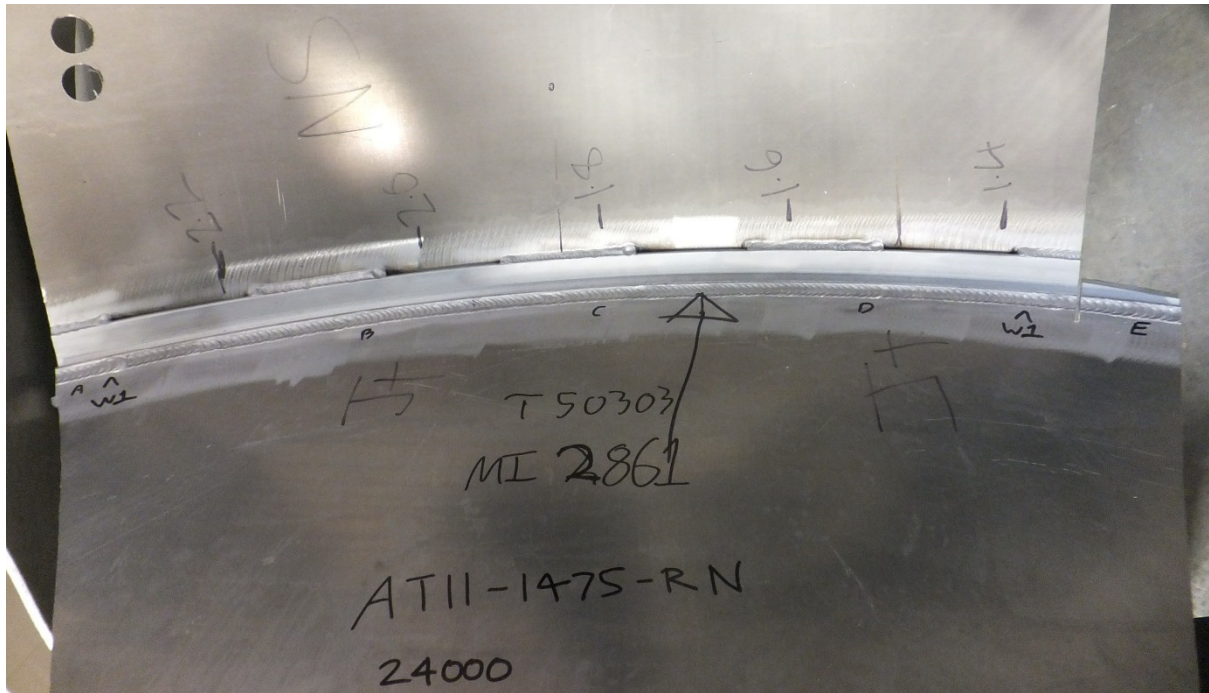
Radiograph Number	Weld Number	Datum Points	Comments
P0112	W3	A-B	Groove Noted, linear aligned pores throughout <1.0mm Ø.
P0113	W3	B-C	Groove Noted, linear aligned pores throughout <1.0mm Ø.
P0114	W3	C-D	Groove Noted, linear aligned pores throughout <1.0mm Ø.
P0115	W3	D-E	Groove Noted, linear aligned pores throughout <1.0mm Ø.

Figure 5 Image of the section from the rear nearside of AT11-1475 showing the datum markers (A-E) for the radiography (Table 2).

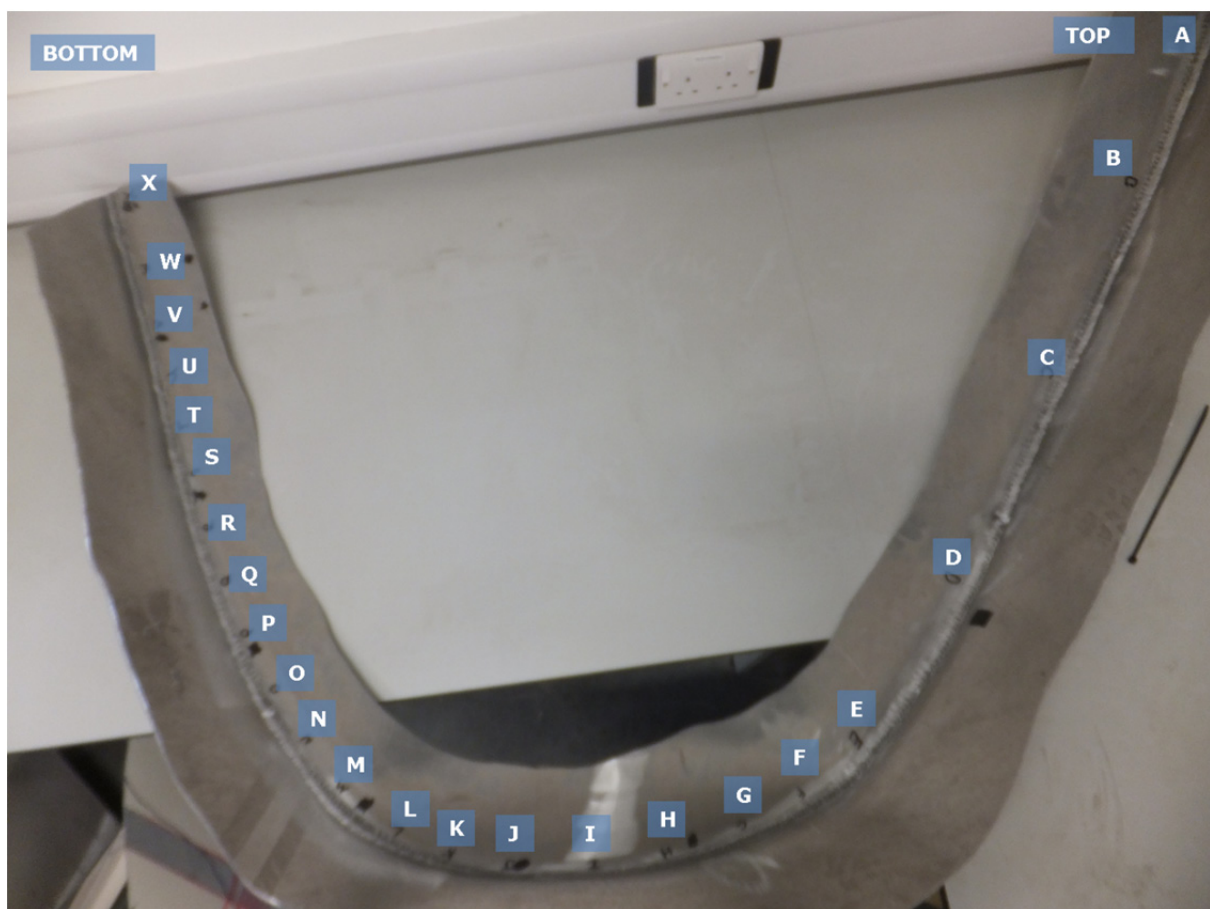
Radiograph Number	Weld Number	Datum Points	Comments
P0151	W1	A-B	Linear lack of penetration noted throughout radiograph. Isolated porosity noted no greater than 1mm \emptyset .
P0152	W1	B-C	Linear lack of penetration noted throughout radiograph. Isolated porosity noted no greater than 1mm \emptyset .
P0153	W1	C-D	Linear lack of penetration noted throughout radiograph. Isolated porosity noted no greater than 1mm \emptyset .
P0154	W1	D-E	Linear lack of penetration noted throughout radiograph. Isolated porosity noted no greater than 1mm \emptyset .
P0155	W1	E-F	Isolated porosity noted no greater than 1mm \emptyset throughout.
P0156	W1	F-G	Linear porosity noted, F + 10mm for a length of 25mm. Isolated porosity noted no greater than 1.5mm \emptyset throughout.
P0157	W1	G-H	Porosity noted no greater than 1.5mm \emptyset throughout.
P0158	W1	H-I	Porosity noted no greater than 1.5mm \emptyset throughout.

P0159	W1	I-J	Porosity noted no greater than 1.5mm \emptyset throughout. Lack of penetration 20mm up to J.
P0160	W1	J-K	Porosity noted no greater than 1.0mm \emptyset throughout, transverse void noted positioned J+15mm, 4mm long
P0161	W1	K-L	Porosity noted no greater than 1.0mm \emptyset throughout. Two large pores noted 25mm before L.
P0162	W1	L-M	Porosity noted no greater than 1.0mm \emptyset throughout. Two gas pores noted, position L +10mm, and L +18mm. Lack of penetration starting 60mm from L to M.
P0163	W1	M-N	Minor porosity noted throughout. Intermittent Lack of Penetration, position M +20mm.
P0164	W1	N-O	Minor porosity noted throughout. Intermittent Lack of Penetration, position N +25mm to O.
P0165	W1	O-P	Minor porosity noted throughout. Linear Pore noted, 4mm \emptyset .
P0166	W1	P-Q	Minor porosity noted no greater than 0.2mm \emptyset throughout. Lack of penetration throughout.
P0167	W1	Q-R	Minor porosity noted no greater than 0.5mm \emptyset throughout. 1 gas pore noted, position Q +35mm. Intermittent lack of penetration throughout.

P0168	W1	R-S	Minor porosity noted no greater than 0.5mm \emptyset throughout. Intermittent lack of penetration throughout.
P0169	W1	S-T	Minor porosity noted no greater than 0.7mm \emptyset throughout. Intermittent lack of penetration throughout.
P0170	W1	T-U	Minor porosity noted no greater than 0.5mm \emptyset throughout. Intermittent lack of penetration throughout.
P0171	W1	U-V	Intermittent lack of penetration throughout.
P0172	W1	V-W	Intermittent lack of penetration throughout.
P0173	W1	W-X	4 gas pores noted, 4mm \emptyset . Minor porosity noted no greater than 0.5mm \emptyset throughout. Intermittent lack of penetration noted at X position.

Figure 6 Image of the section from the front offside of AT11-1475 showing the datum marks (A-X) for the radiography (Table 3).

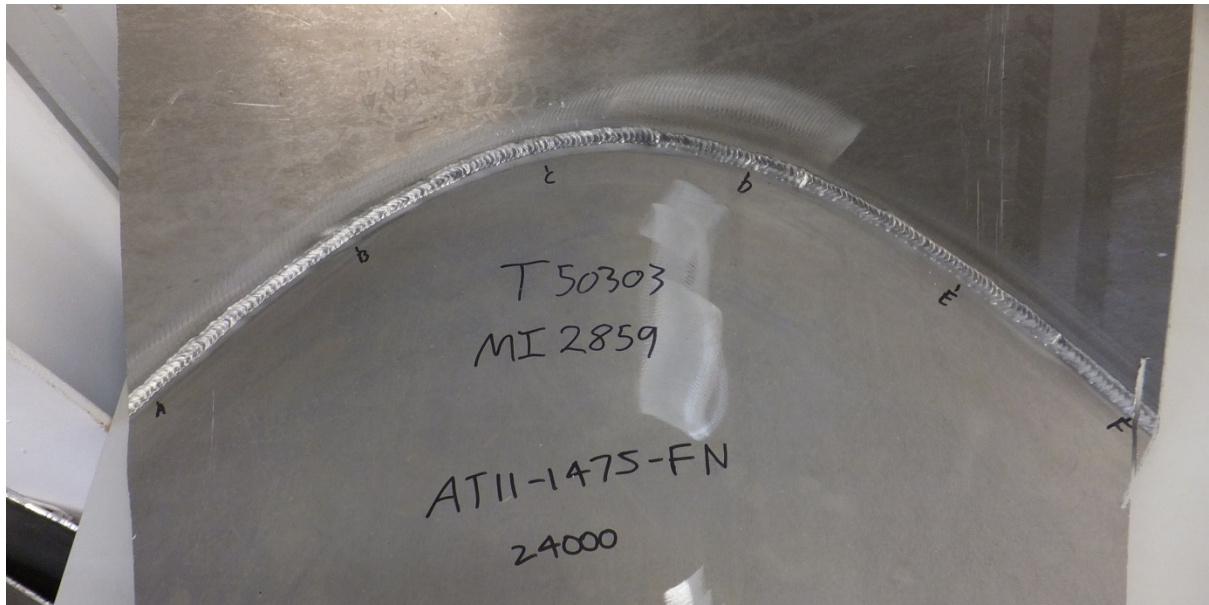
Radiograph Number	Weld Number	Datum Points	Comments
P0096	W1	A-B	Porosity noted throughout radiograph between 0.2 to 1.3mm ø. Linear lack of fusion noted 60mm from A to 30mm behind B.
P0097	W1	B-C	Isolated porosity noted throughout radiograph <1.0mm ø. Linear lack of fusion noted 20mm long, 50mm behind C.
P0098	W1	C-D	Isolated scattered porosity noted throughout radiograph <0.5mm ø. 2 large pores noted at the stop/start no greater than 1.5mm ø.
P0099	W1	D-E	Isolated porosity noted throughout radiograph <0.5mm ø. Intermittent lack of fusion noted.
P0100	W1	E-F	Isolated porosity noted throughout radiograph <0.5mm ø. Intermittent lack of fusion noted.

Figure 7 Image of the section from the front nearside of AT11-1475 showing the datum markers (A-F) for the radiography (Table 4).

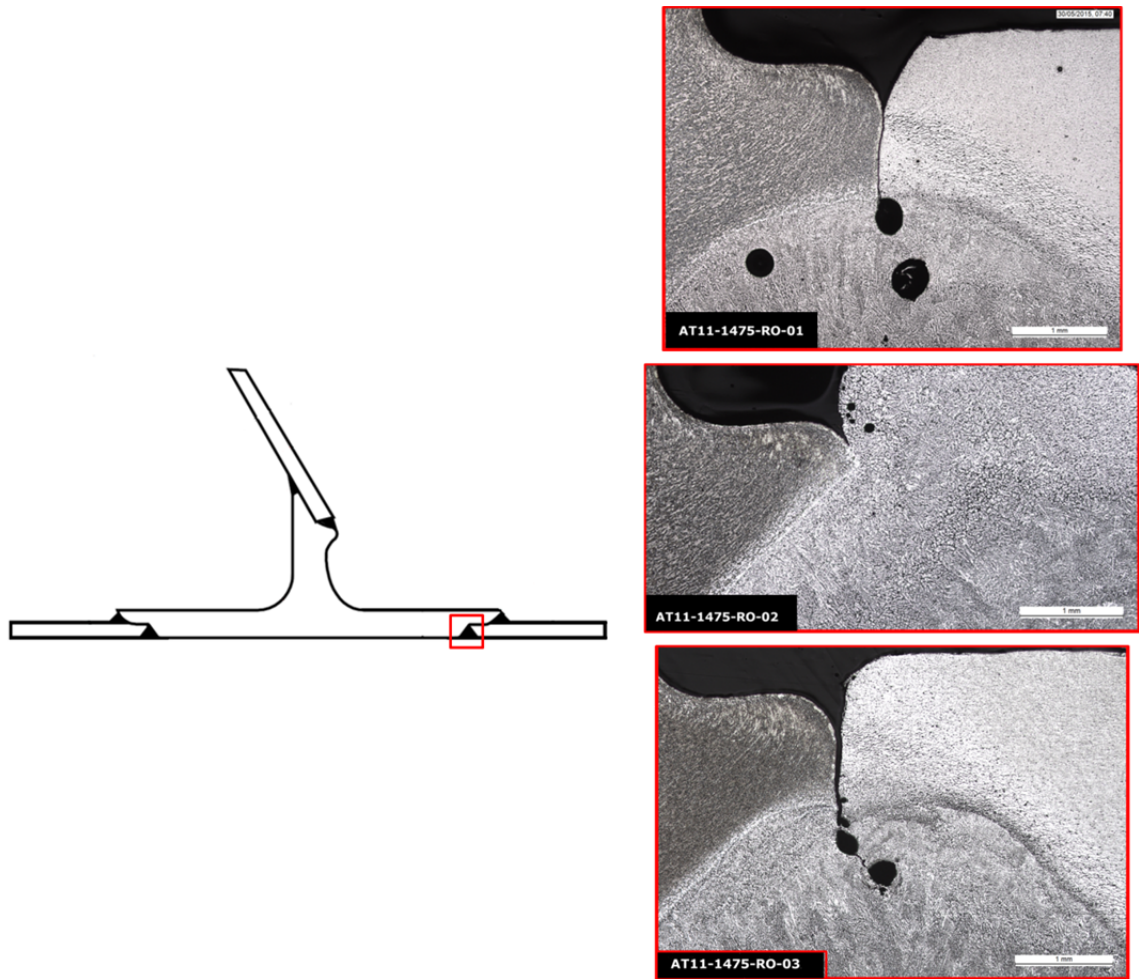
samples were spaced approximately 125mm apart. Samples RN-01 to RN- are shown in Figure 14. All of the primary circumferential welds from the rear nearside samples are shown in Figure 15. As with the rear offside, the penetration into the root of the weld is variable, with sample RN-03 exhibiting good penetration and fusion between the tanker shell and extrusion band, whilst samples RN-01, RN-02 and RN-04 show signs of lack of fusion at the root of the weld, resulting in surface-breaking defects that are up to 1.5mm deep.

3. The samples of the rear circumferential joint exhibited variable root penetration in the main circumferential welds. This resulted in some internal surface-breaking, lack of root fusion defects being observed with typical defect depths ranging from 1.0mm to 2.0mm.

Figure 9 Images of samples RO-01 (top right), RO-02 (middle right), and RO-03 (bottom right) with the reference location shown on the BS EN 13094 indicative joint design D.14(c) on the left. The scale bars on the right indicate 1.0mm. Samples RO-01 and RO-03 exhibit lack of root fusion defects, whilst RO-02 exhibits good penetration and fusion.

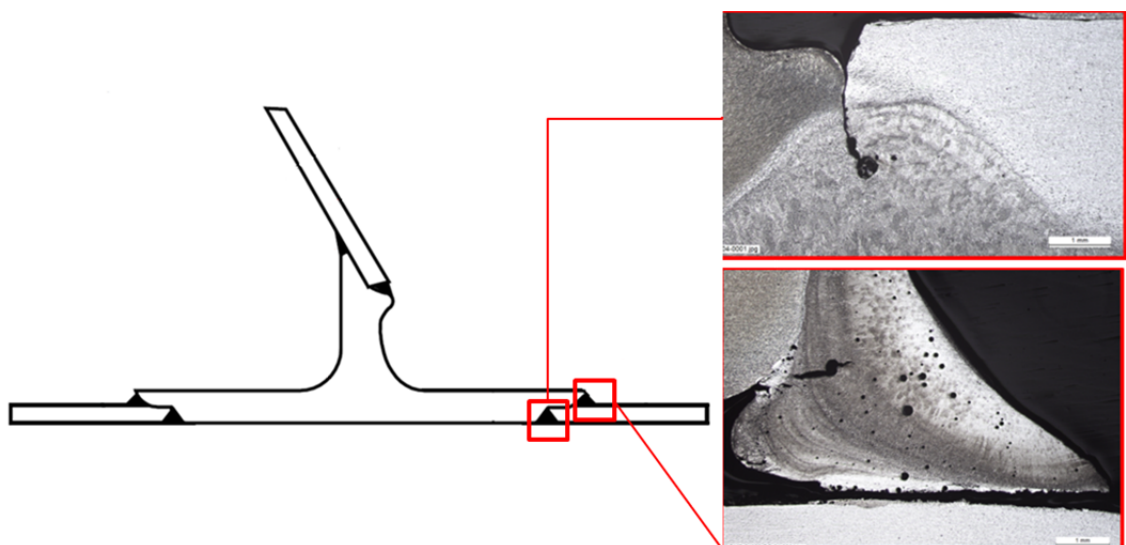
Figure 10 Images of sample RO-04. On the right images, the scale bars indicate 1.0mm length. The top right image shows the lack of root fusion defect, and the right frame shows the fracture between the internal fillet weld and the inner surface of the tanker shell along the fusion line.

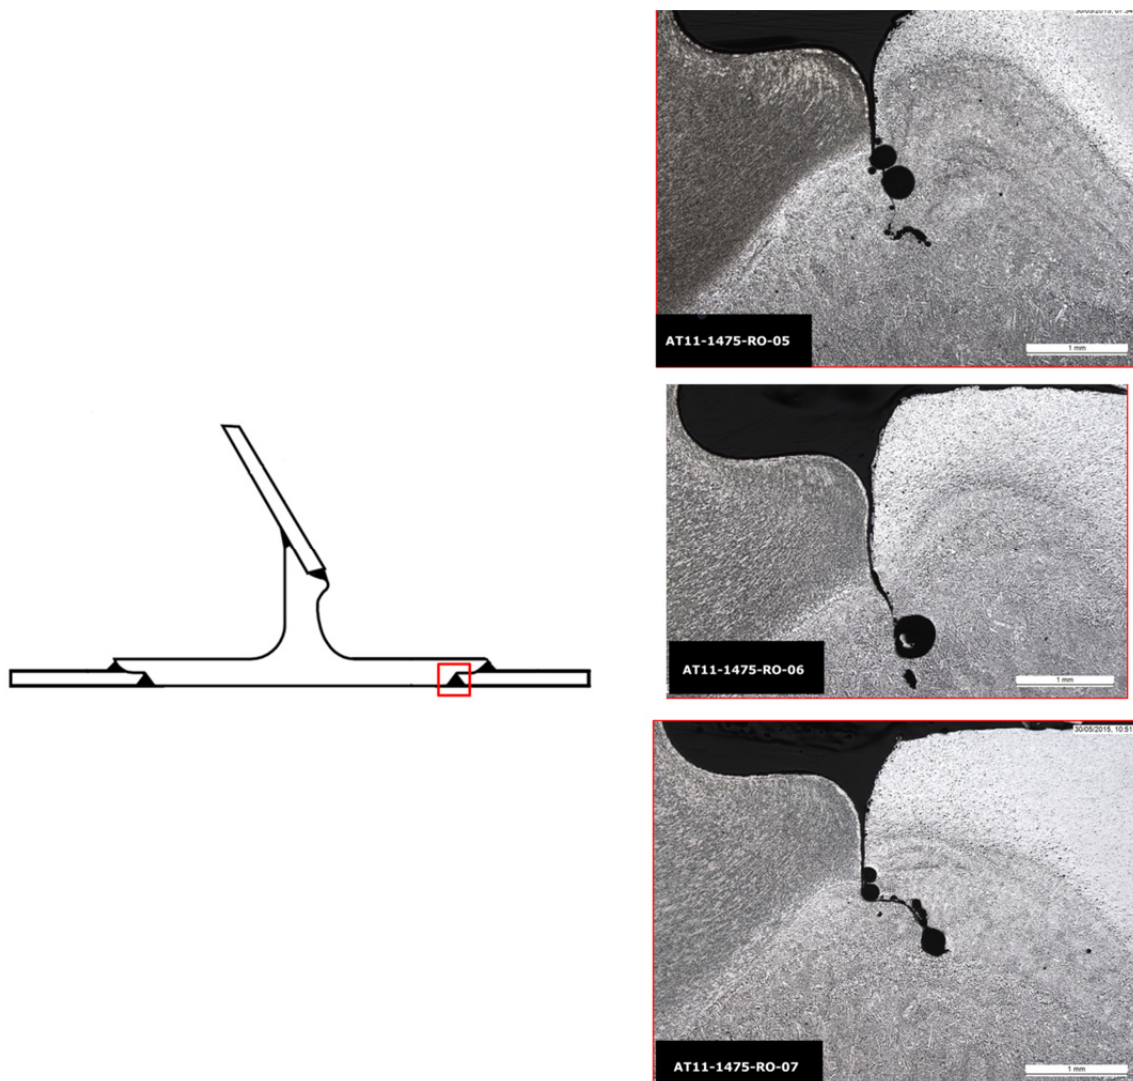
Figure 11 Images of samples RO-05 (top right), RO-06 (middle right), and RO-07 (bottom right), with the reference location shown on the BS EN 13094 indicative joint design D.14(c) on the left. On the left frames, the scale bar indicates 1.0mm length. All three samples exhibit lack of root fusion defects.

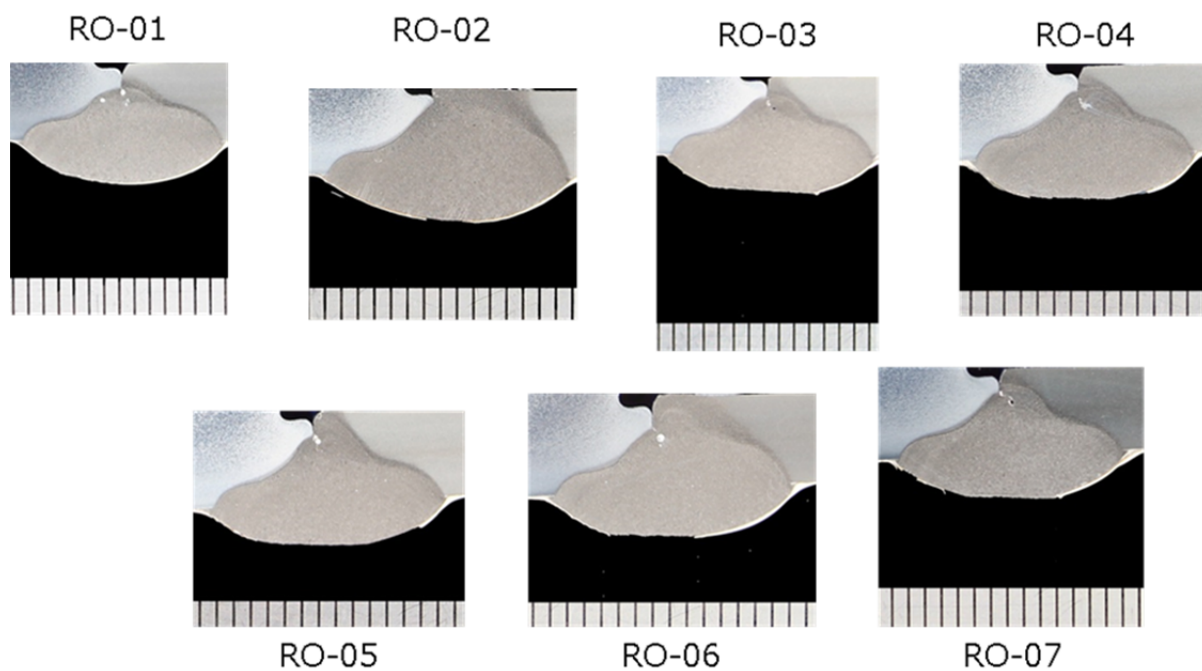
The main circumferential welds in the samples from both the rear offside and rear nearside were shown to exhibit weld caps (or overfill) typically in excess of 3.0mm as measured from the outer surface of the tanker shell. Previous research on tanker performance under topple test conditions (TWI, 2015) has demonstrated the benefits that a large weld cap can have in resisting the bending moments experienced by the joint under topple test conditions. Nevertheless, an excessive weld cap can also be indicative of poor root penetration, which is evident in many of the samples taken from the rear welds. All weld samples from the rear offside and rear near side showed very good alignment, with axial misalignment measurements typically being less than 0.5mm. The previous TWI research (2015) also demonstrated the significant effect of misalignment on the acceptability of defects; specifically, the maximum tolerable defect size under topple test conditions reduced rapidly as the level of axial misalignment increased. Thus, although a surface-breaking, lack of root fusion defect is present in many of the rear weld samples, it is likely that the combination of good joint alignment and relatively large weld cap size contributed to the lack of failure during the topple test.

4. For the rear weld samples, the joints were found to exhibit good alignment, typically within 0.5mm, and the height of the weld caps of the main circumferential welds was found to be typically in excess of 3.0mm. The combination of low misalignment and large weld caps likely contributed to the good performance of the joints under the topple test. However, the excessive weld cap size was seen to correlate with lack of root penetration (and lack of root fusion defects) in many samples.

Figure 12 Images of the circumferential welds from the rear offside section of AT11-1475. Tick marks indicate 1.0mm length. The locations are shown in Figure 8.

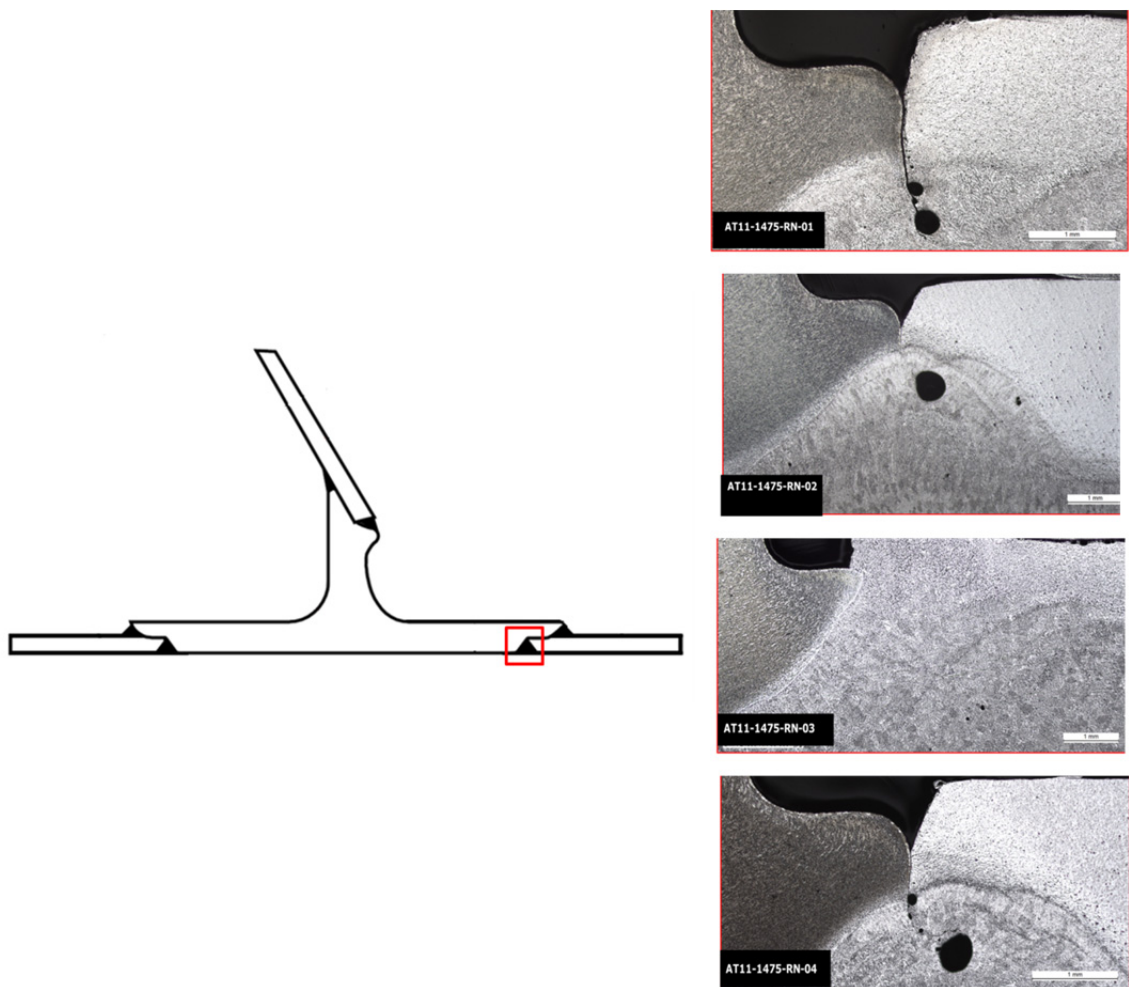
Figure 14 Images of samples RN-01 (top right), RN-02 (second from top right), RN-03 (third from top right), and RN-04 (bottom right). The scale bars on the frames indicate 1.0mm length. Sample RN-01 shows more significant lack of fusion at the root than RN-02. Sample RN-04 exhibits lack of root fusion.

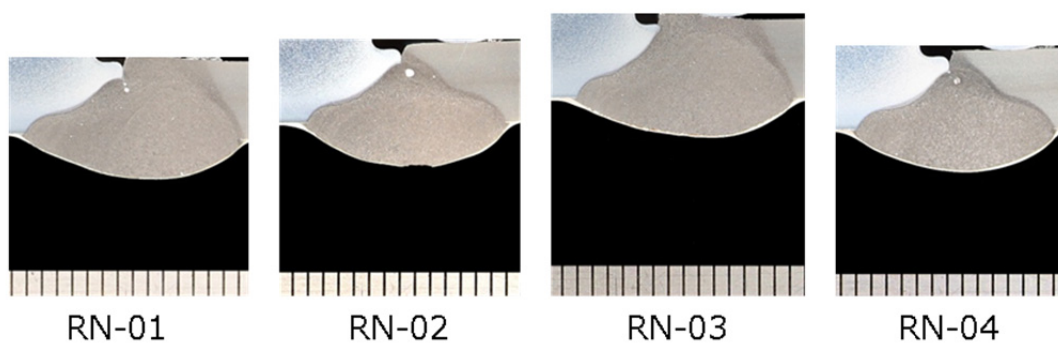
Figure 15 Images of the circumferential welds from the rear nearside section of AT11-1475. Tick marks indicate 1.0mm length scale. The locations are shown in Figure 13.

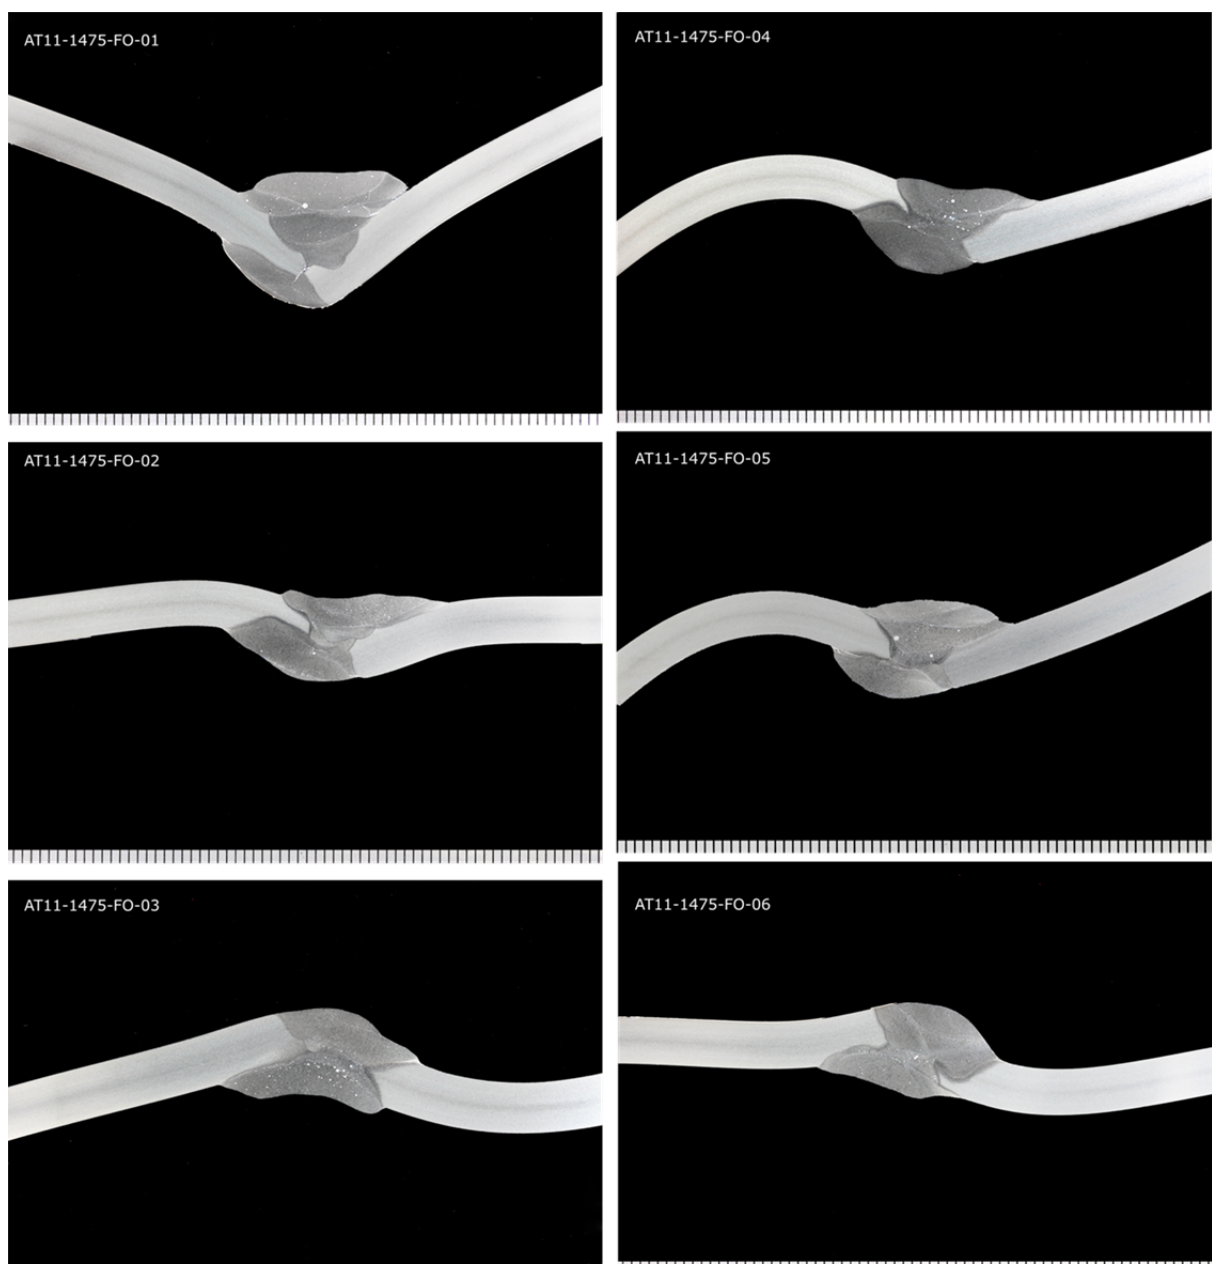
Six samples were machined in the longitudinal direction from the impacted, front offside section of AT11-1475. As described in Section 3.1, all circumferential joints in AT11-1475 are geometrically similar to that shown in Figure 1 except for the front-most joint, which is a double-sided corner joint due to the swept design of the front dish. Of the six samples, five were taken from the crush zone (ie the large plastic bulge that comprises the flattened region that impacted the ground) and one additional sample (FO-01) was taken remote from the crush zone. The locations of the samples are illustrated in Figure 16. In Figure 17, images of the corner joint are shown for each sample from the front offside. Whilst the front circumferential joint has undergone extensive plastic deformation during the topple test as evidenced by the severe bending shown in Figure 17, none of these exhibit any evidence of cracking.

1. No through wall ruptures were observed in any of the samples taken from the front or rear welds of AT11-1475.
2. The samples from the front circumferential joint did not exhibit any significant lack of fusion defects.

Figure 17 Macro-sections from the front offside (impacted) section of AT11-1475. Tick marks indicate a 1.0mm length scale. The locations are shown in Figure 8.

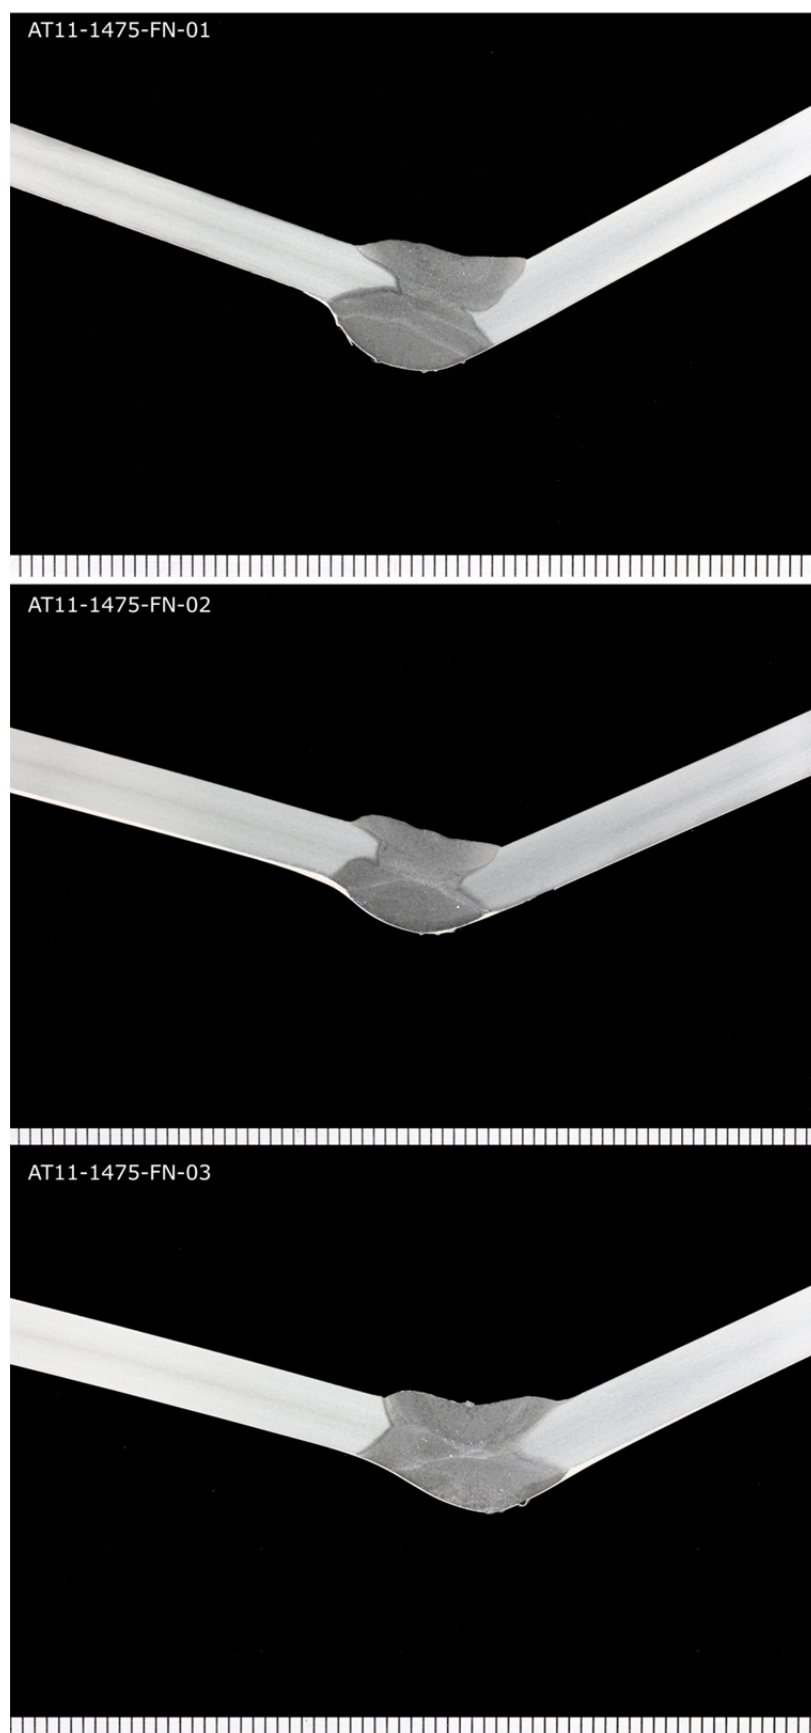
Figure 19 Macro-sections from the front nearside (undamaged) section of AT11-1475. Tick marks indicate 1.0mm length scale. The locations are shown in Figure 10.

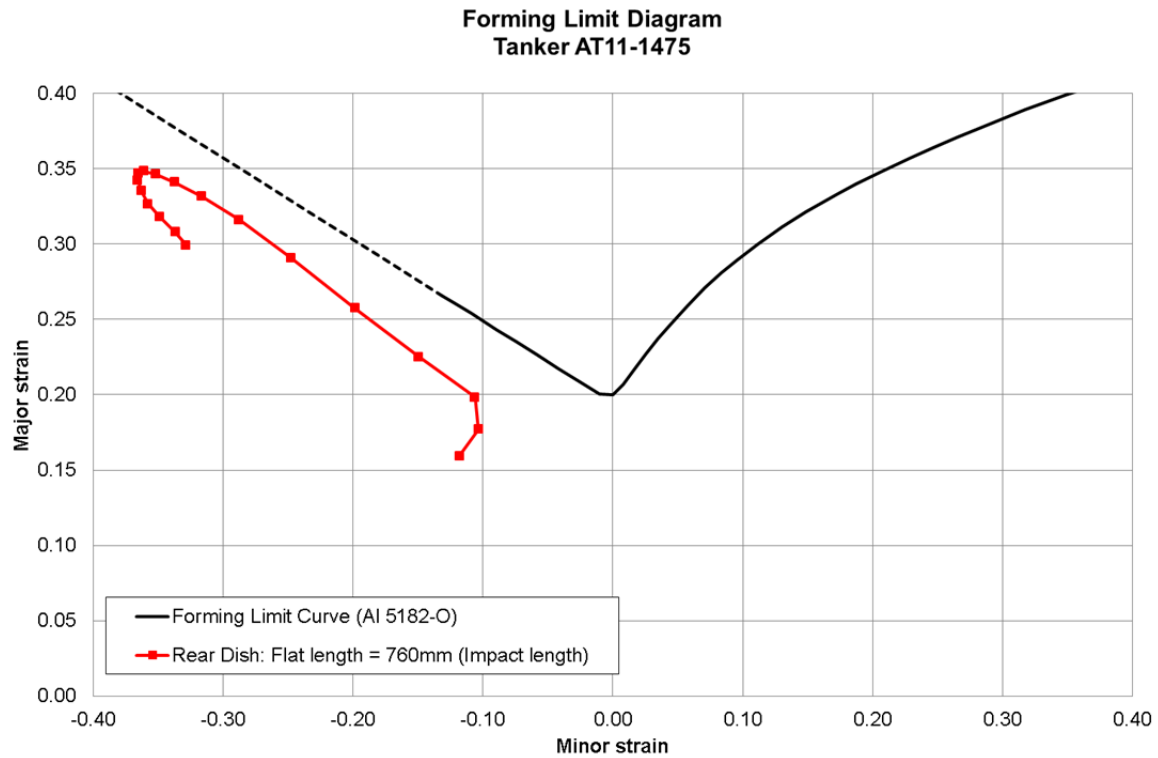
minor strain and major strain were plotted on the FLD against the forming limit curve from Wu et al (2003) as shown in Figure 29. In this figure, the red curve (strains from the FE model) lies below the forming limit curve (black curve). This indicates that the forming limit diagram approach does not predict failure to occur. This result agrees with the observations from the topple test and subsequent metallographic examinations, where no cracking or failure of the rear dish was seen.

Figure 29 Forming limit diagram for the rear dish simulation. Each red point represents the minor and major strains output at a node in the circumferential path passing through the most severely strained region of the model.

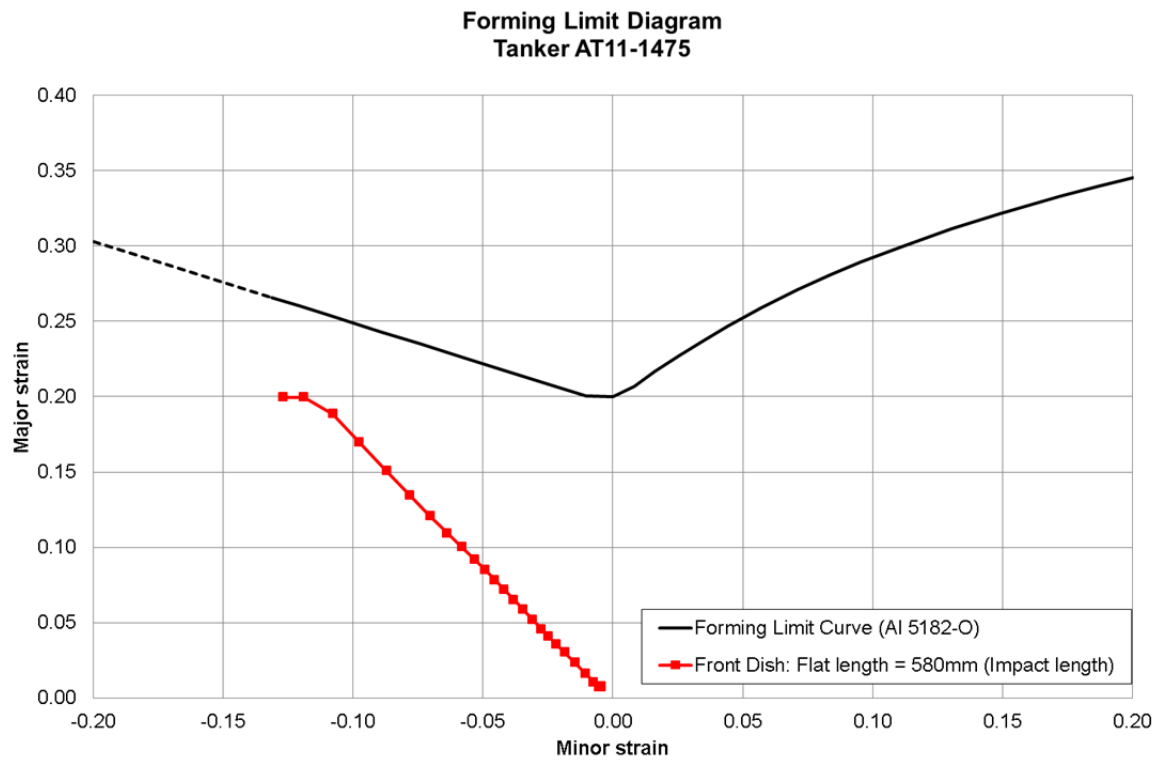
For the front dish model, a circumferential path of nodes was created along the corner joint between the swept design front dish and the tanker shell. As with the rear band model, the maximum and minimum principal strains were extracted at each node on this path and the results were plotted on the forming limit diagram in Figure 30. Again, the strains from the model all lie below the forming limit curve and hence the FLD approach does not predict failure to occur, which agrees with the lack of failure observed in the front dish after the topple test and subsequent metallographic examinations.

Figure 30 Forming limit diagram for the front dish simulation. Each red point represents the minor and major strains output at a node in the circumferential path passing through the most severely strained region of the model.
