## **Appendix L: Metallographic Examination of Samples from GRW Tanker J3217**

This appendix specifically addresses the examination of two sections from J3217.

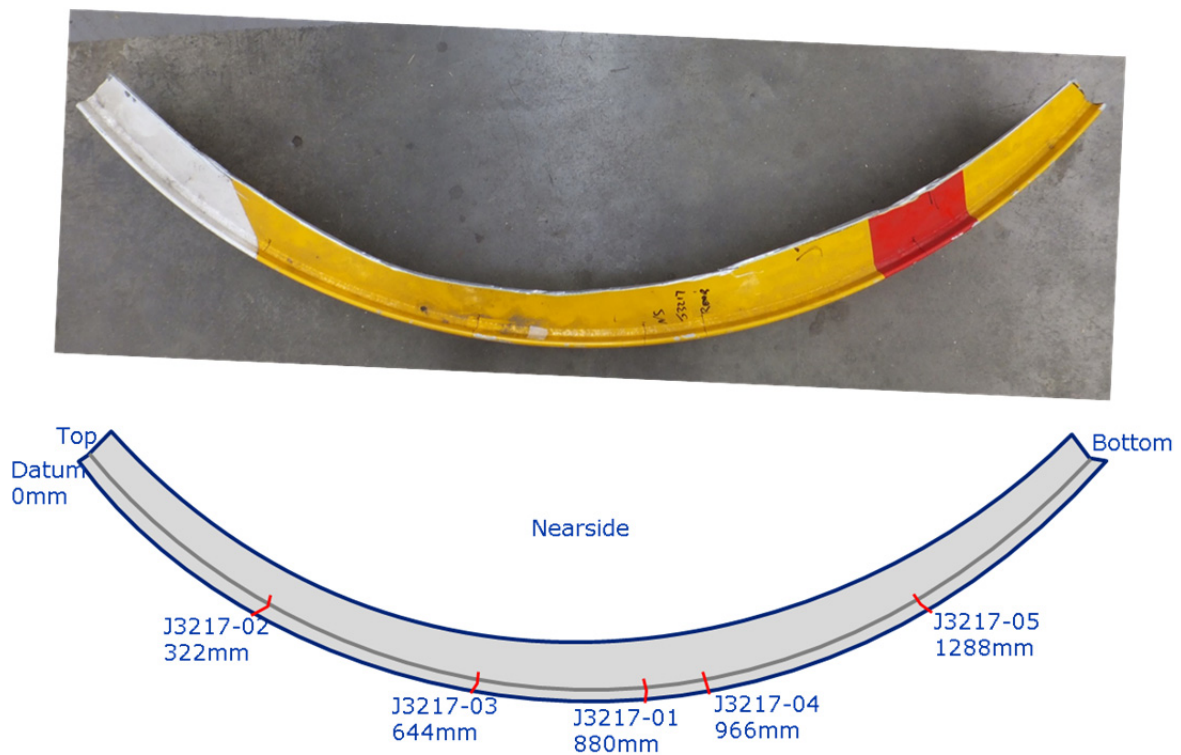
**Figure L1** Diagram of samples taken from the undamaged nearside of J3217.

The undamaged sample from J3217 was removed from the rear dish near side. This section was not involved in the collision that resulted in damage to the off side. Visual examination of the as-received condition showed no ruptures of evidence of damage/cracking to the rim joint weld or the circumferential weld. The sample is shown in Figure L1.

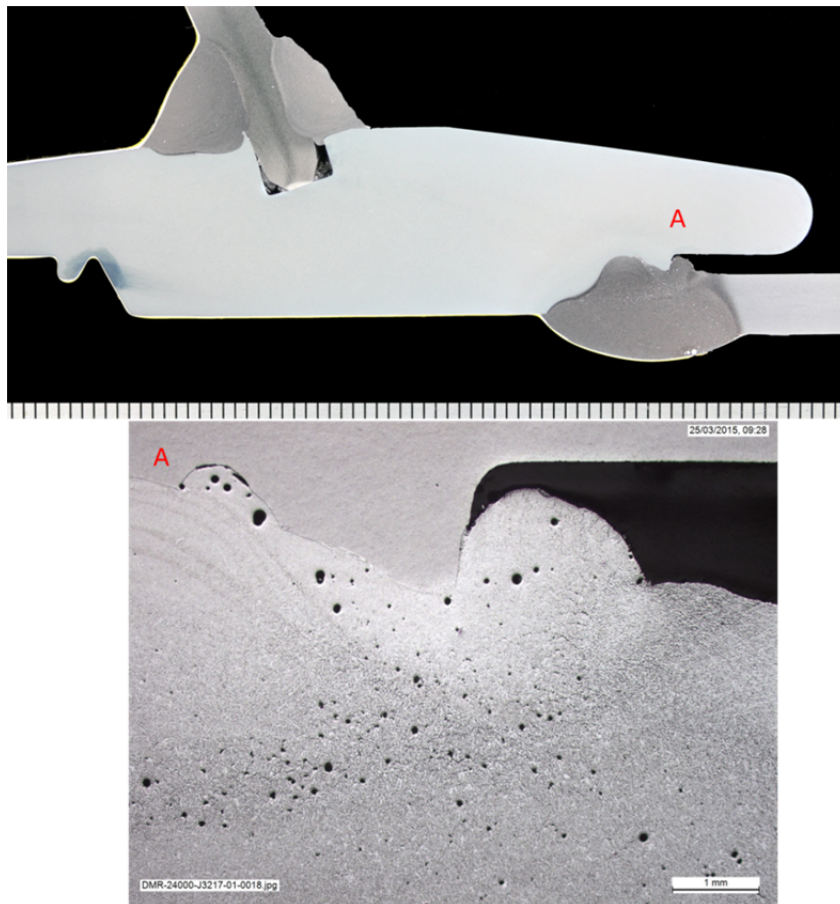
**Figure L2** Sample J3217-01 from the undamaged near side of the J3217 section.

The macro section revealed no defects in the vicinity of the rim joint weld due to lack of penetration, lack of root fusion or poor fit up. A micrograph of feature A, the extrusion profile positioner lip is shown. An approximately 1.0mm surface-breaking defect is shown with the cause of the defect being lack of fusion between the positioner lip that has not been properly removed and the circumferential weld metal. The etching reveals that potentially the lack of fusion is due to the presence of an external tack weld.
- Sample J3217-02 (Figure L3)

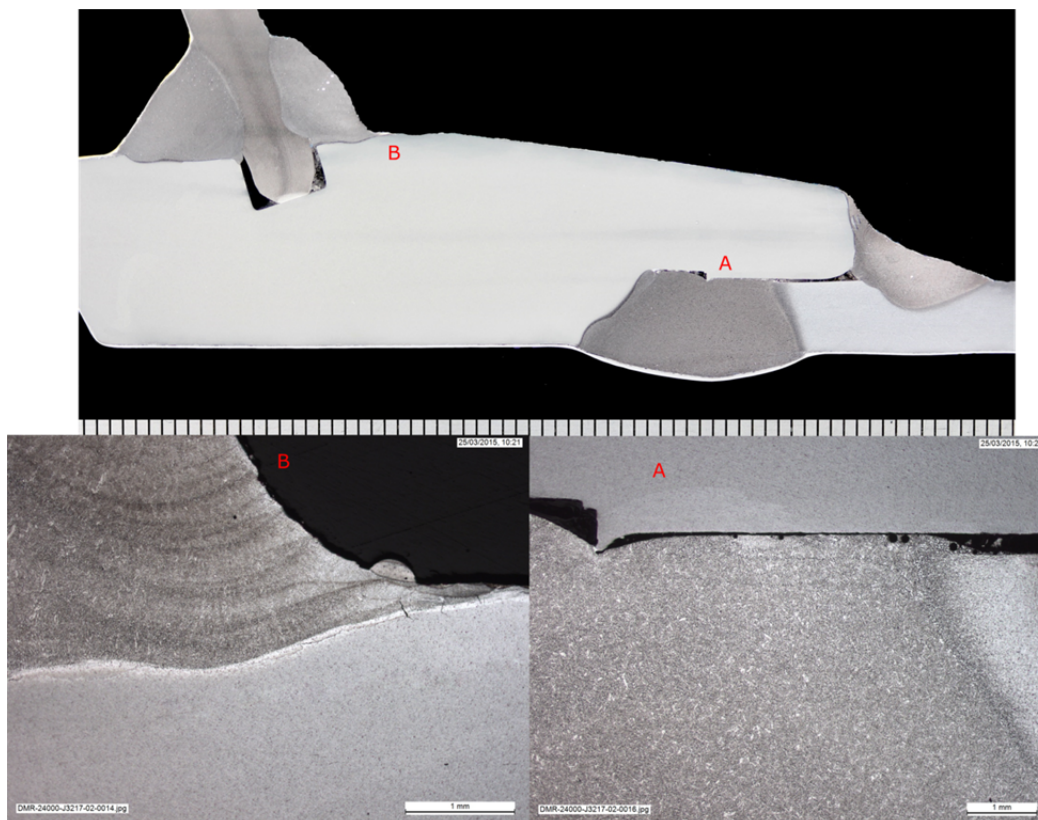
**Figure L3** Sample J3217-02 from the undamaged near side of the J3217 section. Scale bars on the bottom to images indicate 1.0mm. Ticks on the top frame indicate 1.0mm.

This figure highlights two features of the J3217-02 sample. At position A, the circumferential weld is shown where, although the positioner lip has been almost entirely removed, there is no fusion between the surface of the extrusion band and the circumferential weld. However, this lack of fusion is orientated parallel (or in-plane) to the primary loading and therefore not be considered as severe as flaws normal to the applied loading such as the surface defect shown in Figure L2. At position B, small micro-cracking can be seen at the toe of the rim joint weld on the inner surface of the end dish.
- Sample J3217-03 (Figure L4)

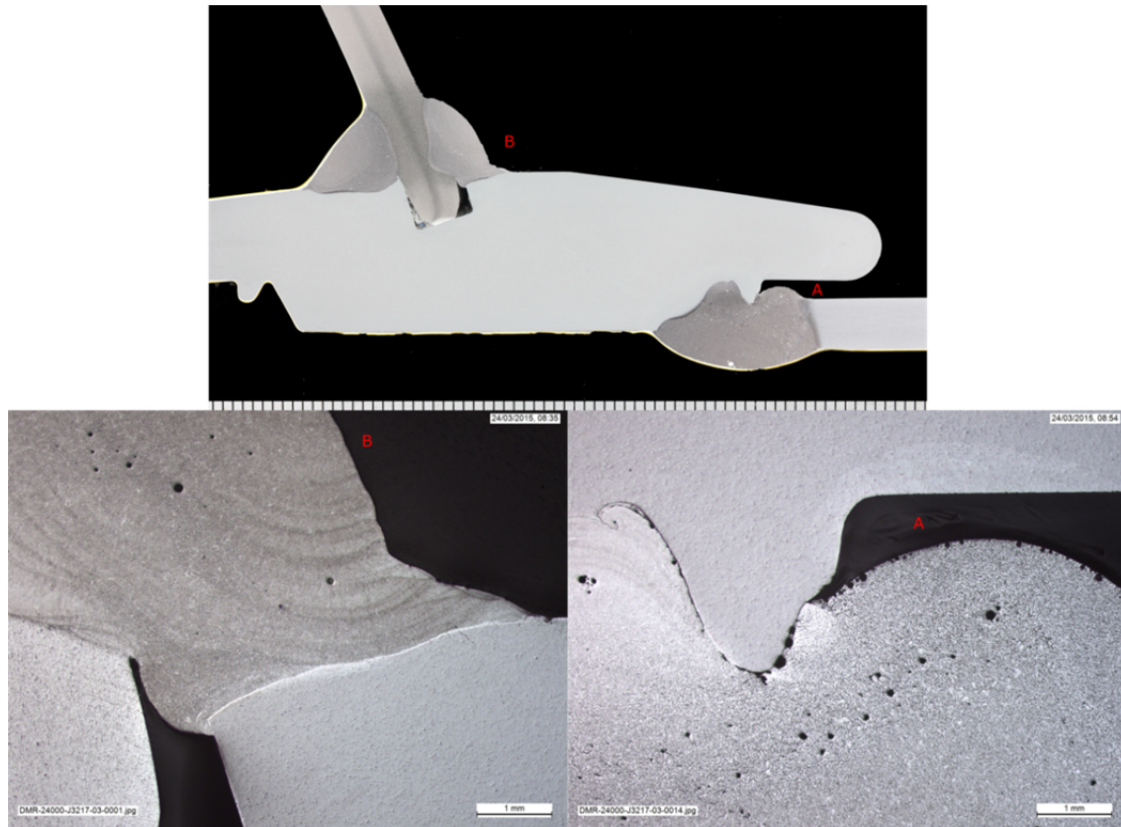
**Figure L4** Sample J3217-03 from the undamaged near side of the J3217 section. Scale bars on the bottom two frames indicate 1.0mm. Ticks on the top frame indicate 1.0mm.

Micrographs of the circumferential weld in the vicinity of the positioner lip (location A) and the root of the internal rim joint weld (location B) are shown in this figure. At the positioner lip, there is clear lack of fusion due to the non-removal of the lip. Whilst, the lack of fusion comprising both sides of the positioner lip, such a defect would be treated in an engineering critical assessment by projecting the entire flaw onto a plane normal to the applied load. In this case, it is likely that the defect shown at location A would be considered as an almost 2.0mm deep surface defect. At position B, the root of the rim joint weld has penetrated into the slot of the extrusion band. This has resulted in an approximately 1.0mm lack of fusion defect at the root of the weld and a non-uniform, reduced throat thickness compared to the external rim joint weld. The macrograph shows significant misalignment between the plate and the extrusion band.

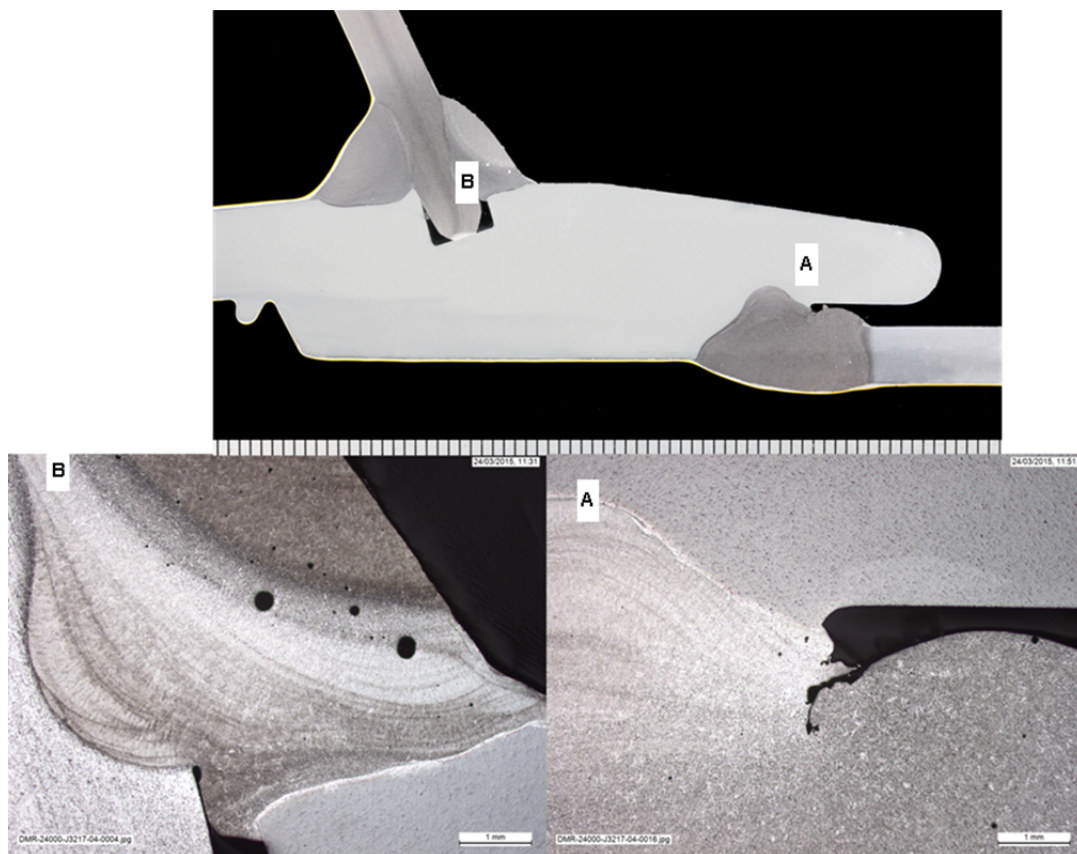
**Figure L5** Samples J3217-04 from the undamaged near side of the J3217 section. Scale bars on the bottom two frames indicate 1.0mm. Ticks on the top frame indicate 1.0mm

Micrographs of the internal rim joint weld (position B) and the circumferential weld in the vicinity of the positioner lip (position A) are shown for Sample J3217-04 in this figure. Again, there is an excessive gap between the slot between the extrusion band and end dish that has resulted in weld metal flowing into the slot. This has caused a lack of fusion defect about 1.0mm deep at the root of the weld and a slightly reduce through thickness compared to the outer surface/external rim joint weld. At the positioner lip, whilst most of it was removed prior to welding, a small amount remained and there is evidence of a crack-like, 1.0mm deep surface-breaking defect in the circumferential weld. The macrograph shows significant misalignment between the plate and the extrusion band.
- Sample J3217-05 (Figure L6)

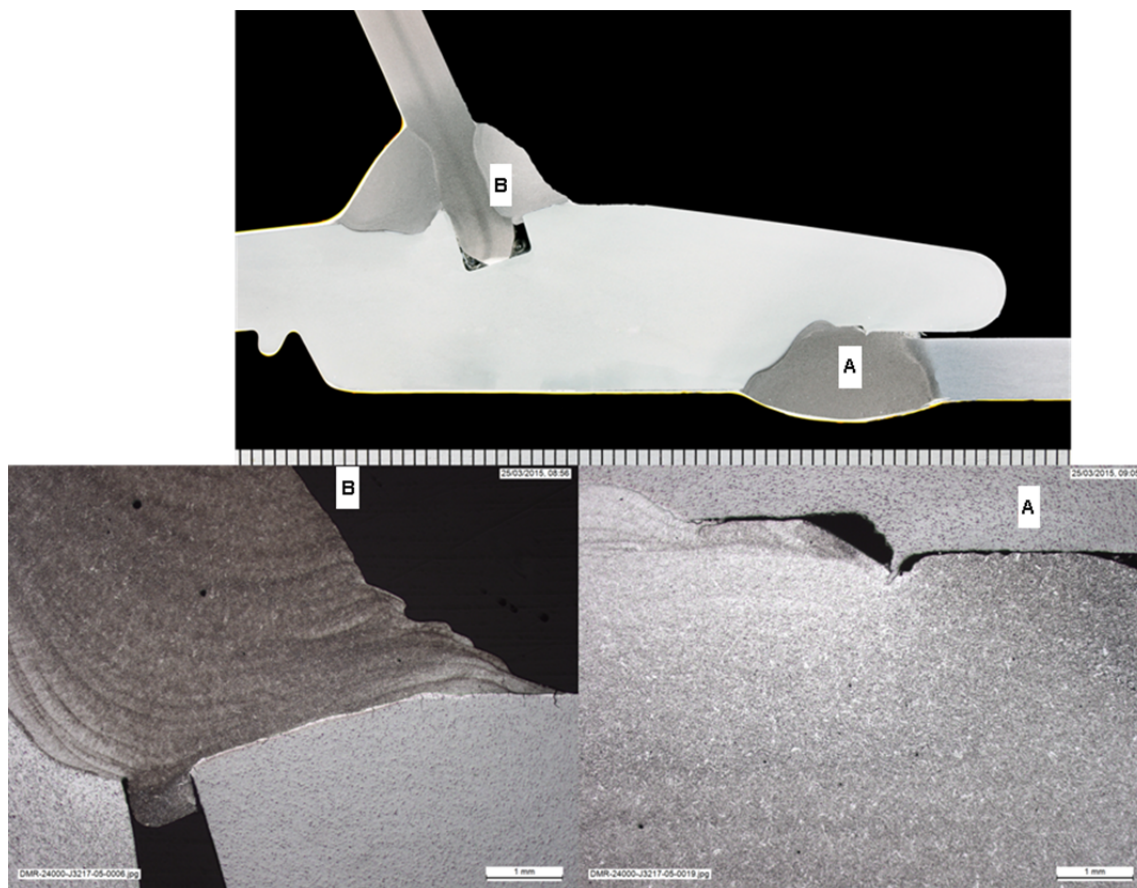
**Figure L6** Sample J3217-05 taken from the undamaged nearside of J3217. Scale bars on bottom two frames indicate 1.0mm and ticks on the top frame indicate 1.0mm.

Similar to above, micrographs of the internal rim joint weld and the circumferential weld have been provided (denoted by positions B and A, respectively.) The poor fit-up between the end dish and the extrusion band slot is most evident in this Figure, as excessive weld metal has flowed into the gap between the two. The positioner lip has been almost fully removed, but again there is poor fusion between the surface of the extrusion profile and the corresponding parallel surface of the weld bead.

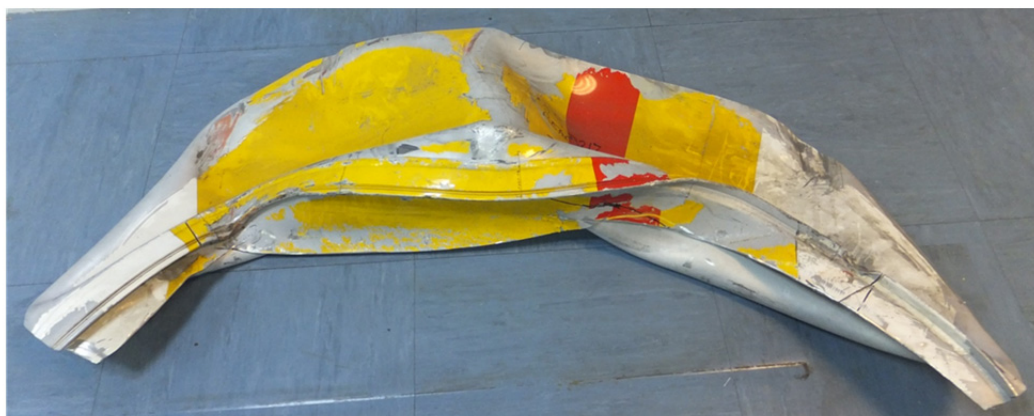
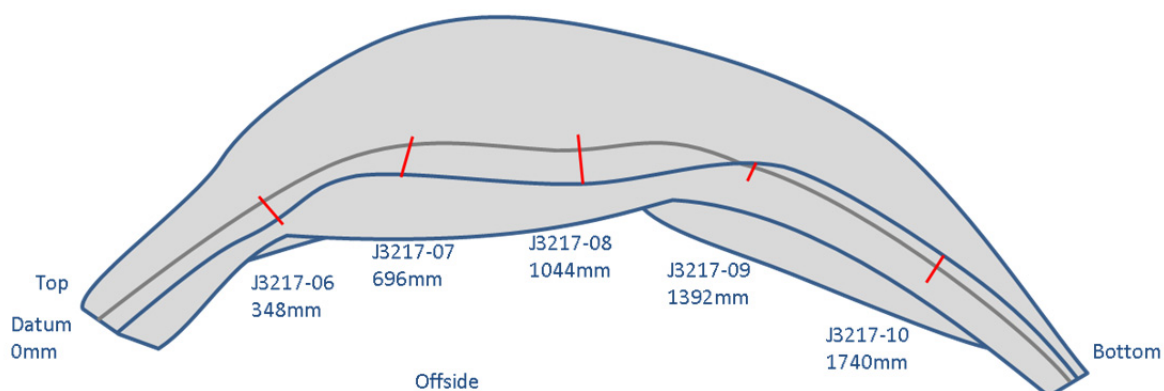
**Figure L7** Diagram of the samples taken from the damaged offside of J3217.

The undamaged sample from J3217 was removed from the rear dish off side. Visual examination of the as-received condition showed no ruptures or evidence of damage/cracking to the rim joint weld or the circumferential weld; however, visibility was impaired due to the deformed shape of the section. The sample is shown in Figure L7.

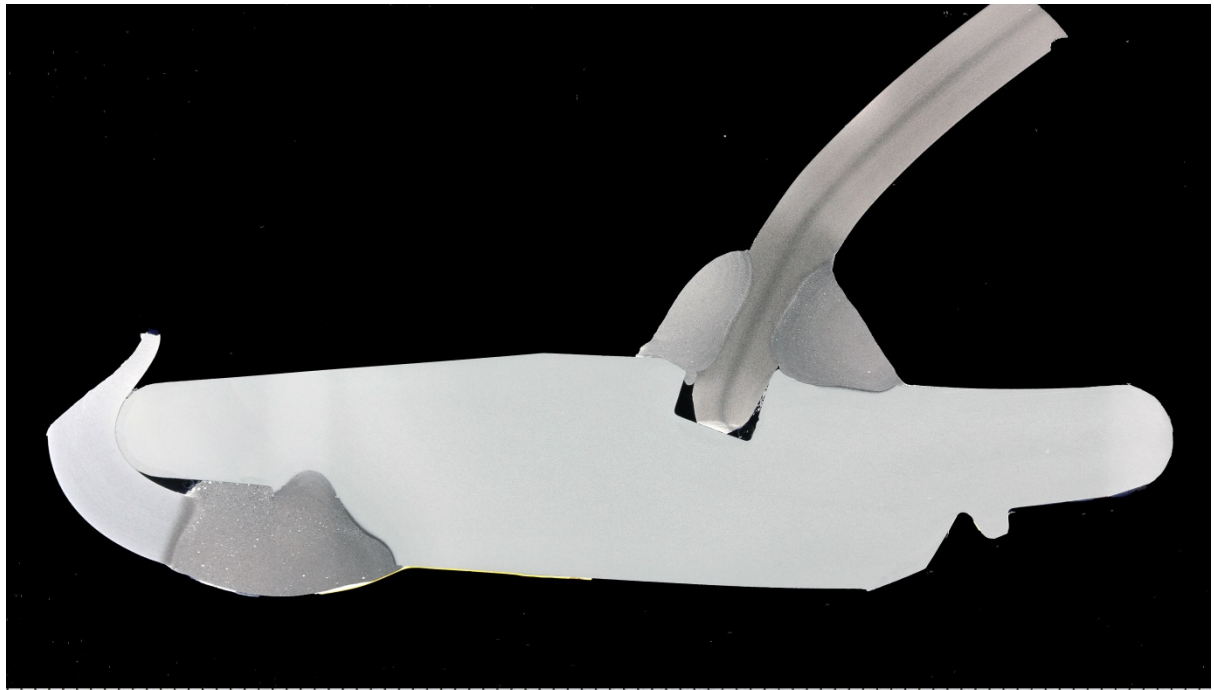
**Figure L8** Sample J3217-06 from the damaged offside of J3217. Ticks indicate millimetre scale.

In this sample, the deformation experienced by the cross-section is clearly visible. Whilst the tanker shell has experienced extensive bending strains, the orientation of the bending is opposite to what occurs during topple testing. The result is that even if there was a significant surface-breaking lack of fusion defect at the positioner lip (which there is not), the defect would be primarily under compressive loading which would not lead to a fracture failure. The end dish also exhibits some bending, though not as extreme as the tanker shell. The tensile side of the bend is located on the inner surface of the end dish. Whilst there is some excessive weld metal at the root of the inner surface rim joint weld between the extrusion profile and the end dish, there is no significant defect present and no evidence of crack initiation or tearing.

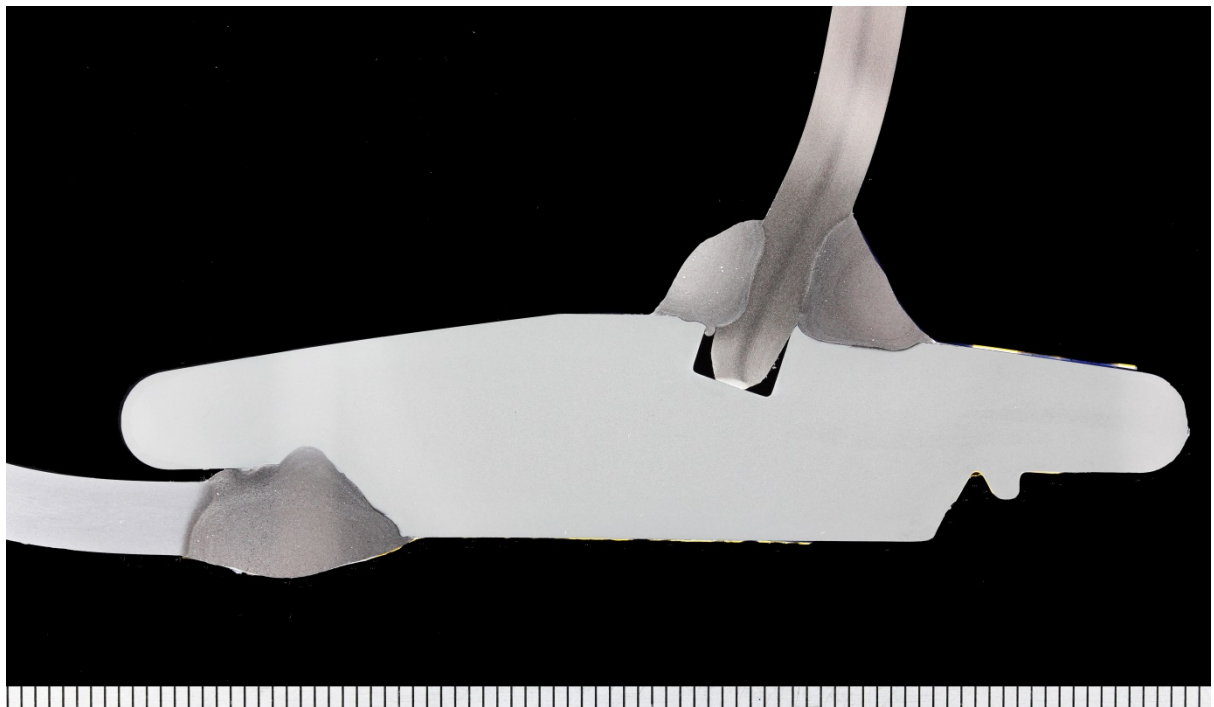
**Figure L9** Sample J3217-07 from the damaged offside of J3217. Ticks indicate millimetre scale.

In this sample, the deformation of the tanker shell is similar to that of J3217-06, but the bending is not as extreme. There are no defects at the positioner lip as the lip has been wholly removed before welding, but even if there was one present, it would have experienced compressive stresses, causing the crack to close and not extend. The end dish for this sample exhibits bending but with the tensile side on the external surface, highlighting the complexities of the deformation experienced by the overall section during impact. Both rim joint welds appear to have sufficient throat thickness to have withstood the applied loads and no evidence of cracking was observed.

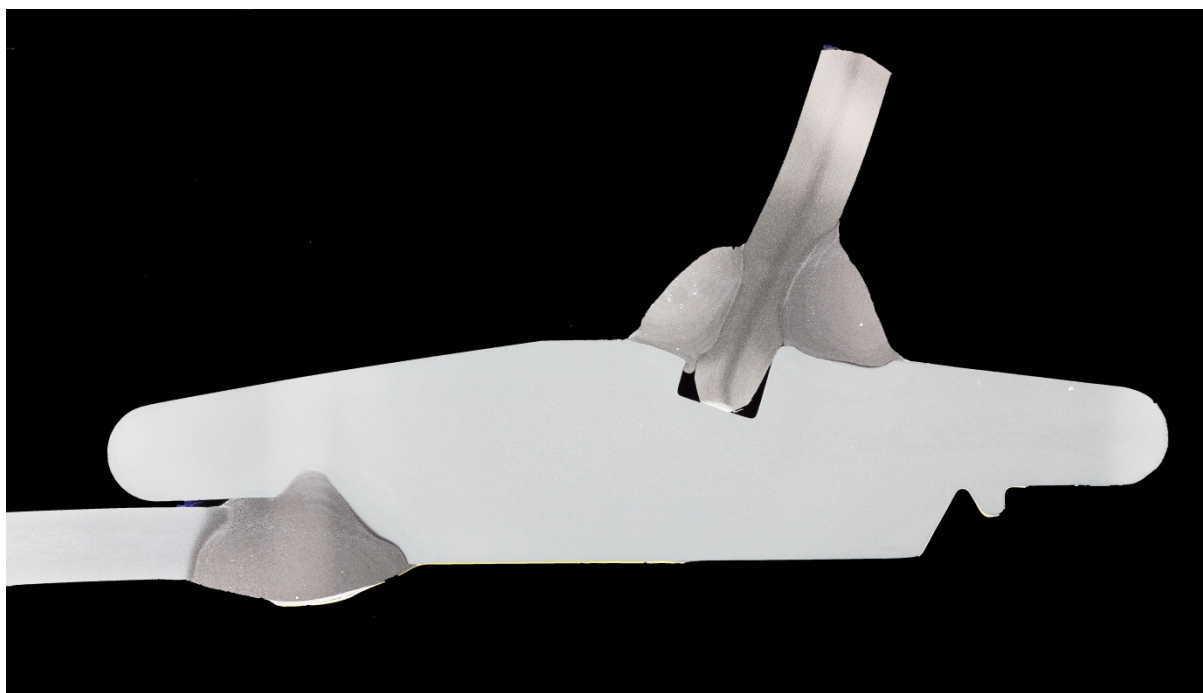
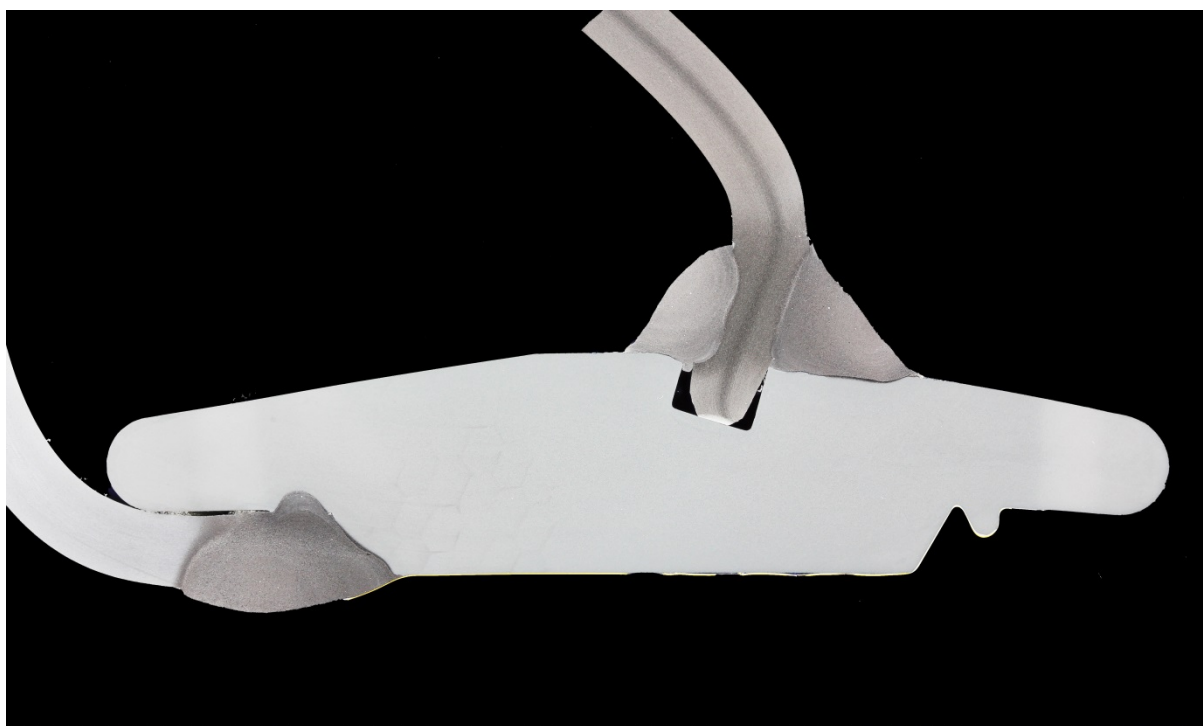
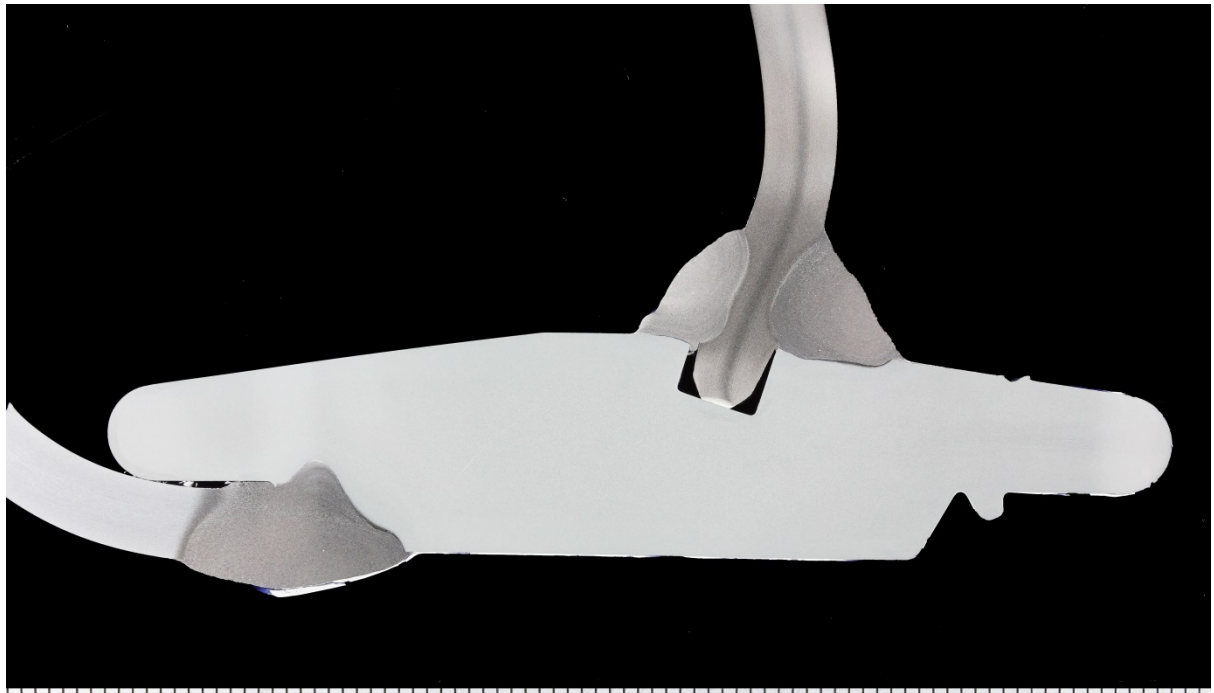
The features of the remaining samples from the damaged section of J3217 exhibit the same characteristics of samples -06 and -07. Specifically: the tanker shell exhibits bending orientated in way such that any lack of fusion defects located at the positioner lip would experience compressive strains and crack closure (eg samples 09 and 10). The end dish exhibits permanent plastic bending but the rim joints show sufficient throat thickness to resist rupture through the weld throat. No significant manufacturing defects are observable at either the circumferential weld or the rim joint welds.
