## **Appendix K: Metallographic Examination of Samples from GRW Tanker J3564**

This appendix specifically addresses the examination of sections from J3564.

Sections from the cradle position of bands C, D and G of GRW tanker J3564 were removed and sent to TWI. These samples are located in positions where the fatigue stresses are likely to be relatively high and therefore the main objective of the examination of these samples was to identify whether there was any evidence of fatigue crack growth. Additionally, the circumferential length of these specimens means that they could be subjected to impact under a roll over event. Each of the three sections was sectioned at approximately 100mm intervals and macros were prepared of the cross-section. Table K2 describes the positions of each of the macros that are presented. This table can be cross-referenced with Table K1 for reference to the specific band from which the section was obtained.

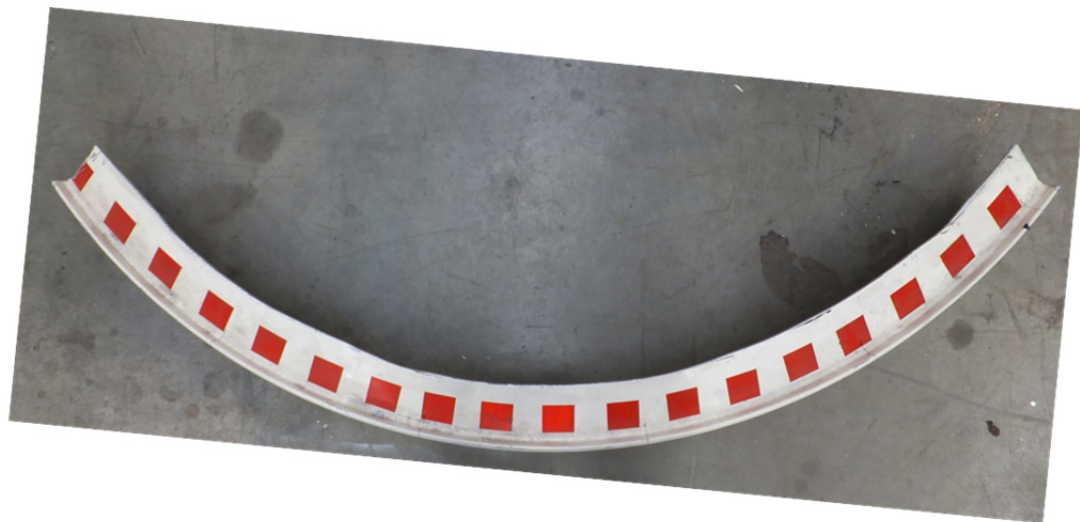
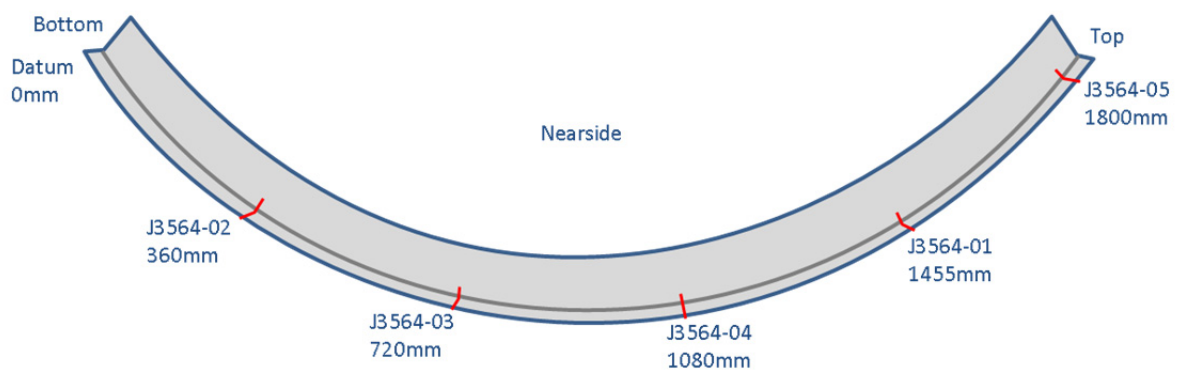
**Figure K1** Image of the rear weld section sent to TWI and a diagram showing the location of additional sampling.

The large section of the rear end weld provided to TWI is shown in Figure K1. The objectives of the metallographic examination of samples removed from this section were to:

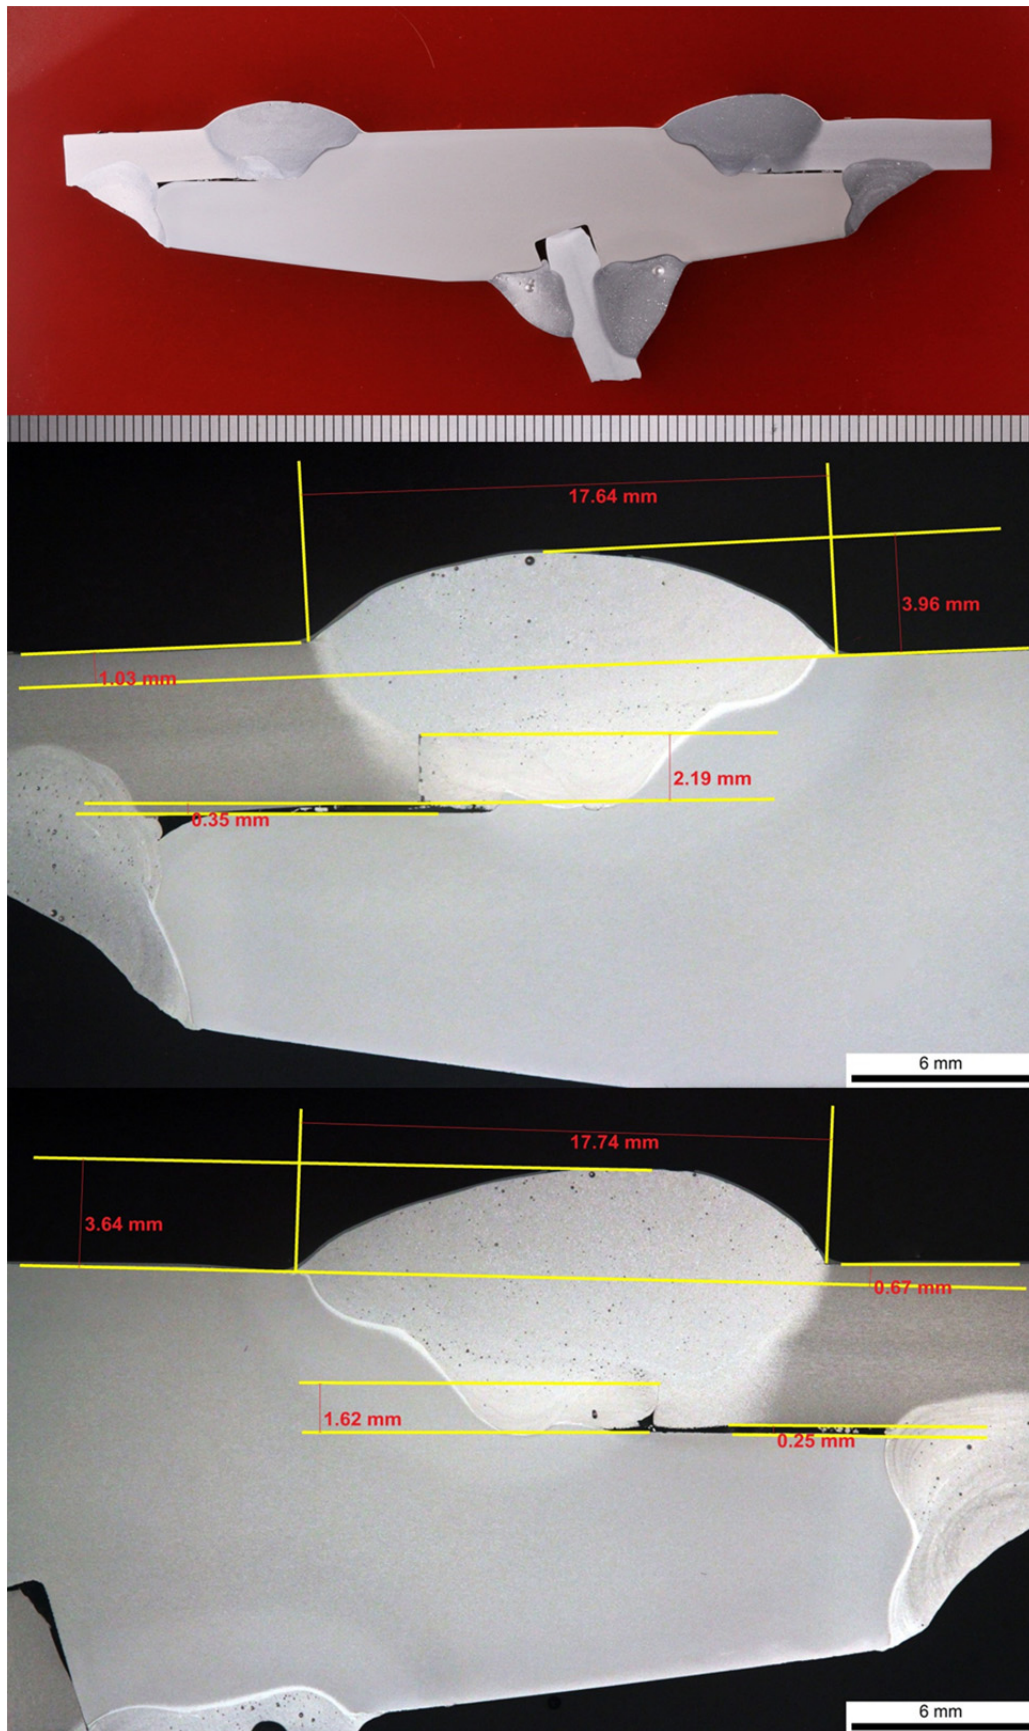
**Figure K5** J3564 sample W03-04, slice 4.

Figure K5 is of particular interest. The weld on the left side shows a 2.19mm crack-like, surface-breaking defect is present. This is a significant defect and arises purely as a result of lack of fusion and not fatigue. The right hand side (rear-side weld) shows a 1.62mm crack-like, surface-breaking flaw is present. Again, this defect arises purely as a result of lack of fusion and not fatigue.

These defects are present in slice 4, but either side of this macro (slice 3 and slice 5), only a gas pore is present where the crack-like defect appears in slice 4. Further sectioning of the macro-section was undertaken and the results are shown in Figure K6. In this figure, it can be seen that, up to a 10mm resolution of the length, both flaws are at least 40mm in length and no more than 50mm in length. Additionally, the further sectioning revealed that on the side containing the 1.62mm deep flaw, there was a deeper point along the length, with the maximum observed depth equal to 2.04mm.

These crack-like defects are not located directly at the positioner lip, as was the defect that led to rupture in J2580. An additional study to clarify the acceptability of these defects was undertaken and is described in Appendix M.

- One section exhibited crack-like, surface-breaking defects, 1.62mm and 2.19mm in height. Further sectioning revealed that the lengths of these defects were between 40mm and 50mm. The additional sectioning revealed that on the side containing the 1.62mm defect, there was a deeper point of the flaw, with the maximum observed depth equal to 2.04mm.

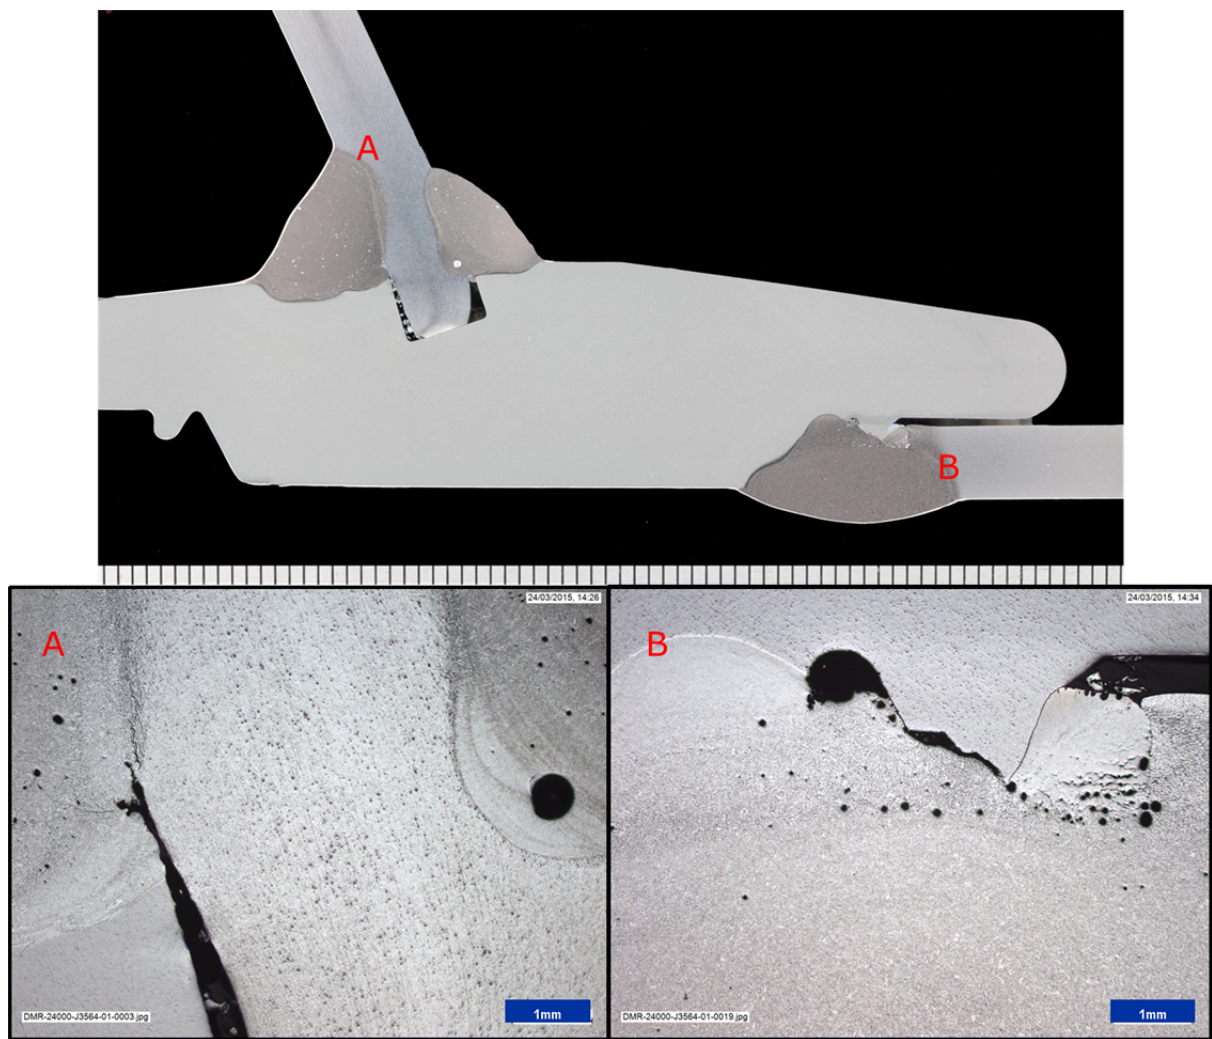
**Figure K26** J3564 Sample W-01 from the rear weld.

- The micrograph taken of the rim joint root in Figure K26 (micrograph "A") shows evidence of a similar lack of root fusion defect as discussed in Appendix O. This has the potential to lead to rupture of the rim joint weld throat during topple test conditions.

- The micrograph taken of the positioner lip in Figure K26 (micrograph "B") shows the existence a previous weld bead or evidence of a similar external tack weld that gave rise to the finite length flaw previously discussed. Whilst this external tack weld is not adjacent to an additional internal fillet weld, there is better fusion/penetration at this joint (compared to Figures K5 and K6) and therefore there is no offset surface-crack. The positioner lip defect is still present, but is small.

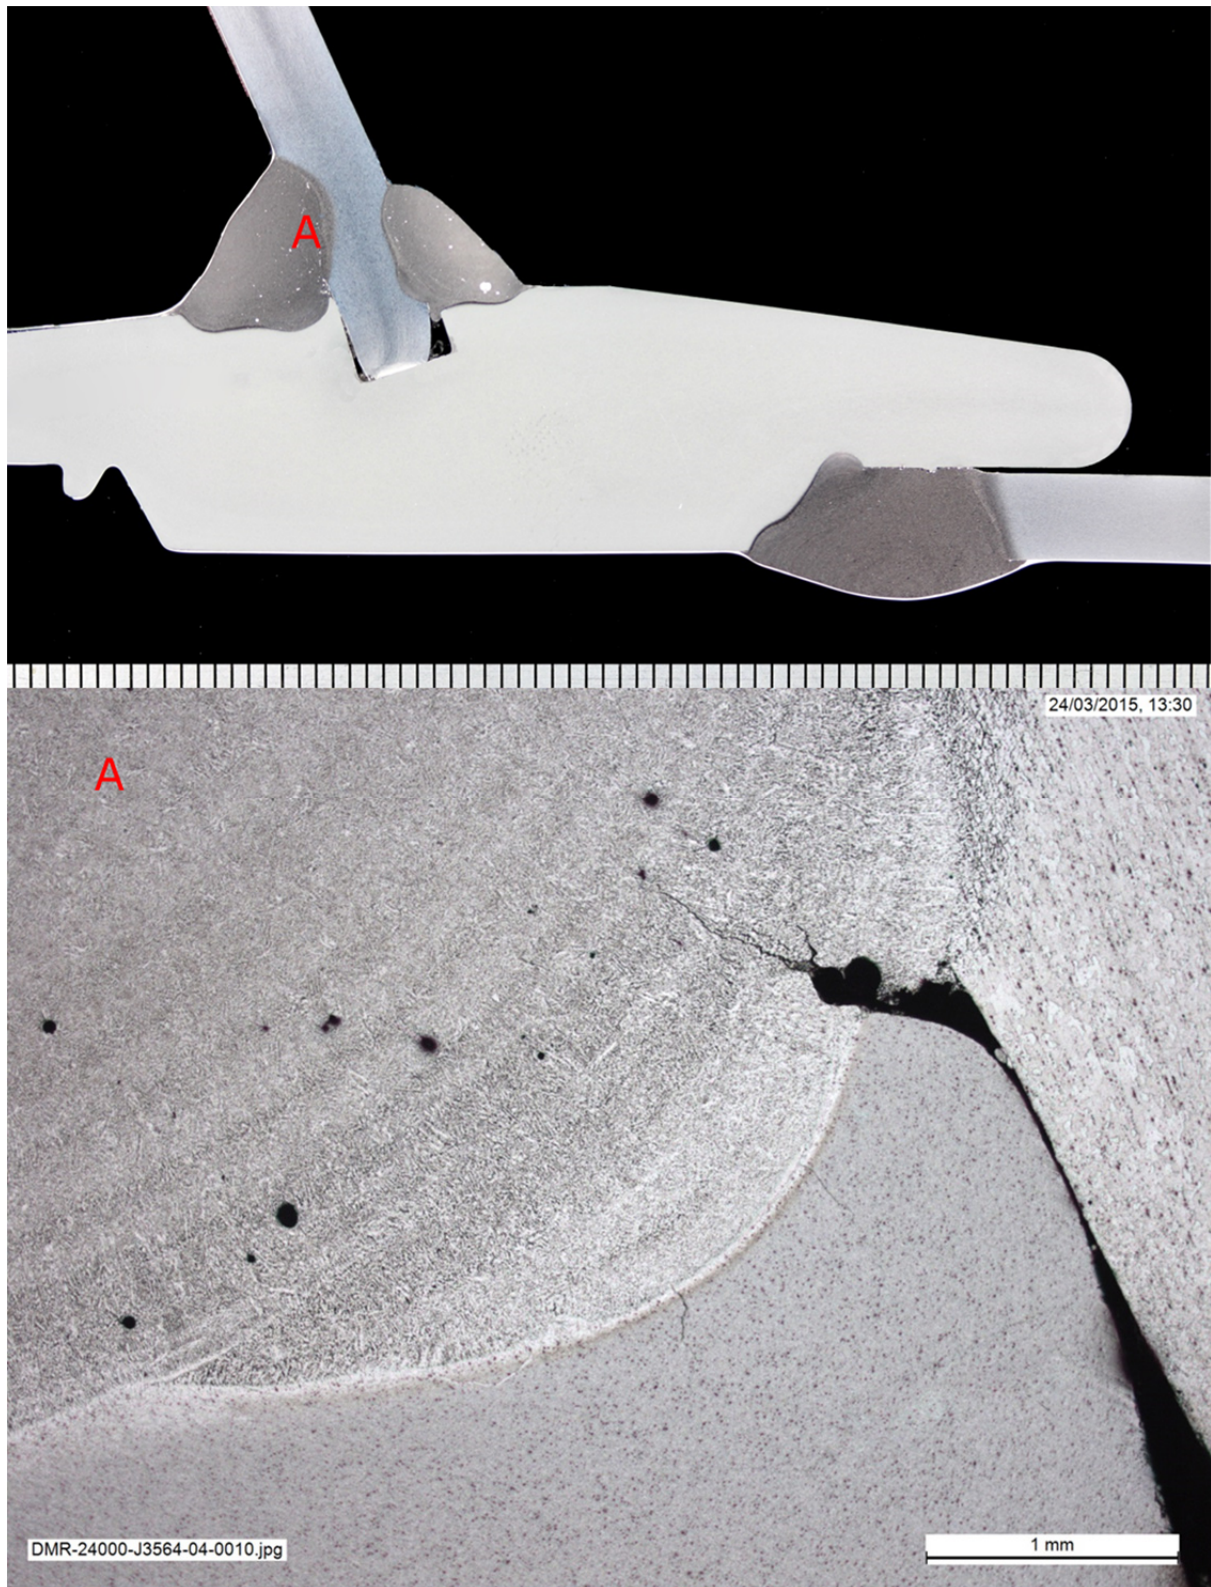
- The micrograph taken of the rim joint root in Figure K29 shows another lack of root fusion defect. There is some evidence of potential fatigue crack growth from the defect

- Examination of the rear weld showed some evidence of potential fatigue crack growth from a lack of root fusion defect in the rim joint weld.

**Figure K29** J3564 Sample W-04 from the rear weld. Potential evidence of fatigue.
