Rail Accident Investigation Branch

# Rail Accident Report

**Signal T172 passed at danger at Purley station,  
Surrey  
18 August 2006**

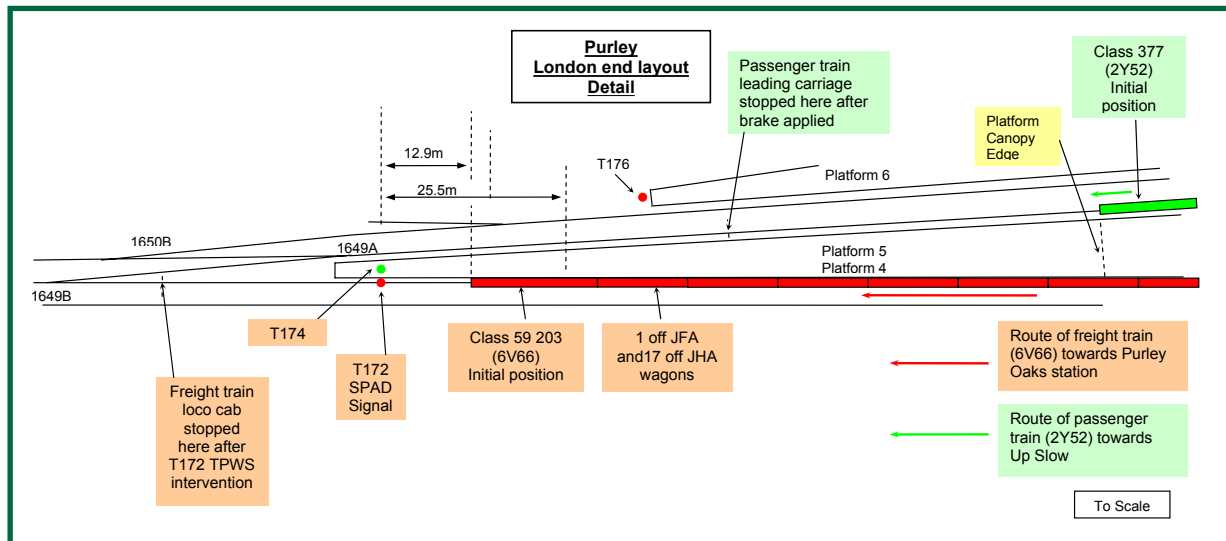
Figure 3: Detailed plan of incident site showing initial and final positions of trains at Purley station

- 20 The freight train was automatically stopped following a TPWS intervention, 35 m (38.27 yards) past signal T172.

11:02:02	Train 6V66 comes to a stand 12.9 m (14.10 yards) on the approach to signal T172. See Figure 3. (Note: The driver cannot see signal T172 when in his seat.)

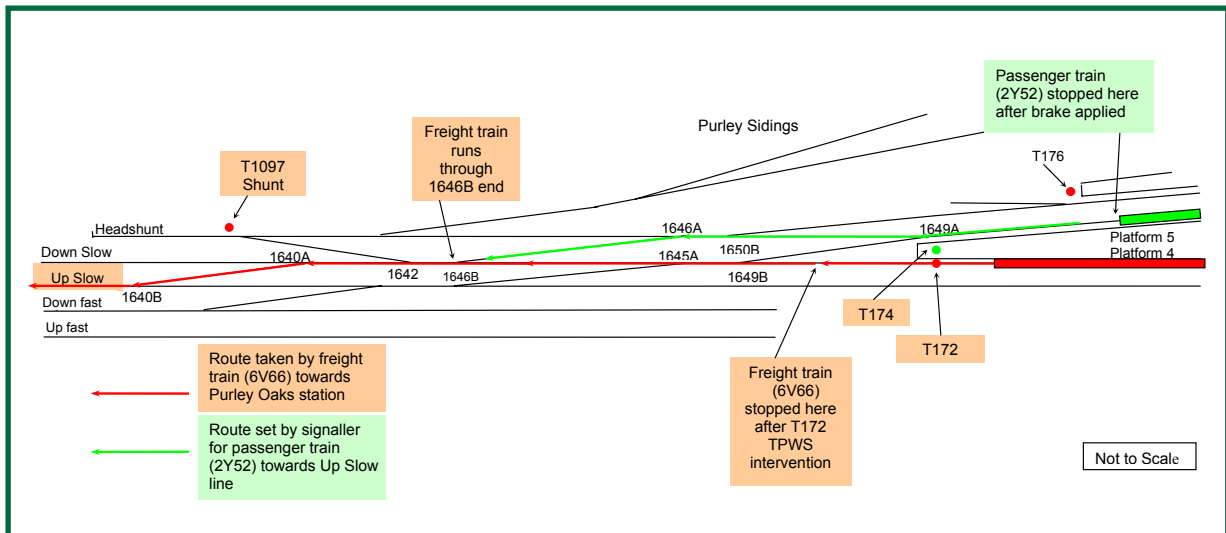
Figure 6: Purley station and the London end layout showing routes set and taken of both trains

11:04:42	Train 6V66 runs through 1646B points to take the up slow route towards Purley Oaks station (see Figure 6).

- 45 Following the TPWS reset, the driver of train 6V66 continued travelling towards London on the up slow line. As a consequence, train 6V66 ran through 1646B points which had been set for the passenger train, 2Y52. The driver of train 6V66 did not see the points set against him and was unaware of the run through.
- 46 The run through of 1646B points caused some minor damage to the front *stretcher bar* and a broken *stretcher bar* bracket which initially left the points usable only in their *normal* position. This resulted in the blocking of the routes into and out of the London end of platform 6.
- 47 There was no damage to either train.
- 48 The driver of train 2Y52 avoided a possible collision with train 6V66 by controlling his train to a stop while still in platform 5.
- 49 The passenger train was travelling at 11.9 mph (19.15 km/h) when the driver braked.

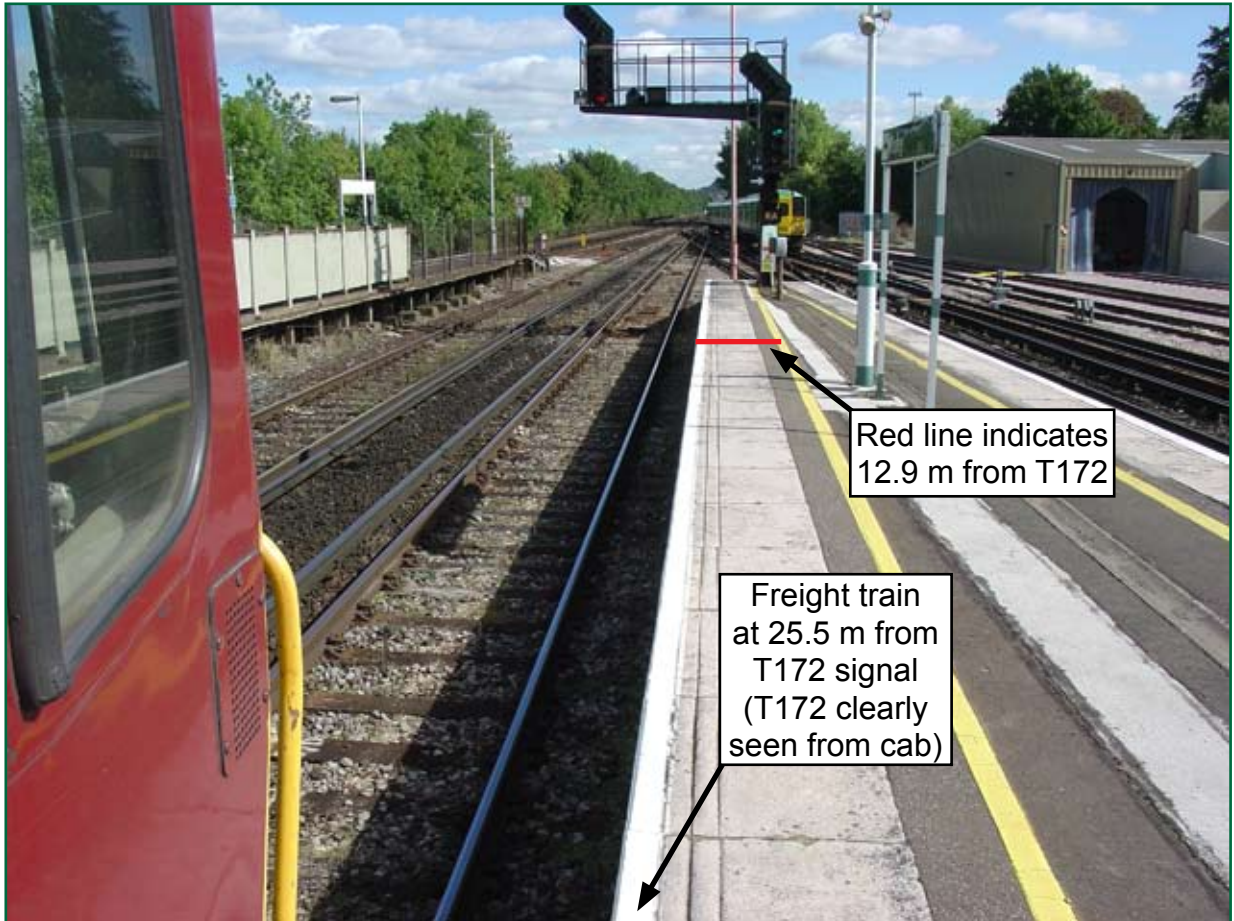
- 85 Figure 8 shows the relative positions of a class 59 at 25.5 m (27.88 yards) on the approach to signal T172 and where the locomotive stopped on the 18 August, only 12.9 m (14.10 yards) on the approach.
- 86 The correct route for the passenger train from Purley platform 5 to Purley Oaks, when set by the signaller, (after the freight train had come to a rest behind signal T172) had resulted in all signals on the route between those two points on the up slow line showing green. Two of these signals were visible to the freight train driver when at signal T172.

Figure 8: Photograph taken from platform 4, (adjacent to the driving cab and at the same height of a train driver seated in the driving seat) of the position of a Class 59 locomotive 25.5 m from signal T172
