AAIB Bulletin

11/2015

ACCIDENT

Aircraft Type and Registration:	Dassault Falcon 20D, G-FRAK	
No & Type of Engines:	2 x General Electric CO CF700-2D-2	
Year of Manufacture:	1969	
Date & Time (UTC):	25 April 2015 at 1650 hrs	
Location:	English Channel, approximately 20 nm south of Portland Bill	
Type of Flight:	Special operations, target towing	
Persons on Board:	Crew - 3	Passengers - None
Injuries:	Crew - None	Passengers - N/A
Nature of Damage:	Wing leading edge torn and dented, winch carrier damaged, target lost at sea	
Commander's Licence:	Air Transport Pilot's Licence	
Commander's Age:	64	
Commander's Flying Experience:	12,700 hours (of which 9,000 were on type) Last 90 day - 121 hours Last 28 days - 32 hours	
Information Source:	AAIB Field Investigation

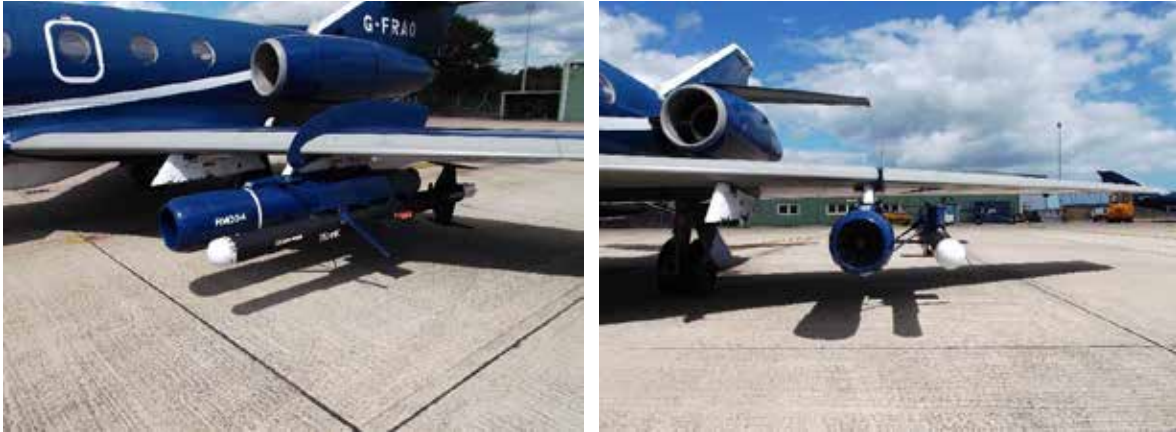
Figure 3

Images of winch, target, launcher and pylon

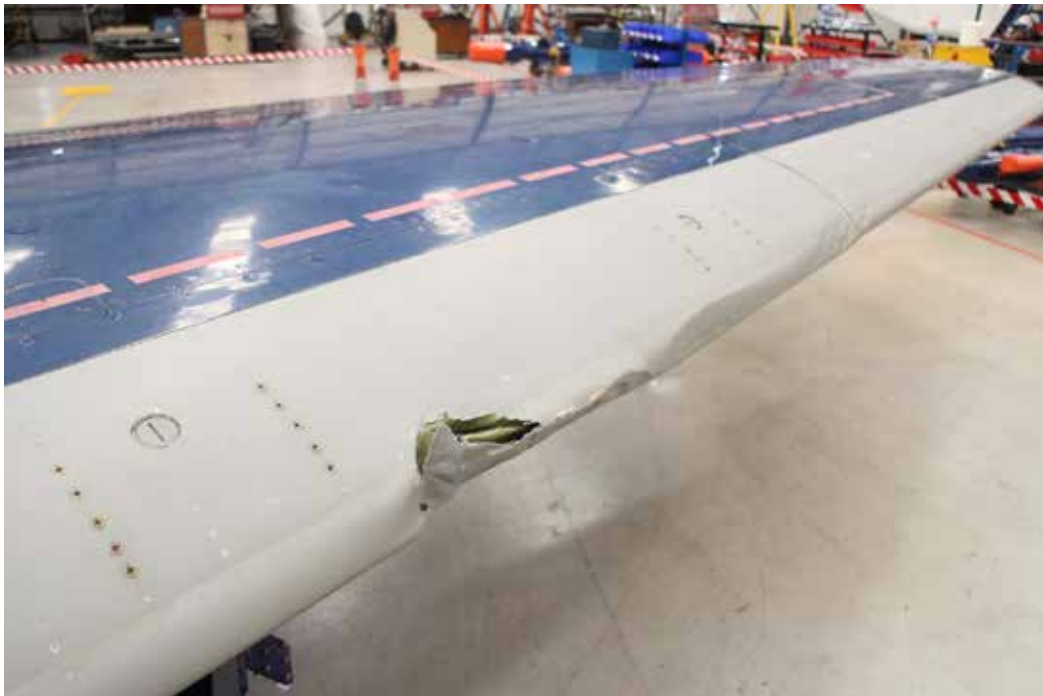
Figure 4

There was damage to the droop leading edge on the left wing and the struts between the target winch and the launcher. There was also deformation to the pylon where it attached to the wing spar, Figure 4.

Image showing damage to leading edge
