PART 1.4 – ANALYSIS AND FINDINGS

DETERMINING THE CAUSE OF THE ACCIDENT

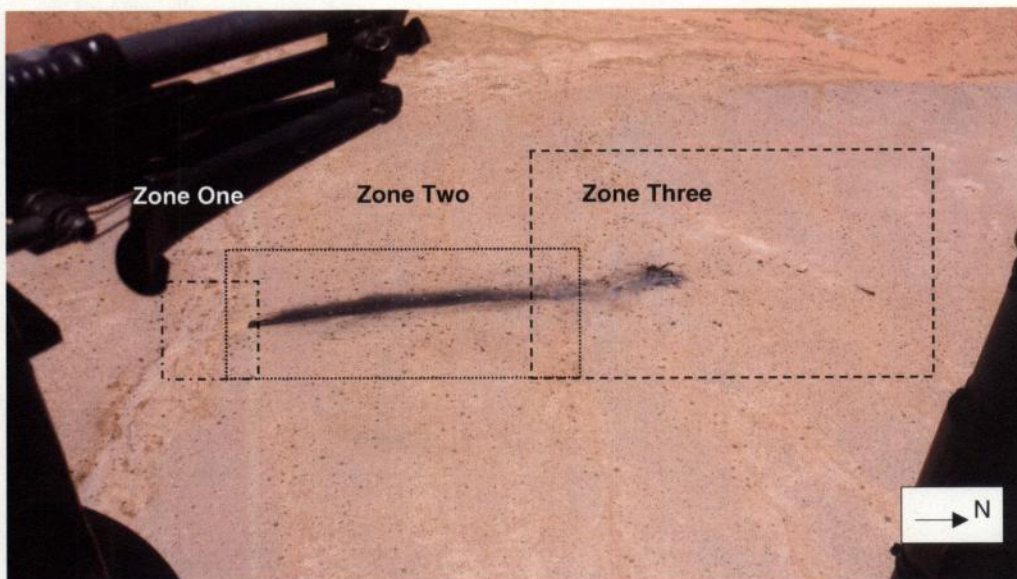
Figure 1 – Aerial Photo of Accident Site Taken By Lynx 2

1.4.23 Figure 1 is one of the first aerial photos of the accident site, taken by the crew of Lynx 2. For the purpose of this analysis, the accident site has been divided into three illustrative¹⁰ zones:

- a. Zone One – Initial Impact Area.
- b. Zone Two – Fuel Burnt Debris Trail.
- c. Zone Three – Final Resting Position.

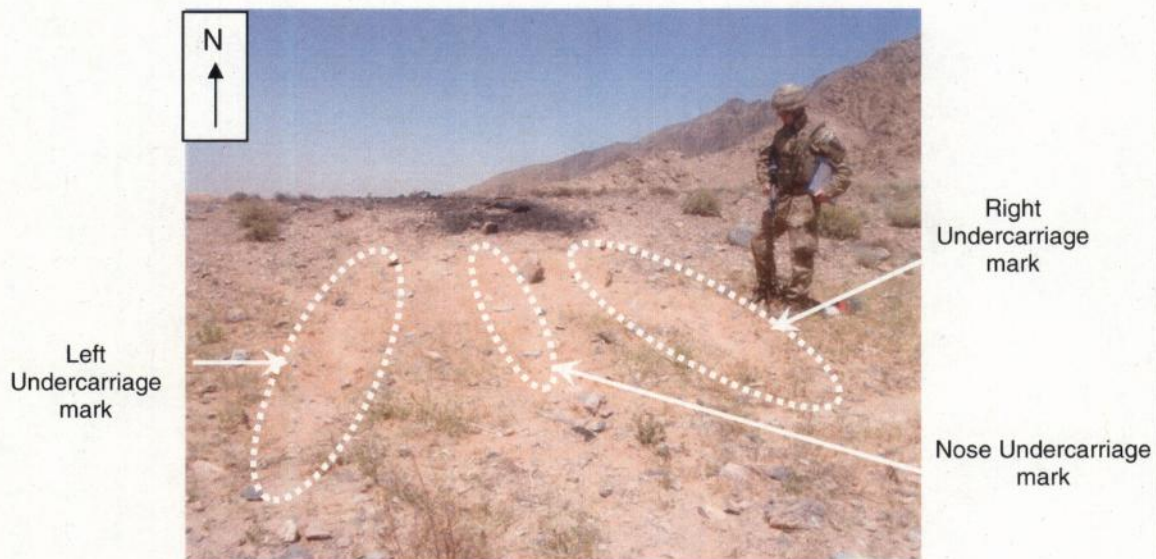
Figure 2 – Three Impact Marks; Photo Taken Slightly Offset, Looking North

1.4.24 **Zone One – Initial Impact Area.** The initial point of impact was on the upward face of a dried-up water course. Three clear impact marks were documented by the UK Post Crash Management (PCM) team, and were assessed by the MilAAIB to be from the left, right and nose wheel undercarriages (Figures 2, 3 and 4). The central impact mark

1.4.26 The initial impact marks were evenly distributed and prior to a straight fuel burnt debris field and enabled the Panel to conclude that the aircraft impacted the ground in a wings-level¹⁴ attitude, with minimal drift and with downward force¹⁵. It is at this point that the MilAAIB concluded the aircraft lost all structural integrity¹⁶. A section of TRB was also found 45 metres behind the initial impact point (behind the direction of travel) consistent with it being projected rearwards by its own rotational velocity, enabling the Panel to conclude that tail rotor drive was also likely lost on immediate impact with the ground.

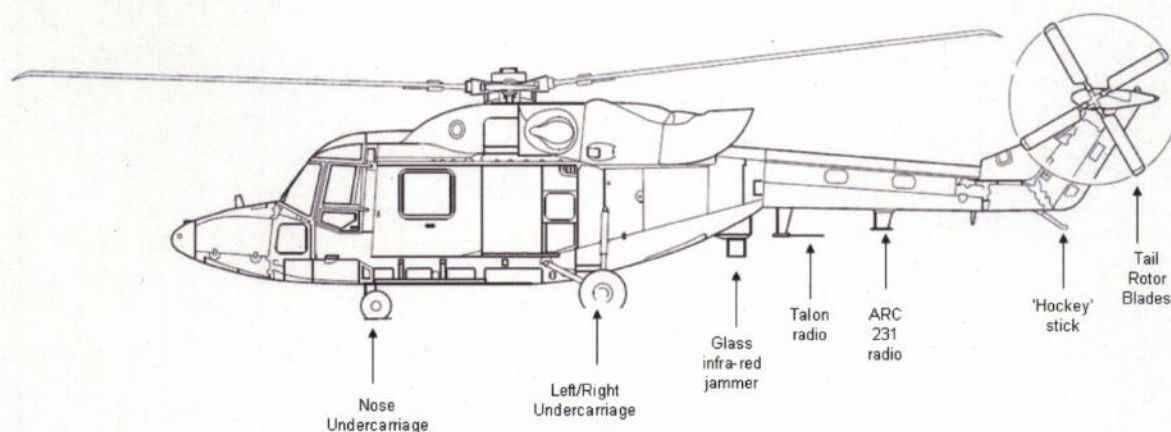
Figure 5 – Location of Components on Lynx¹².

also included components¹¹ from under the aircraft tail. Figure 5 shows the location of these components on the aircraft.

¹¹ Shattered glass from the infra-red jamming device, upper end of the ARC 231 radio antenna and lower plate of Talon radio antenna.

1.4.25 The aircraft tail skid (colloquially known as the 'hockey stick' (Figure 5)) was not recovered¹³ and there was a small piece of Tail Rotor Blade (TRB) photographed in the initial impact area. The underside of the tail cone displayed numerous longitudinal scorings and the lower surface had lost its rigidity and structural integrity. These facts supported the prognosis that the tail cone impacted the ground, concurrently with or immediately post initial impact and was dragged behind the aircraft.

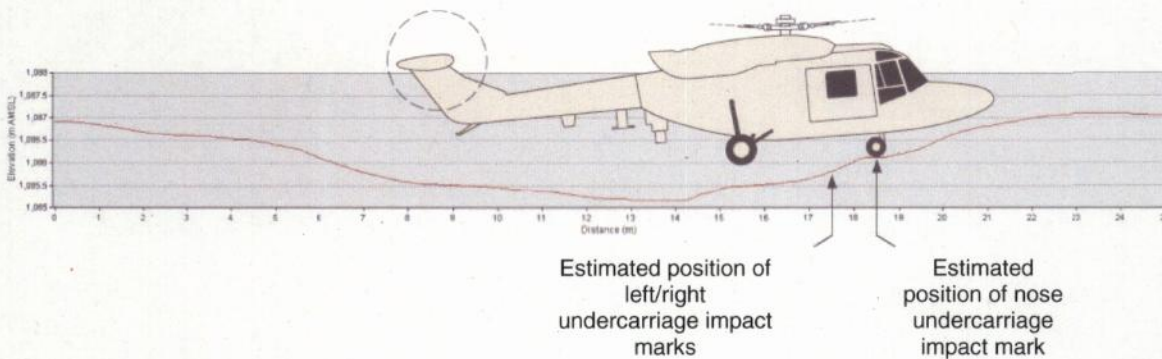
Figure 6 – Terrain Modelling Indicating Five Degree Nose-Up on Impact

1.4.27 **Zone Two – Fuel Burnt Debris Trail.** The wreckage had sufficient momentum to travel 75 metres along the ground, providing the Panel with compelling evidence of a high speed impact. In addition to the speed, the aircraft must have impacted the ground in a 'shallow' nose-up attitude, as the debris field remained largely together¹⁷ throughout the accident sequence until the final resting place. Based on all the evidence available, the Panel assessed that the most likely nose-up attitude on impact was approximately five degrees (illustrated in Figure 6), but without the fitment of an FDR this could not be determined conclusively.

¹⁷ A nose-down attitude at impact would have resulted in a much smaller compressed debris field; conversely a high nose-up attitude at impact would have resulted in a much more spread out debris field.

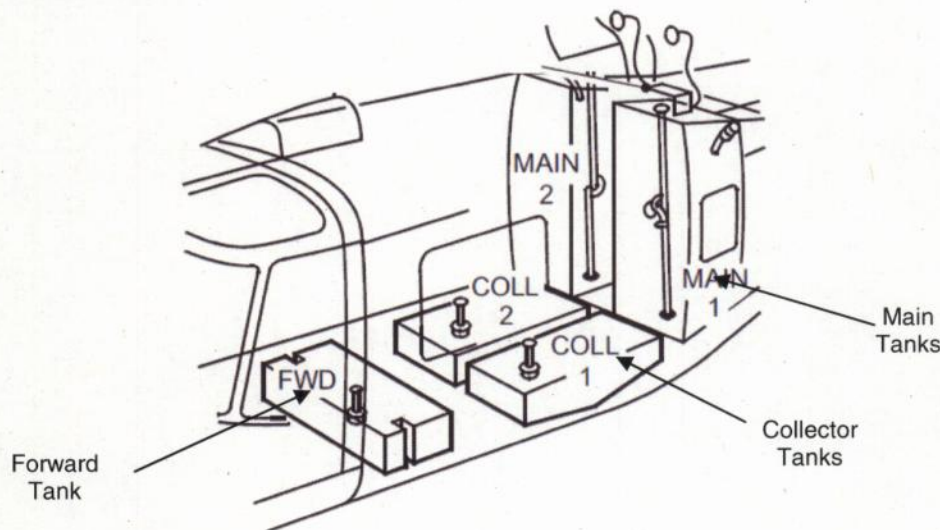
Figure 7 – Location Of Fuel Tanks

1.4.28 Evidence suggested the initial impact was of sufficient force to rupture the two main fuel tanks (located to the rear of the main cabin, immediately behind the rear crew seats), the left and right collector tanks and the forward tank (Figure 7). Fuel from the ruptured tanks was most likely diffused either as a mist or as fluid, and immediately vaporised and ignited¹⁸. The origin of the ignition source was not determined.

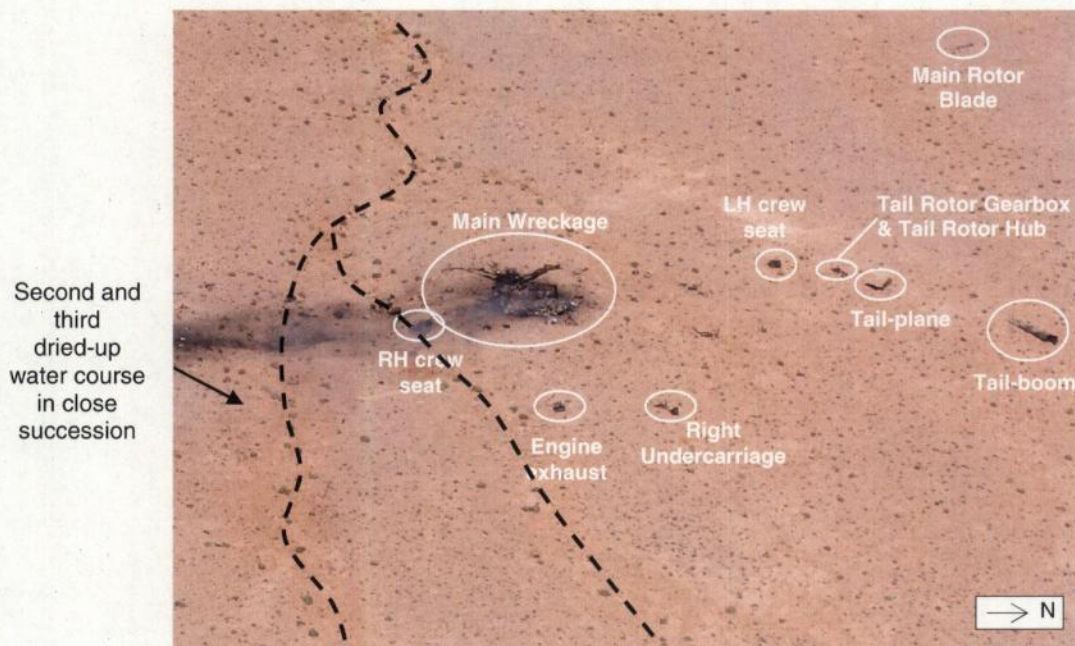
Figure 8 – Dried-Up Water Courses Before Final Resting Position

1.4.32 The MRH was found upright in the main wreckage with signs of heat exposure and heavy sooting (Figure 9) but there were no obvious signs of impact damage. This enabled the Panel to conclude that the MRH did not tumble throughout the accident sequence, providing further evidence that the aircraft was in a wings-level attitude and in controlled flight on initial impact. A large section of one Composite Main Rotor Blade (CMRB) was located approximately 40 metres forward and 20 metres to the left of the main wreckage site (Figure 8), suggesting the MRH was rotating during the accident sequence.

1.4.33 The right-hand cockpit seat was found to the rear and right of the main wreckage, and the left-hand cockpit seat was found forward of the main wreckage (Figure 8); analysed in greater detail at 1.4.453.

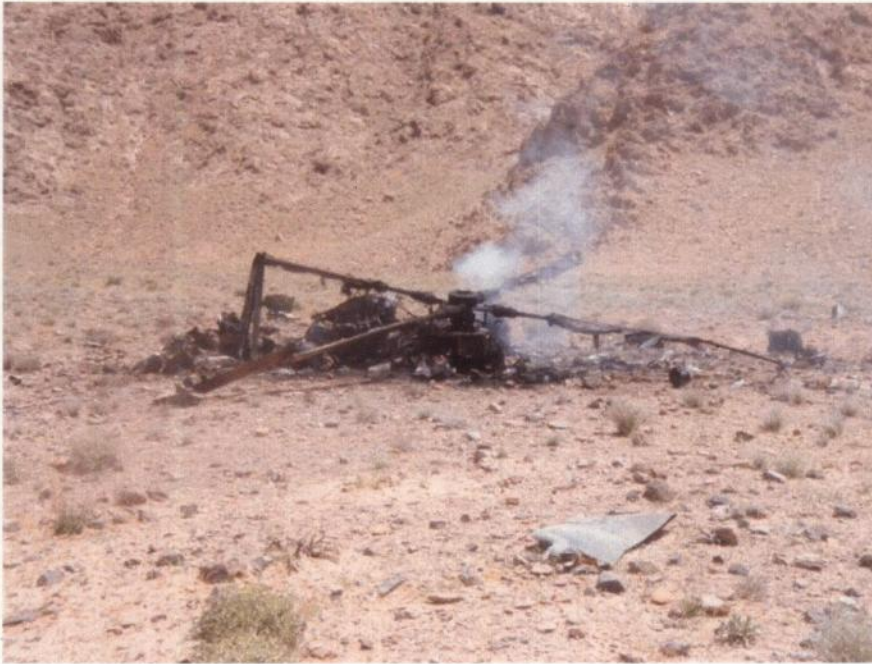
Figure 9 – Main Rotor Head (MRH)

h. **Main Rotor Head (MRH).** There were no signs of damage to the upper sections of the MRH, indicating the aircraft did not roll or tumble during the accident sequence, and the four CMRB were still attached. The MRH could be turned by hand (smoothly and with ease) post the accident. The Panel concluded that **MRH failure/malfunction was not a factor in the accident.**

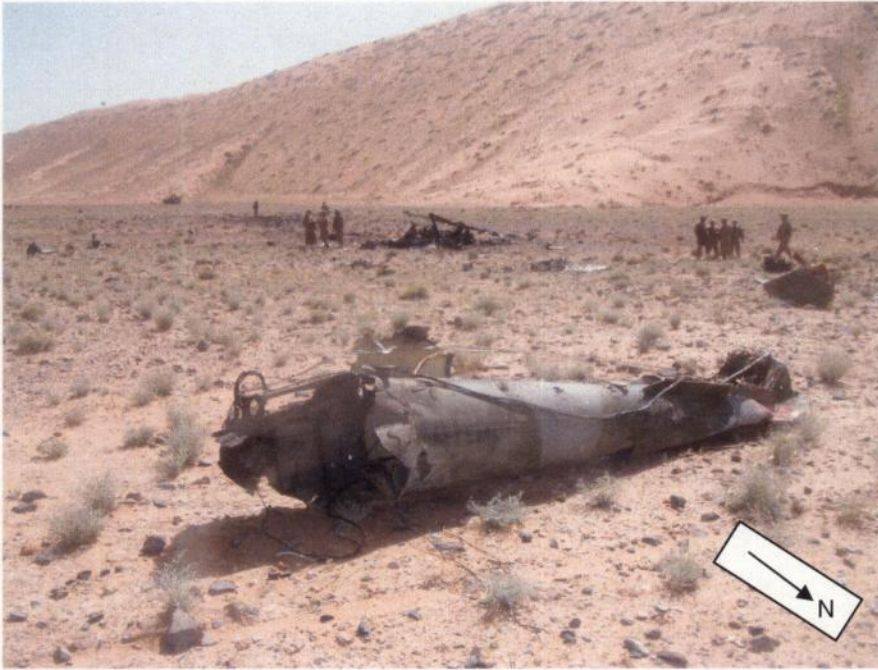
Figure 10 – Tail Cone Forwards and Right of the Main Wreckage

1.4.34 The tail cone was found significantly forward and to the right of the main wreckage, broken into three main sections¹⁹ (Figure 8). The MilAAIB concluded that the tail cone, although severely weakened on initial impact, remained attached to the main wreckage throughout the accident sequence²⁰ until the rotational phase. The Panel believed the rotational phase was strong enough to throw the tail cone forwards and photographic evidence suggested it may have tumbled as it landed, hence breaking into the three sections in close proximity to one another (Figure 10).

²⁰ Heavy sooting was on the leading edge of the tail strake and the forward end of the sheared tail cone also displayed light sooting.

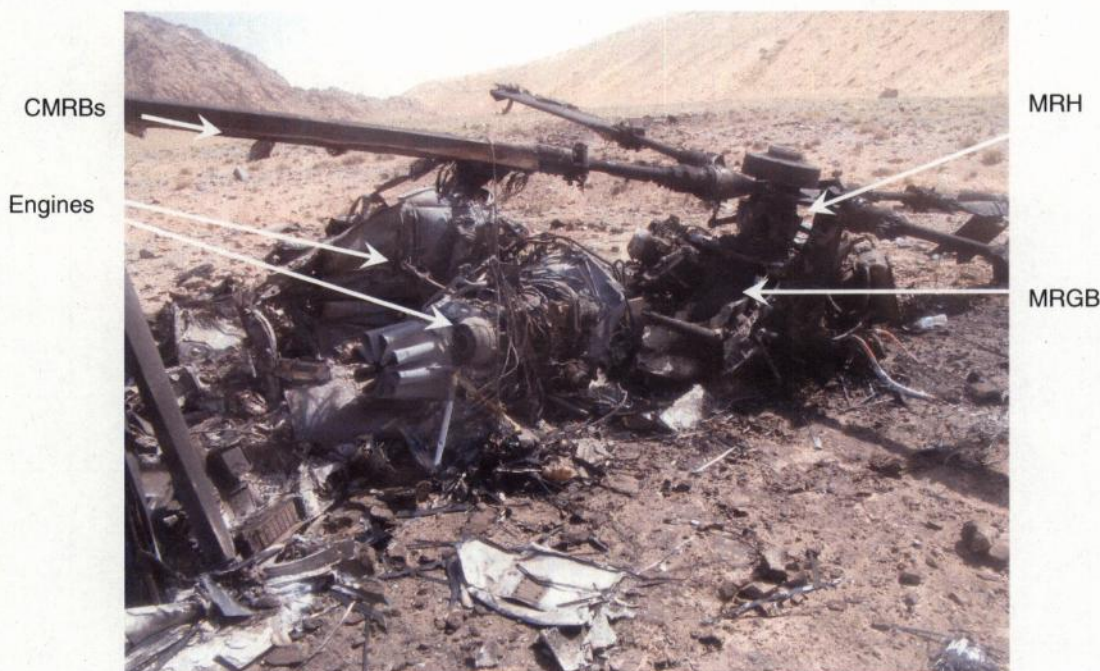
Figure 11 – Major Rotables Recovered for Technical Assessment

1.4.59 **Secondary/Tertiary Layers of Evidence.** The wreckage recovered included most of the major rotables³⁰ which have been subjected to detailed analysis by MilAAIB and Industry experts for signs of technical failure/malfunction (Figure 11).

1.4.64 **Technical Failure/Malfunction Summary.** CVR and expert analysis of recovered aircraft components, confirmed by the MilAAIB Technical Report, provided evidence to indicate that **technical failure/malfunction was not a factor in the accident.**

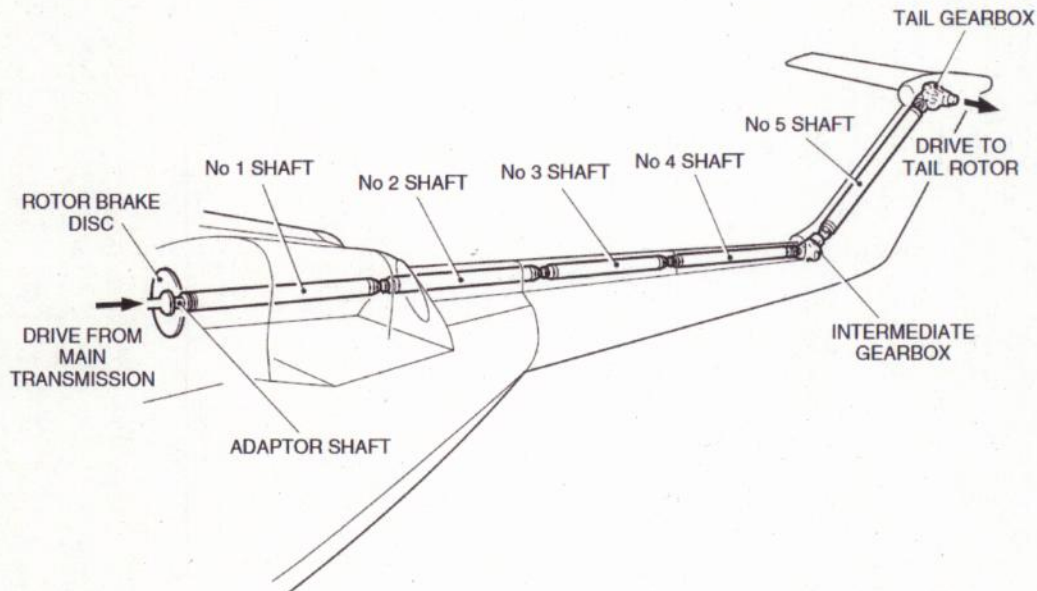
Figure 12 – Five Tail Rotor Drive Shafts (TRDS)

g. **Tail Rotor Drive Shaft (TRDS).** Lynx aircraft are fitted with five Tail Rotor Drive Shafts (TRDS) that transmit rotational drive from the main transmission (the MRGB) to the aircraft tail (see Figure 12). The Number Four (No 4) TRDS was the only shaft recovered; it had been torn apart (in torsion) and remained attached to the IGB. The failure is consistent with a rapid deceleration of tail rotor drive when the TRBs struck the ground. A circumferential mark was observed and subsequently matched to a point of impact with the tail structure³⁹. The torsional ripping of the drive shaft and circumferential mark indicate that the TRDS was being driven at the moment of impact and the damage was a result of the impact and subsequent break-up of the tail cone section. Electronic records prove the aircraft was at the correct latest modification standard⁴⁰. The Panel also noted that TRDS

failure/malfunction would have resulted in loss of tail rotor drive and the aircraft would have yawed before impacting the ground, leading to a different accident site profile. The Panel concluded that **TRDS failure/malfunction was not a factor in the accident.**

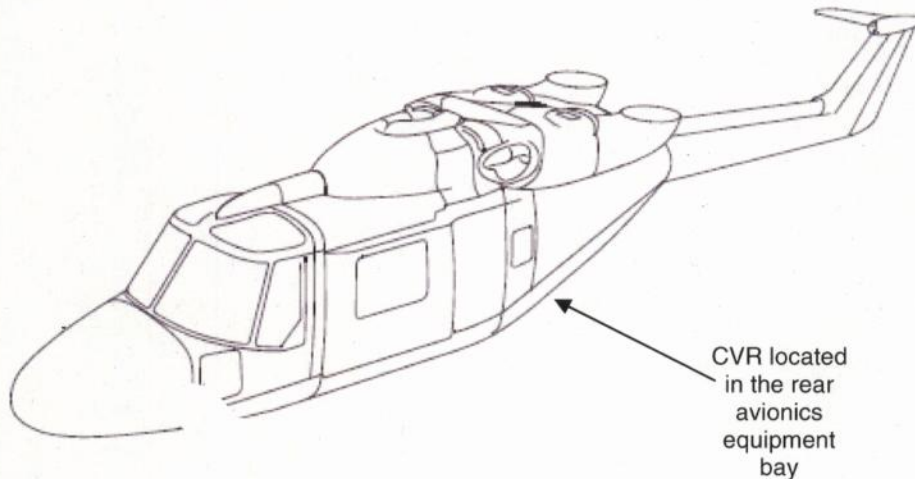
Figure 13 – Location of CVR on Lynx AH Mk 9A

1.4.62 **Quality of CVR Recording.** The CVR was located in the rear of the aircraft (Figure 13). The Panel noted that, whilst the CVR was recovered in reasonable condition, the CVR ended abruptly on what is believed to be the initial impact due to the magnetic tape's driveshaft breaking. The impact loading required to cause this failure is covered at 1.4.446.

1.4.65 **The Panel recommends that the Lynx Project Team Leader should fit a solid state CVR to Lynx AH Mk 9A aircraft to overcome the problems associated with the current magnetic tape CVR.**
