Rail Accident Investigation Branch

# Rail Accident Report

**Passenger trapped and dragged by a train at  
Hayes & Harlington station  
25 July 2015**

Report 12/2016  
June 2016

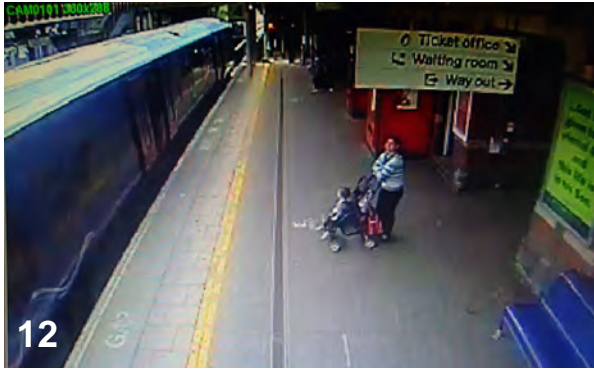
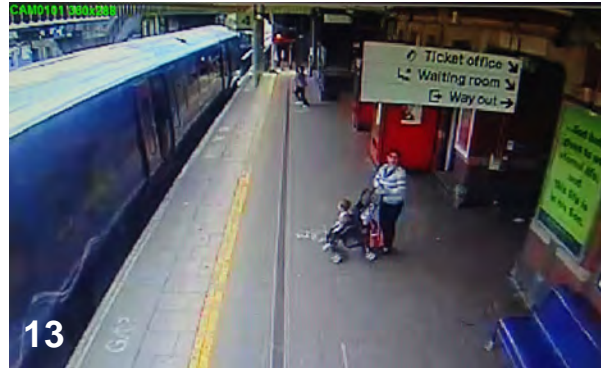
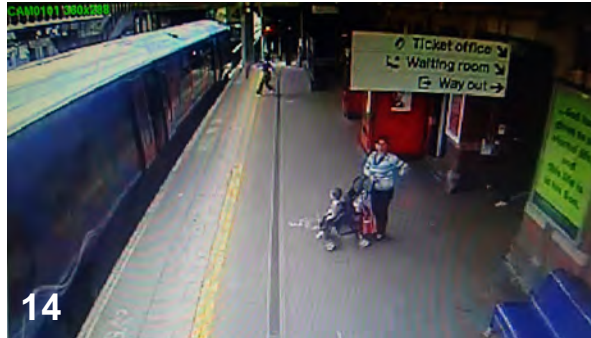
16 At 13:09:48 the passenger involved in the accident ran from the stairwell onto platform 4 (figure 12). The RAIB has established using CCTV evidence that this is around the same time at which the train driver pressed the door close button to initiate their closure. The passenger continued to run (figures 13 and 14) towards the train doors which were still open, but with the audible 'hustle' alarm sounding indicating imminent closure.

Figures 12 to 14: CCTV images showing the passenger running from the stairwell and onto the platform towards the stationary train as the doors were closing (courtesy of GWR)

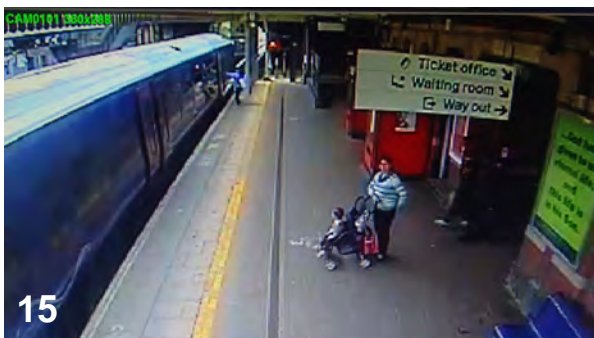
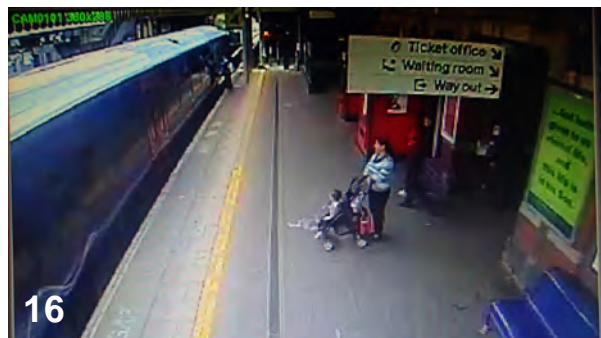
17 At 13:09:50 the passenger put her leg and left hand between the rear door leaves (which were by now almost closed) on the last coach of the train, in an attempt to prevent them from fully closing. Almost immediately, she retracted her leg, leaving her left hand in the door (figure 15). At 13:09:51 the *Body Side Indicator light* on the rear carriage was extinguished. The driver's *door interlock light* illuminated in the cab a second or two later, once the safety circuits had identified that all the train doors were closed and locked (figure 16) (the CCTV evidence does not show all of the doors on the train so it is not possible to be precise about the time that the door interlock light illuminated).

Figures 15 and 16: CCTV images showing the passenger running towards the train and trapping her hands in the door of the rear carriage of train 2P48 (courtesy of GWR)

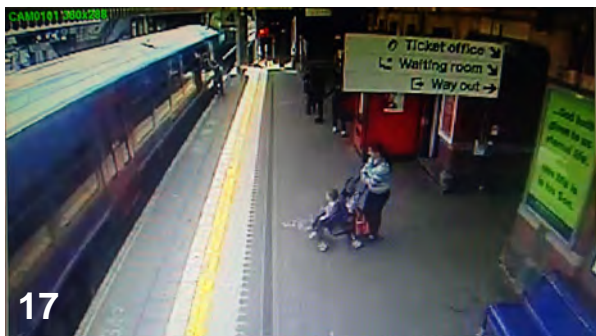
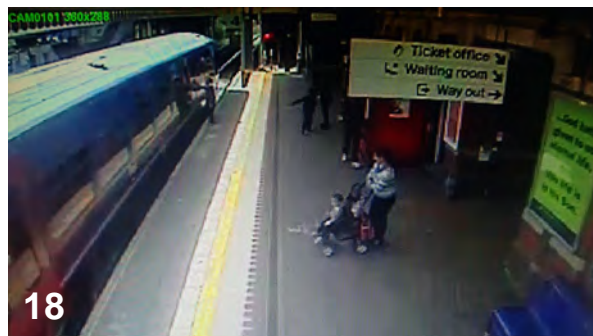
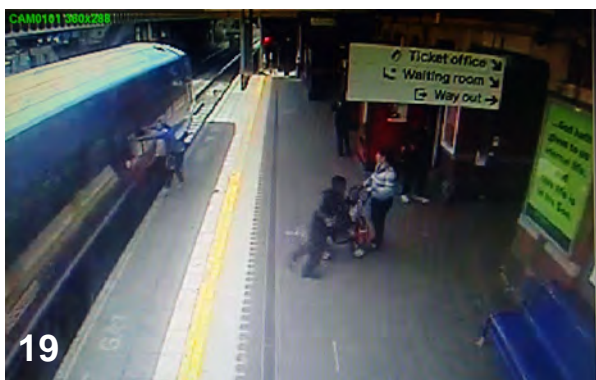
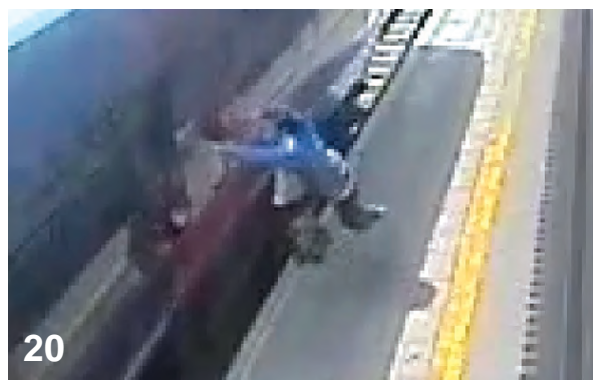
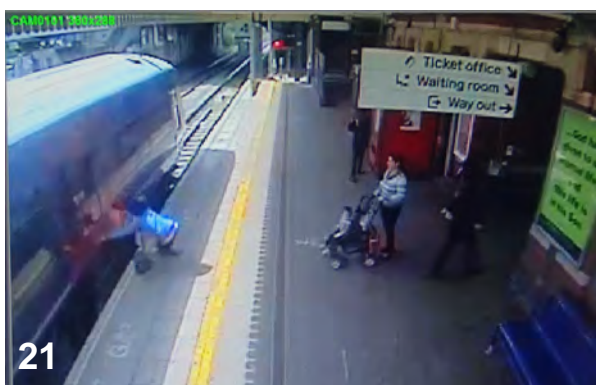
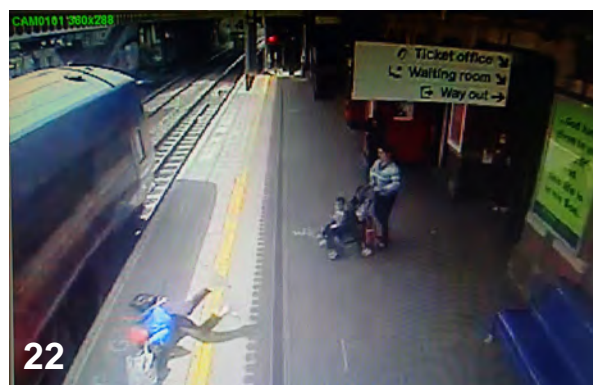
- 19 At approximately 13:10:01, the train started to move. At this time other passengers on the platform became aware of the trapped passenger (figures 17 and 18). The train gathered speed, dragging the passenger along the platform (figure 19) until 13:10:07 hrs, when the speed of the train caused her to lose her footing and she became airborne (figure 20). The weight of her body falling and the angle of her trapped left hand resulted in her hand becoming free from the doors, and she fell heavily onto the platform. Fortunately, she rolled away from the platform edge (figures 21 and 22).

Figures 17 to 22: CCTV images showing the passenger being dragged along the platform and falling away from train 2P48 (courtesy of GWR)

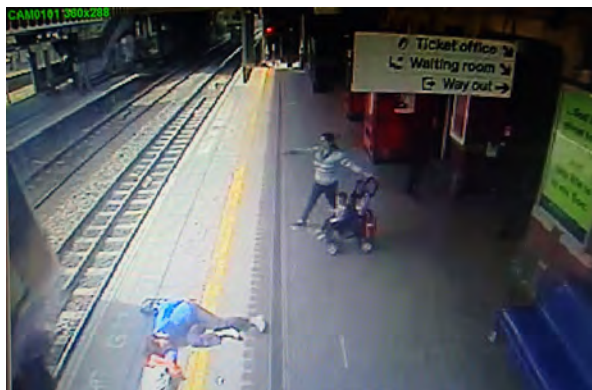
Figure 23: CCTV images showing the passenger on the platform after falling away from train 2P48 (courtesy of GWR)

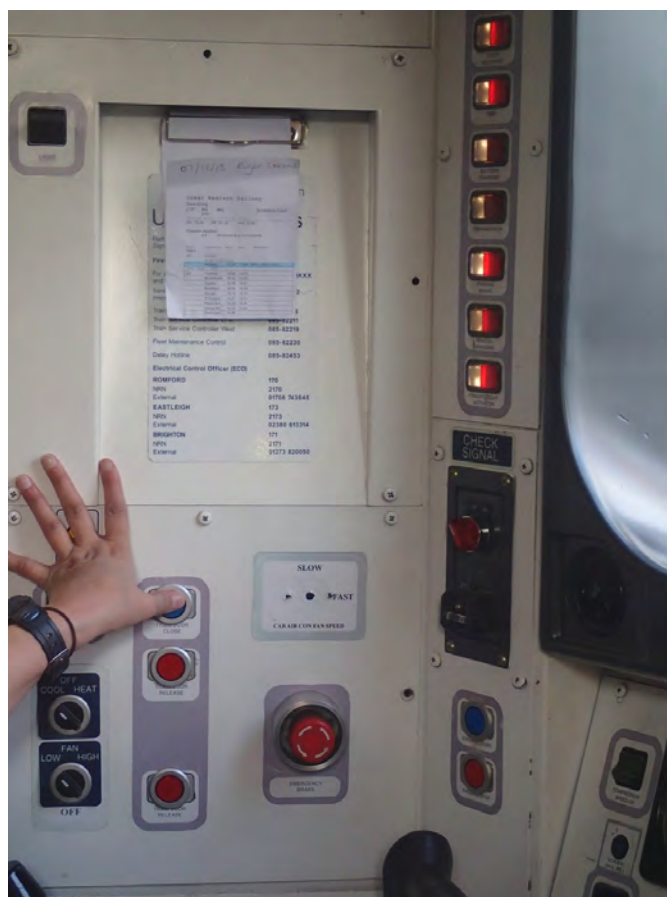
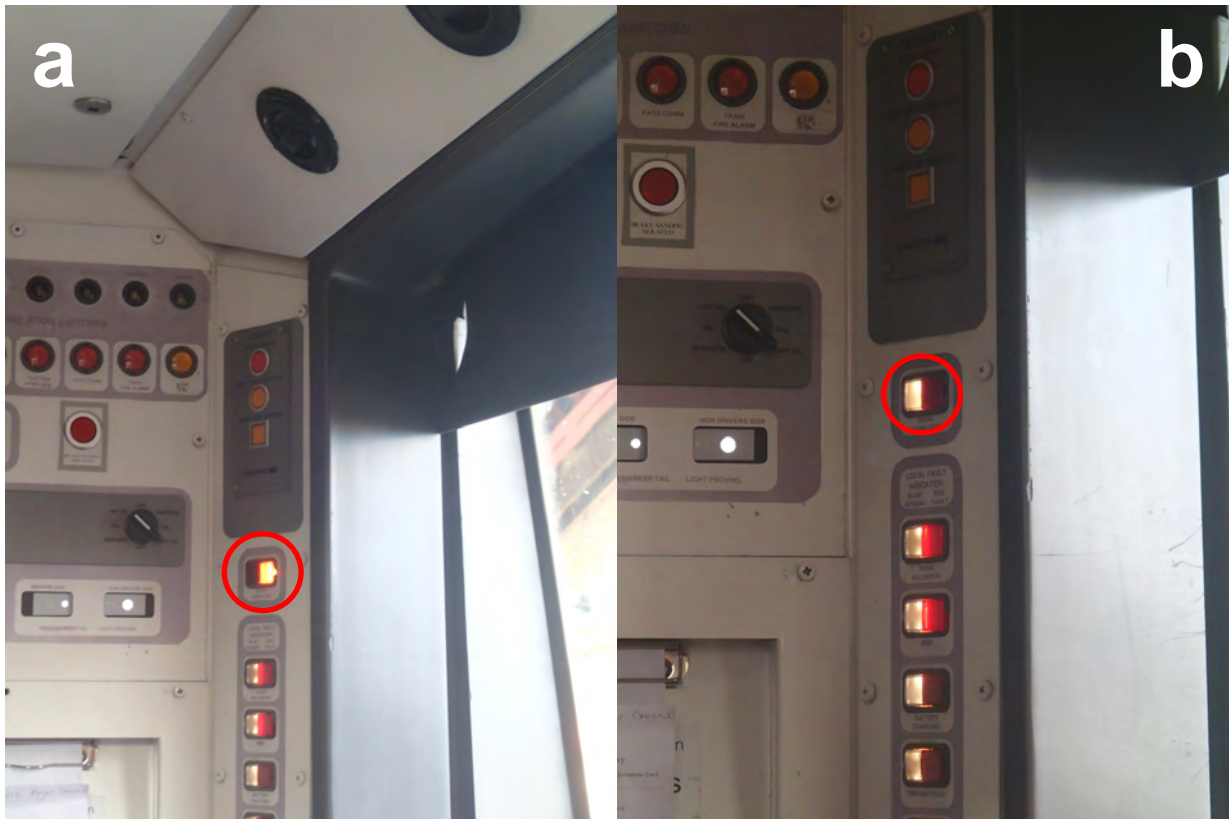
- 49 For the purposes of testing whether the door interlock is working properly, a test object is used. FGW specifies a test object 25 mm wide for testing the door interlock (this is derived from the British Rail Standard GO/OTS 300 and therefore more onerous than the requirement in the current equivalent Standard GM/RT2473, which specifies a test object 30 mm in width). The test involved inserting the object into the closing leaves of a train door and confirming that interlock prevents the driver from taking power (figures 25, 26(a) and 26(b)).

- 50 When FGW tested the door involved in the accident to determine if it met the requirements of its test specification, the door passed the test; interlock could not be obtained when the object of 25 mm width was inserted into the closed door leaves. However, because the passenger's hand was less than 25 mm thick, the interlock circuit could be made, which illuminated the door interlock light in the driving cab and enabled the driver to start the train. This was confirmed by the reconstruction exercise at Hayes & Harlington referred to in paragraph 43. In all three tests, the driver was able to obtain door interlock and move the train. One further test was undertaken, involving the member of staff placing a foot in between the closing doors. Because the width of the obstruction exceeded 25 mm, the doors partially re-opened and the driver was unable to obtain door interlock and start the train. This was consistent with a further requirement of GM/RT2473 which required that the 150 N door closing force be reduced, or the door automatically reopen, if the door leaves detect an obstacle of a given width or greater (25 mm or greater in the case of class 165 doors).
