Rail Accident Investigation Branch

Rail Accident Report

Train fire at South Gosforth 8 January 2013

Report 18/2013
September 2013

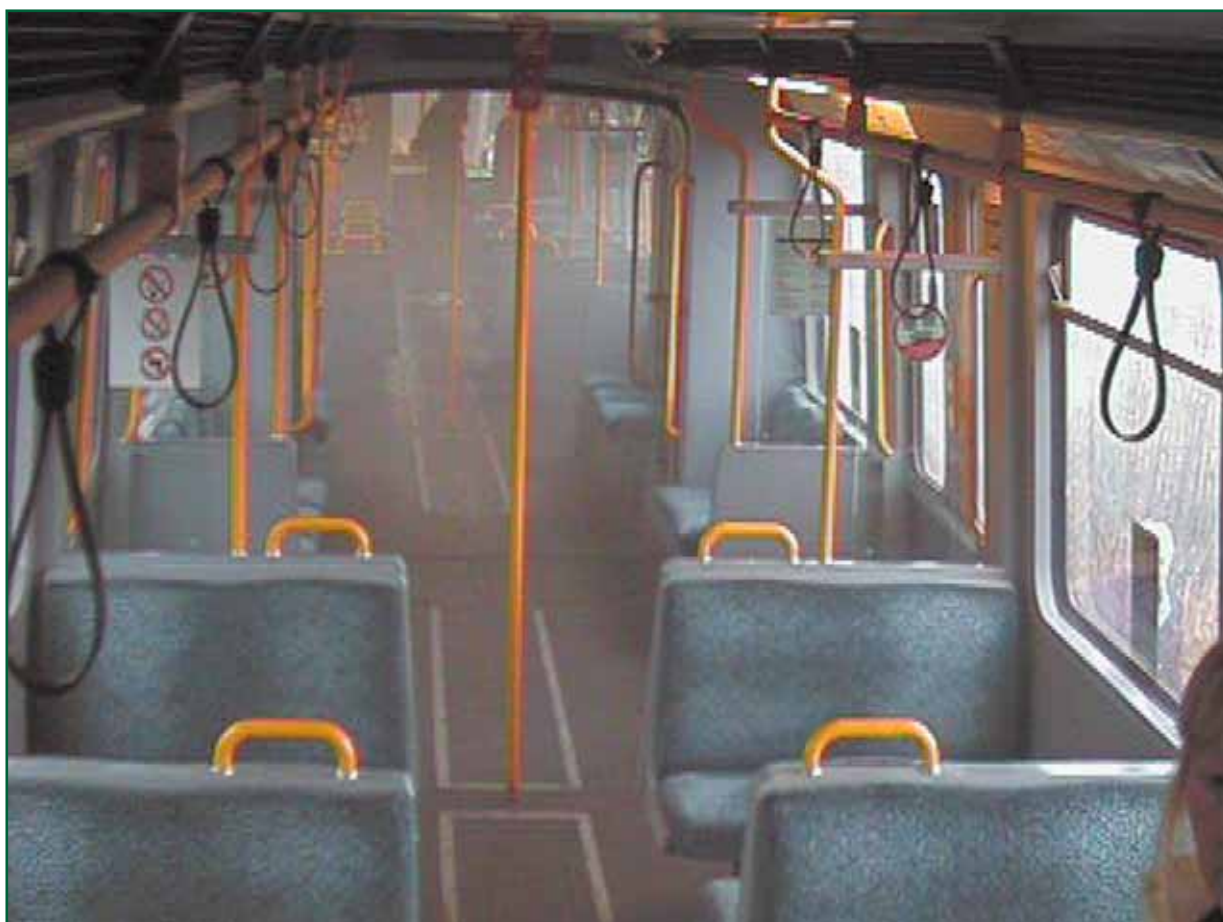
- 34 There were 45 passengers in car 4052. They succeeded in opening the doors on the left side (the side away from the other track) at the front and rear of the car (1 minute 18 seconds), but the handle of door 6 (at the rear of the leading section of the car) was too stiff for the passenger who tried it, and she moved to the rear section. No-one attempted to open the other door on that side of the car, probably because it was close to the source of smoke (figure 5).
- 35 The OHL contact wire melted and parted at the point where it was in contact with the *pantograph*, and fell onto the train roof and onto the ground on the right-hand side of the train (facing in the direction of travel) at about the same moment as the first door on the left-hand side of the train was opened by passengers (CCTV shows this happening at 1 minute 18 seconds).

Figure 5: Interior of car 4052 during the evacuation of passengers, 4 minutes 19 seconds after the start of the accident. Door 6 is on the right (image courtesy of DBTW).

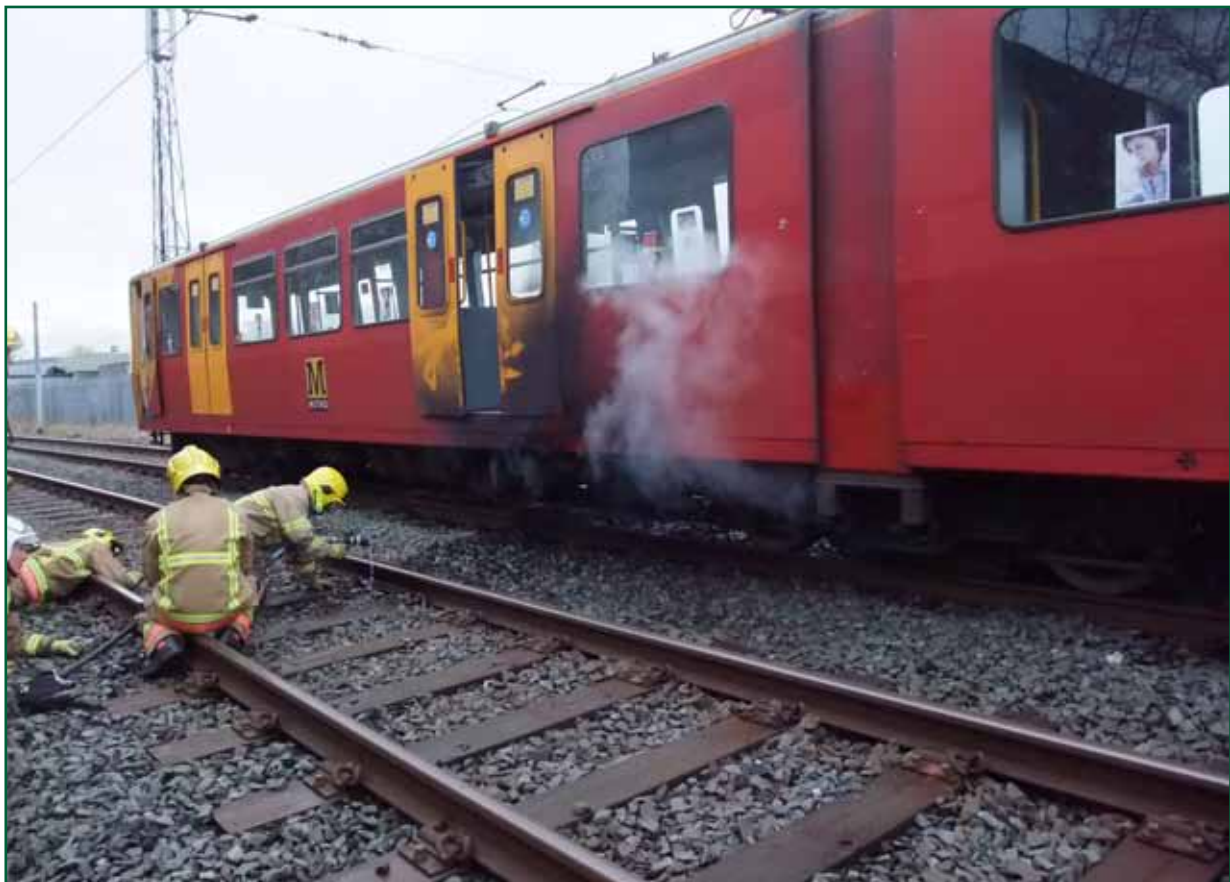
- 37 While the driver was attempting to make contact, the passengers in car 4052 evacuated themselves onto the lineside through the two doors which they had been able to open, without apparently experiencing any difficulties (completed at 6 minutes 7 seconds).
- 38 The train driver, after using the public address system on the train to reassure passengers, then left the cab and made contact with the passengers from the rear car (8 minutes 47 seconds), took control of the situation at the scene, and escorted the passengers into an adjacent Nexus training centre car park (via an access gate (completed at about 11 minutes). There were no injuries.
- 39 The fire brigade attended, and after assessing the situation and confirming that electrical isolations were in place, used hoses to extinguish the smouldering equipment under the train about 40 minutes after it came to a stop (figure 6).

Figure 6: Car 4052 after the accident, with fire brigade in attendance. The doors nearest the camera in this view were opened after the arrival of the emergency services, and were not used for the evacuation of passengers (image courtesy of DBTW)

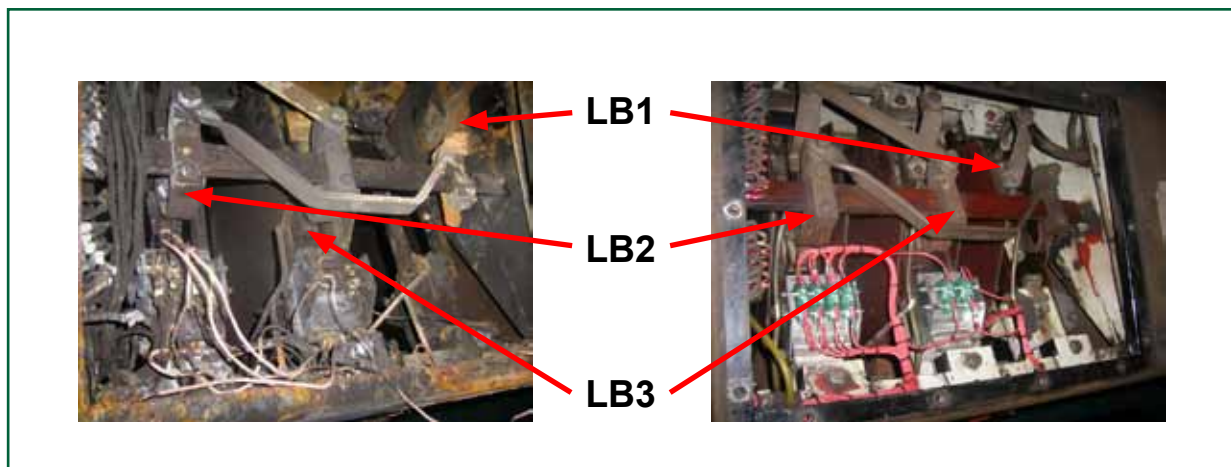
- 43 The immediate cause of the fire was electrical arcing following a fault in the line breaker case on car 4052.
- 44 The fire was the result of a sustained arc, which burnt away much of the equipment in the vicinity of the line breaker LB1. This produced a large volume of smoke, some of which entered the passenger saloon.
- 45 The size and position of the arc is clear from the condition of the equipment in the line breaker case after the accident (figure 7).

Figure 7: (left) Interior of line breaker case, showing damage to LB1; (right) the same equipment in an undamaged state

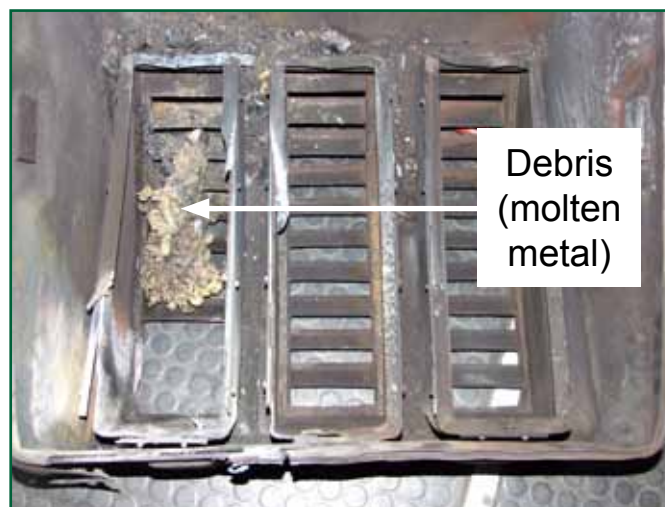
- 46 Line breaker LB1 was almost completely destroyed. Molten metal from the contactor assembly and support bar was sprayed around the interior of the line breaker case (figure 8).

Figure 8: Interior of the line breaker case cover (image courtesy of DBTW)

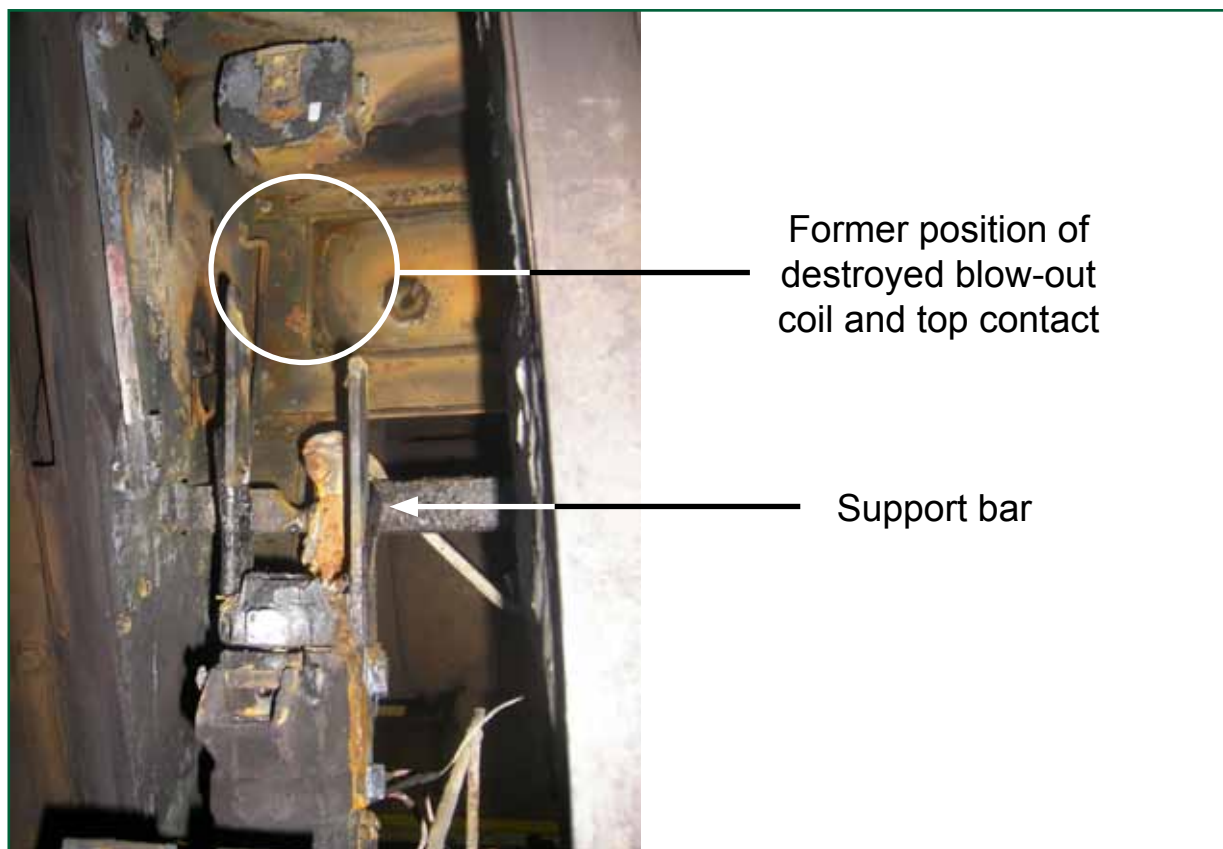
- 49 The *flashover* which initiated the arcing was the result of an earth fault (ie a short circuit of the power supply on this design of system) on or around the input side of line breaker LB1. This is likely to have manifested itself, and caused the initial damage to the line breaker, when the driver shut off power to coast through the neutral section.
- 50 The upper section of LB1 (the vertical support bars, blow-out coil, top contact and brackets, braid and upper support block) was completely destroyed. The horizontal support bar was burnt through about two-thirds of its section (figure 9).

Figure 9: Damage to line breaker LB1 blow-out coil and support bar

- 53 The damage to LB1 and the surrounding equipment was so severe that it is not possible to identify the exact location or nature of the original fault, or the reason why it manifested itself when it did. Possibilities include degradation or damage to the insulation of the mounting bar, or a build-up of dirt.

- 1 *The objective of this recommendation is that Nexus, with support from DBTW, should identify and mitigate the risk associated with electrical breakdown in the train line breaker assemblies.*

Appropriate actions to reduce the risk and potential consequences of failures should be defined and implemented following the review (paragraphs 104a, 104b and 104c).

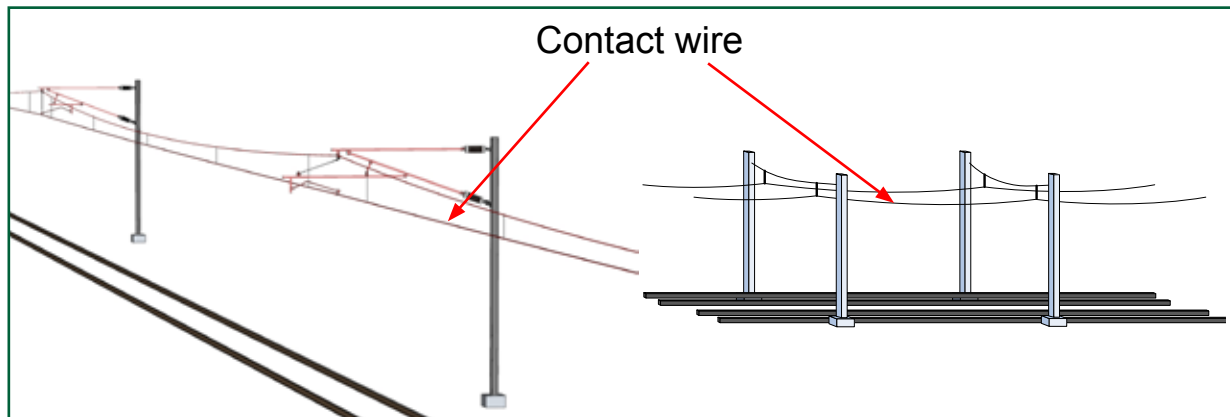
80 The overhead line parted about twelve seconds after the train stopped (as shown by the CCTV footage) and up to three seconds before the power was finally cut off from the South Gosforth – Benton Square section. At the place where the train stopped, the contact wire is a single conductor supported by solid droppers suspended from transverse cables (as distinct from catenary, figure 11), and is designed to withstand a continuous current of 360 A.

Figure 11: Catenary OHL (left) and tramway-type OHL (right)

- 81 The point where the contact wire failed corresponds to the position of the pantograph on the rear car, and it is likely that the high current flowing through a small contact area between the wire and the pantograph produced sufficient local heating to melt the wire. Examination of the wire showed marks of arcing on the wire on the side of the failure point from which the train had travelled.

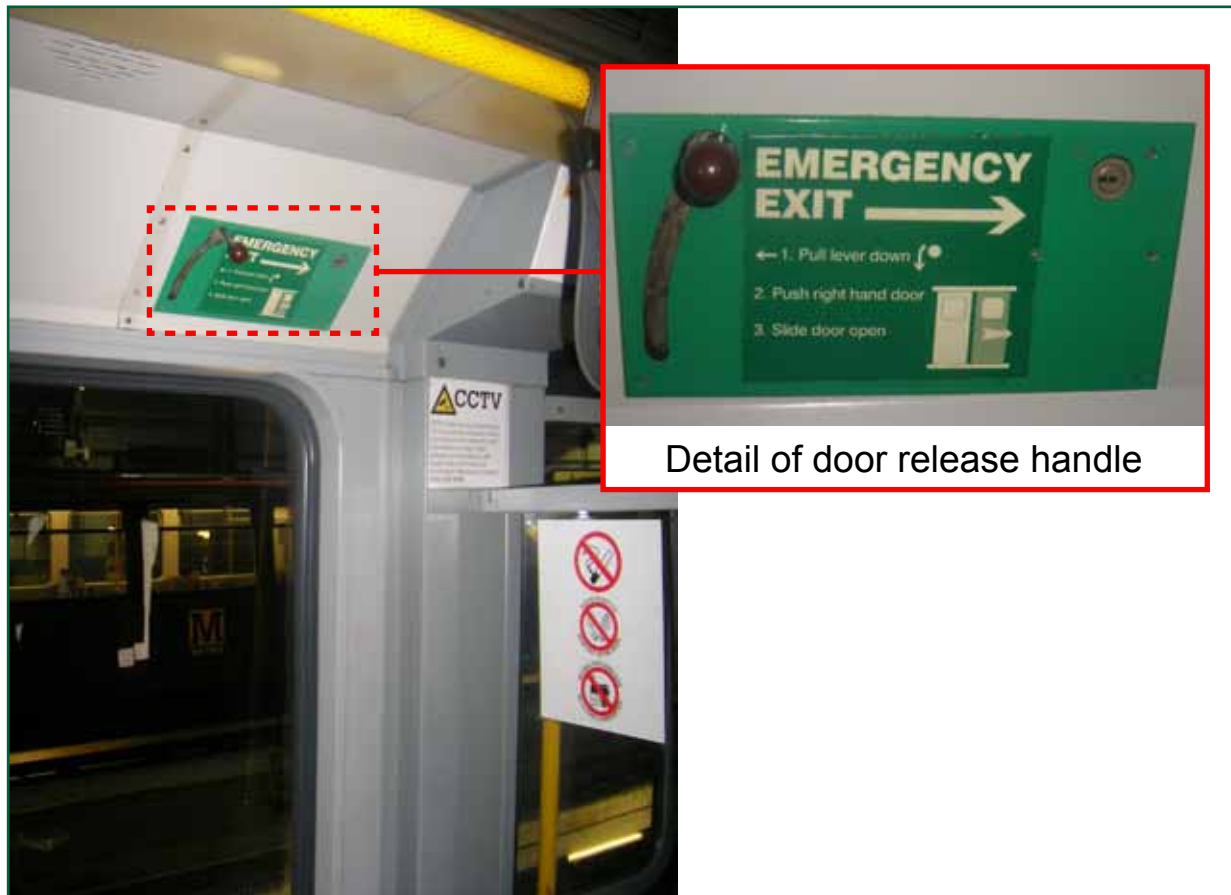
- 88 The remaining set of doors, not opened during the evacuation, were the second set from the front of car 4052 (identified as door 6). CCTV shows a passenger attempting to use the emergency door release handle to open door 6, but giving up after a short time and joining the evacuation from the other doors. After the evacuation, a number of passengers reported to the driver that they had had difficulty with the door release handles. Subsequent examination of the release handle mechanism for door 6 found that it was extremely stiff to operate, and tests using a diverse range of people showed that many passengers were likely to have been unable to obtain sufficient purchase to operate the handle far enough to open the doors.

- 89 The emergency release handle is shown in figure 12. It is designed to be pulled downwards to release the doors, and uses a wire-in-tube system to operate a latch on the door closing mechanism, and a valve to release the air pressure in the door actuator system. The angle at which the handle is mounted is intended to make it possible for it to be worked from outside the vehicle by a hooked pole wielded by the emergency services and passed through the open window immediately below, avoiding the need to break windows to enter the vehicle. However, this makes it more awkward for a person inside to use the handle without instruction and/or practice.

- 90 The regular examination schedule for the Metro cars (defined by Nexus, and carried out by DBTW) requires the operation of the emergency release handle for each door to be checked during each 'A' exam. These generally take place every 12000 km (approximately three weeks running). DBTW's records showed that these checks had been carried out on car 4052, most recently on 13 October 2012. The car was in Gosforth depot from 2 November 2012 to 2 January 2013 for a 'D' exam, which included under-frame equipment renewal along with traction motor, gearbox and associated work, but not checks on the doors. The RAIB found that staff in the Gosforth depot, where these checks are carried out, were accustomed to carrying out the functional test of the emergency release handles, which consisted of operating the handle and confirming that doing so released the doors. However, during and after the accident on 8 January, people who were not familiar with them found the handles difficult to operate and stiff, particularly so in the case of the handle for door 6 on car 4052 (paragraph 34).

Figure 12: Emergency door release at door 6 in car 4052

- 91 After the accident, DBTW tested the force required to operate the door release handles on two cars, neither of which were involved in the accident on 8 January. DBTW reported that the results of these tests showed a range from 25 to 36 kg(f) (55 to 79 lb(f)). DBTW reported that the test equipment was unable to develop sufficient force and failed when it was used on door 6 of car 4052.

- 2 *The objective of this recommendation is to facilitate passenger evacuation from trains using the emergency handles to release doors by identifying a maximum level of force required to operate them and then periodically checking that handles comply with the identified maximum.*
