The Serviceability of Helicopter Passenger
Immersion Suits - A Report
following the ditching of
G-BISO on 2nd May 1984

July 1984

AIRCRAFT EQUIPMENT GROUP REPORT NO. 508

The Serviceability of Helicopter Passenger Immersion Suits - a Report
following the ditching of G-B180 on 2nd May 1984

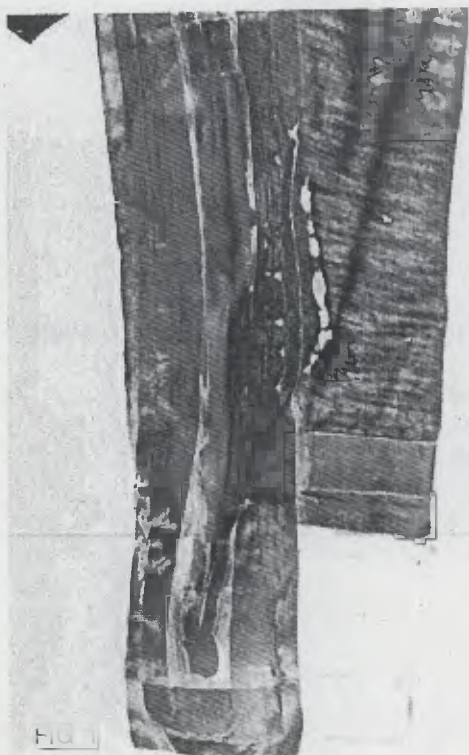
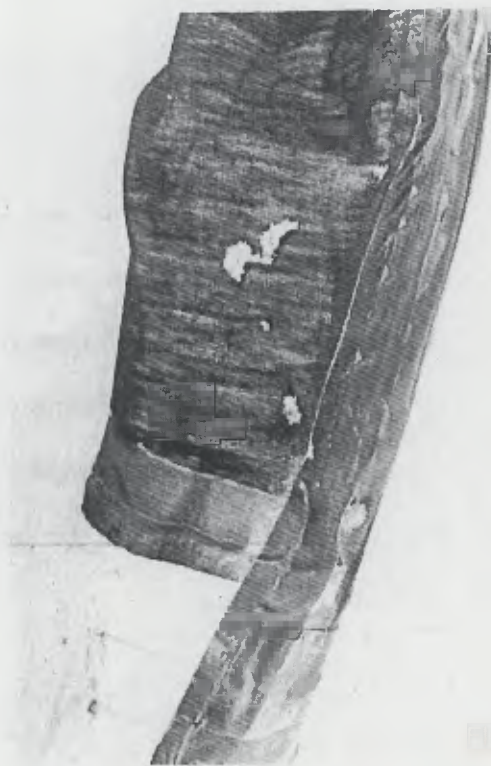
Although a particular feature of wear and tear at the wrist openings, we found many other examples of wear and tear failure of the inner layer of the suit. We believe the inner layer of the particular variety of Gore-tex used in these suits to be insufficiently robust. Clearly fabric specifications for Gore-tex immersion suits should include clauses specifying the abrasion resistance of both inner and outer layers.

1. Wear and tear of inner layer fabric at wrist, penetrating the waterproof layer.
2. As figure 1.
3. Inner lining wear and lifting of repair patches.
4. Burn damage, probably from a cigarette.
5. External taping failure at wrist zip.
6. "Over enthusiastic" repairs at the wrist.
7. Burn damage, probably from heat sealing machine, with patch over.
8. Suit diagram for recording defects and leaks.
9. Visible defects, incidence and distribution.
10. Sources of leaks at bench test Parts 1, 2 and 3.
11. Defect proforma.

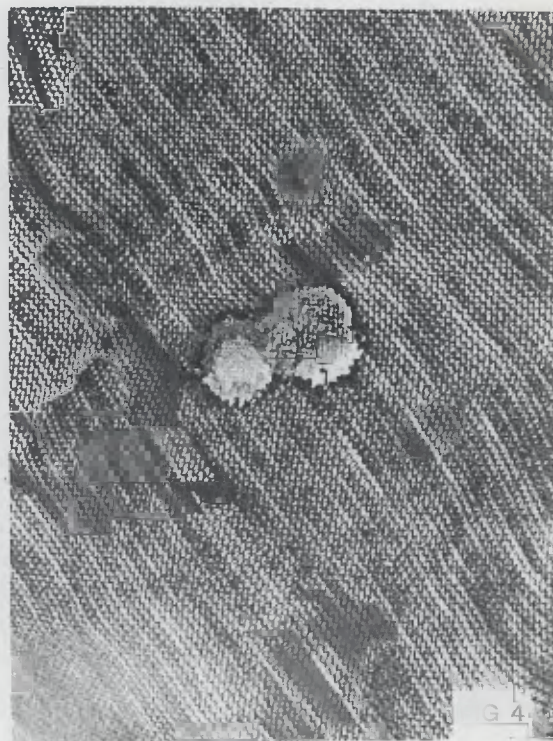
There were a few signs of careless use by the wearers e.g. cigarette burns, but it was difficult to be sure of the cause of many of the defects.
