Collision between a train and an engineering trolley, Stowe Hill Tunnel, 7 December 2016

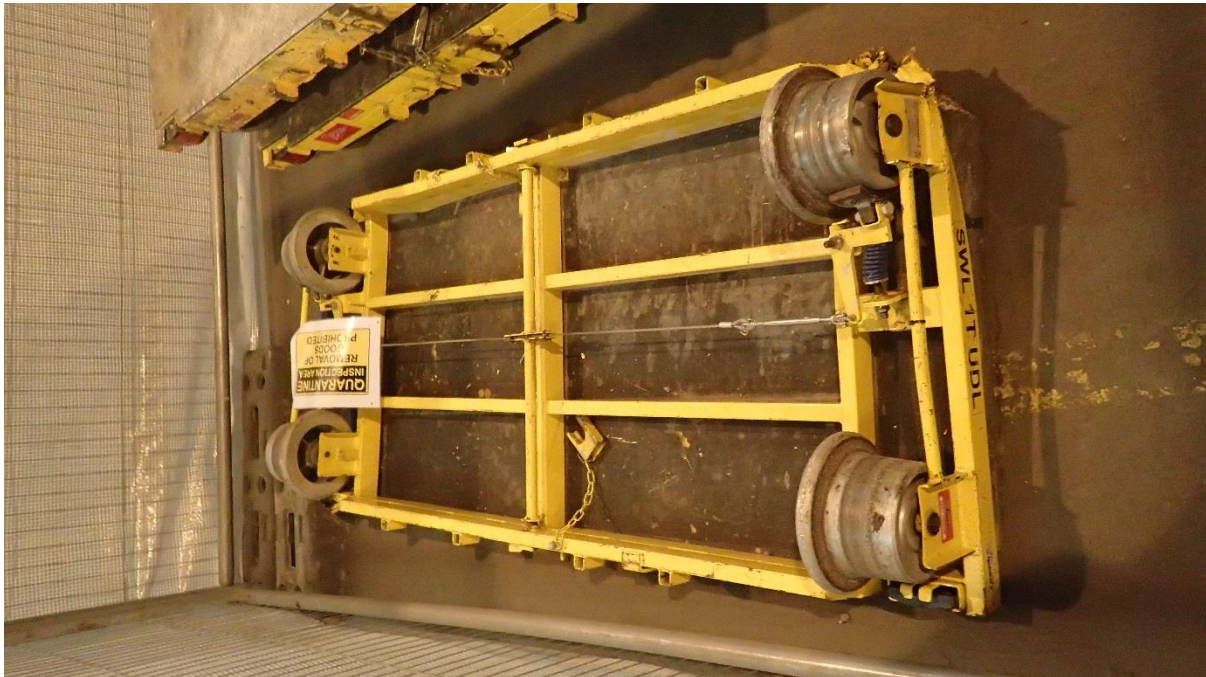
The engineering trolley found between the Up Main line and the Down Main line

- one trolley was between the tunnel wall and the Up Main line and had been completely destroyed;
- a second trolley was located between the Up Main and Down Main lines and had damage consistent with having been struck by passing trains;
- a third trolley was in the recess of pressure relief shaft No.1 and was undamaged; and
- a fourth trolley in the recess at pressure relief shaft No.2, also undamaged.

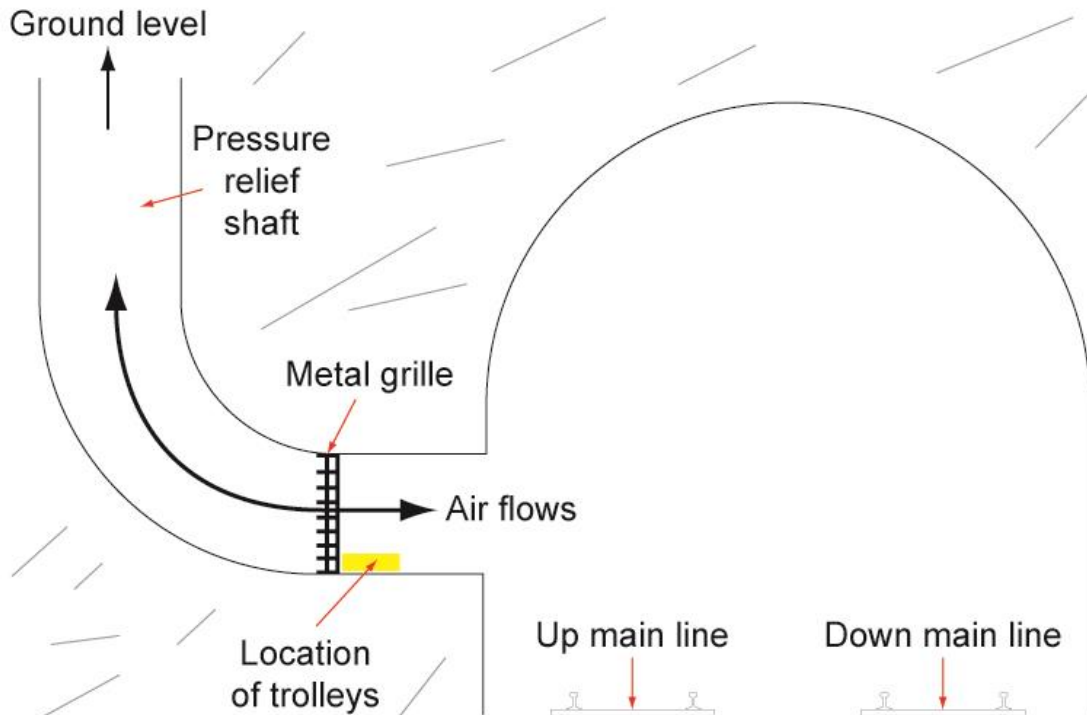
Cross section through the tunnel showing pressure relief shaft and location of trolley stowage (schematic). The edge of the trolley is 1.77 metres from the Up Main line.

The railway rulebook (GE/RT8000), Handbook 1, Section 7.1 states that 'Tools & equipment must not be placed any closer than 2 metres from a line on which a train could pass, unless you are absolutely sure that they will not be hit by a passing train or be moved by the slipstream of passing trains'. In this case the trolleys were less than two metres from the Up Main line, and had not been adequately secured.

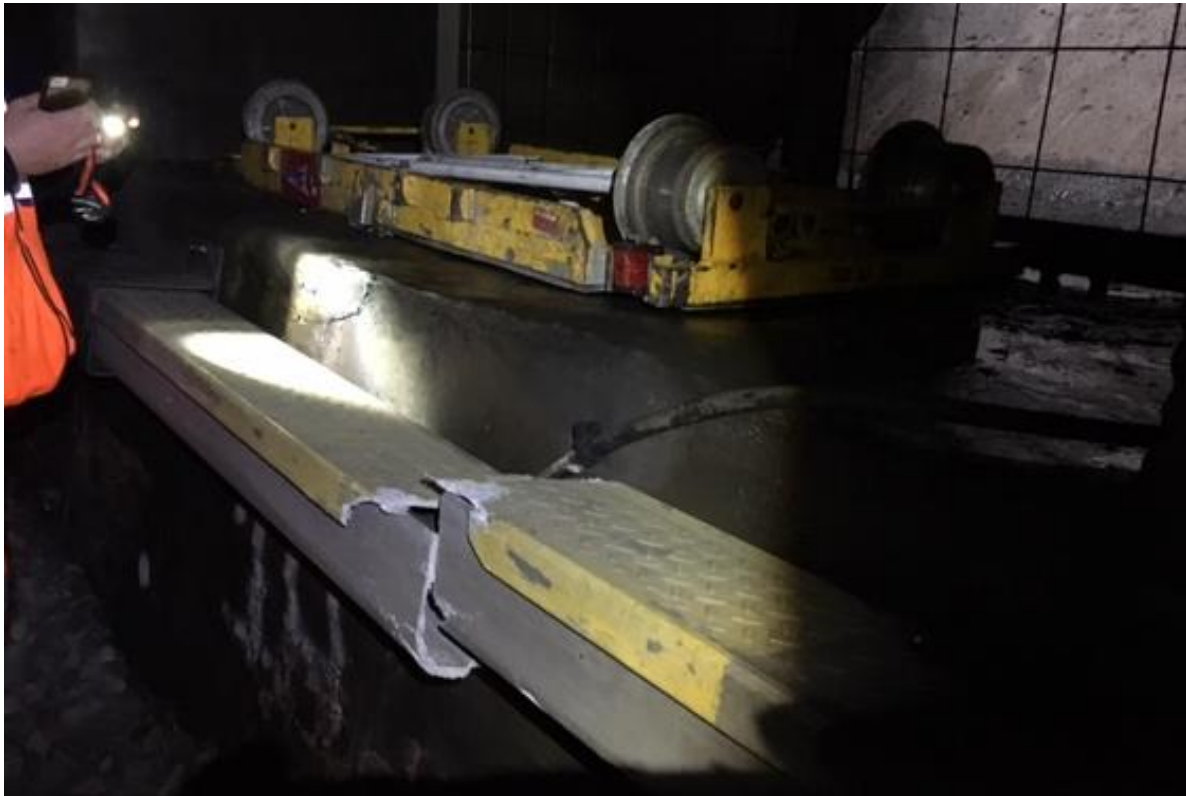
The two trolleys which had remained in the recesses were reported to be unsecured. However, broken cable ties were subsequently found in the vicinity of the trolleys.

Undamaged trolley as found within the pressure relief shaft No. 1 recess in Stowe Hill Tunnel. The metal grille at the bottom of the shaft can be seen in the background (photo courtesy Network Rail)

However, at the end of the planned work, and after the Network Rail staff had left site, the AMCO staff realised that they did not have any chains or padlocks available. They reported that the four trolleys were placed and secured in the recesses at No.1 and No.2 shafts, two per recess. In each recess, one trolley was placed on top of the second, and they were secured to the grille using cable ties.
