AAIB Bulletin

5/2015

Aircraft Type and Registration:	BAE ATP, G-BTPF	
No & Type of Engines:	2 Pratt & Whitney Canada PW126 turboprop engines	
Year of Manufacture:	1989 (Serial no: 2013)	
Date & Time (UTC):	7 October 2014 at 2035 hrs	
Location:	Outbound from Bournemouth Airport, Dorset	
Type of Flight:	Commercial Air Transport (Cargo)	
Persons on Board:	Crew - 2	Passengers - None
Injuries:	Crew - None	Passengers - N/A
Nature of Damage:	None	
Commander's Licence:	Airline Transport Pilot's Licence	
Commander's Age:	31 years	
Commander's Flying Experience:	2,570 hours (of which 325 were on type) Last 90 days - 43 hours Last 28 days - 16 hours	
Information Source:	Crew reports and AAIB enquiries

Aircraft Type and Registration:	CZAW SportCruiser, G-EWZZ
No & Type of Engines:	1 Rotax 912 ULS piston engine
Year of Manufacture:	2010 (Serial no: LAA 338-14815)
Date & Time (UTC):	9 August 2014 at 1440 hrs
Location:	Kingarth, Isle of Bute, Scotland
Type of Flight:	Private
Persons on Board:	Crew - 1 Passengers - 1
Injuries:	Crew - 1 (Serious) Passengers - 1 (Fatal)
Nature of Damage:	Aircraft destroyed
Commander's Licence:	National Private Pilot Licence
Commander's Age:	53 years
Commander's F

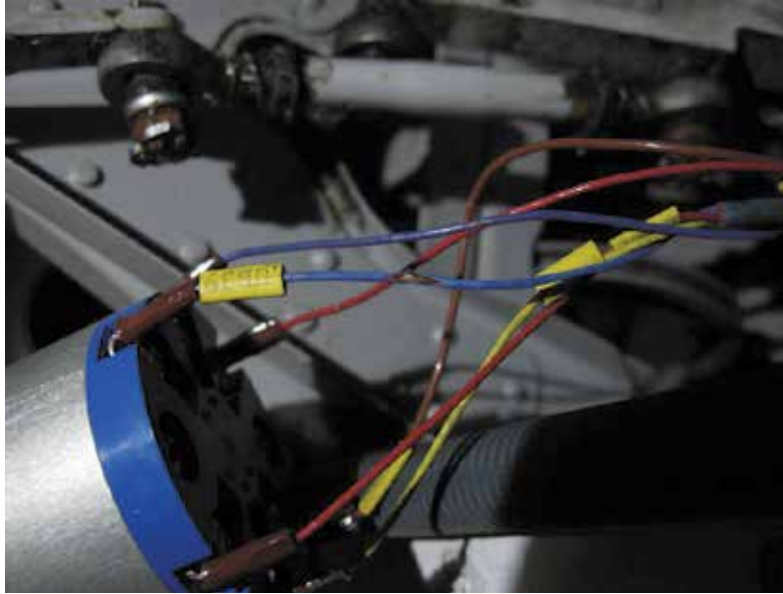
Figure 3

The aileron position synchros were visually examined and one wire, labelled UB39, on the left aileron synchro was found to be chafed down to the bare metal, Figure 3. This wire provides one of the three secondary outputs from the synchro. The terminals on the contacts on both synchros were found to be corroded.

Chafed wire on left aileron position servo

The chafed wire and corroded contacts found on the left aileron position synchro transmitter would not have affected the SCS as it only provides position information of the left aileron to the FDR.

Further inspections and tests could not identify the source of the smoke or the reason for the reported uncommanded control input. As a precaution the No 1 inverter, both aileron synchro transmitters and the aileron release unit were replaced and the aircraft was released for flight.

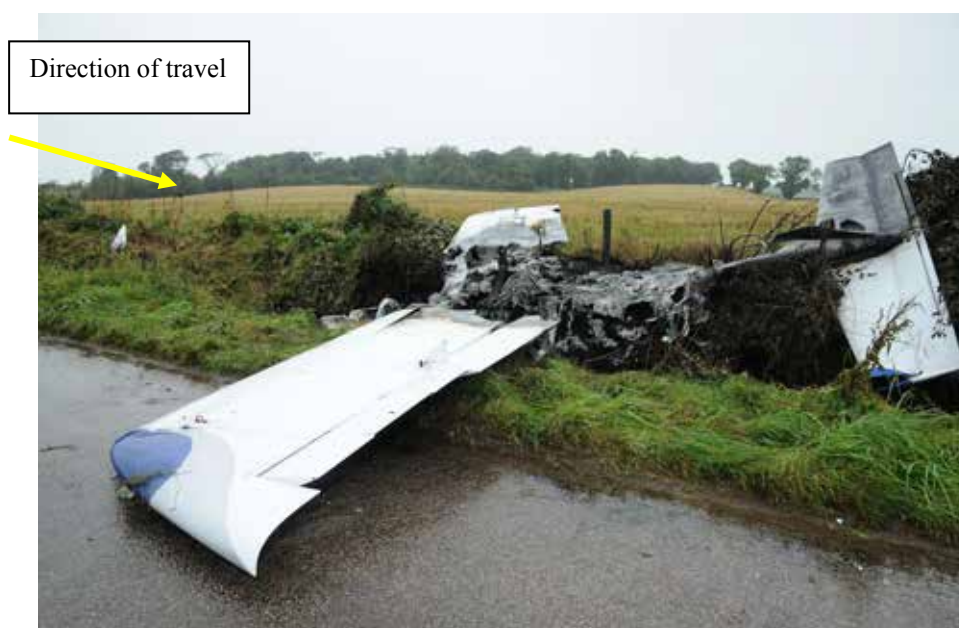
Figure 2
Accident site

The accident site was approximately 590 m north of Bute Airstrip along the line of a fence and ditch that ran parallel to the A844. With the exception of the field to the north of the road, which contained a crop of corn approximately 0.4 m high, there were no other suitable areas in the immediate vicinity in which to land. See Figure 2.

Ground marks and paint flakes from the right wingtip show that the aircraft touched down on the right mainwheel and nosewheel at a relatively shallow angle, banked to the right on a heading of approximately $115^{\circ}(T)$. The nosewheel broke off and the aircraft continued to slide forward with the inner section of the left wing striking and knocking over several fence posts. After approximately 10 m the front section of the aircraft dropped into a ditch and the aircraft turned over onto its back with the fin coming to rest in a hedge. Propeller cut marks in the ground indicated that the engine was still producing power when it struck the ground.

Foliage in the ditch, the fence posts and foliage on the north side of the ditch were all badly burnt, whereas the grass on the south side of the road was not. This burn pattern was consistent with the direction of the wind.

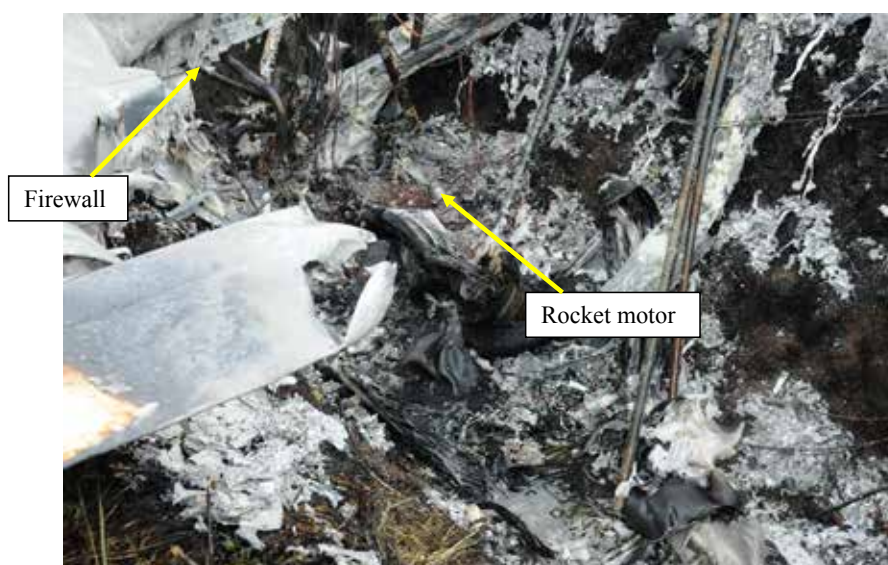
Figure 7

The empty rocket motor casing was found lying within the inverted wreckage, approximately 1 m from the firewall where the launcher was fitted, Figure 7.

Location of burnt out rocket motor

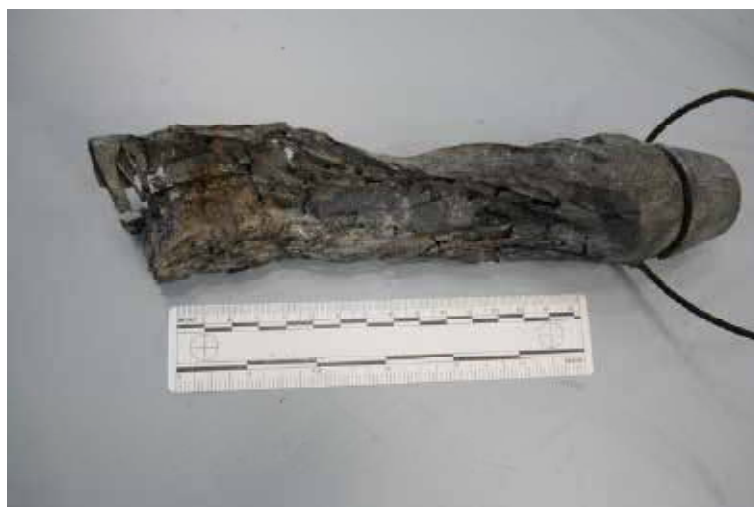
Figure 8

The rocket casing had been badly damaged by heat and on one side the metal had melted leaving numerous holes. The forward bulkhead on the rocket motor was missing and there was no evidence of propellant remaining in either the rocket motor or nozzle. There was also no evidence of the rocket casing having exploded, Figure 8.

Rocket motor casing

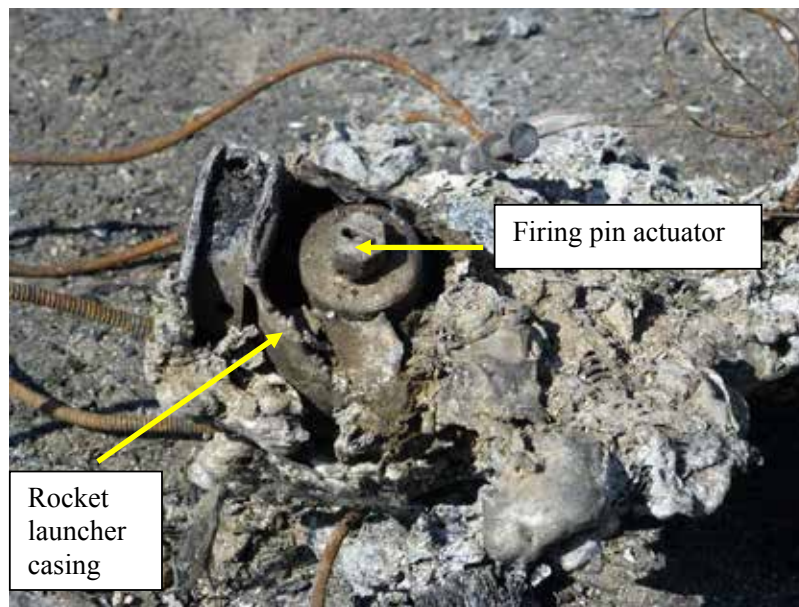
Figure 9

Approximately two thirds of the rocket launcher had been destroyed in the fire and the remaining part had detached from the firewall and combined with other components and molten metal, Figure 9. The cable from the firing handle was not attached to the firing pin actuator which was still fitted in the base of the launch tube. An x-ray examination revealed that both primer cartridges had operated. The police advised that tests carried out on similar primers showed that they generally 'cooked off' at a temperature of approximately 180°C. The firing handle had been badly distorted, the red paint had burnt off and the outer conduit had burnt away. It is believed that the actuating cable became detached from the firing unit as a result of the crimp, which forms the loop at the end of the cable, having softened and possibly melted in the post-crash fire.

Base of rocket motor launch tube

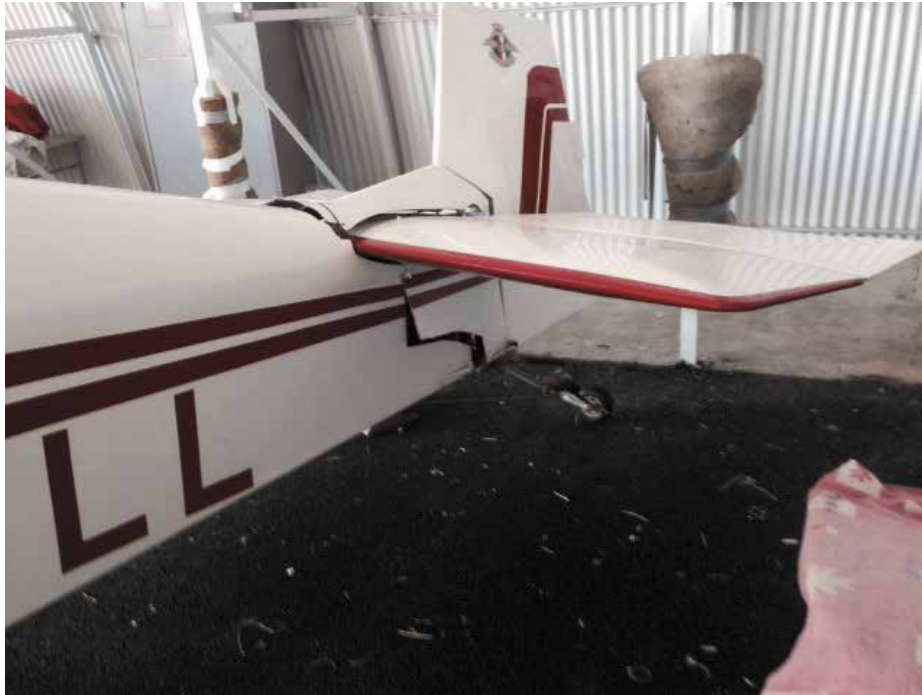
Figure 1

As the pilot shut down and vacated the aircraft, he saw that the rear fuselage had been badly damaged (Figure 1). He had not been aware of the severity of the damage until then.

G-AYLL showing damage to rear fuselage discovered after a ground loop landing incident.
(Photograph via pilot)
