Rail Accident Investigation Branch

Rail Accident Report

**Signal passed at danger and subsequent
near miss at Didcot North junction
22 August 2007**

Signal passed at danger and subsequent near miss at Didcot North junction, 22 August 2007

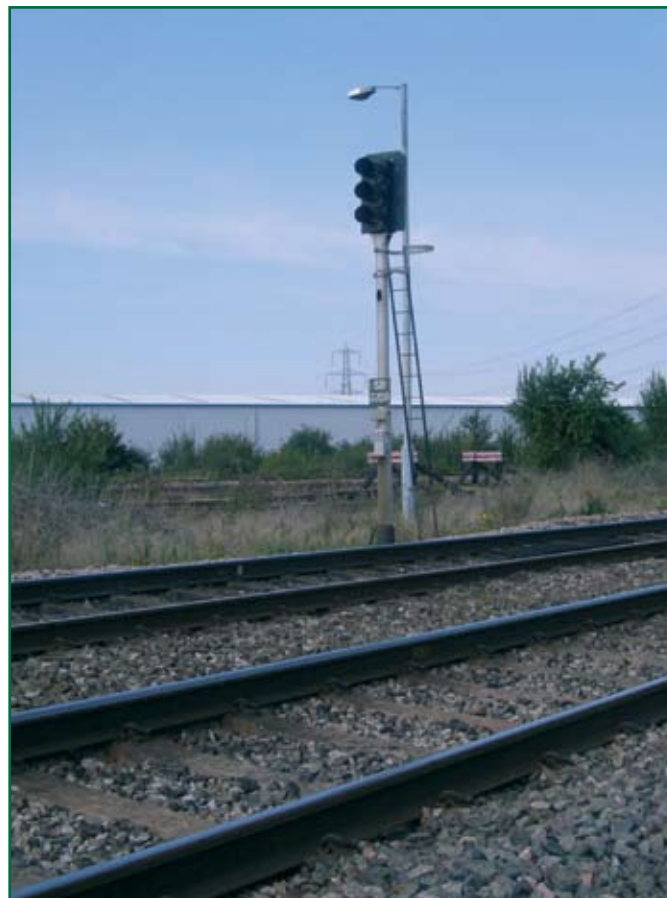
Figure 2: Signal SB2209

- 22 The signal that was passed at danger during this incident was located at the north end of the Down Avoiding line, 225 m south of Didcot North junction.

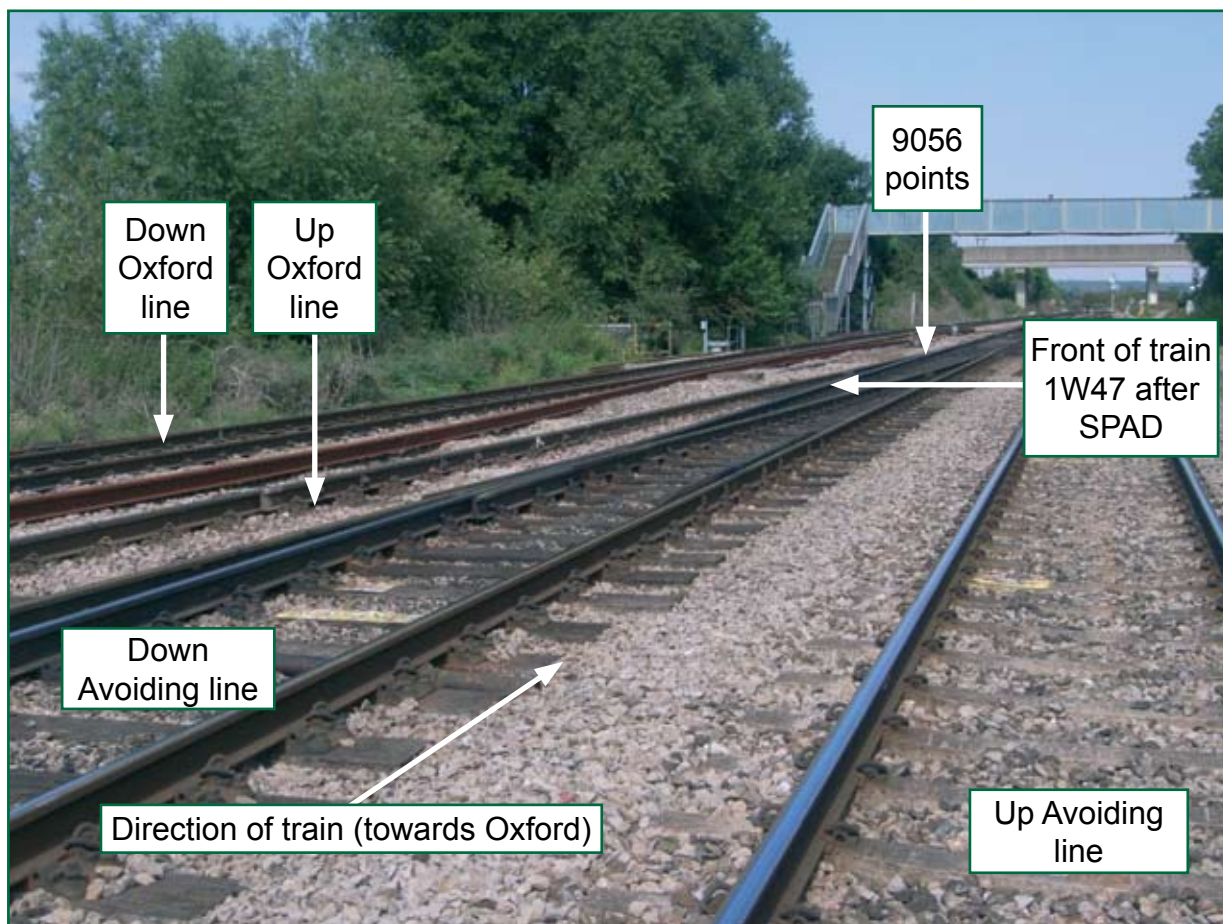
Figure 3: Didcot North junction

- At 16:38 hrs on 22 August 2007 train 1W47, the 15:51 hrs First Great Western passenger service from London Paddington to Worcester Shrub Hill, formed by a High Speed Train (HST) set, passed SB2209 signal at danger on the *Down Avoiding line* to the north of Didcot Parkway station. At the same time train 2P66, the 16:21 hrs First Great Western passenger service from Oxford to London Paddington, was just passing clear of the junction after being routed from the *Up Oxford line* towards Didcot Parkway station. Despite the correct operation of the *Train Protection Warning System (TPWS)* equipment, train 1W47 did not come to a stand until it had run onto the *Up Oxford line*, foul of the junction (Figure 1).

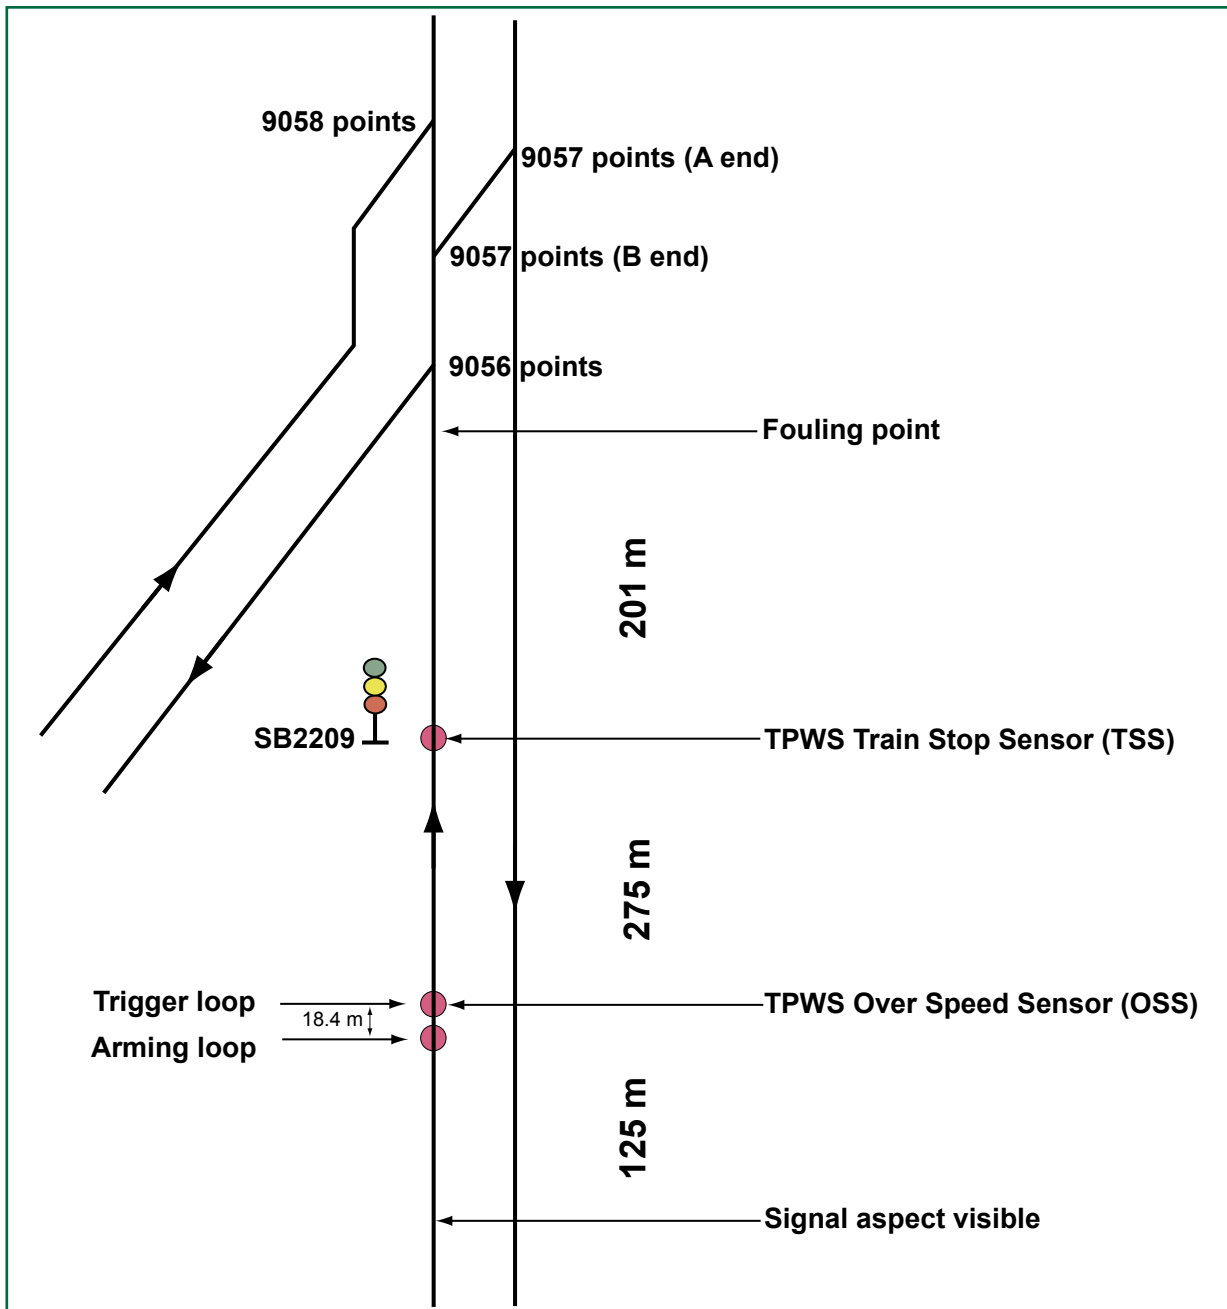
Figure 6: Track layout, the arrangement of signalling equipment, TPWS and key dimensions in the immediate proximity of signal SB2209

<i>Sighting distance</i> of signal SB2209	400 m
Distance between over speed sensor <i>arming</i> and <i>trigger loops</i>	18.4 m
Distance between over speed sensor trigger loop and signal SB2209	275 m
Speed at which the over speed sensor would cause the emergency brakes of a passenger train to apply	41.5 mph (67 km/h)
Distance between signal SB2209 and fouling point	201m

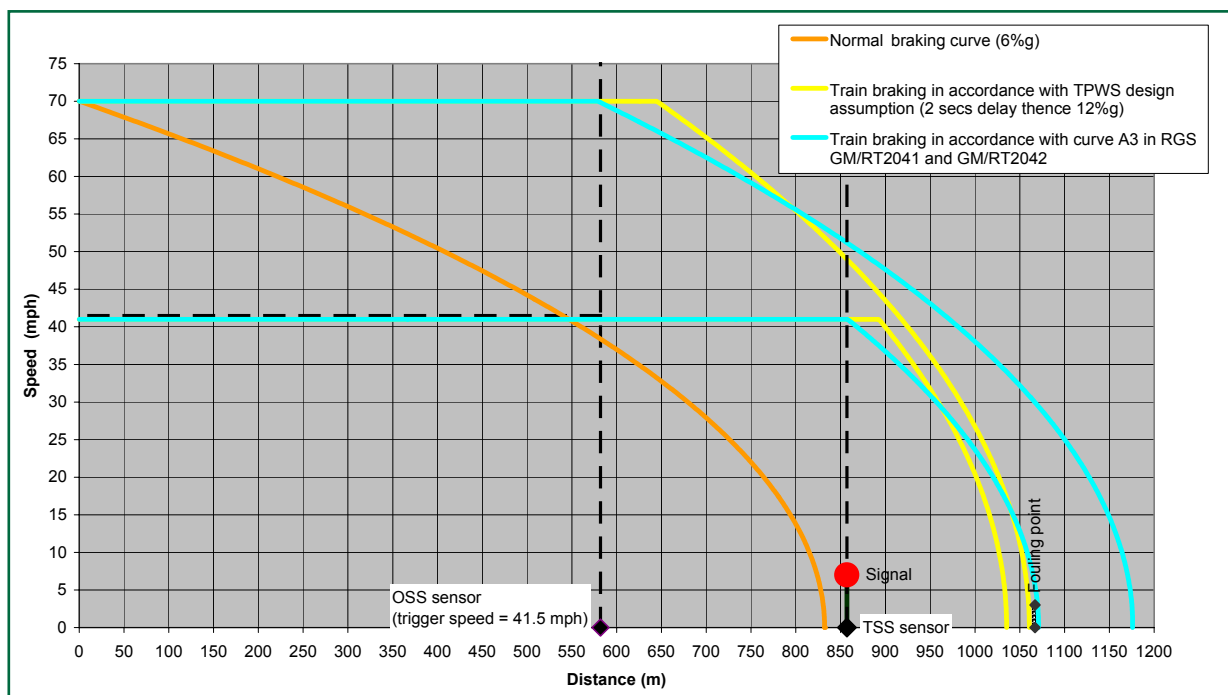
Figure 8: Typical TPWS arrangement for permitted speed of 70 mph with a 'safe over-run distance' of 201 m

142 The graph at Figure 8 demonstrates that the typical configuration of TPWS equipment is sufficient to bring a train that has passed a signal at danger to a stand before the fouling point, provided its braking performance is at least consistent with the TPWS design assumption. However, this performance cannot be assured for trains that are designed to comply with the minimum requirements of current Railway Group Standards.

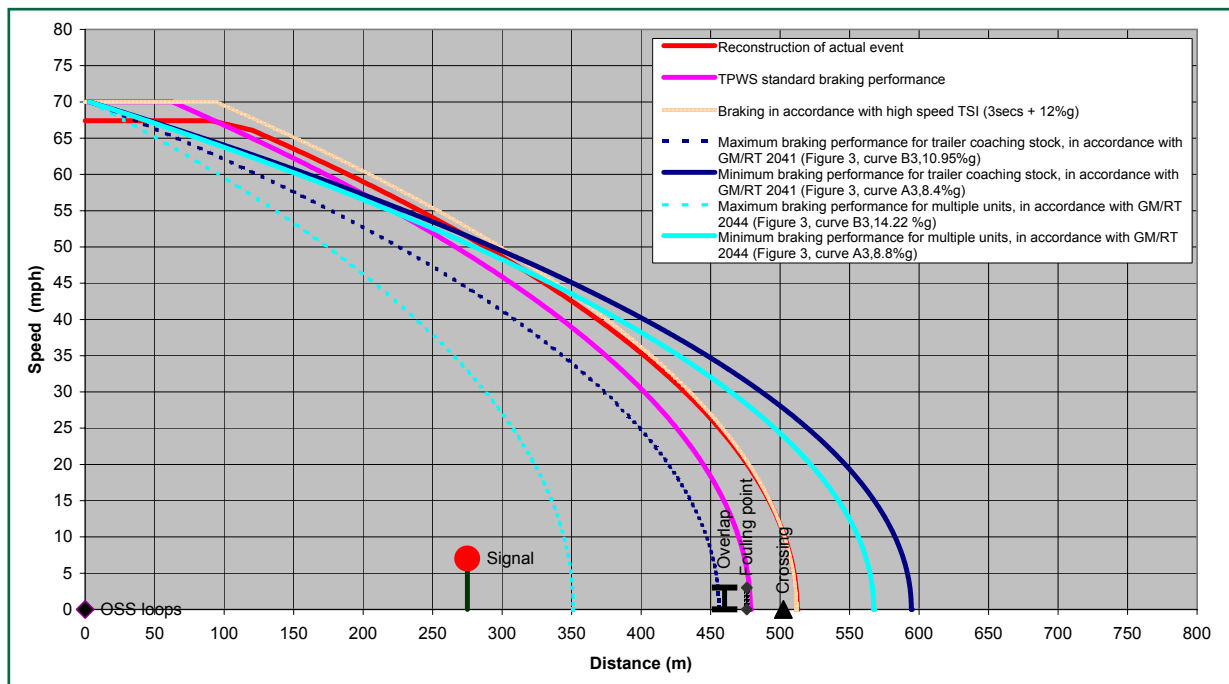
Figure 9: Standard braking curves from 70 mph following TPWS intervention at OSS loops ('classic' TPWS configuration - as signal SB2209, Didcot)

212 Even new passenger trains designed in accordance with the current Railway Group Standards are not guaranteed to possess braking performance consistent with that specified for TPWS. The graph at Figure 9 shows that the minimum braking performance specified for new trailer coaching stock and multiple units in RGS GM/RT 2041 and 2044 is below that assumed in the design of TPWS.
