Rail Accident Investigation Branch

Rail Accident Report

**Fatal accident at Morden Hall Park footpath
crossing
13 September 2008**

Report 06/2009
March 2009

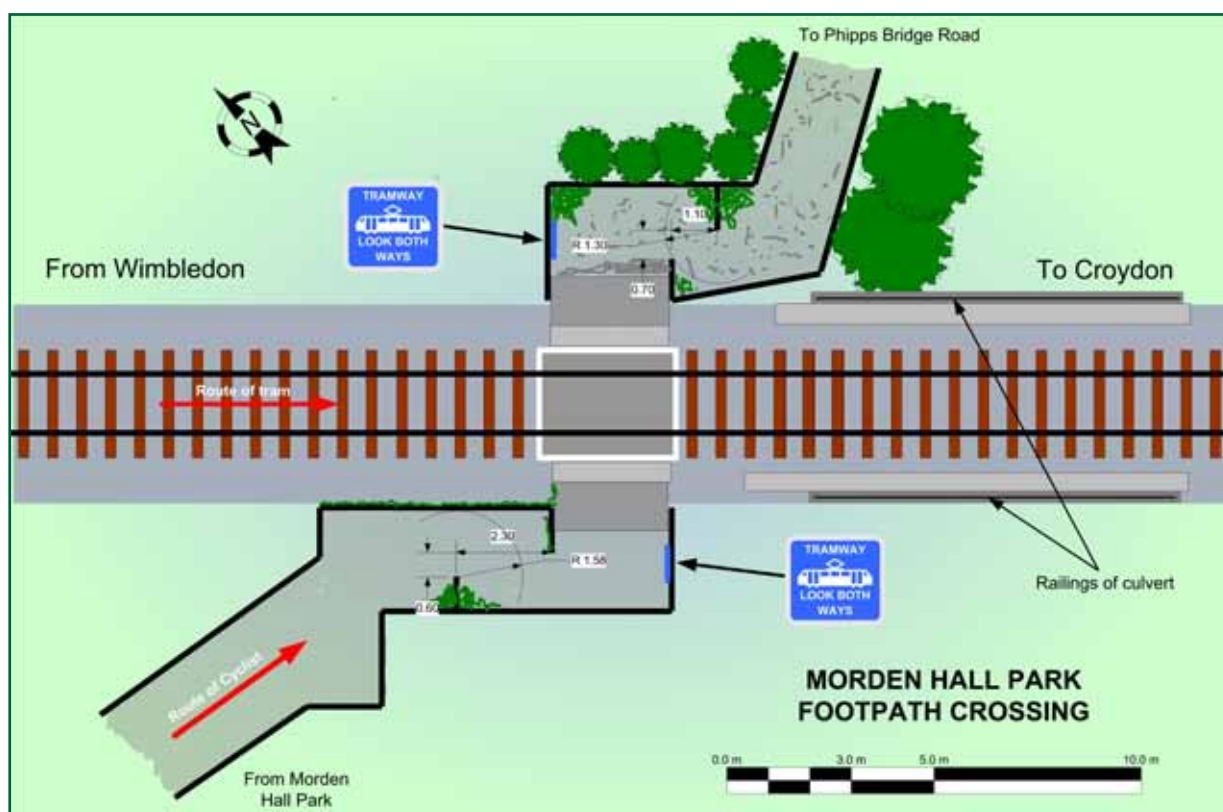
Figure 2: Layout of foot crossing

- 18 The crossing is approached through *chicanes* on both sides, constructed of wooden post and rail fencing about 1.25 m high. The chicanes on each side have quite different dimensions, but a common factor is that the barriers which form the chicanes do not overlap, but have a clear gap 0.6 m - 0.7 m wide between them, which gives a clear path width of at least 1.3 m through the chicane (Figure 2).

- 52 Mr Sivalingam cycled towards the crossing with his back to the tram. The design of the chicane at the crossing made him slow down, but did not cause him to stop or dismount. After passing through the chicane, he turned left to cross over the track, but he did not complete the turn (so that he was at right angles to the track), until he reached the centre of the track. The design of the chicane and crossing permitted him to approach the tramway without turning to be at right angles to the track, and hence he remained with his back to the approaching tram. If he had turned and seen the tram before moving onto the crossing, he would probably have been able to stop clear of the track.

- ‘Fencing or pedestrian guard rails should be provided where necessary to guide pedestrians to face oncoming trams before they cross the track.’
- 55 The chicanes at Morden Hall Park crossing were not effective in this respect because the distance between the chicane barriers and their orientation at right angles to the track, combined with the very short final approach to the crossing, did not force users, both on foot and on bicycles, to turn fully towards the tramway when passing through the chicane and before turning onto the track. This was a causal factor in the accident.

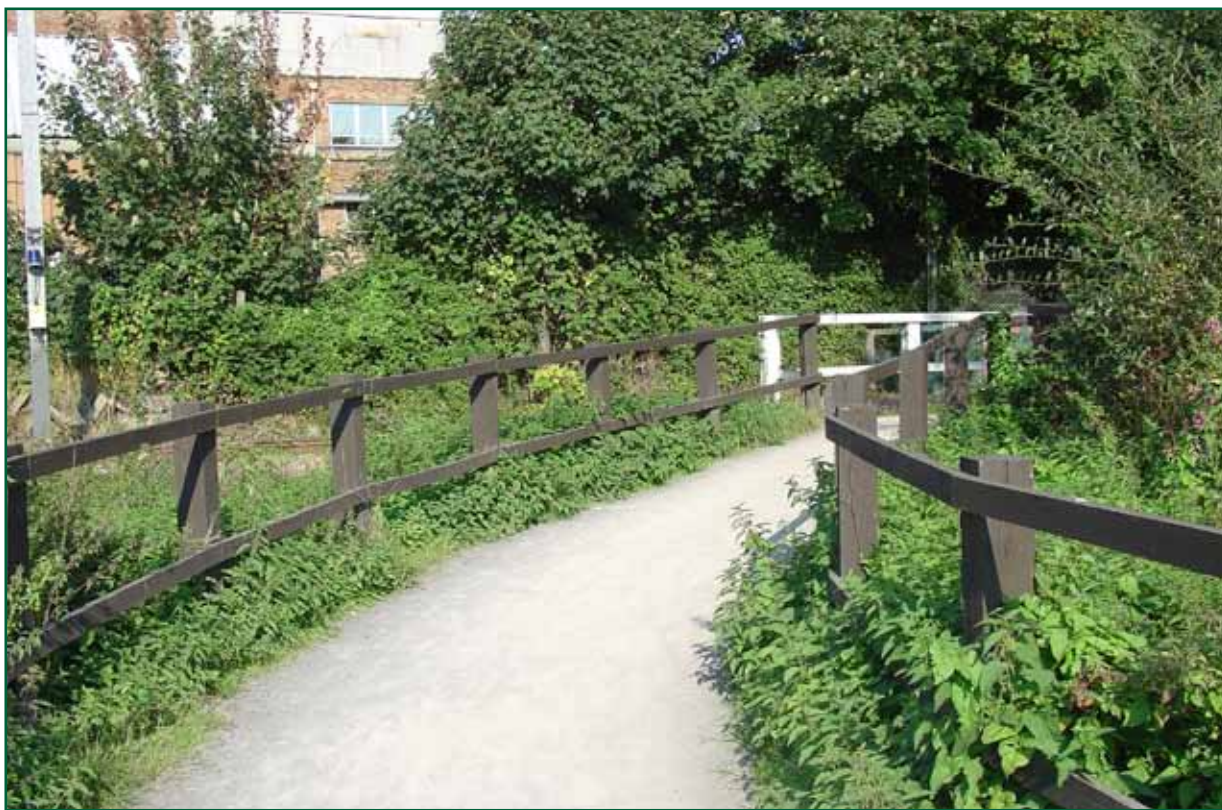
Figure 3: Approach to crossing from south-west

- 19 The approach to the crossing from the south-west is along a fenced, curving path 2.6 m wide (Figure 3). Before 2006, this approach was by a narrower path which ran directly towards the tramway at right angles to the track. In the winter of 2005/06 the layout of the approach paths was altered as part of a project to re-route the Wandle Trail around the edge of the wetlands which are an important feature of the park (Figure 4). The re-routed path curves round to approach the tramway at an angle of about 40°, and then bends sharply to enter the chicane, which is parallel to the tramway. Visibility along the tramway in both directions is unobstructed for several hundred metres in both directions from the point when a potential user reaches the centre of the chicanes (Figures 5 and 6).

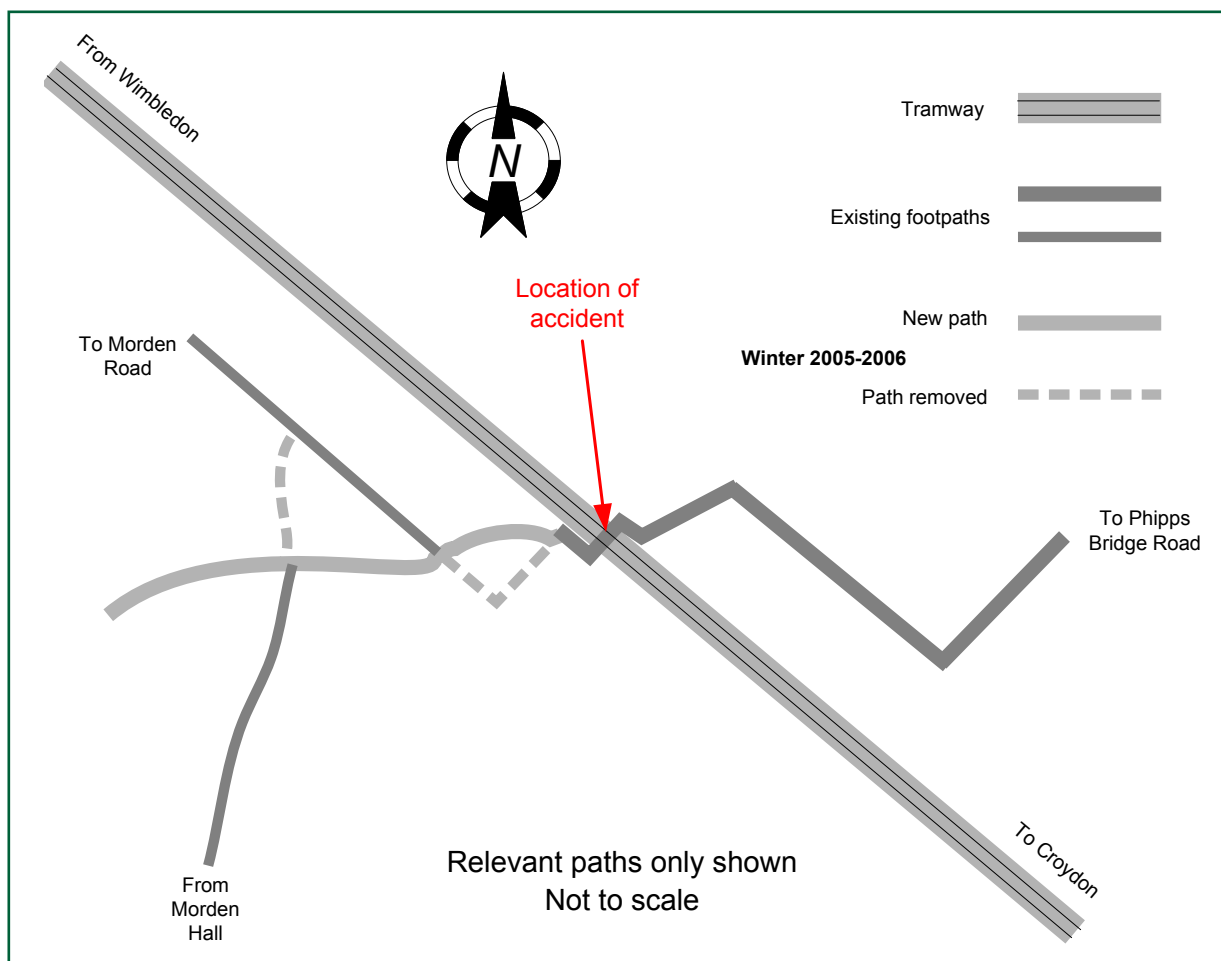
Figure 4: Footpaths near tramway crossing

- 60 The layout of the path on the south-west side of the crossing was altered over the winter of 2005-06 (paragraph 19 and Figure 4). As originally installed, the path approached the crossing at right angles, giving a user the opportunity to look both ways before turning right to pass through the chicane. The revised layout turns the user to the right gradually as they approach the crossing. This means that as they enter the chicane cyclists and pedestrians have their back to trams approaching from the Wimbledon direction, making it less likely that such people will become aware of trams unless they deliberately turn to look.

- 62 There was consultation between SWELTRAC, the National Trust and TCL before the work was done, but there is no evidence that the risk associated with the revised layout was identified by TCL. The change to the layout was a possible contributory factor in the accident.

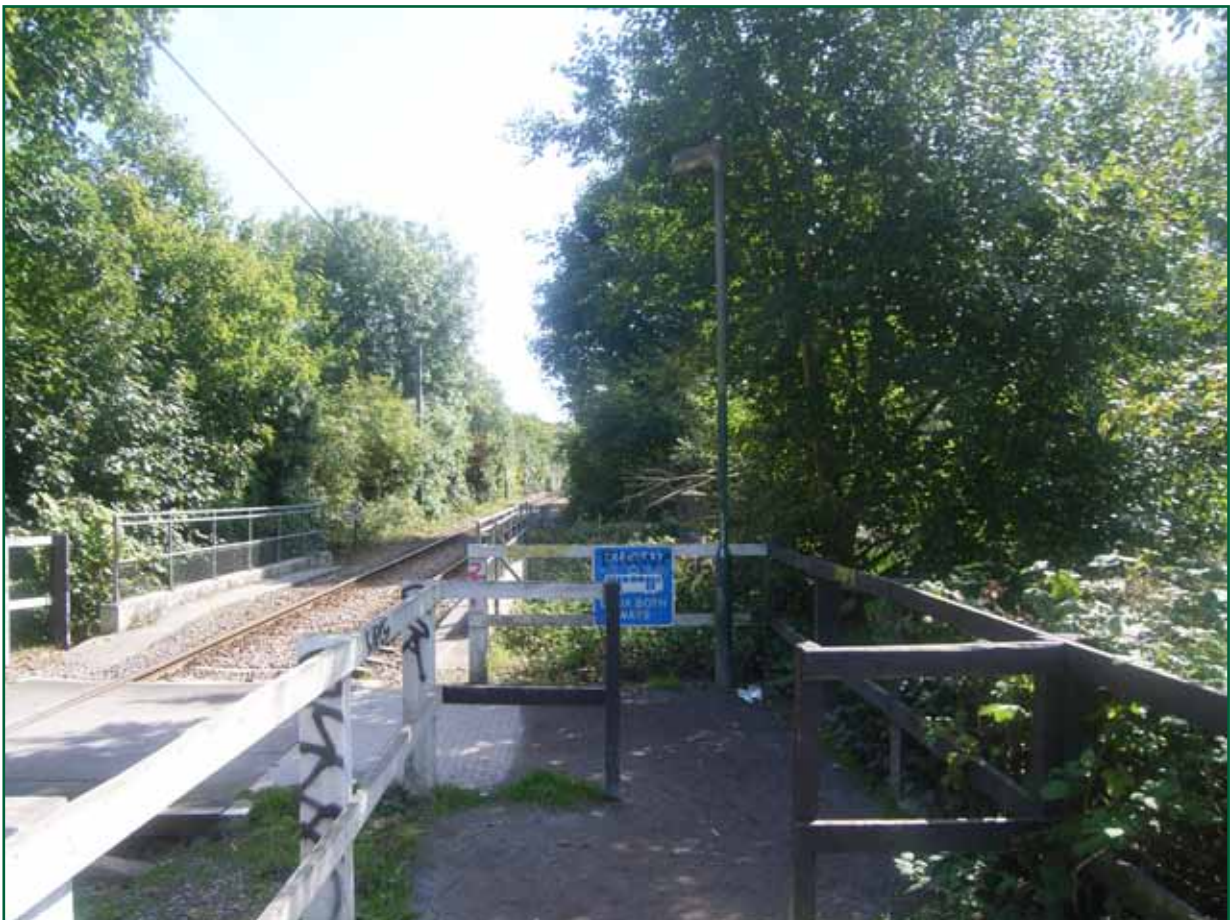
Figure 6: View towards Phipps Bridge, south-east from crossing

- 15 One of the channels of the river Wandle passes under the tramway in a culvert just to the south-east of the crossing. There are trees and bushes all around the crossing (Figures 2 and 6).

- 20 There are blue signs 0.7 m square showing a pictogram of a tram and the wording '**TRAMWAY – LOOK BOTH WAYS**' (diagram 963.3 of the Traffic Signs Regulations and General Directions 2002), fixed to the fencing at waist level, facing users coming through the chicanes, on both sides of the crossing (Figures 2 and 6).

- 21 The crossing approaches are equipped with lamps on poles at both sides (one can be seen in Figure 6), but these were not lit at the time of the accident (which occurred during daylight), and, although this was not relevant to the accident, subsequent investigation found that they had not been maintained since installation and were no longer functional (paragraph 67).

- 58 The sign warning of the tramway was slightly obscured by graffiti (Figure 6). Mr Sivalingam was a local resident who is known to have been familiar with the crossing, and the condition of the sign and its position (paragraph 20) are not considered to have contributed to the accident.
