RAIB Bulletin 02/2013

Near miss at Southwark Bridge Junction, near Elephant & Castle station, London, 21 January 2013

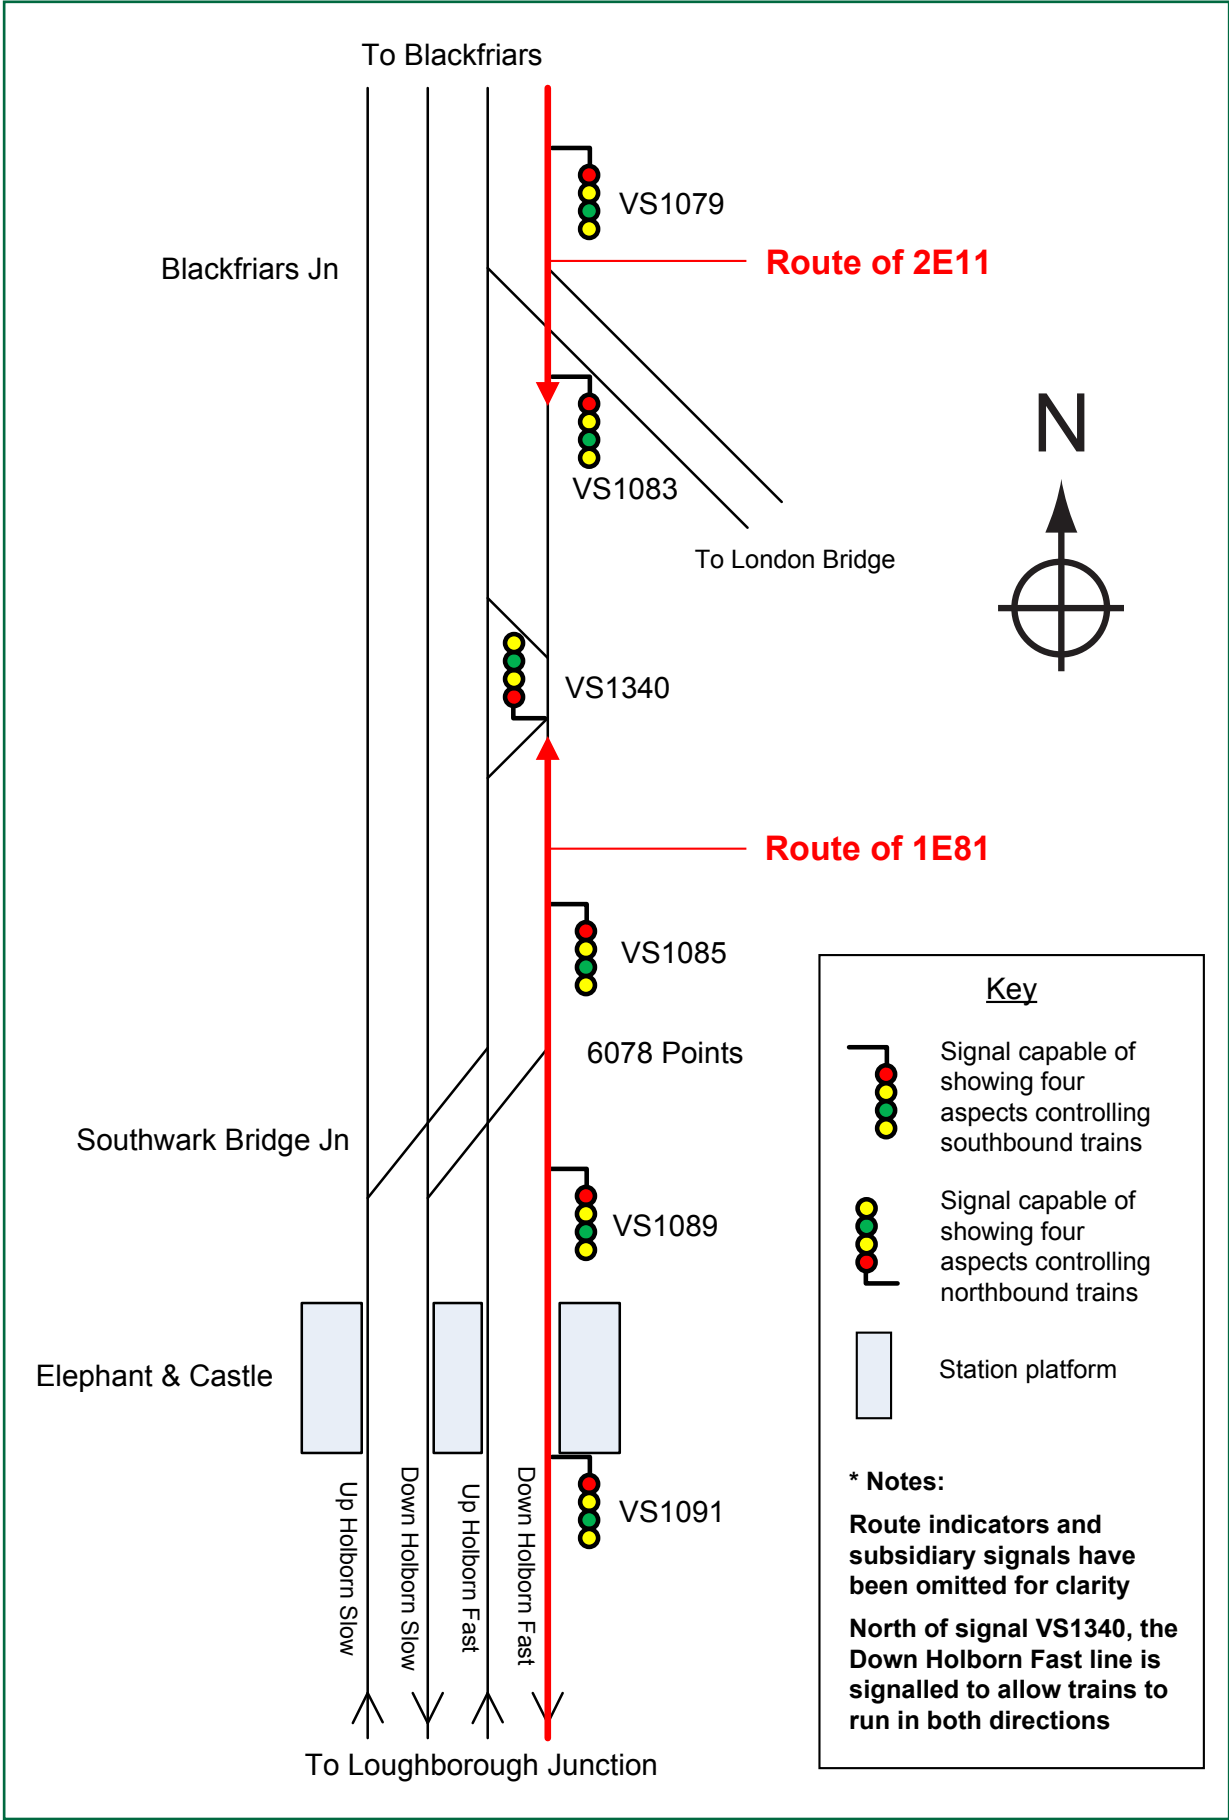
Figure 2: Track and signalling diagram (showing only relevant signals)

- 2 At 07:02 hrs, train 1E81 left Elephant & Castle station on the Down¹ Holborn Fast line, heading south (figure 2), and then encountered problems picking up power due to ice on the conductor rail². About 1.5 miles (2.4 km) south of Elephant & Castle the train was unable to proceed further, so the driver contacted the Network Rail signaller and agreed to move to the rear driving cab, ready to return towards Elephant & Castle. Having made an announcement to passengers that the train was not proceeding any further, the driver was asked by some of them if they could alight at Elephant & Castle station.

- 4 The driver drove the train to Elephant & Castle station, reaching a maximum speed of 23 mph (37 km/h). On arrival at the station he stopped the train and allowed passengers to disembark. After 50 seconds, at approximately 07:31 hrs, the driver restarted the train, heading towards signal VS1340 (figure 2), the first signal controlling northbound movements on the Down Holborn Fast line. During this movement, train 1E81 reached a maximum speed of 17 mph (27 km/h) and passed over and damaged points³ 6078, which were set as part of the route for train 2E11 to travel from the Down Holborn Fast line to the Down Holborn Slow line.

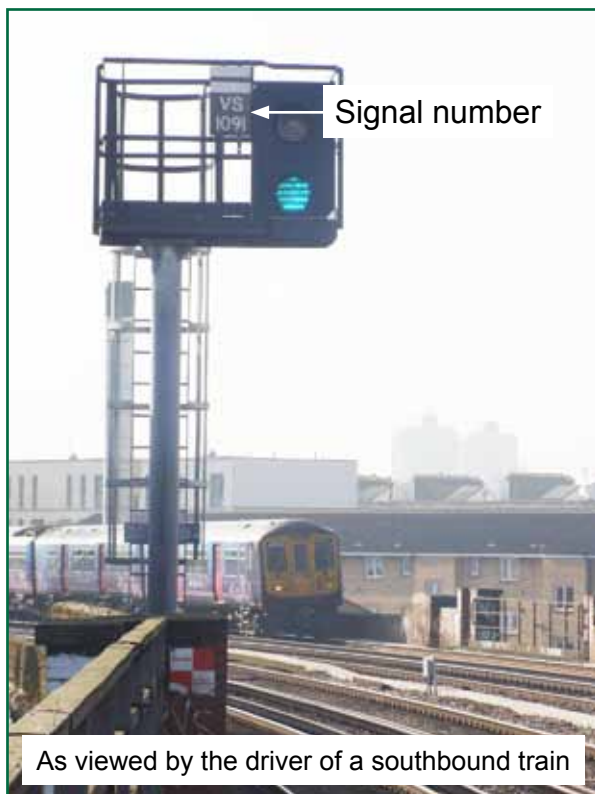
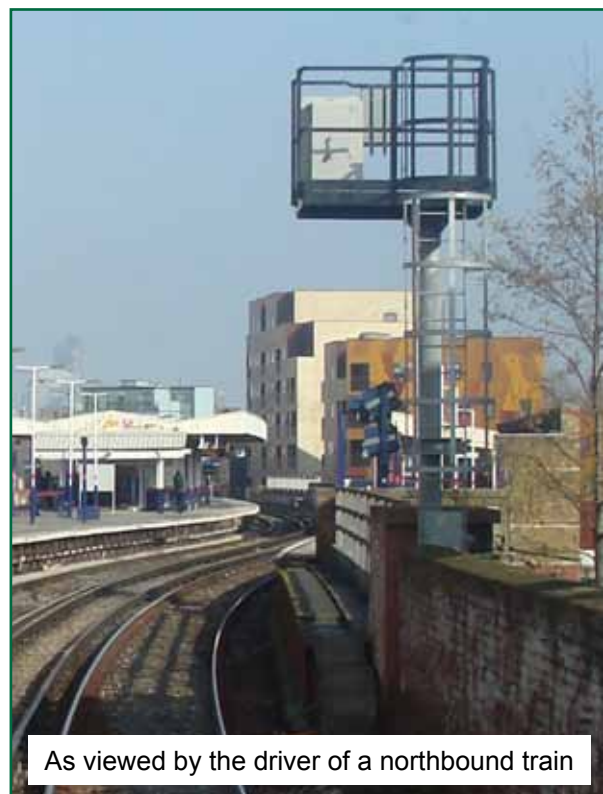
Figure 3: Signal VS1091

- The signaller did not insist that the driver repeat the message back to him to demonstrate his understanding.
- 10 The signaller specified the intended stop location for the train using the signal identification number, which was familiar to him and visible on his display screen. The driver was not, and is not required by his training to be, familiar with all the signal numbers on his route. Each signal carries a plate showing the signal number, facing towards trains moving in the direction controlled by that signal. The signal mentioned in the signaller's instruction (VS1091) controlled southbound trains, and so the number could not be seen by the driver of train 1E81, as he approached it heading north (figure 3).

- 11 The driver has stated he was unclear about the precise location of the signal that the signaller had specified, but was aware that there was a signal beyond Elephant & Castle controlling his direction of travel. The driver has stated he believed this was where the signaller had intended him to stop, and he only stopped at Elephant & Castle in response to passenger requests (paragraph 2). The driver did not appreciate that the specified signal number was likely to be facing southbound trains (signals for the down direction usually have odd numbers, while those for the up direction usually have even numbers).

As viewed by the driver of a southbound train

As viewed by the driver of a northbound train

- signallers should not rely on train drivers knowing the identification number of a signal unless the driver is approaching from the direction in which the front of the identification number plate can be seen;
